# Assessment and Repair of a Precast Parking Deck with Construction Defects

Kyle Stanish, Ph.D., S.E., P.E.

Klein & Hoffman

# Background

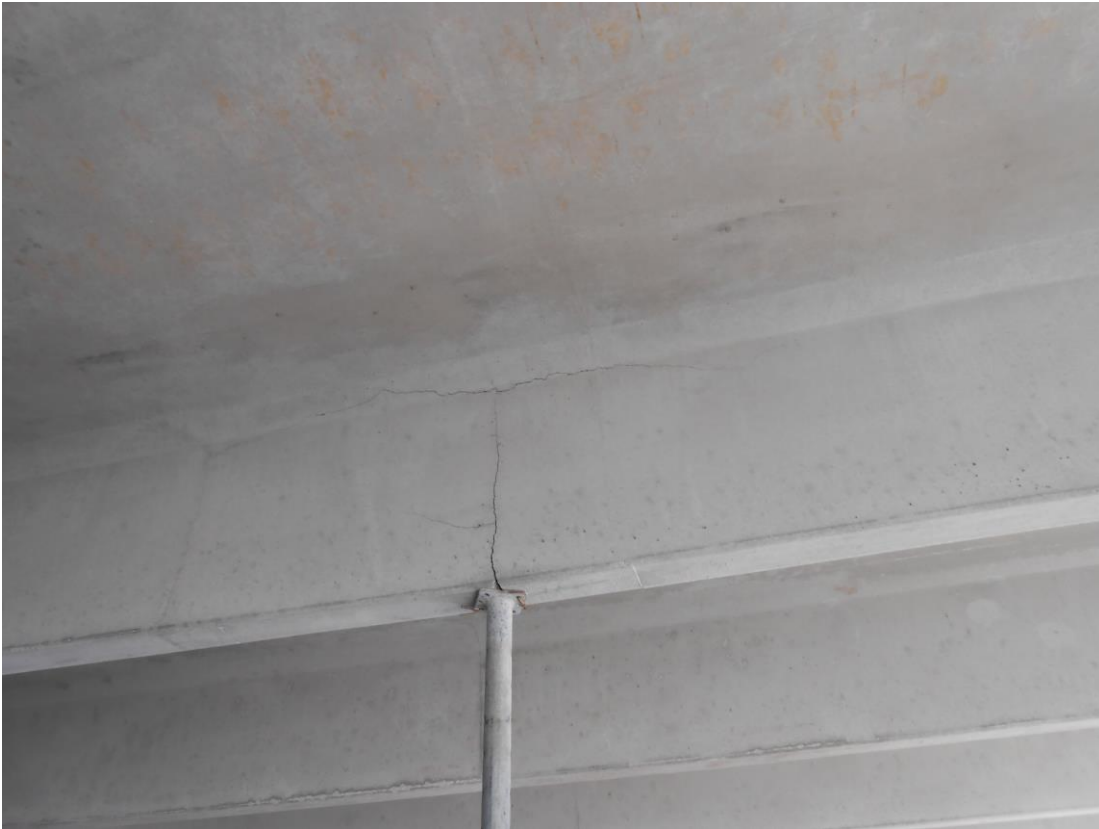
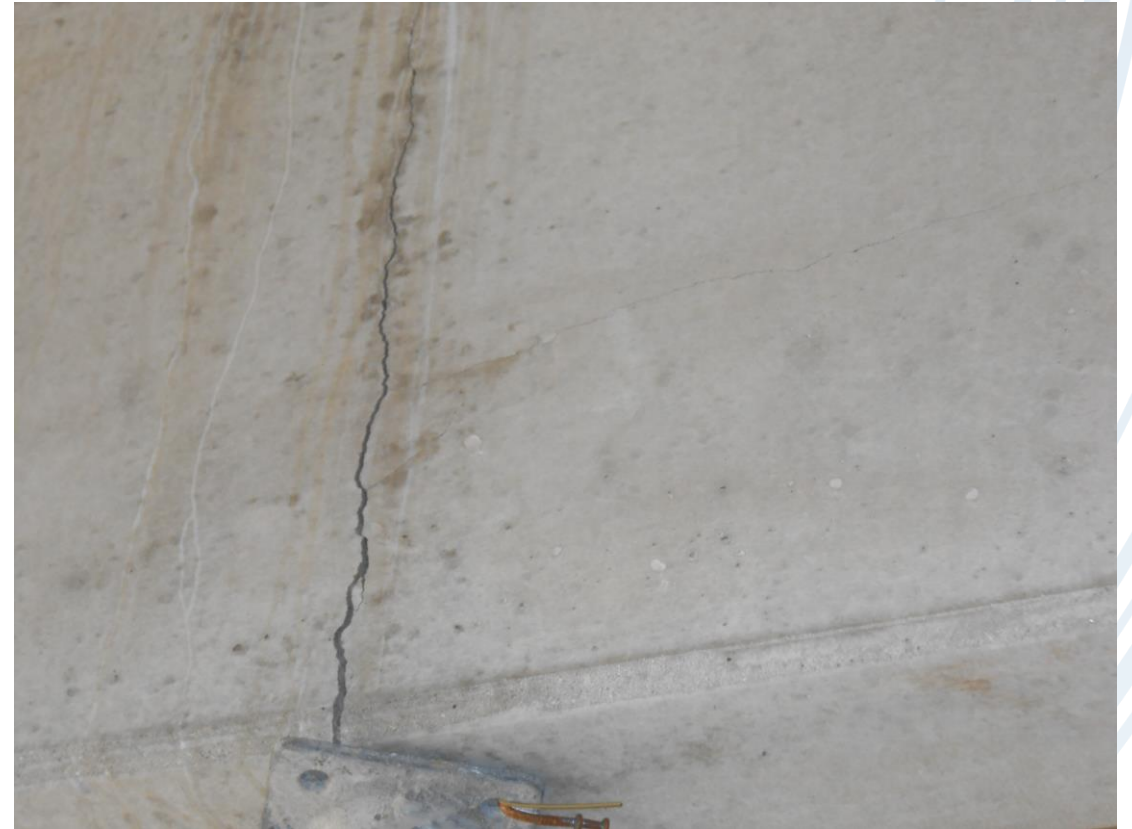
# Cracking of Double Tee Stem

- Exterior Post-tensioning of the Double Tee with the large crack
- FRP Strengthening of remaining double tees

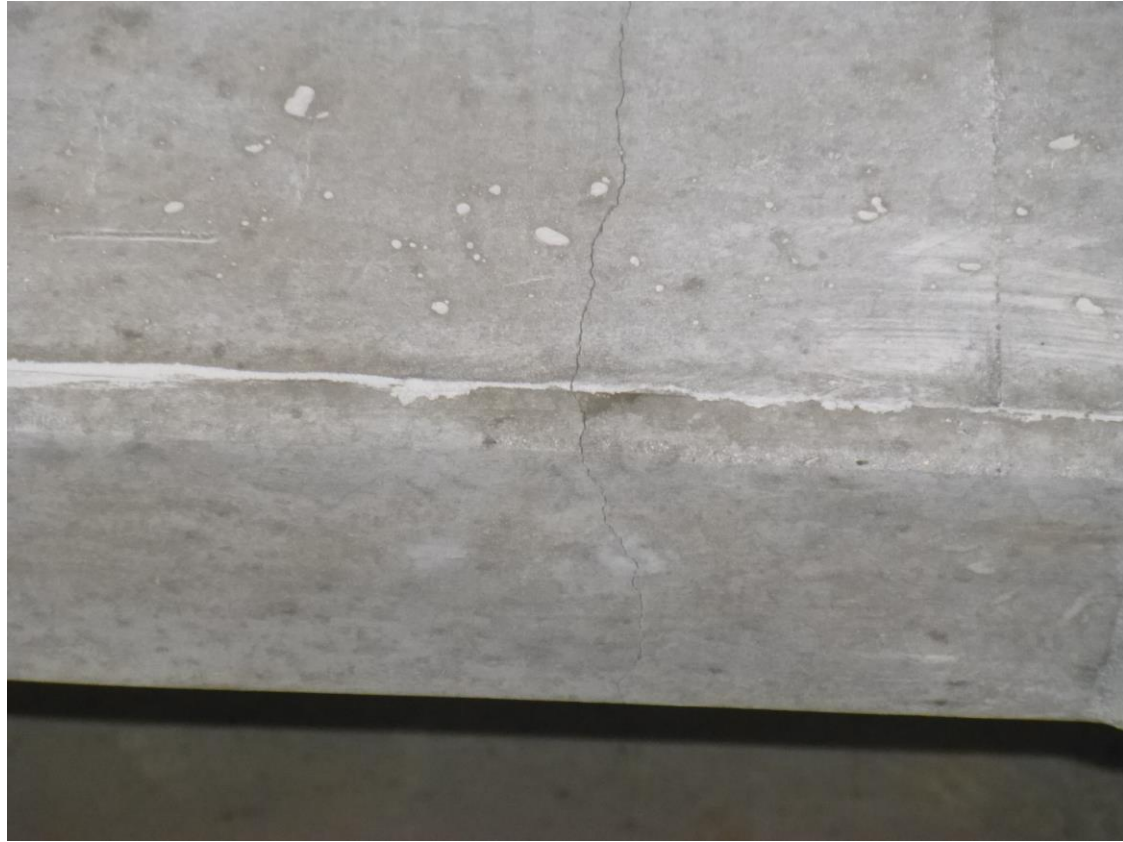
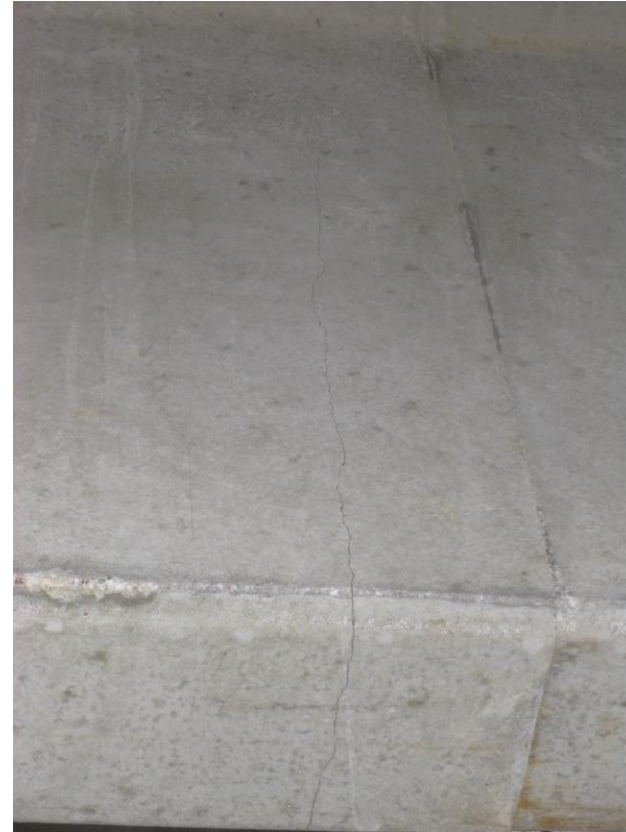
- Characterized the primary crack
  - Location, width at different points, height, looked at both sides
- Other tee stems
  - General location of cracks and width
  - Less detailed look
- Other locations in the parking facility
- **CONCLUSIONS** – the majority of the double tee stems on the lower level were cracked, but not under the roof level

## Hairline Cracking of Other Tee Stems

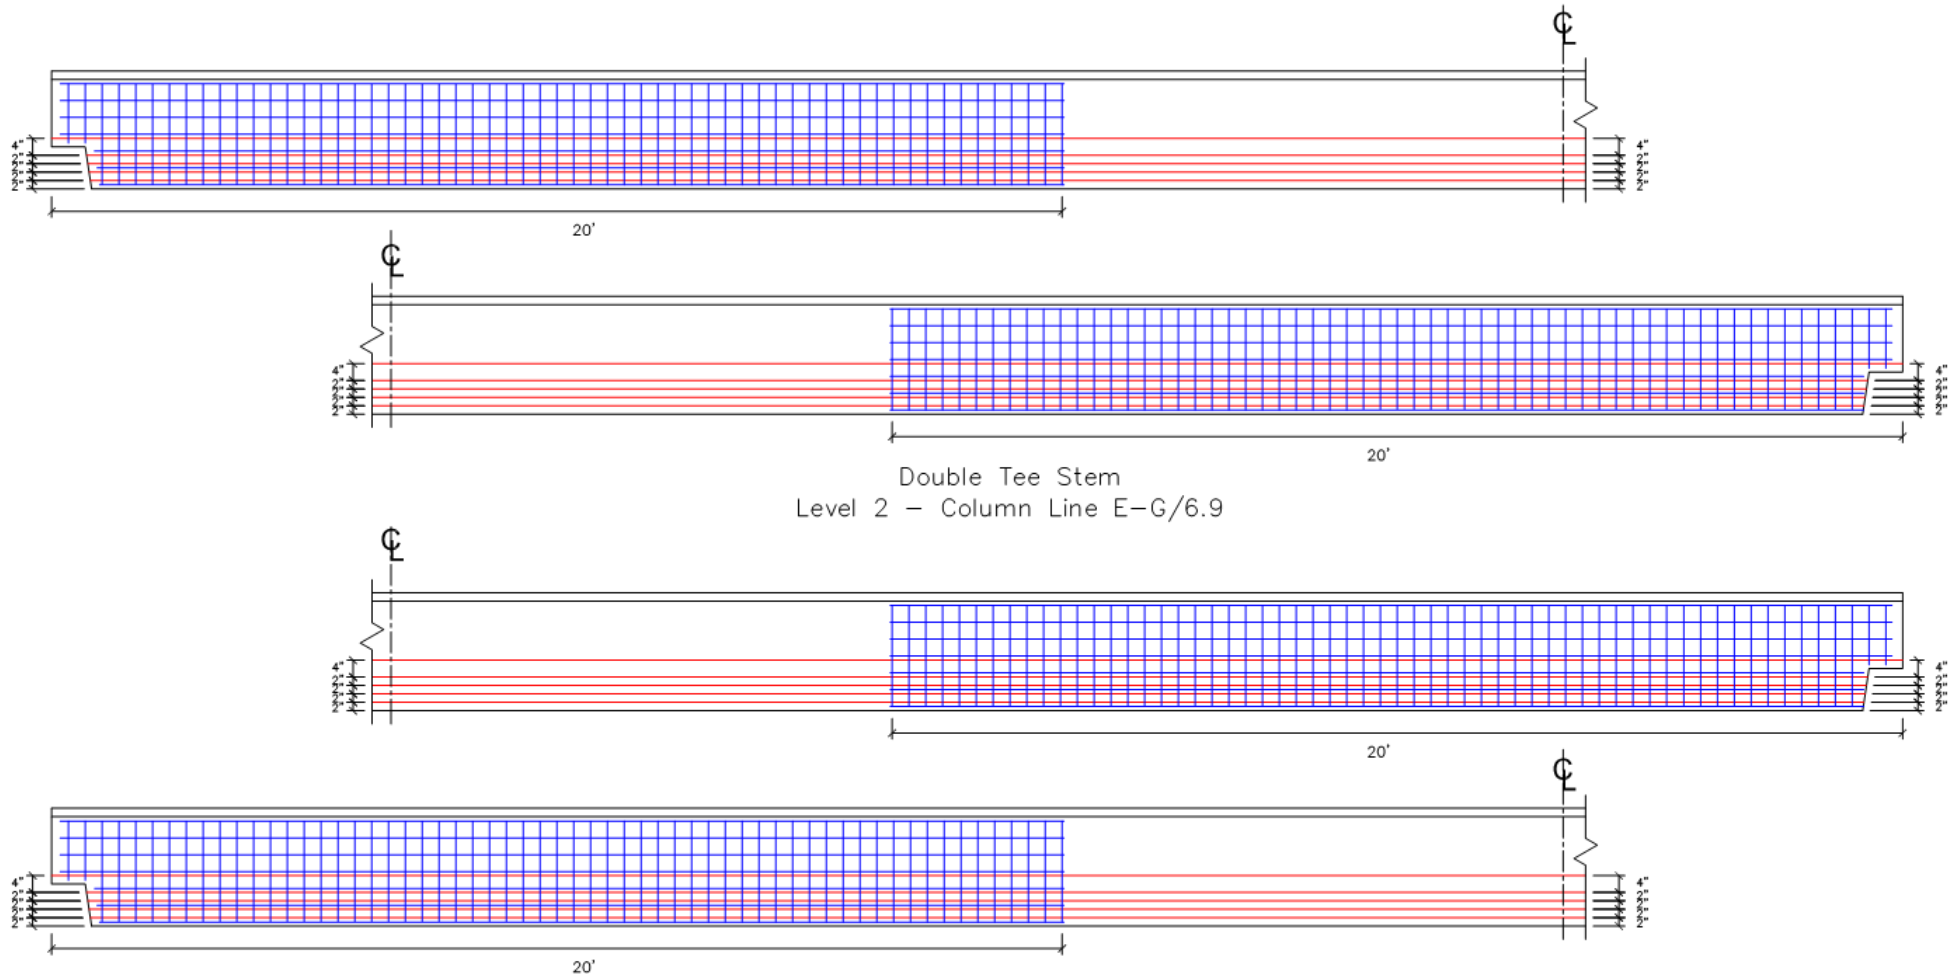
Double Tee Stem  
Level 2 - Column Line E-G/6.9

Double Tee Stem  
Level 2 - Column Line E-G/6.3
