Observations on Proportions of the Reinforced Concrete Buildings in Turkey

Santiago Pujol, Ayhan Irfanoglu, Mario Rodriguez,
Remy Lequesne, and
Chungwook Sim (University of Nebraska-Lincoln)

Deployed by ACI Committee 133 – Disaster Reconnaissance

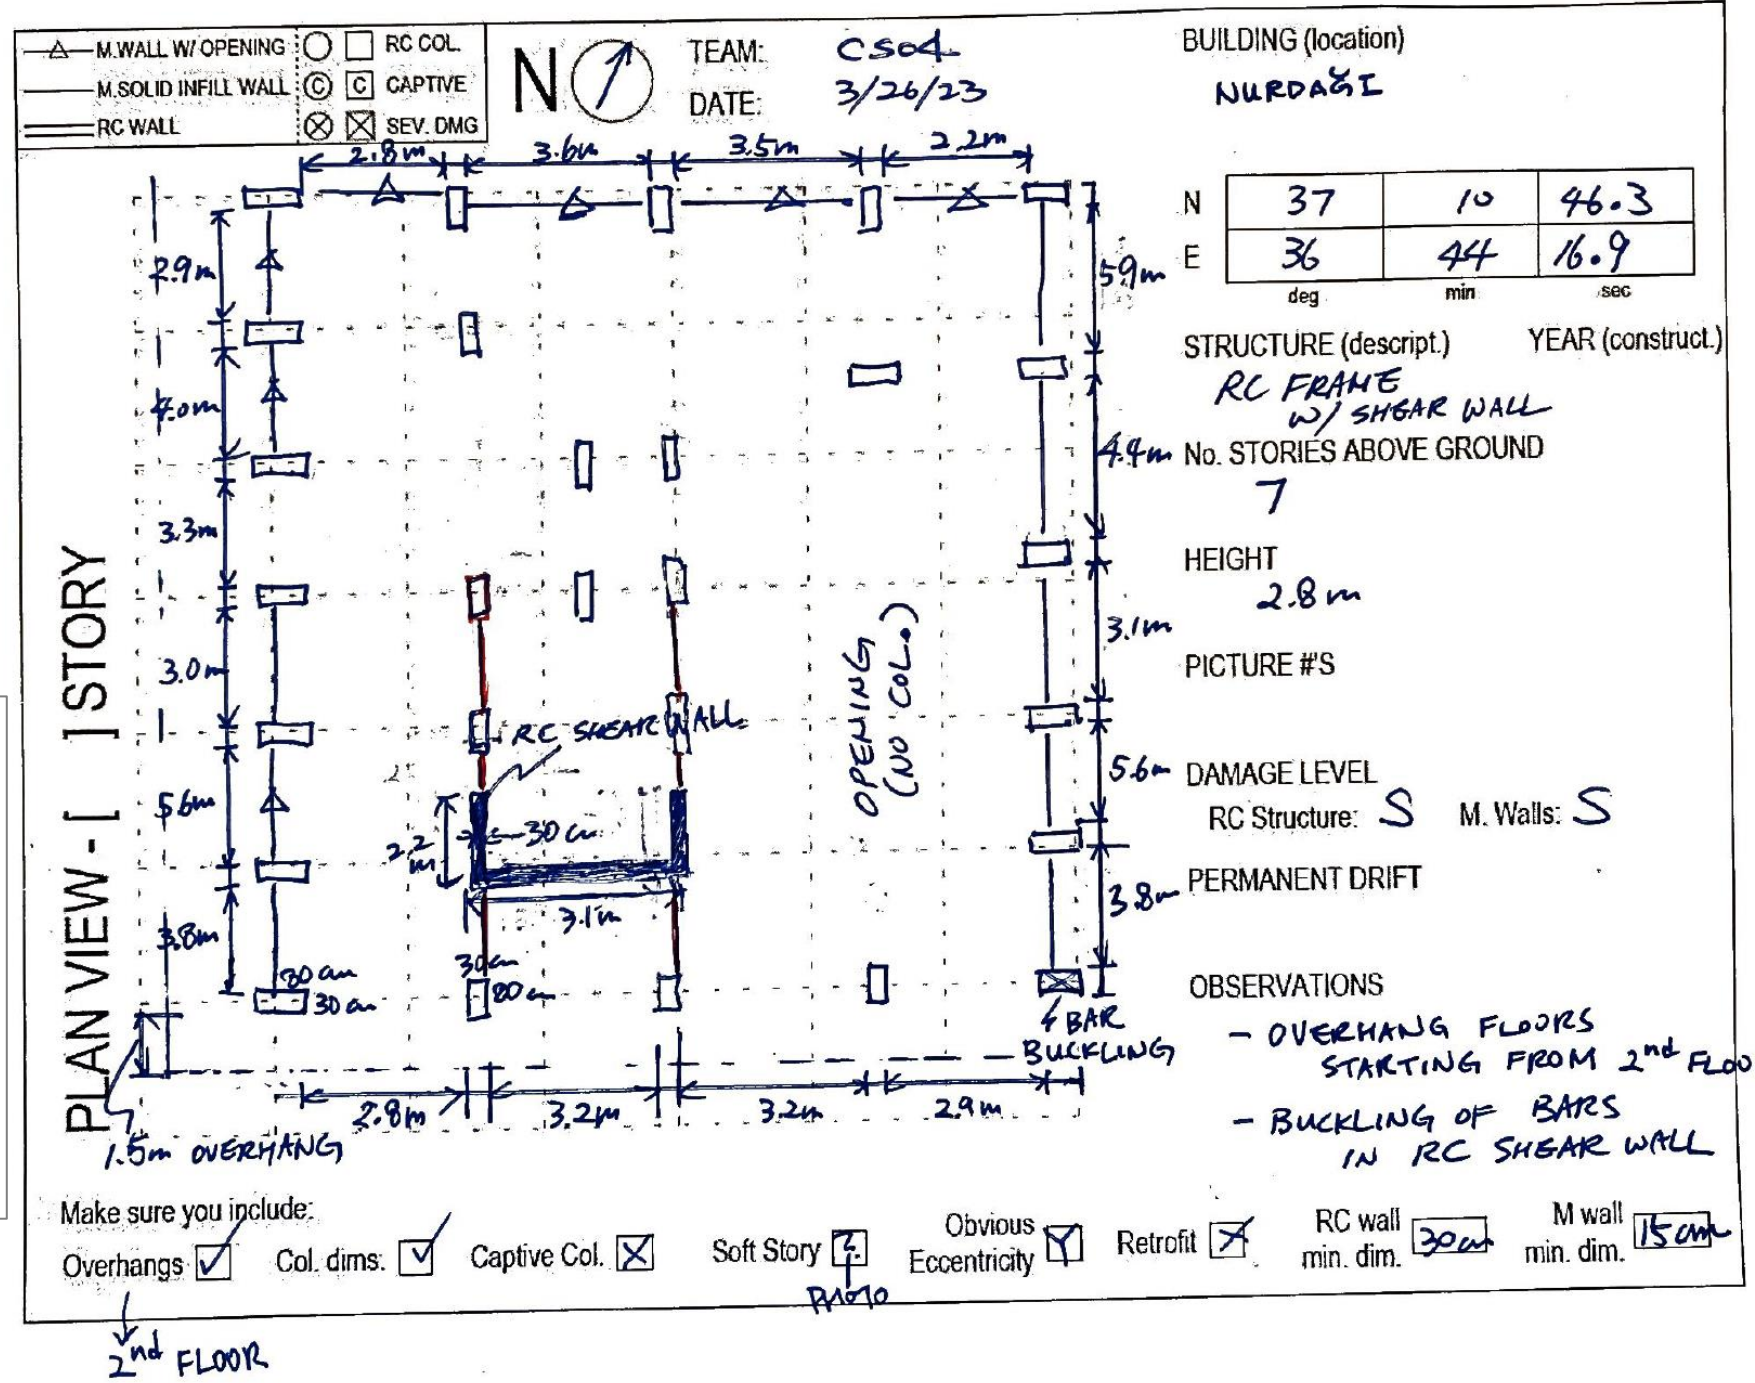
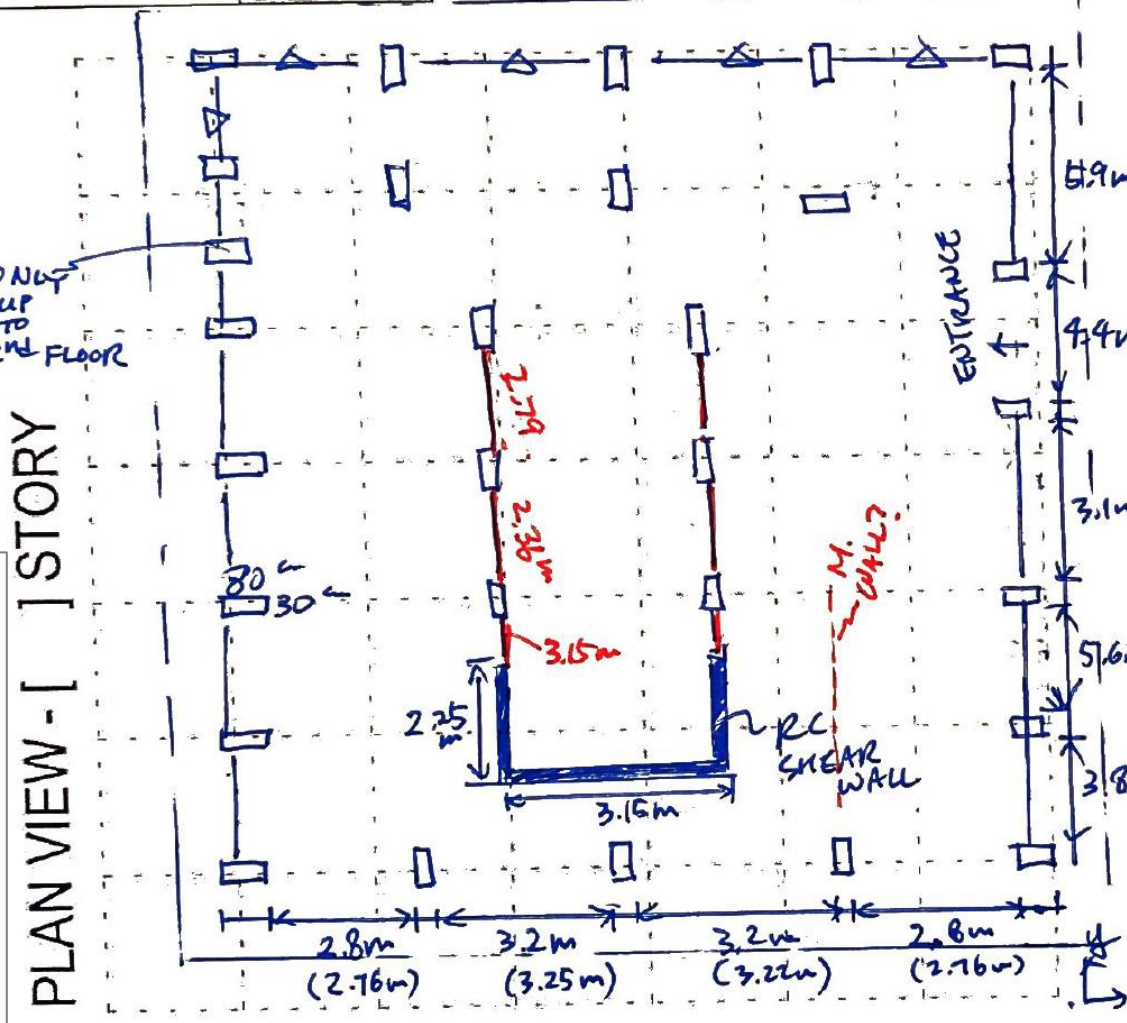
Location: Nurdagi
 PGV: 1.1 m/s
 WI: NS 0.06% EW 0.03%
 Cl: 0.1%

DAMAGE LEVEL
 RC Structure: M M. Walls: S

OBSERVATIONS
 - LESS OPENINGS THAN CS0
 - DIFFERENT DAMAGE LEVEL IN SHEAR WALL
 DUE TO HAVING ECCENTRICITY ONLY IN 1 (4-DI STY)

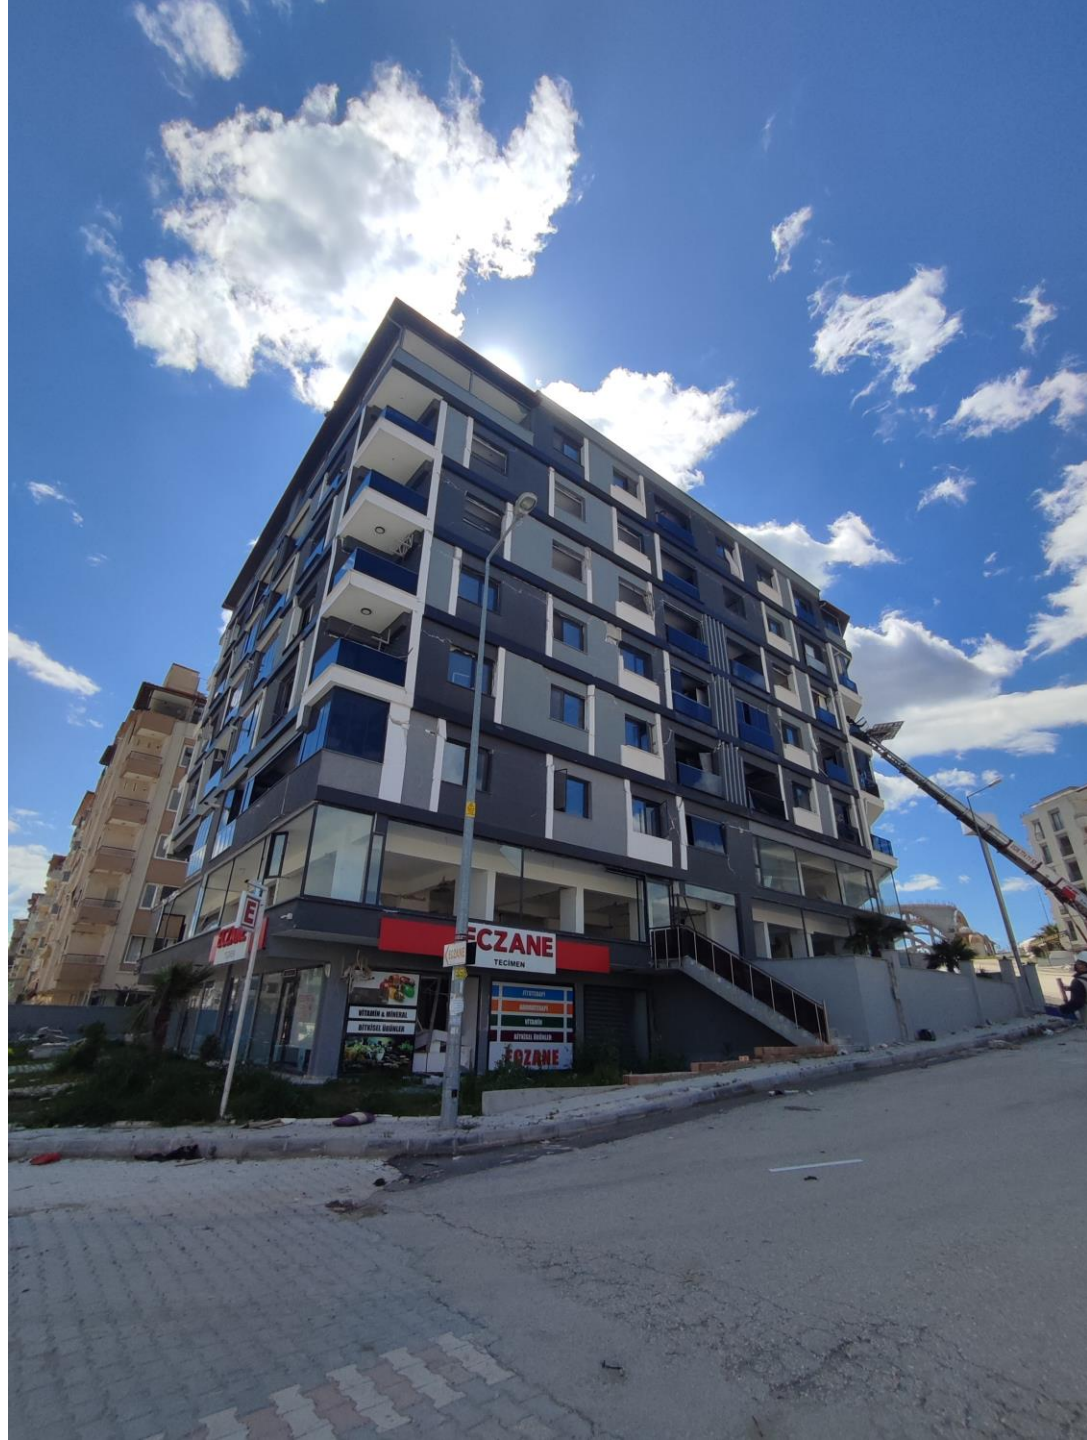
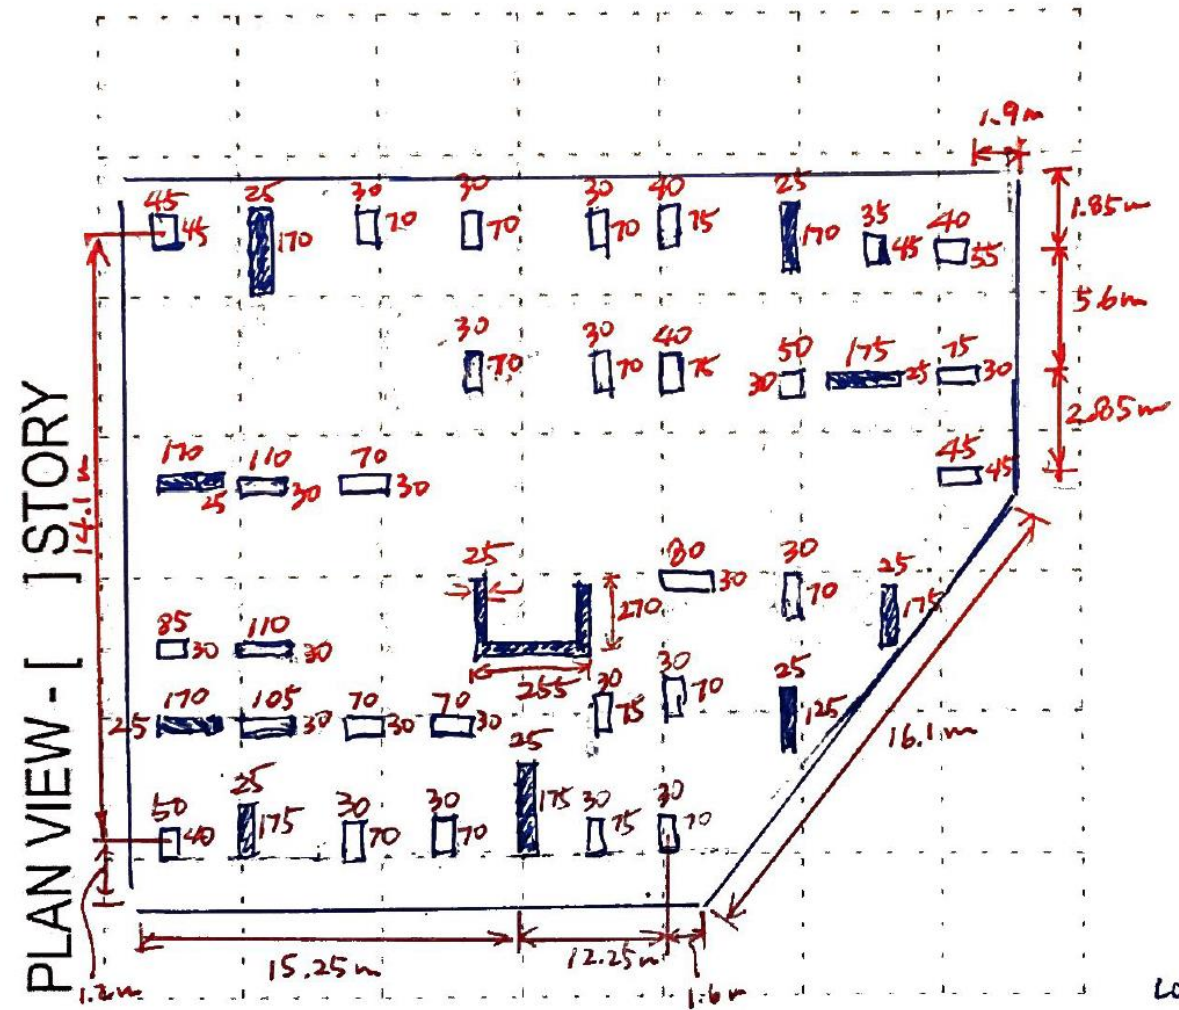
Location: Antakya

RC Structure: S M. Walls: S

- MANY OF THE BEAMS DAMAGED (SOME @ SPICE, SOME AS SEPARATE) LONGITUDINAL BAR BUCKLED! IN BEAMS,
- 1st FLOOR COLS. HAVE HOPE

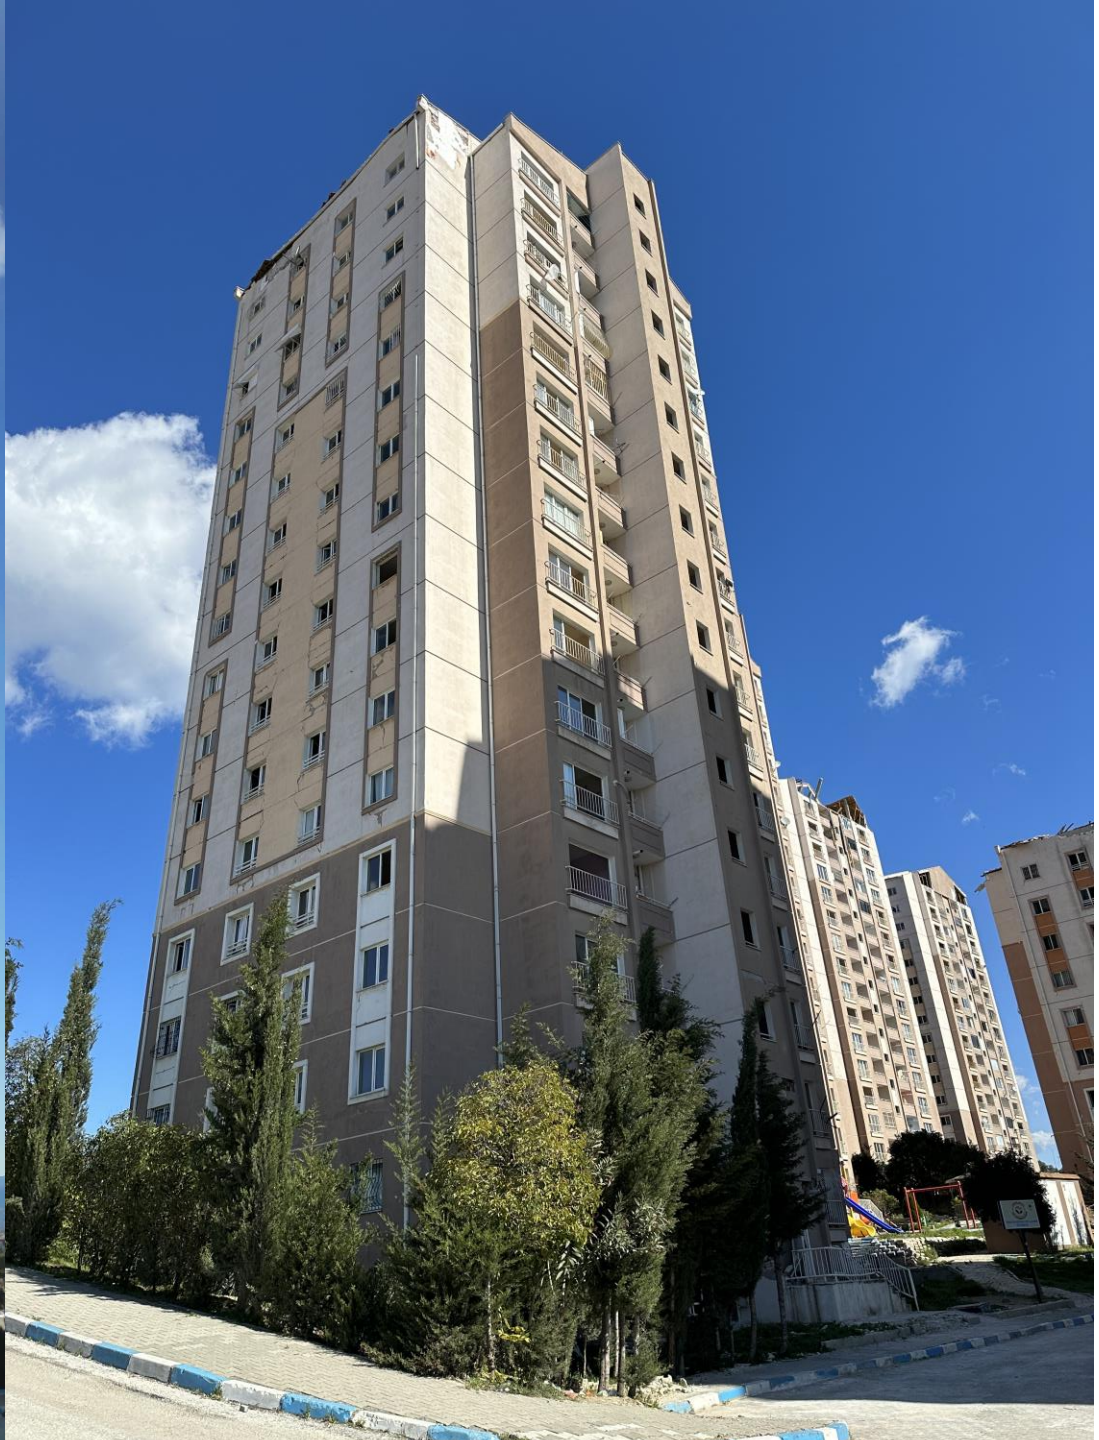
Location: Antakya
 PGV: 1.9 m/s
 WI: NS 0.15% EW 0.23%

STRUCTURE (descript.)	YEAR (construct.)
TUNNEL FORM RC SHEAR WALL	2013
No. STORIES ABOVE GROUND	16
HEIGHT	2.7m
PICTURE #S	
DAMAGE LEVEL	
RC Structure: S	M. Walls: S
PERMANENT DRIFT	
OBSERVATIONS	
- SHEAR WALL DAMAGE ON 1st & B	
- CAN SEE THROUGH MASONRY INFILL DAMAGE	
- ROOF (NON-STRUCTURAL) FELL DOWN DAMAGE

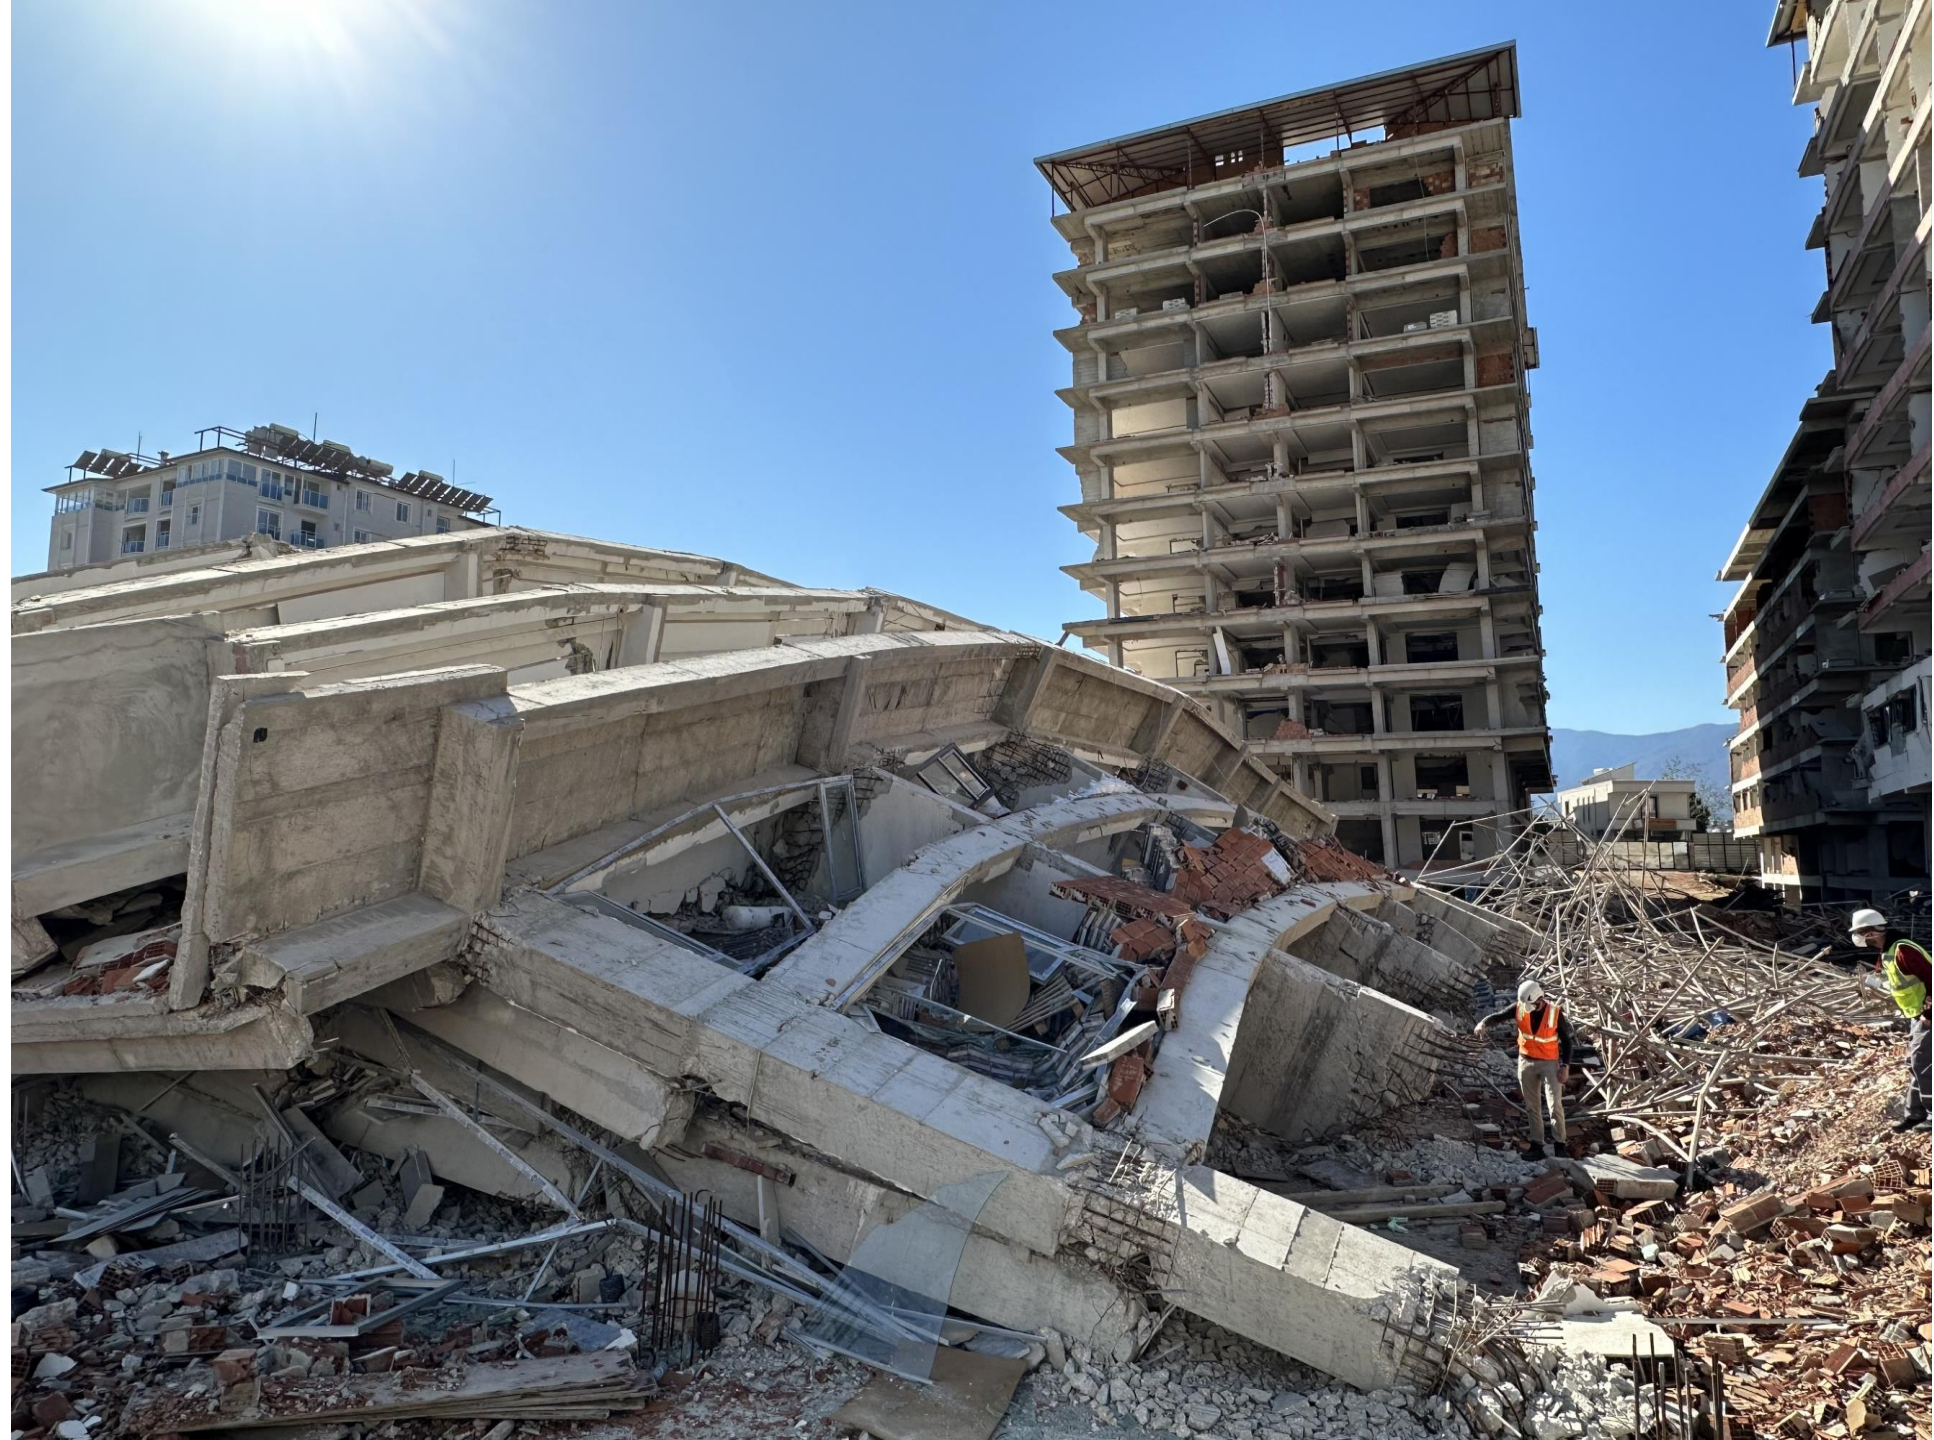
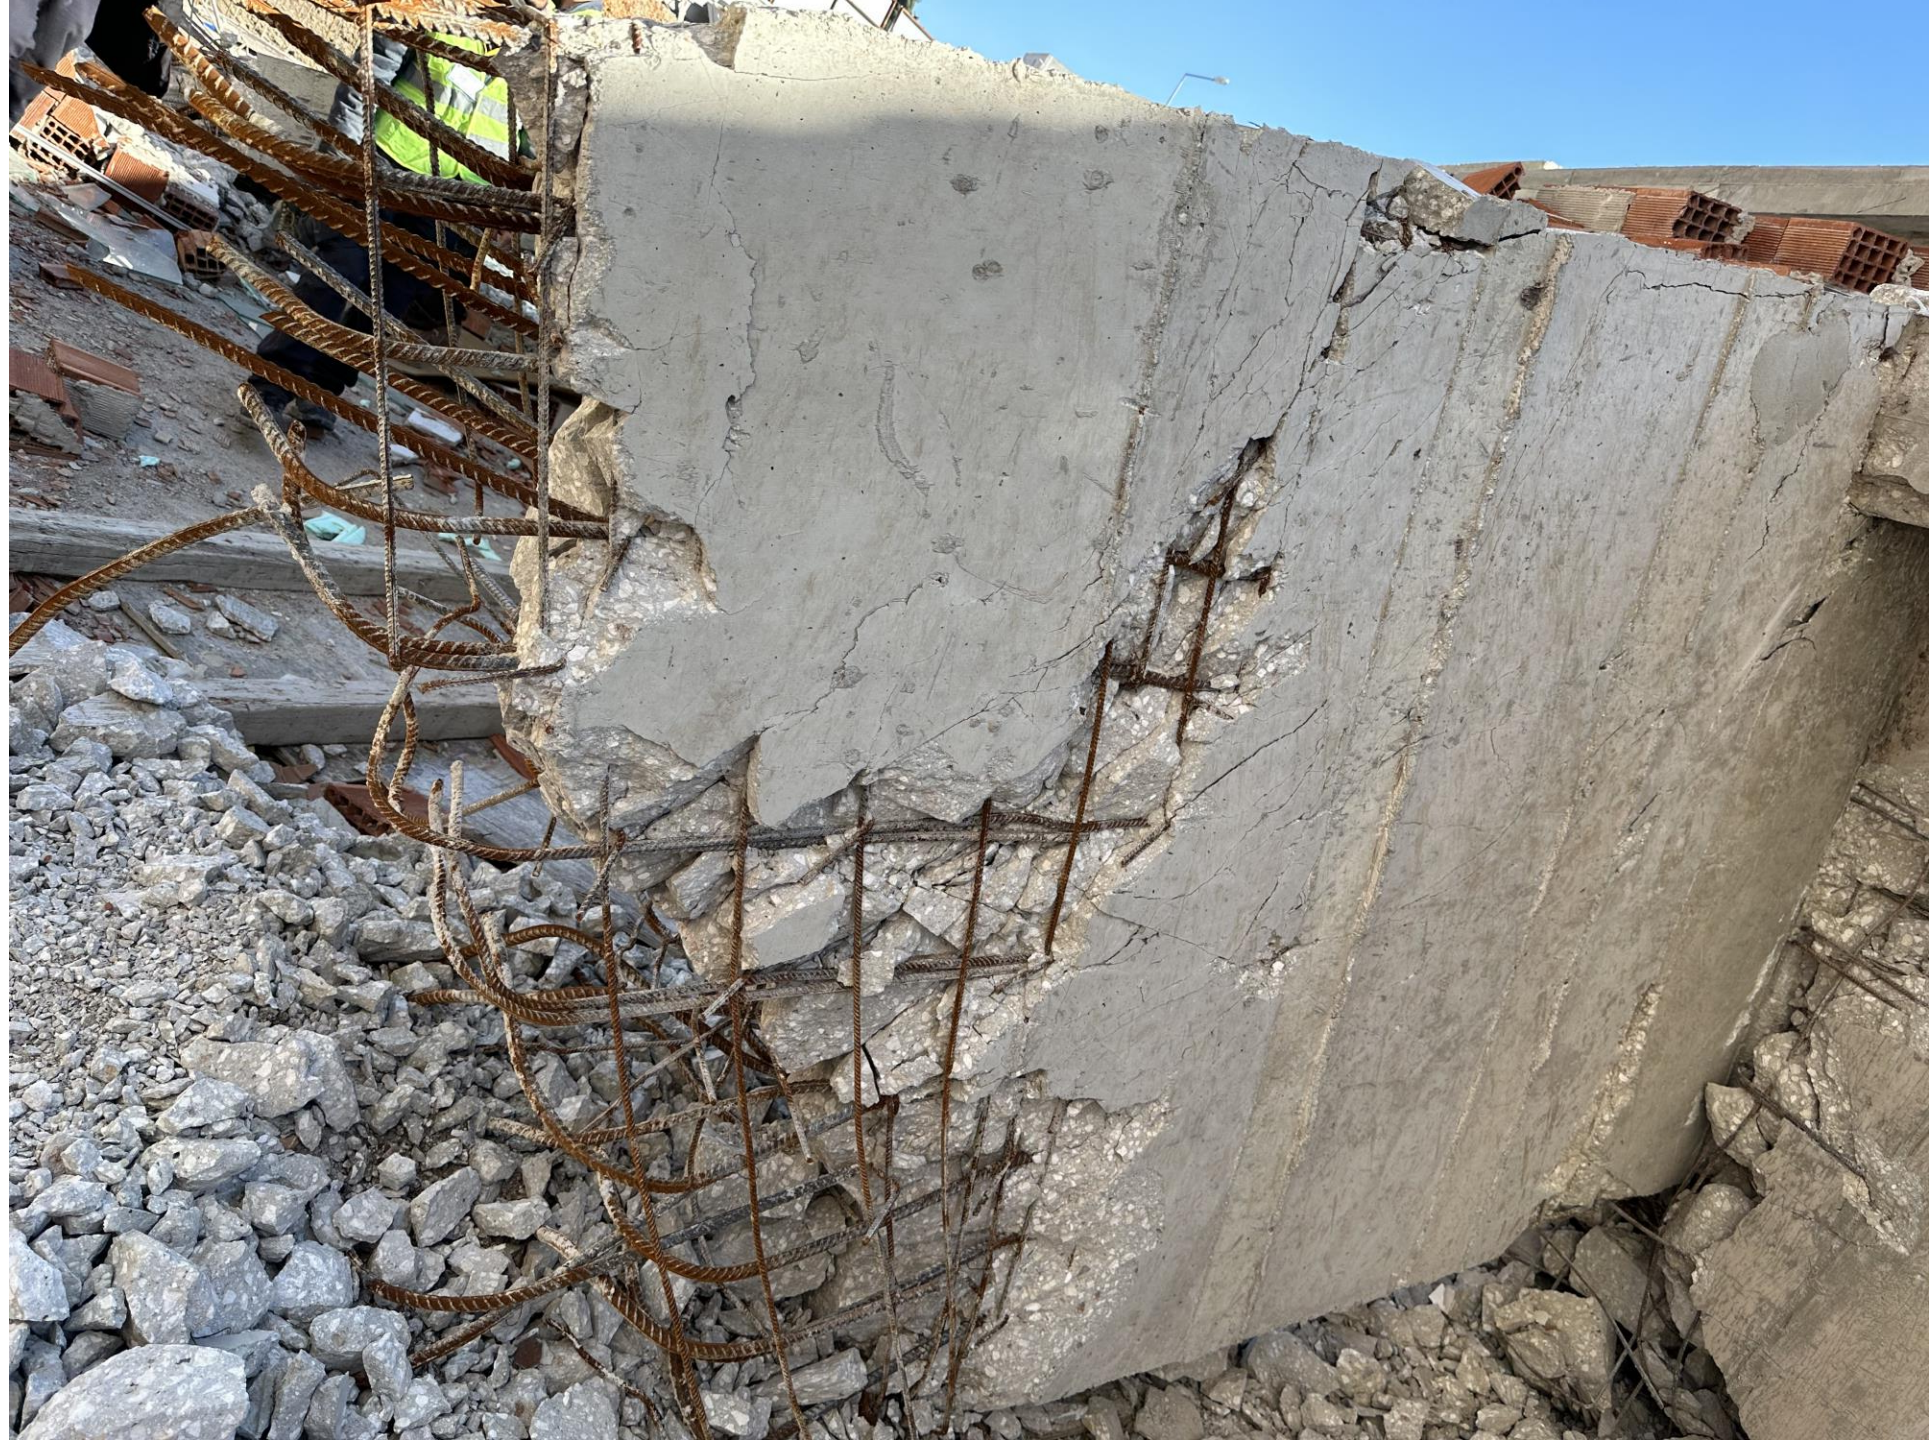
Location: Antakya
PGV: 1.3 m/s (avg.)

WI: 0.04%
Estimated Drift: 6%

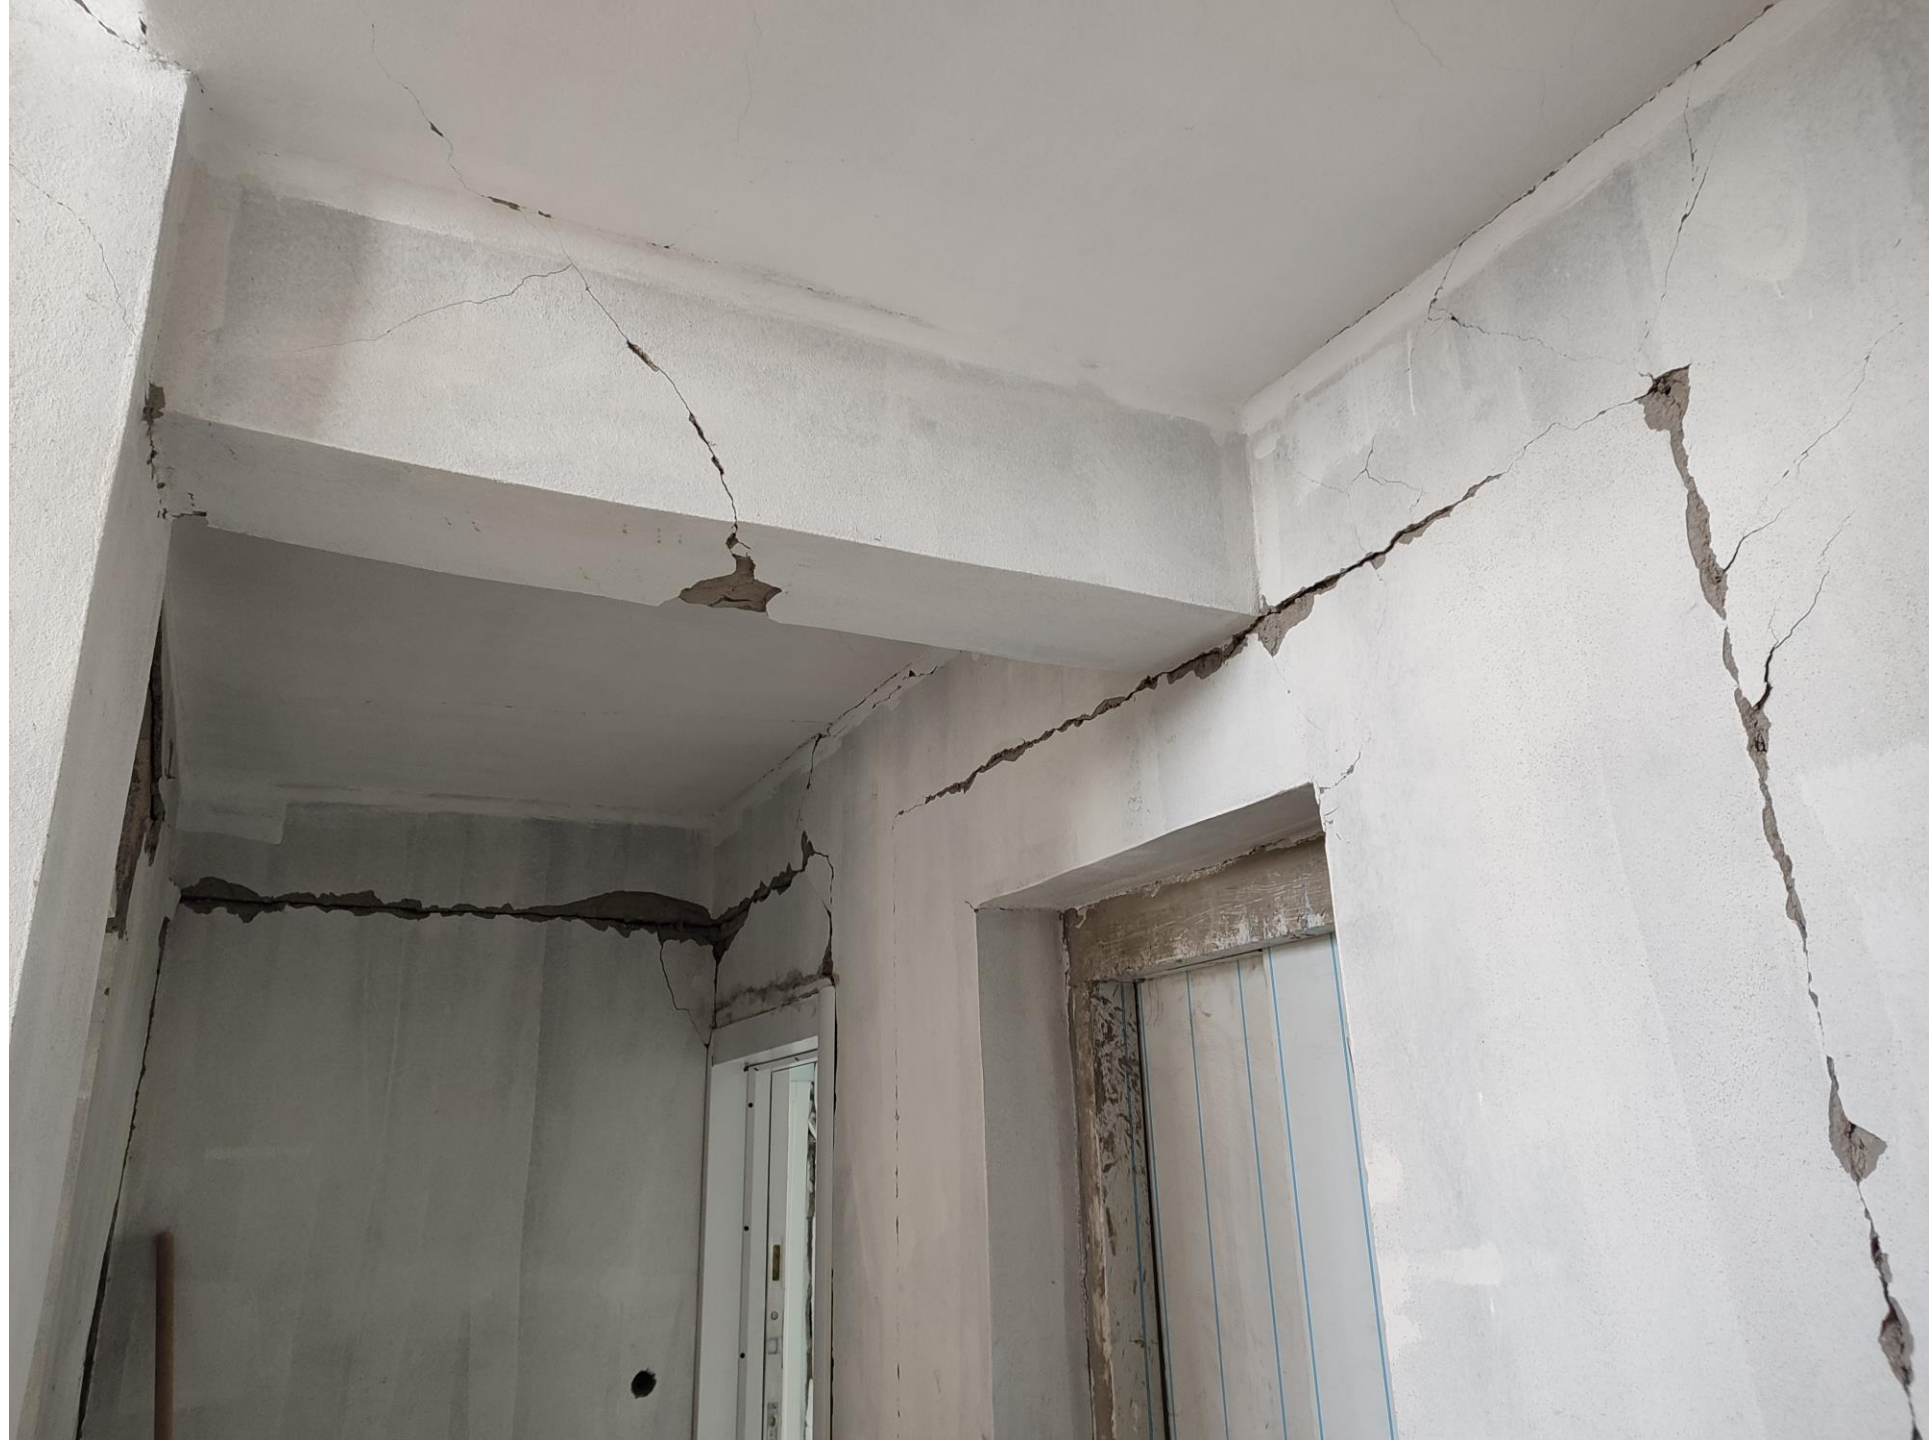
Location: Dulkadiroglu
 PGV: 1 m/s
 WI: NS 0.16% EW 0.12%
 CI: 0.18%

DAMAGE LEVEL
 RC Structure: L M. Walls: S

- CORNER BLDG
- TRIANGULAR ATTACHMENTS TO BLDG
- TRAPEZOIDAL SHAPE
- DRAWINGS AVAILABLE

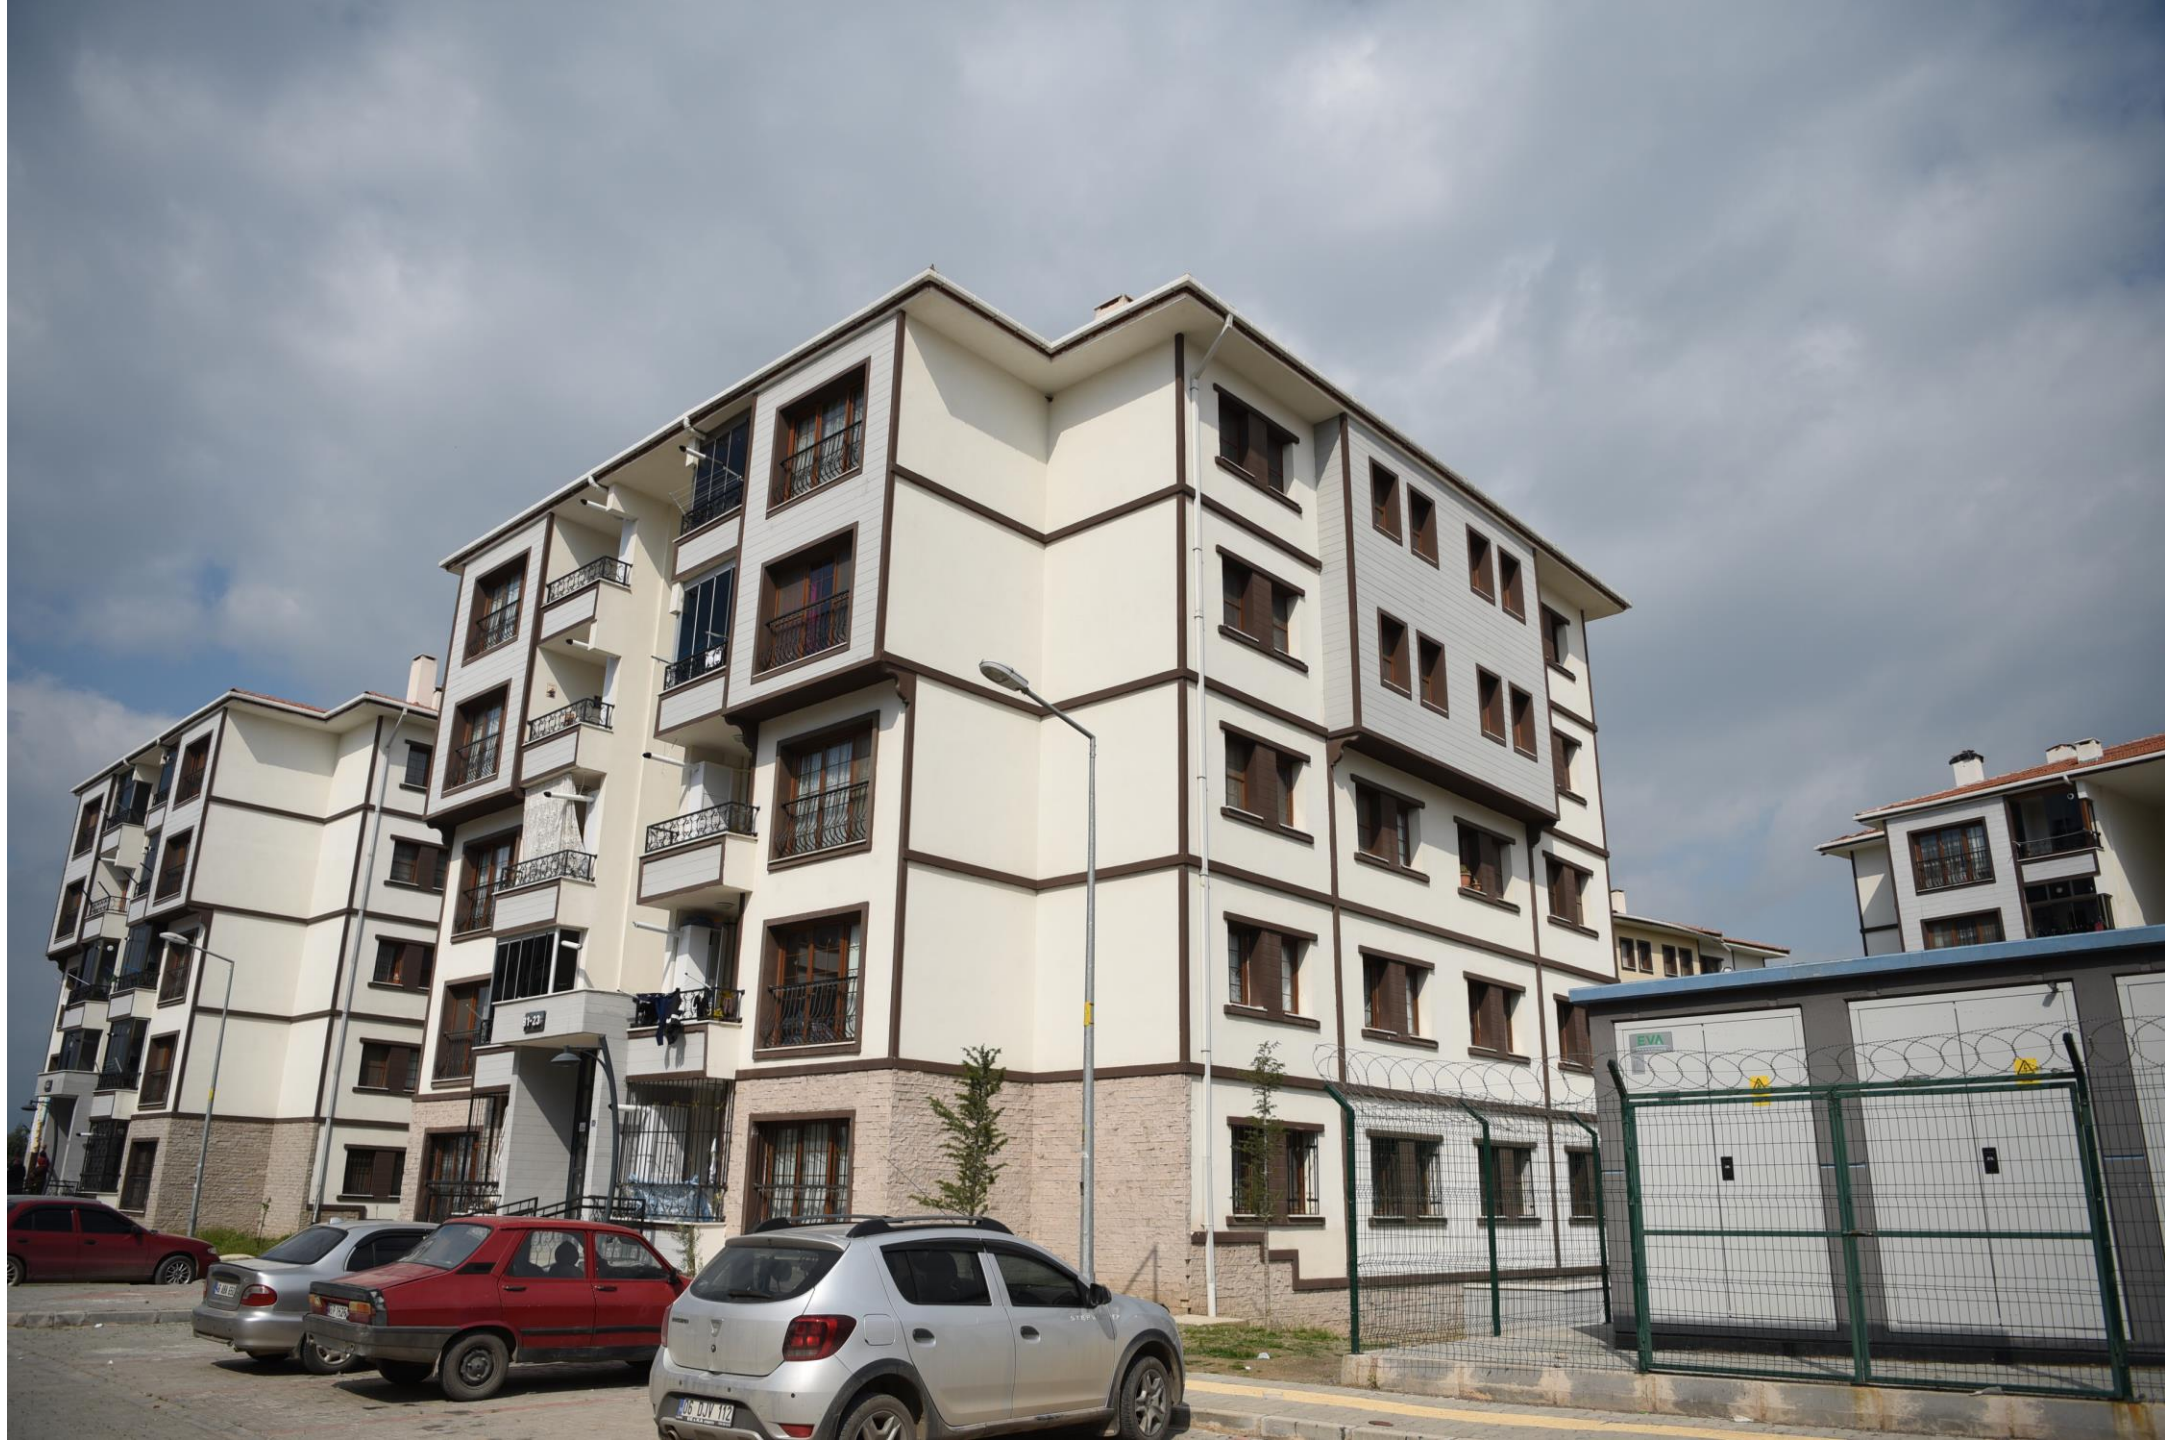
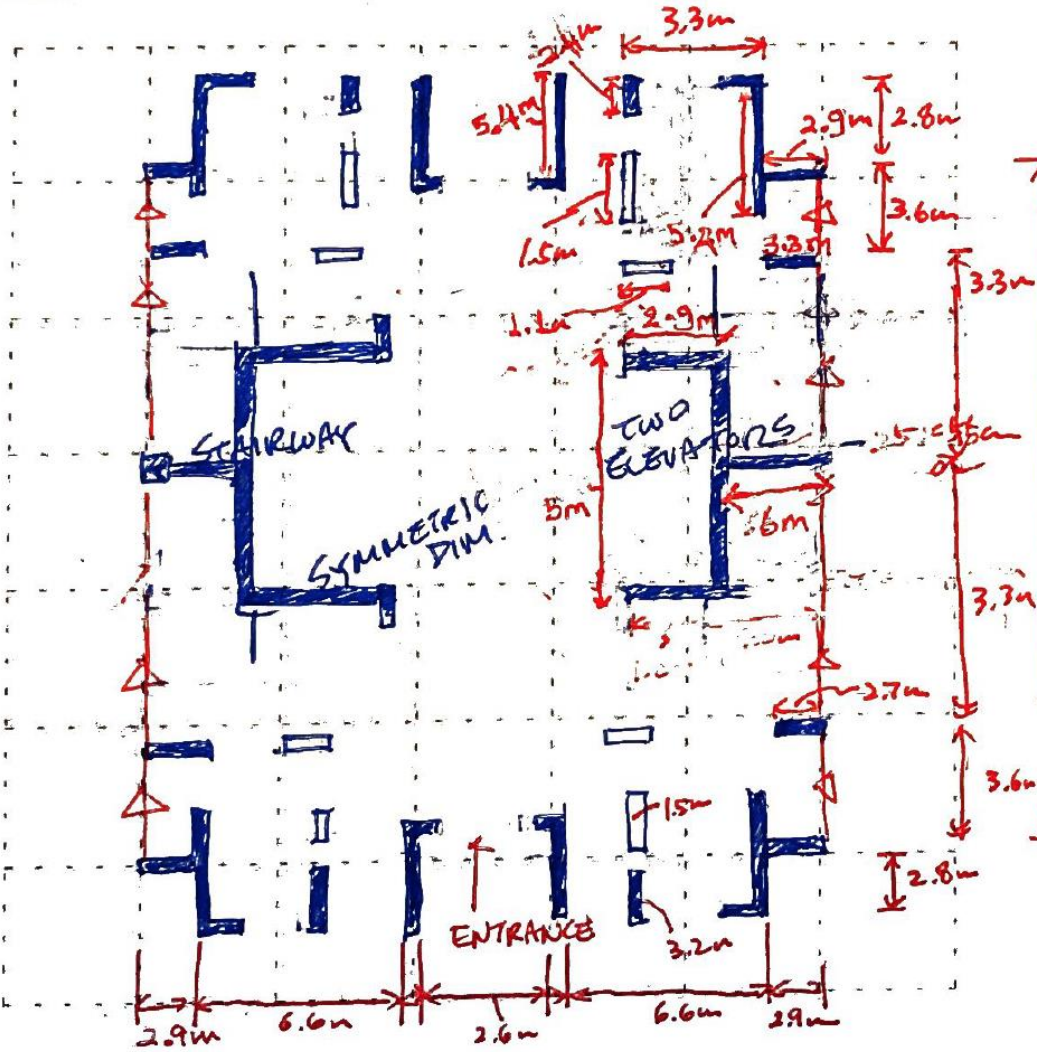
Location: Dulkadiroglu
 PGV: 1 m/s
 WI: NS 0.74% EW 0.57%

DAMAGE LEVEL
 RC Structure: N M. Walls: L (HAIRLINE CRACKS)
 PERMANENT DRIFT

OBSERVATIONS
 - NO DAMAGE IN STRUCTURAL
 - W.I. IN E-W (0)
