Long Term Monitoring of Bridge Decks in Montana

Todd Nelson, P.E.

Wiss Janney Elstner Associates

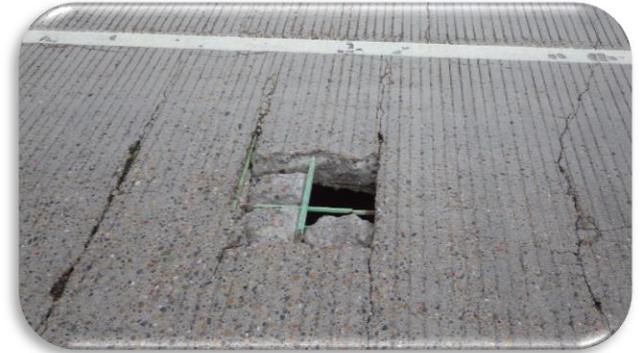
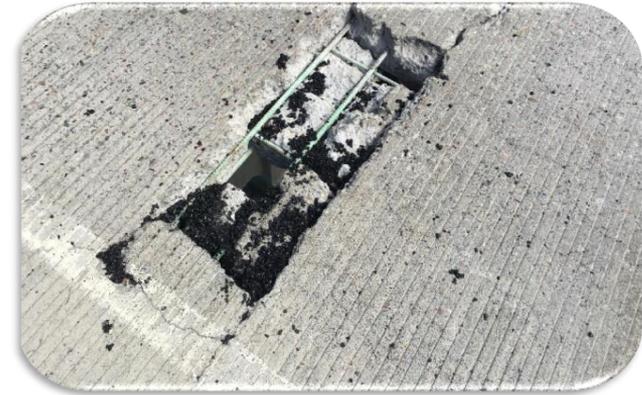
- Closely spaced transverse cracks on numerous bridges in western Montana
- In some cases, through deck penetrations developed
- Young bridge decks < 8 years
- Mostly in the alpine regions

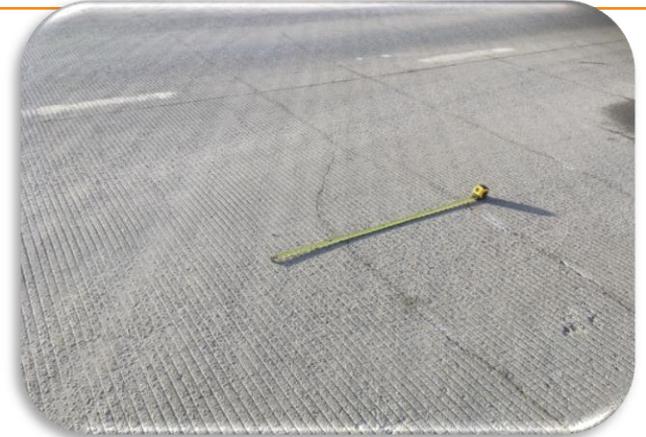
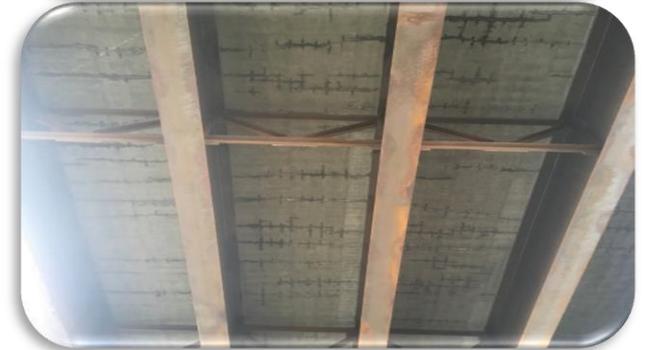
- Overall Visual Rating = 3
- Transverse cracks at 3 to 4 feet
- Crack width 20 to 30 mils

Crack density (ft/ft ²)	Crack Severity (mil*ft/ft ²)
0.19	3.87
0.14	2.45
0.17	3.15

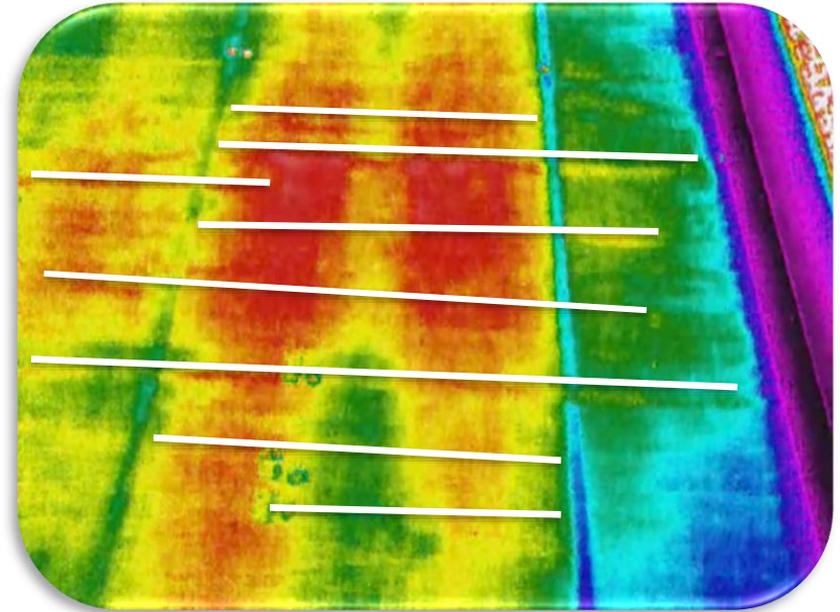
- Drone survey with infrared thermography (IR)
- IR could pick up cracks as tight as 5 mils
- Cracking density but not cracking severity

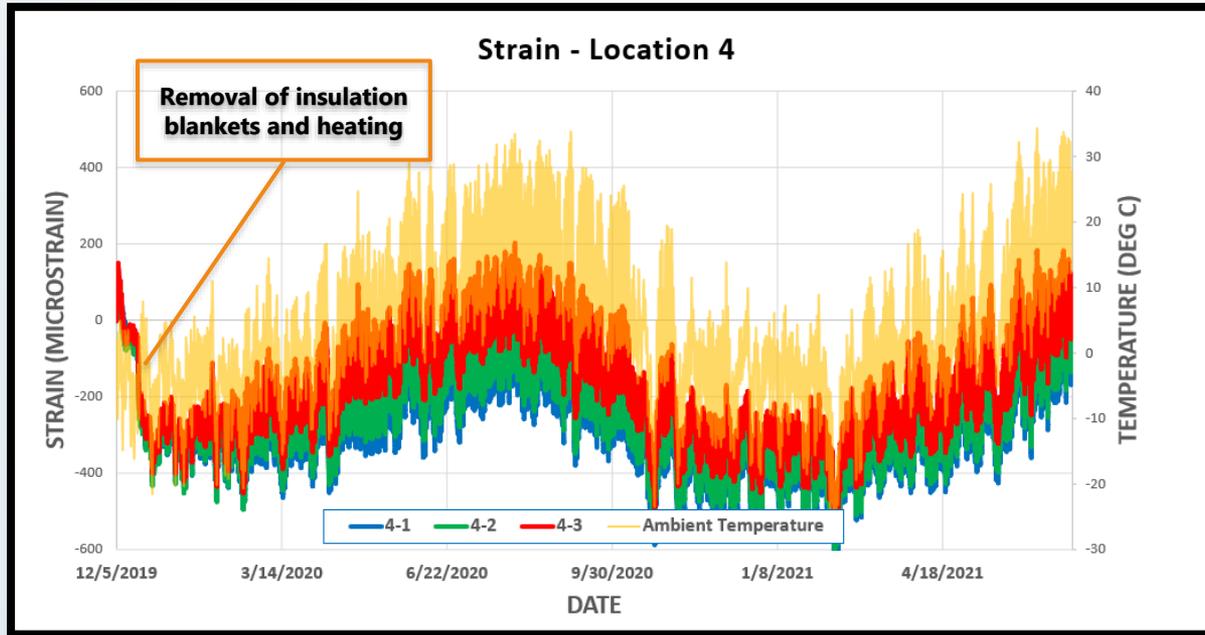
- Compressive strain developed in deck after removal of insulation and heating

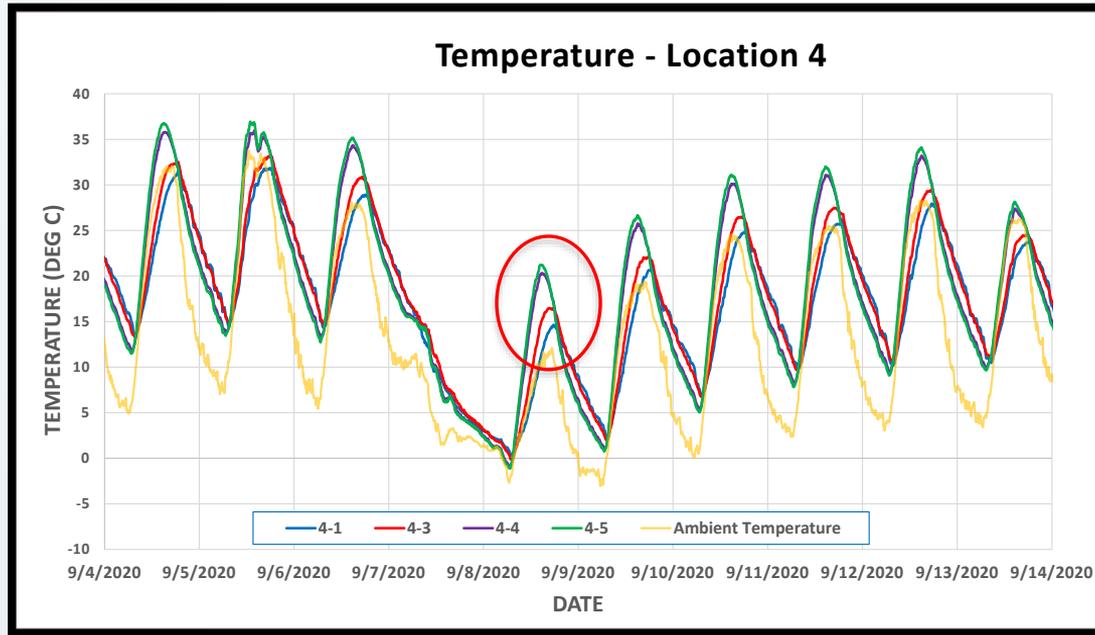
- Large daily temperature changes observed ($\Delta T=55$ to 60°F)
- Temperature gradient within the deck, 20F

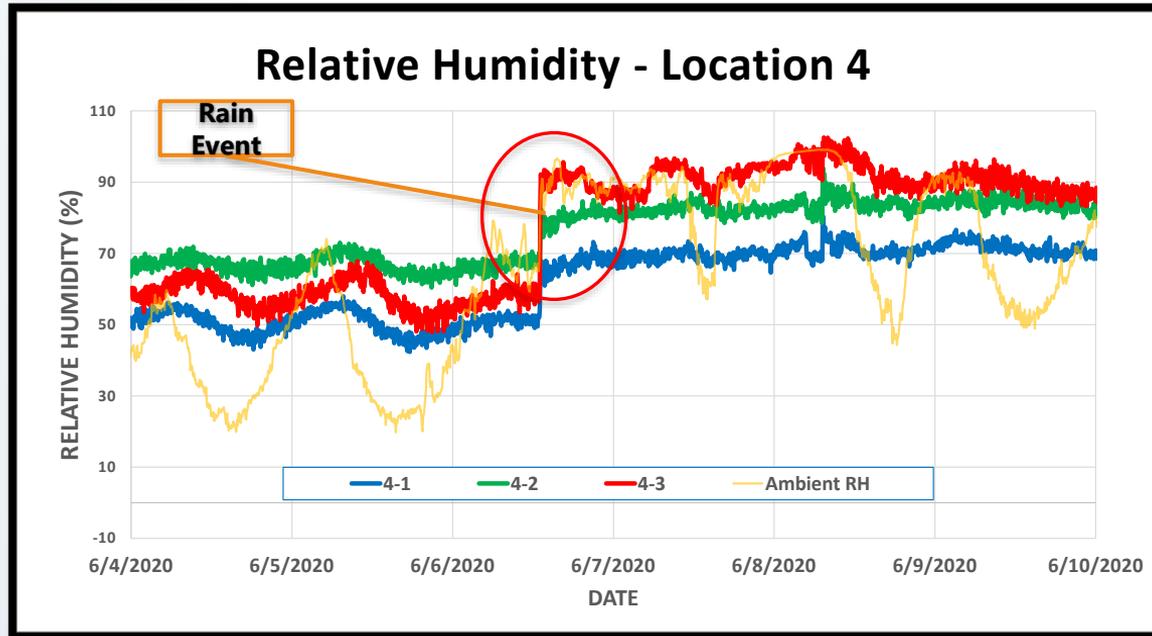
- Large daily RH changes observed, increase from 20 to 100 % within 24 hours - RH gradient within the deck up to 30% RH

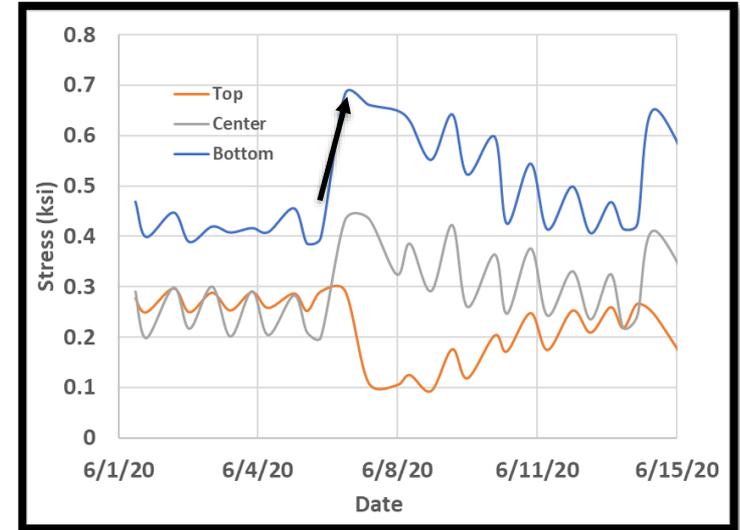
Stress vs time

- Higher RH gradient existed after rain event.
- Increase in tensile stresses at the bottom of the deck ~300 psi

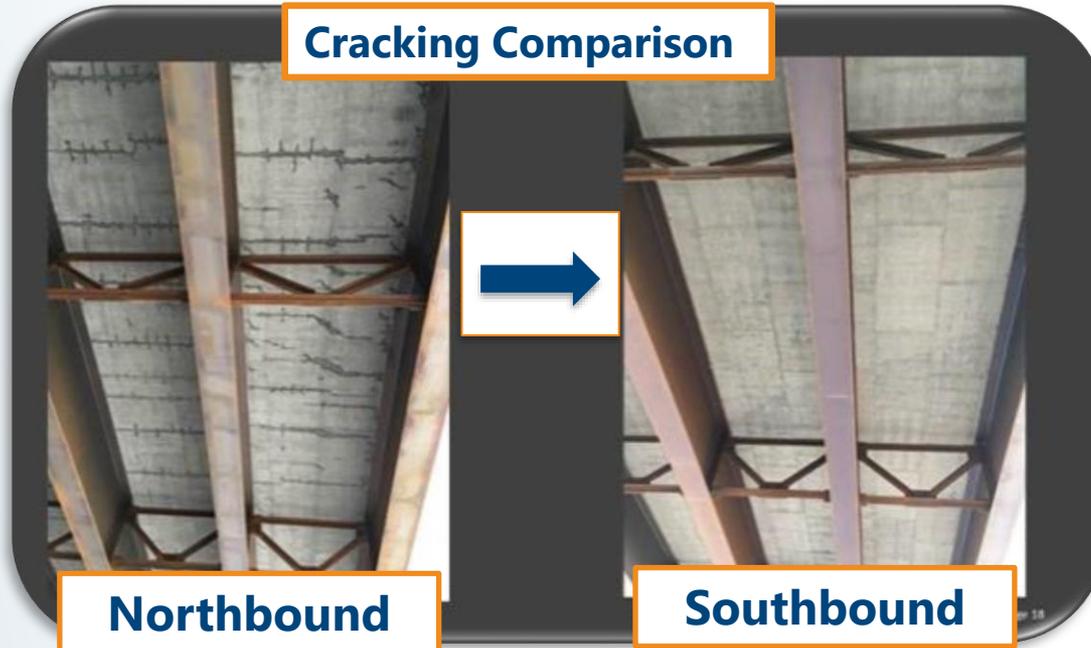
- Cracking comparison, before and after WJE's recommendations
