Lessons Learned from a Master in Concrete Repair – Tony Murray

Presentation by Gene Stevens – J. R. Harris & Company

Concrete Repair Session to Honor the contributions of Tony Murray

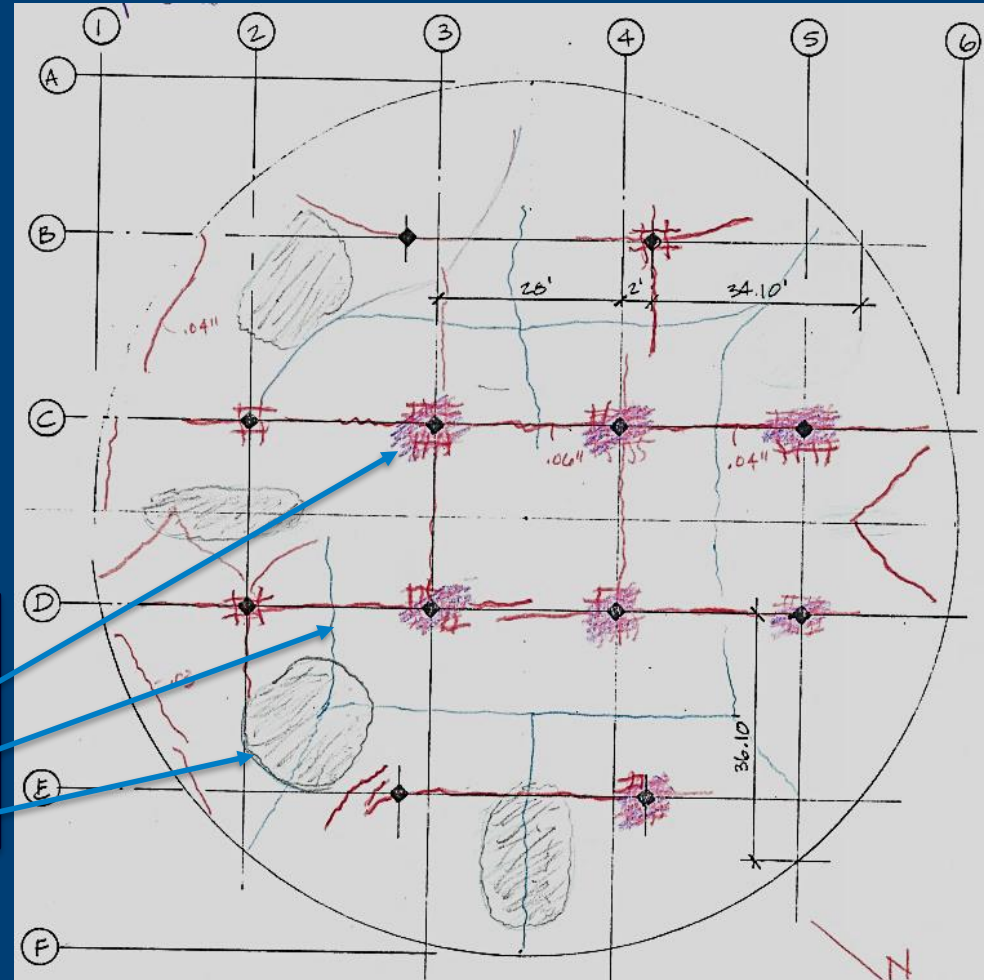
Las Animas – Prestressed Concrete Water Tank.

Roof slab distress: 1986

Spalling in underside of slab at columns

Cracks in the slab top

Low spots

- Design was very thin
- Distress over the interior columns and top crack - unusual

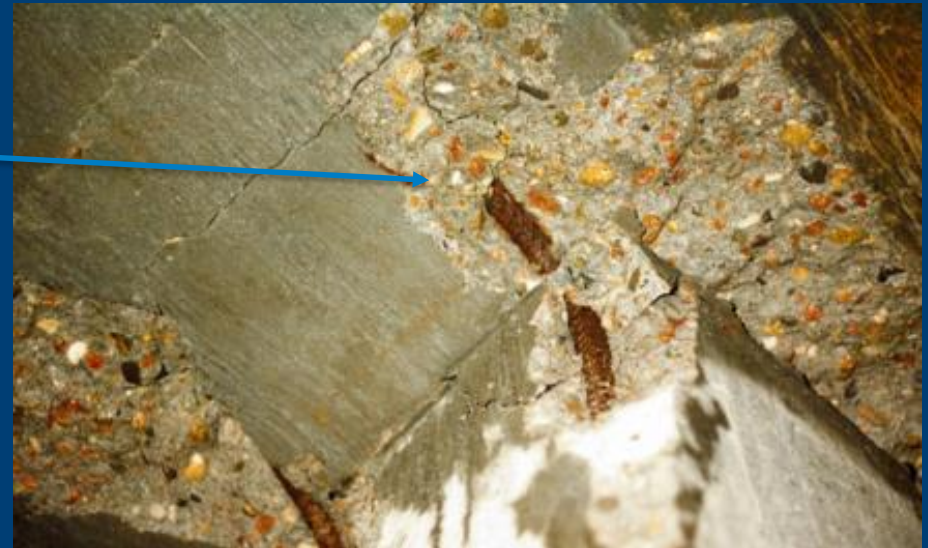
- Depth of spall is about $\frac{1}{2}$ the slab thickness
 - Shear capacity ≈ 79 k ($\phi = 0.85$)
 - Shear demand 74 k for service weight of slab (load factor of 1.0)
- Using current load factors and $\phi = 0.75$, $D/C = 1.5$

Seriously unsafe condition as a result of lack of system redundancy to resist the slab dead load

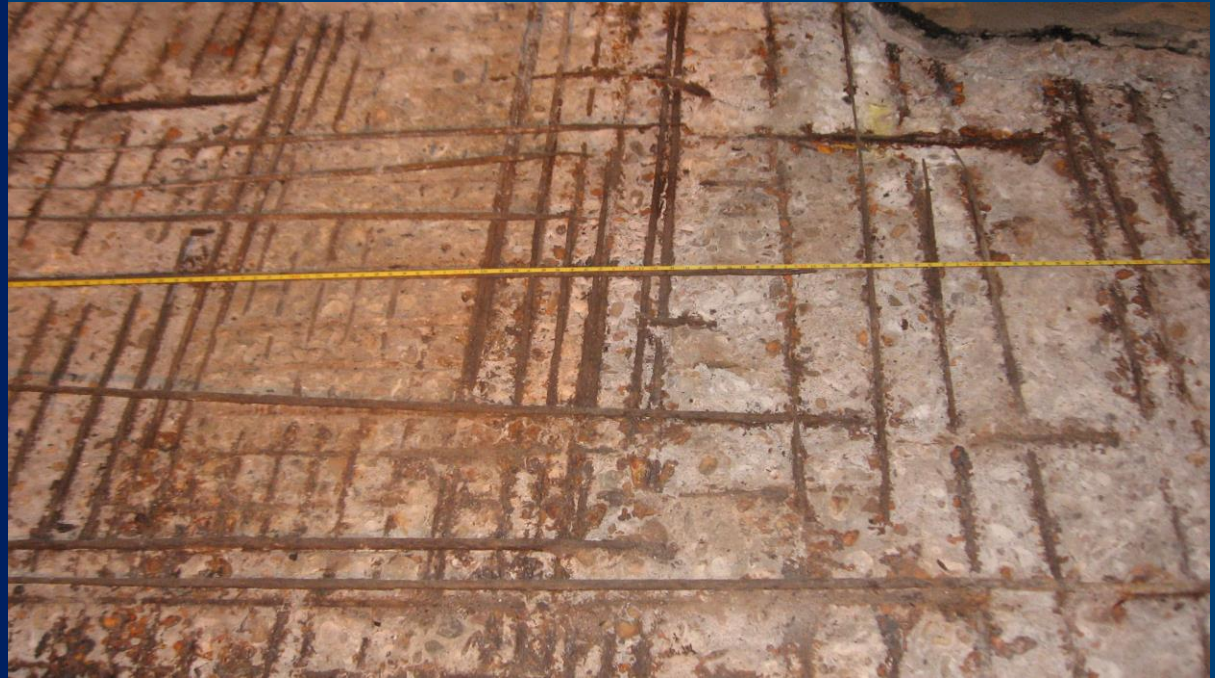
Investigation of concrete & top reinforcement at columns

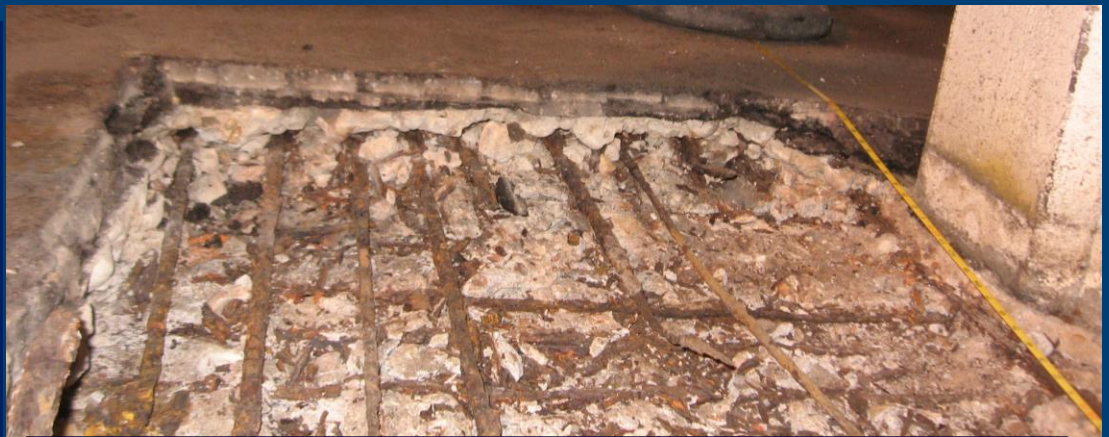
Asphalt overlay conceals concrete spalls at columns

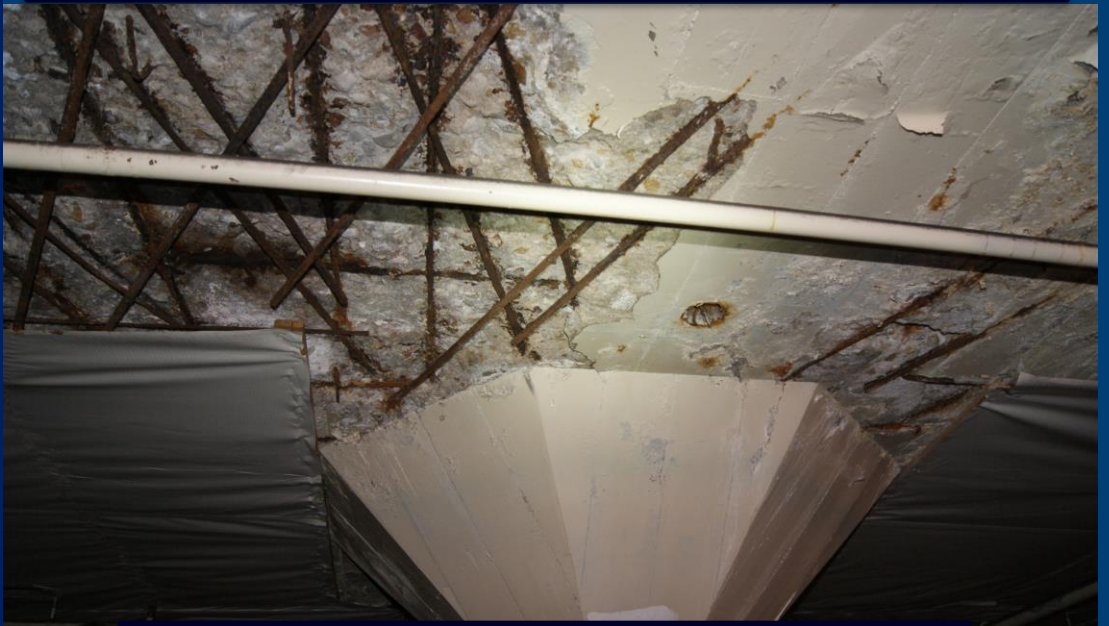
Two to four layers of bars for positive bending.

Bottom reinforcement with
Existing distress is adequate.

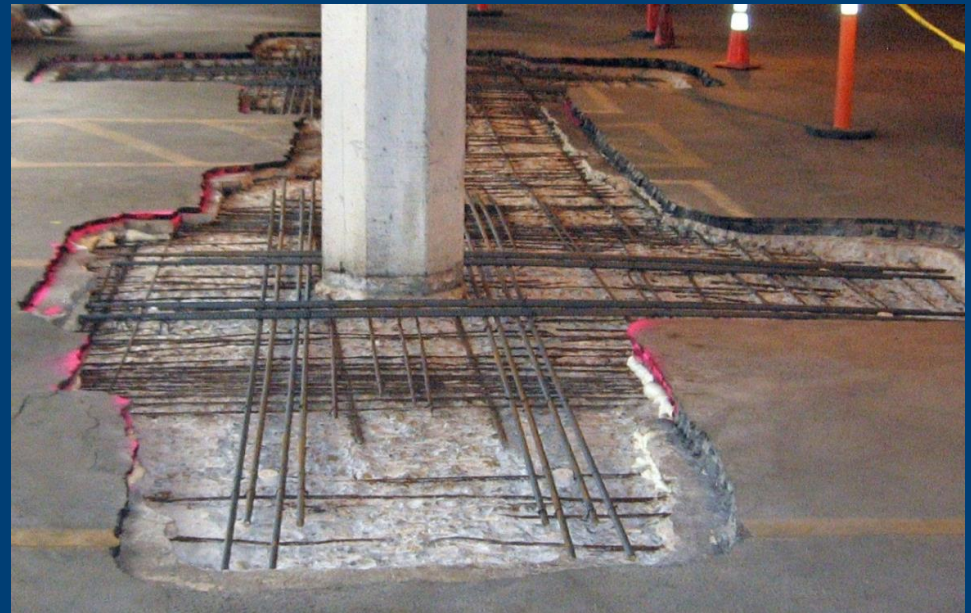
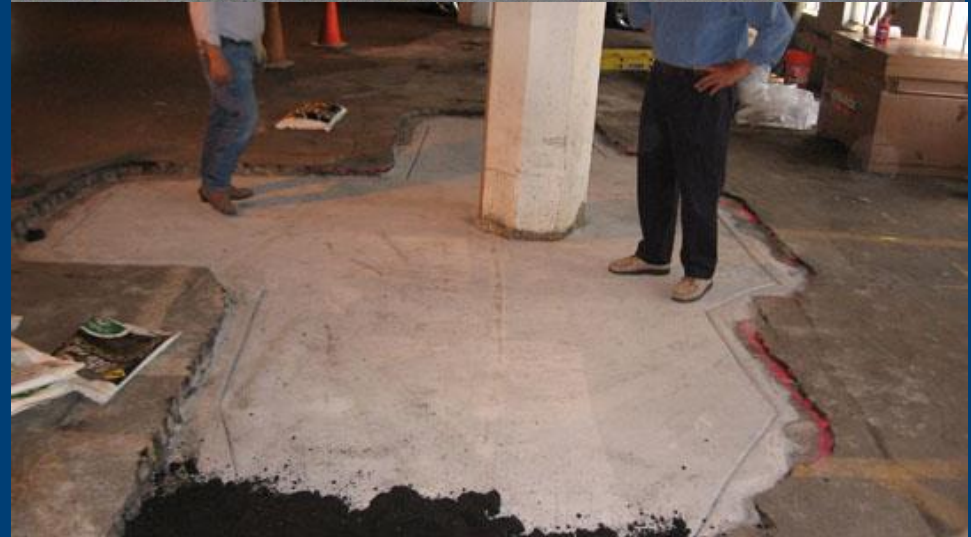
- Evidence of one strand fracture
- Cracked and spalled concrete in underside of pour strip
- Corrosion on bottom bars of the pour strip
- Distress in concrete supporting P.T. slab edge

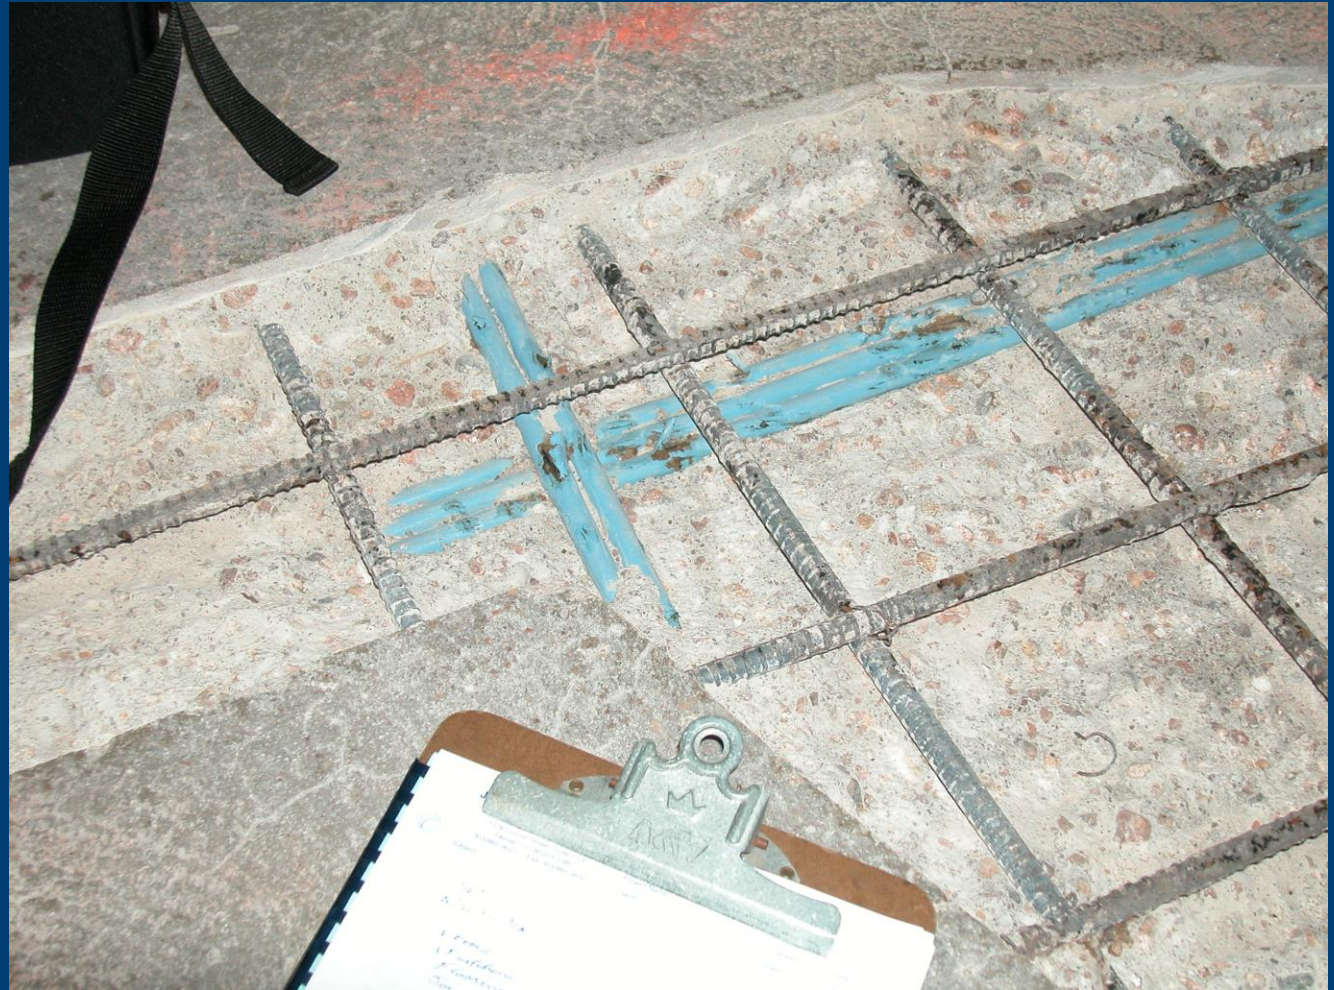
Top reinforcement in good condition in P. T. slab areas checked. No evidence of probable distress.

- Removed and replaced pour strips in the garage
- Removed and replaced support ledge of the Plaza Level
- Replace a P.T. strand

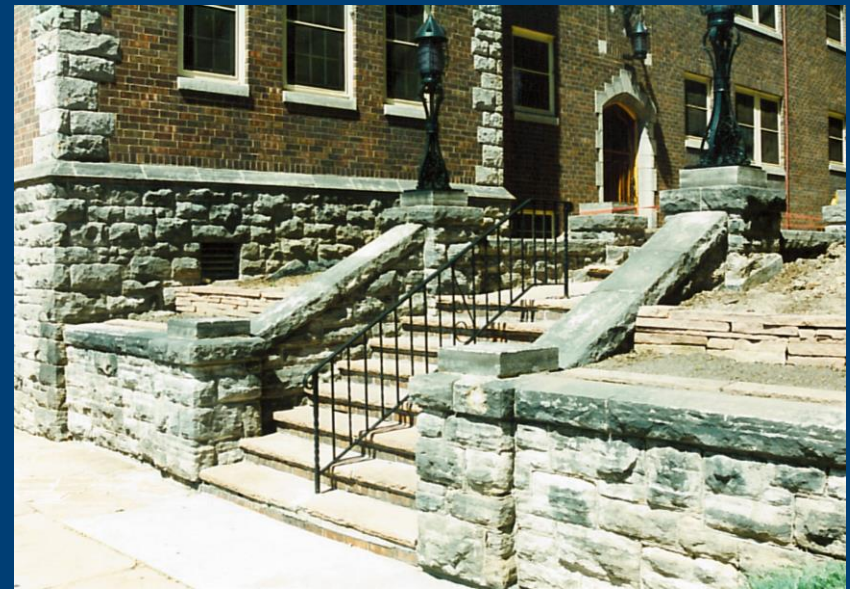
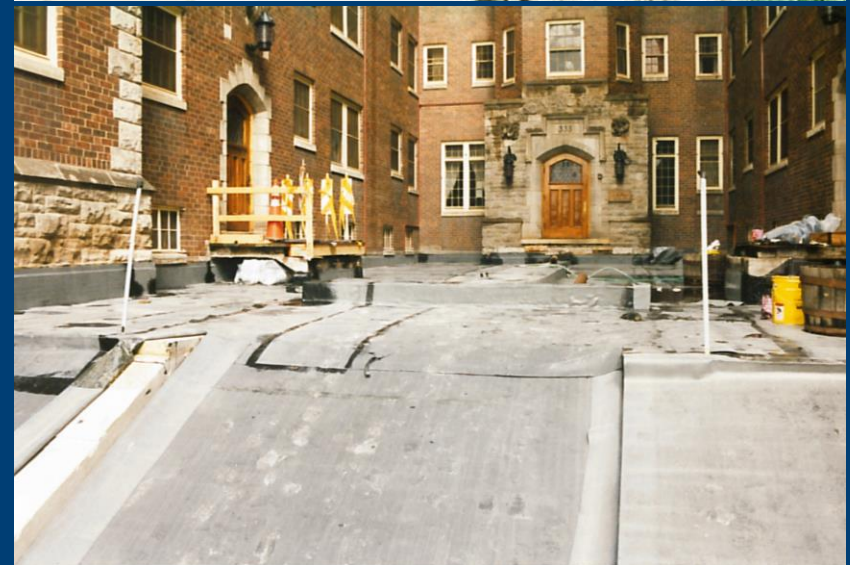
Distress in underside of concrete resulting from leaking water evident prior to repairs

Slab and beam bars corroded

Chip out areas of unsound concrete and remove – some partial and some full depth.

Replace reinforcement as necessary and replace concrete

Add protective membrane on top surface

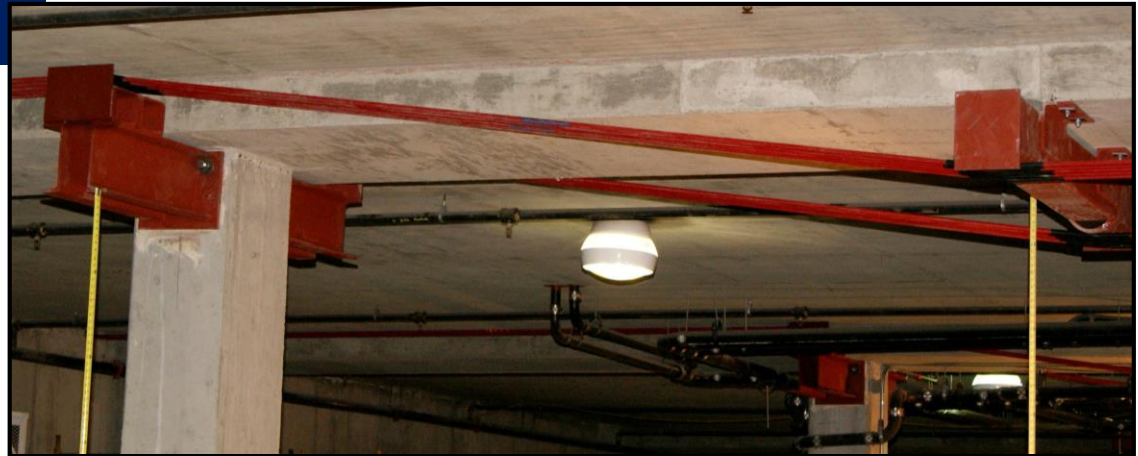
JRH 2009 assessment found

- Several beams with deficient reinforcement for positive bending
- Most cost effective repair external P.T. reinforcement
- 2013 JRH repair design using ACI 562-13
- 2014 repairs by Restruction Corp.

1986 External P.T. Repairs
To 2014 External P.T. repairs

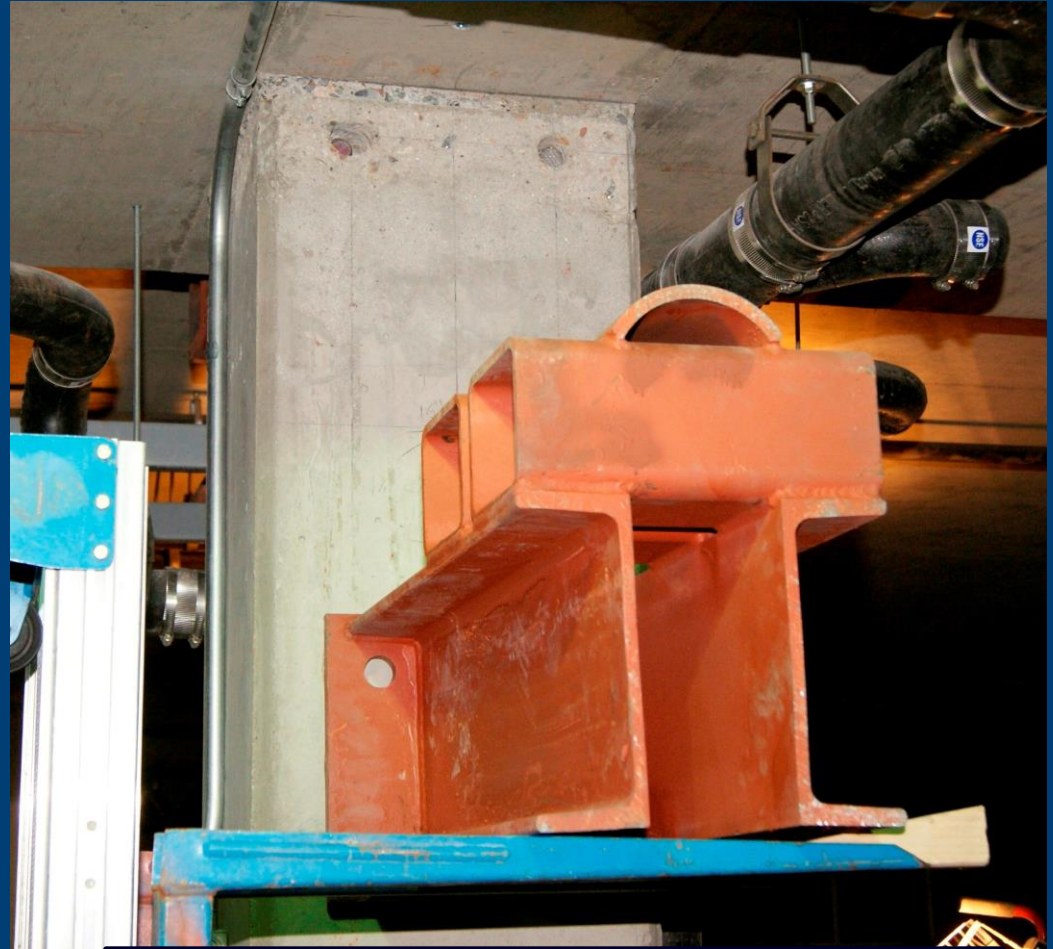
Village Lofts Condominiums
Steel Corbel Added to (E) Concrete Column
for External Post-tensioned Reinforcement

Problem was exactly locating the column reinforcement and positioning the anchoring rods

Steel corbel fabricated off site and fastened to (E) concrete columns with two 1" ϕ ASTM A354 , Grade BD, $F_u = 150$ ksi threaded rods
