# Post-fire Flexural Testing and Rating of Prestressed Concrete Bridge Girders

**ACI CONVENTION, 2019  
CINCINNATI, OHIO**

**Eyosias Beneberu, Ph.D., P.E.**  
Structural Engineer, Bridgefarmer & Associates

**Nur Yazdani, Ph.D., P.E.**  
Professor of Civil  
Engineering, UT Arlington

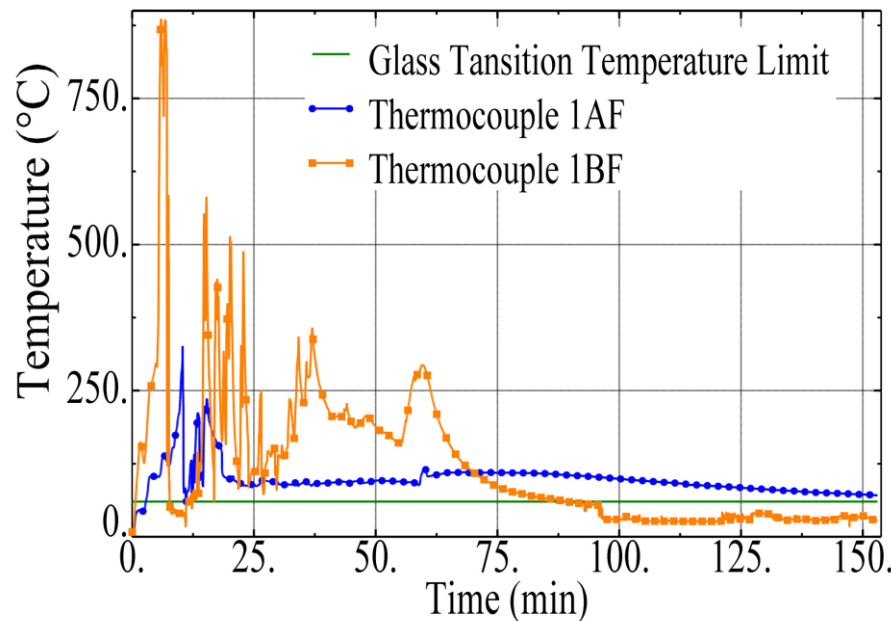
## Girder-1 (with CFRP, no fireproofing)

- Glass transition temperature,  $T_g$ , of the epoxy (60°C) was exceeded 41 and 168 secs after the test began.
- CFRP fully debonded 6 minutes into the test.
- Temperature in the strands reached as high as 473°C; strands lose 70% of their strength at this temperature.

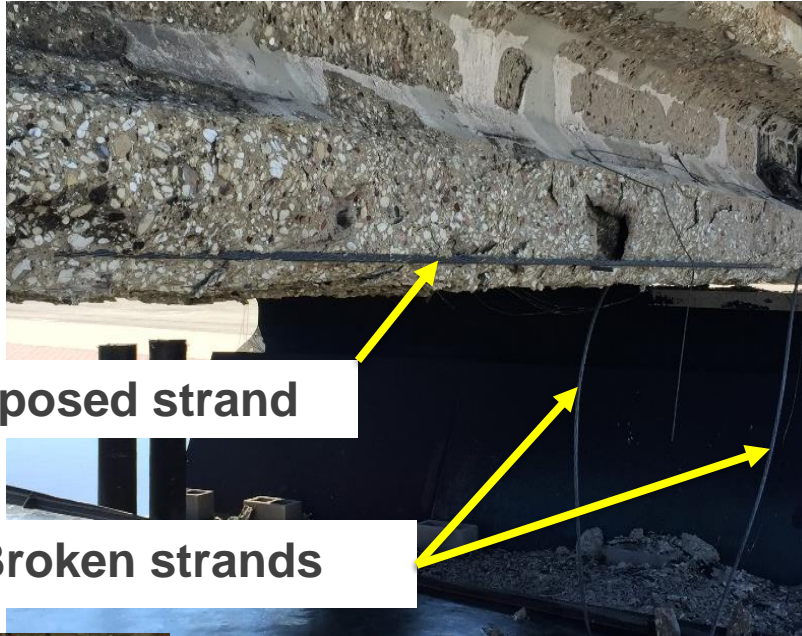
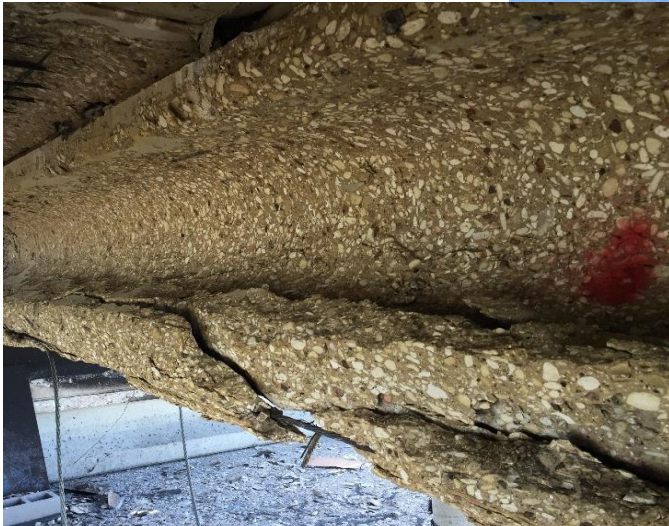
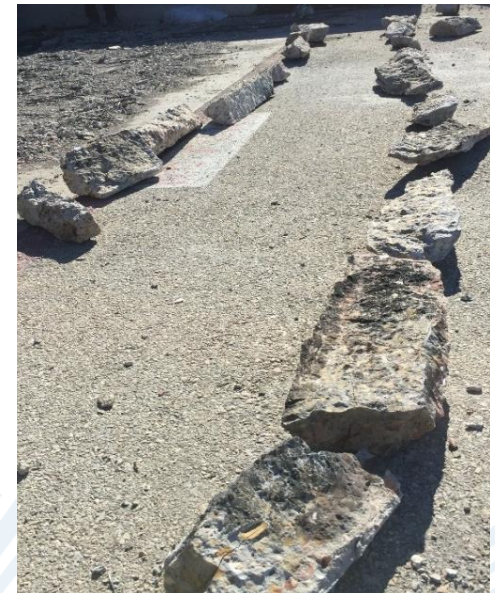
# Girder-1 (with CFRP, no fireproofing)

Exposed strand

Broken strands

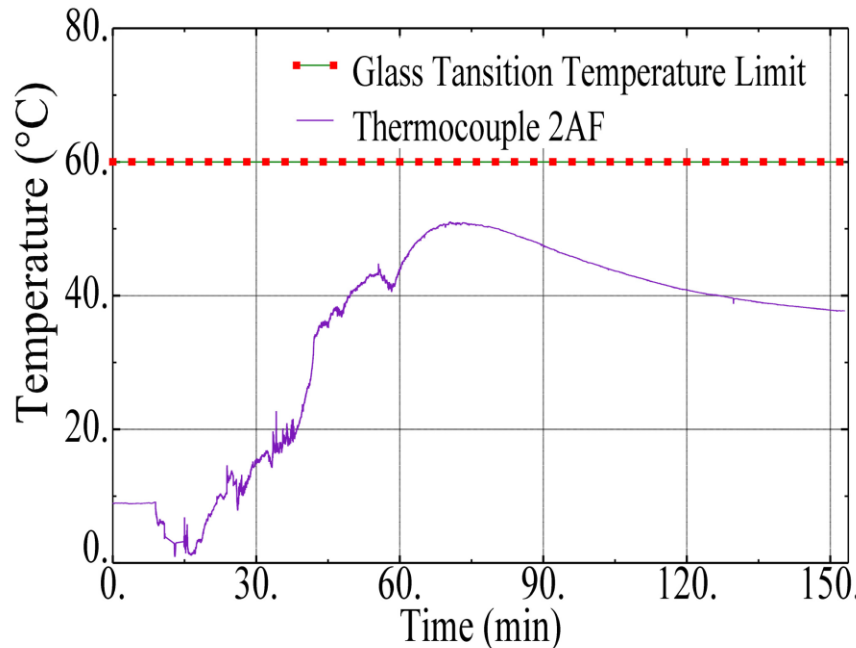
## Girder-2 (with CFRP, fireproofing)

- Fireproofing kept the temperature at the CFRP-concrete interface below glass transition temperature.
- Maximum temperature in the prestressing strands was 48°C; strands retain 100% of their strength at this temperature.

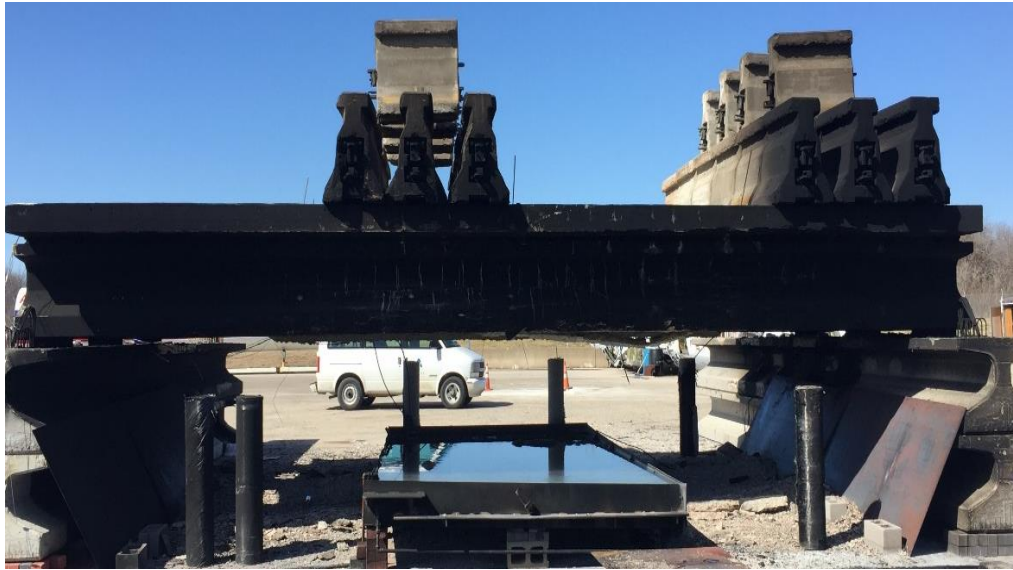
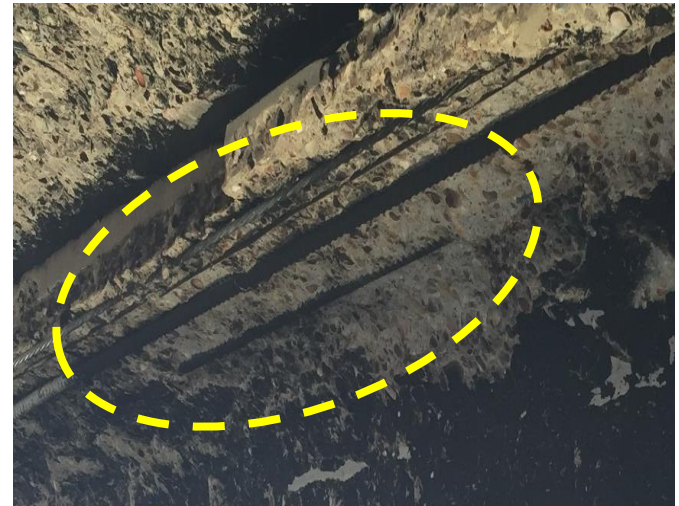
## Girder-3 (no CFRP or fireproofing)

- Had least fire exposure because of the prevailing wind...it sustained minimal damage.

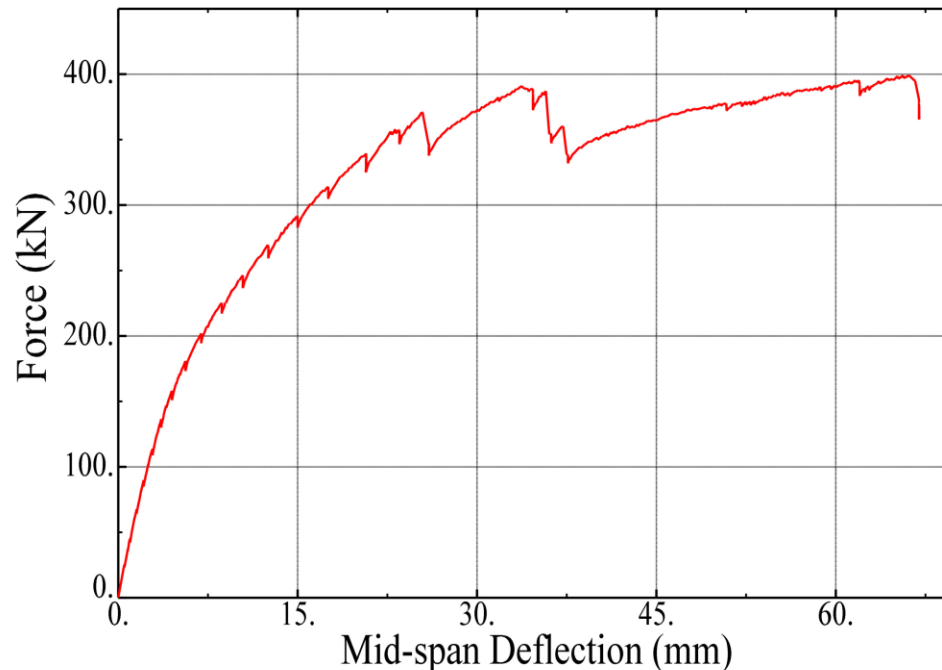
# Girder-1 (with CFRP, no fireproofing)

- Failed at a load of 90 kip (399 kN), corresponding to a bending moment of 707 kip-ft (958 KN-m).
- The undamaged nominal flexural capacity was 1780 kip-ft (2348 kN-m).
- Fire caused a 59% reduction in flexural strength.

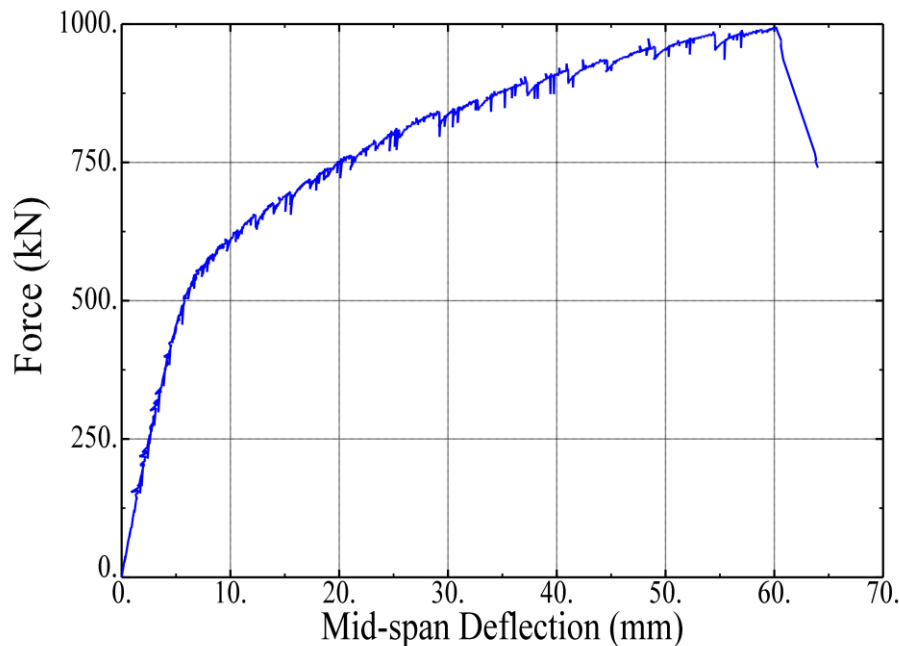
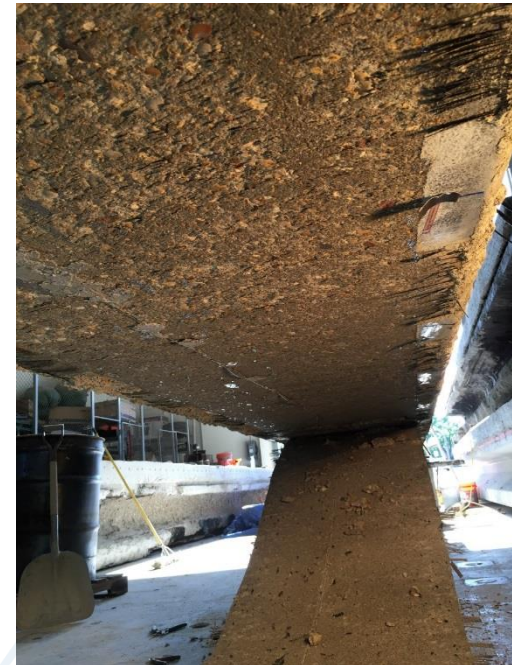
## Girder-2 (with CFRP or fireproofing)

- Failed at a load of 224 kip (995 kN), corresponding to a bending moment of 1761 kip-ft (2388 kN-m).
- Calculated flexural capacity was 1780 kip-ft (2348 kN-m), only 1.7% more than the failure moment.
- Fireproofing was successful in protecting the CFRP, concrete, strands and mild reinforcement.

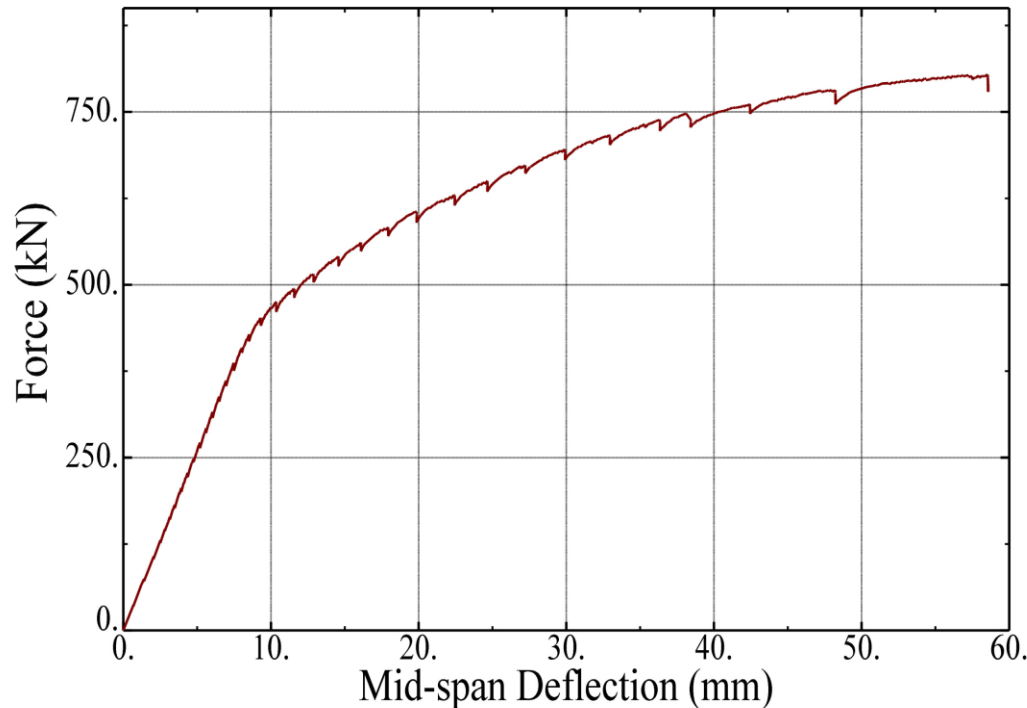
## Girder-3 (no CFRP or fireproofing)

- Failed at a load of 181 kip (805 kN), corresponding to a bending moment of 1424 kip-ft (1930 kN-m).
- Calculated flexural capacity was 1384 kip-ft (1876 kN-m), 2.8% less than the failure moment.
