JOINT DETERIORATION AND CHLORIDE-BASED DEICING CHEMICALS

Why do some concrete pavements and concrete flatwork in freezing-and-thawing damage environments show premature deterioration at joints?

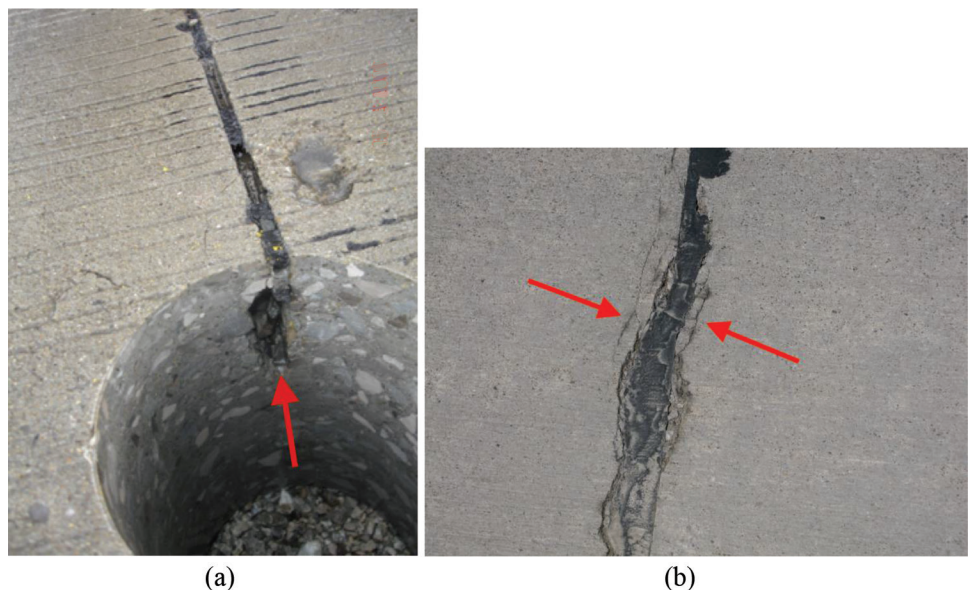
Concrete pavements and exterior flatwork generally provide excellent performance in all climates and exposures. Concrete durability is an essential component in delivering the return on investment that makes concrete an economical and sustainable material. In recent years, the industry has seen an increase in premature deterioration at joints and saw cuts in concrete pavements and flatwork in areas where winter storm events demand the application of deicing chemicals, which are most commonly chloride-based. The damage most commonly manifests itself in one of two forms. In the first, concrete at the base of the saw cut deteriorates, often producing cracks parallel to joint walls and within 4 to 6 in. (100 to 150 mm) of the original joint (Wiese et al. 2015) (Fig. 1(a)). These cracks should not be confused with D-cracking (ACI 201.2R). In the second form of damage, micro-cracking along the joint walls causes raveling, where flakes of concrete typically ranging from 1/8 to 1/4 in. (3 to 6 mm) thick are lost from the joint (Wiese et al. 2015) (Fig. 1(b)).

Fig. 1—Photographs showing: (a) damage at the base of a saw cut (red arrow) that leads to cracks parallel to walls of joint (Arribas-Colón et al. 2012); and (b) flaking of the concrete (red arrow) that presents itself as raveling along a joint (photo courtesy of L. Sutter).
