Earthquake Damage in a Precast Concrete Parking Garage in Christchurch, New Zealand

Building Description

- Completed in 2007
 - Designed with a ductility factor of 1.25 (R equivalent of 1.17)
 - Design base shear coefficient of 0.56g
- Five story parking garage
 - One basement level

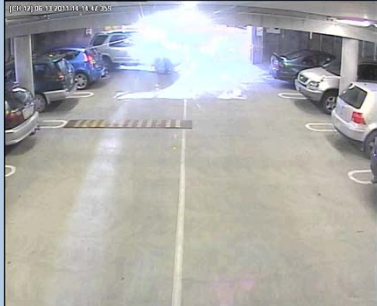
- Wall-to-floor connection damage
 - Further investigation recommended. Inspection report dated June 13th, the day of the June aftershock.

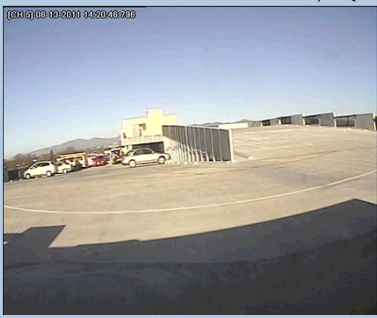
- Damage overview
 - Rapid inspection
 - Detailed investigation
 - Repair cost: 9.4% of initial cost
 - 2 months of down time

Component	Damage	Repair strategy
Soldier panels	Flexural cracking (1 to 2 mm width)	Replaced lowest panel (9 of 10)
Corner walls	Flexural cracking and spalling	Replaced lowest panel (1 of 4)
Wall-to-floor connections	Fractured dowels	Drill-and-bond dowels. Reinstate topping.
