Post-Earthquake Repairs, Part 1

ACI Spring 2012 Convention
March 18 – 21, Dallas, TX

**REPAIR OF CONCRETE BRIDGES
DAMAGED BY 02/27/2010 M8.8
CHILE EARTHQUAKE**

Daniel Ortiz, SE Univ. de Chile. CEO, TECNOAV S.A

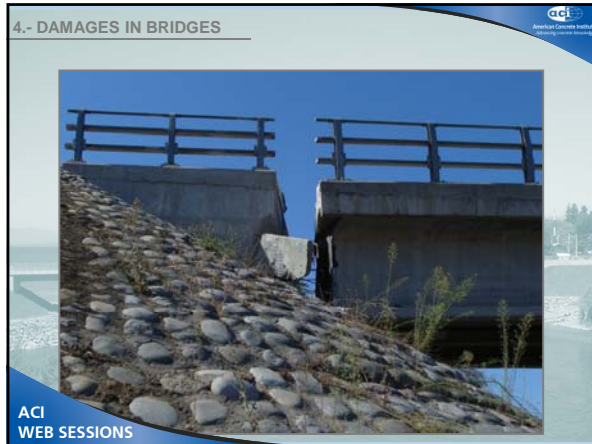
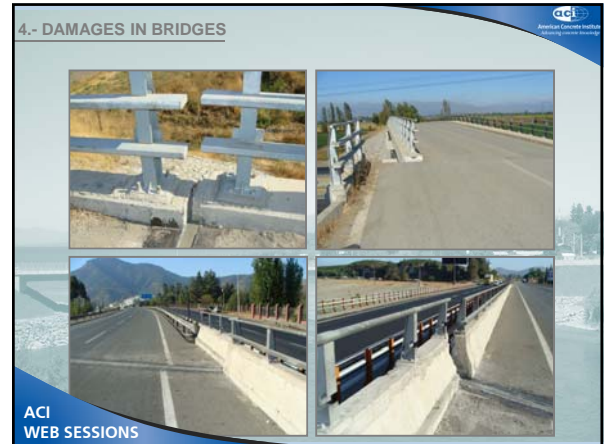
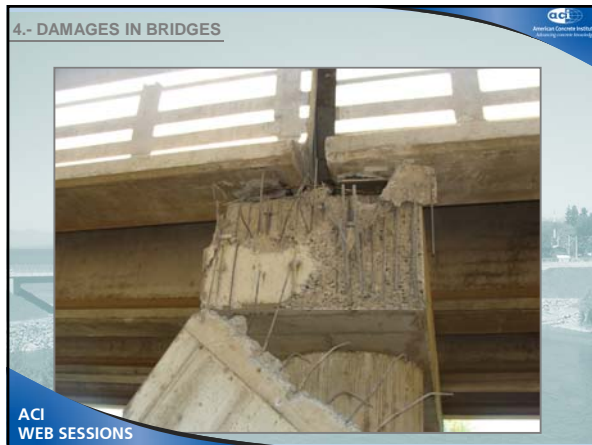
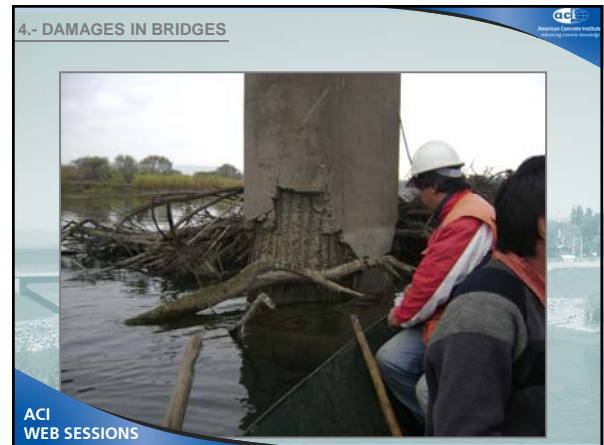
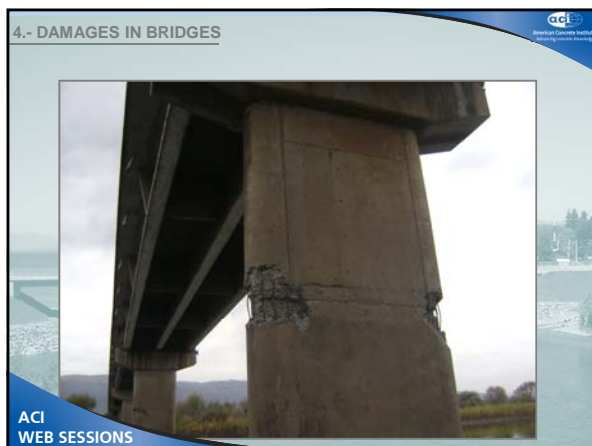
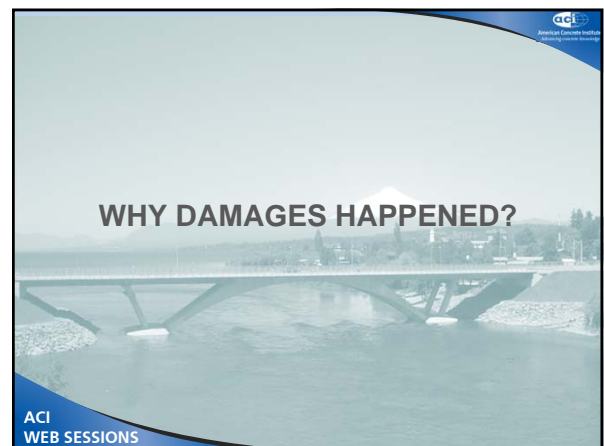
4.- DAMAGES IN BRIDGES

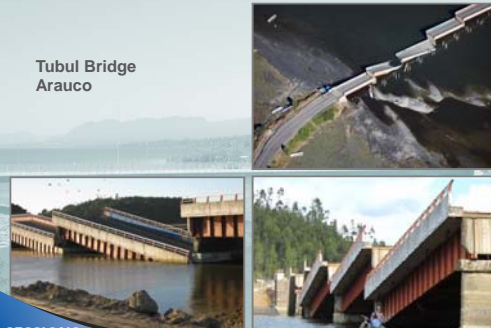
Tubul Bridge
Arauco

Insufficient performance of foundations

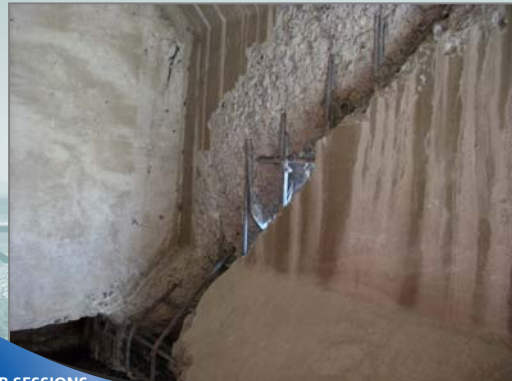
- During the earthquake, external prestressed beams hit against the horizontal concrete stoppers suffering damage in webs and bottom flanges close to their support, reducing their shear strength and affecting their support area.
- The idea was to repair them without having to replace them, reestablishing or improving their original properties without interrupting the traffic over the bridge.

- 1.-Installing a temporary vertical support to the beam as close as possible to the end of the beam.
- 2.-Removing all the concrete and rebars damaged by the distortions or failure and cleaning up all the surfaces.
- 3.-Web and bottom flange concrete repairing were executed using two kinds of concrete depending on the size of the damage:
- -Grout mortar mixed with 25% 10mm gravel, and repairing mortar with fiber for small volumes. In both cases a bonding agent was applied on the old concrete surface.

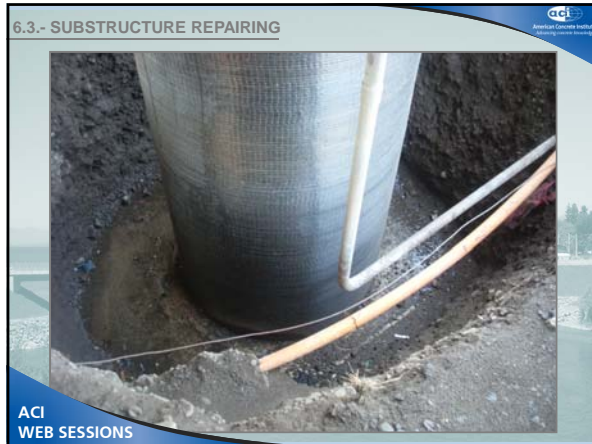
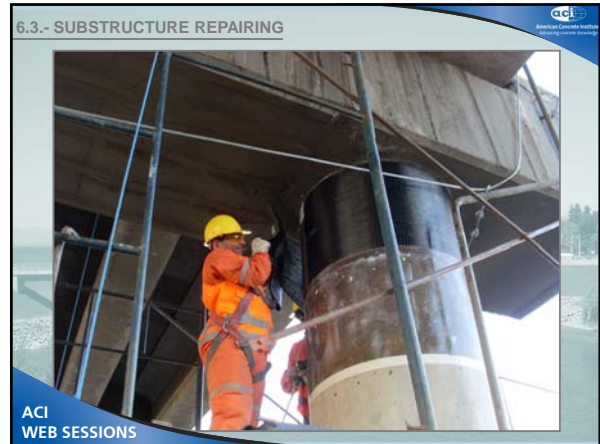
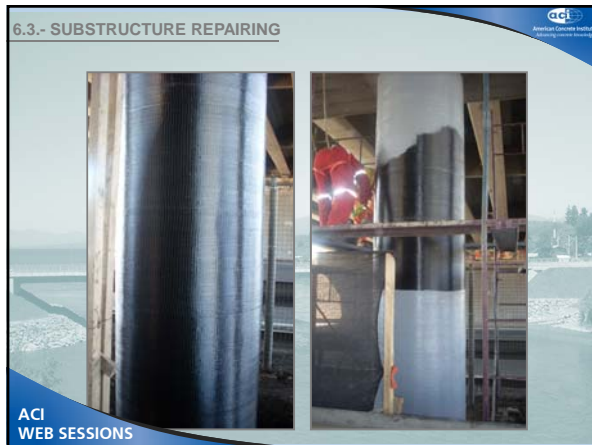
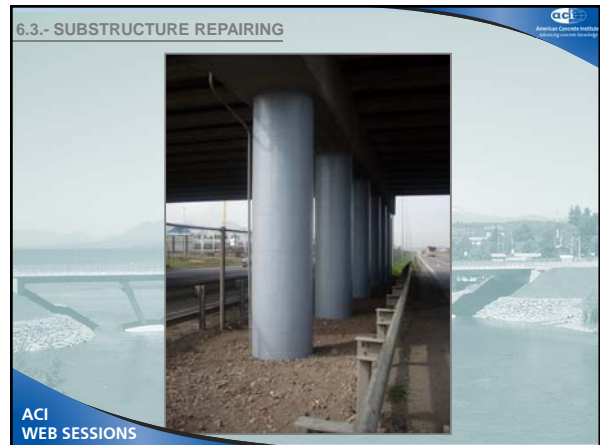
- Repairing and reinforcing frame columns damaged by shear and torsion.
- Repairing and reinforcing shear wall piers damaged by shear and bars buckling by compression because of deficient or inexistent confinement.

- Cleaning and detection of injectable cracks.
- Injection of cracks using epoxy .
- Reinforcement using Carbon Fiber fabric to improve strength and ductility.
- Finishing using UV protective coat.

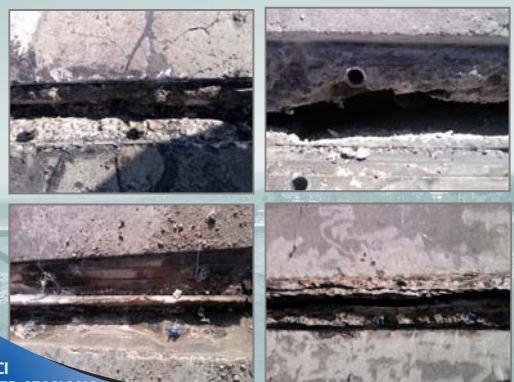
- Replacing of 6.000ft (2.000m) of expansion joints 2" average opening, destroyed by deck movement.
- Most of them were neoprene seal joints from different origins.

- To repair the expansion joints, the process was divided in 4 steps:
- 1.- Removal of damaged expansion joint .
- 2.- Clearing the area of dust and outside elements. Proceed to cut and demolish the damage surface, creating the space to apply the elastomeric concrete.
- 3.- Elastomeric concrete application with formwork.
- 4.- Installation of the neoprene extruded seal expansion joint.
