Post-Earthquake Repairs, Part 2

Repair of R/C Buildings Damaged in Viña del Mar During the 27 February 2010 M_w 8.8 Maule Earthquake

Patricio Bonelli¹, Gilberto Leiva², José I. Restrepo³ and Jorge Federico Carvallo⁴

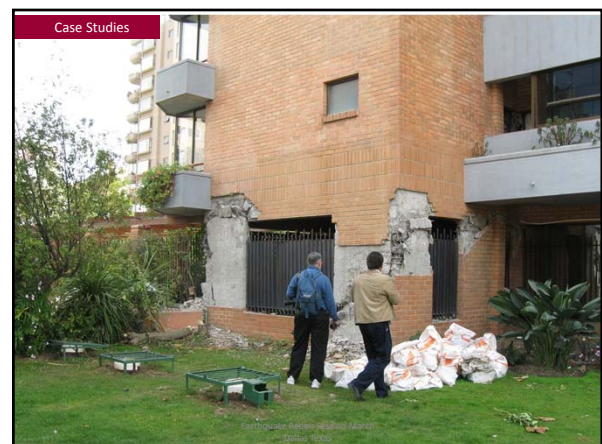
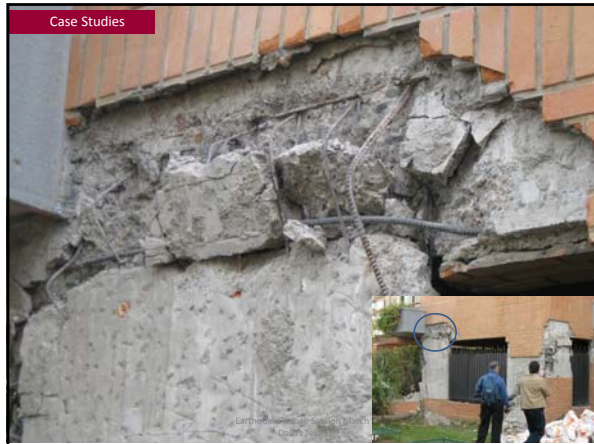
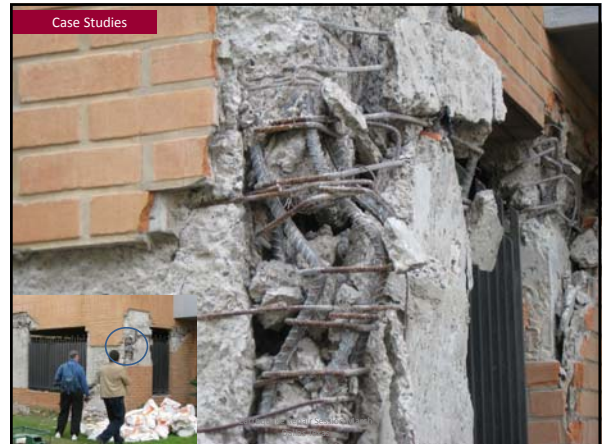
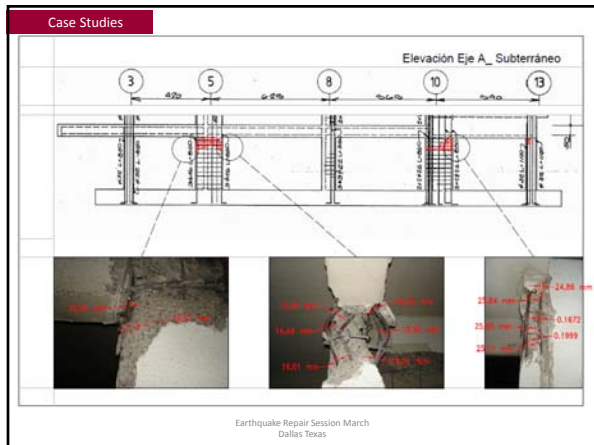
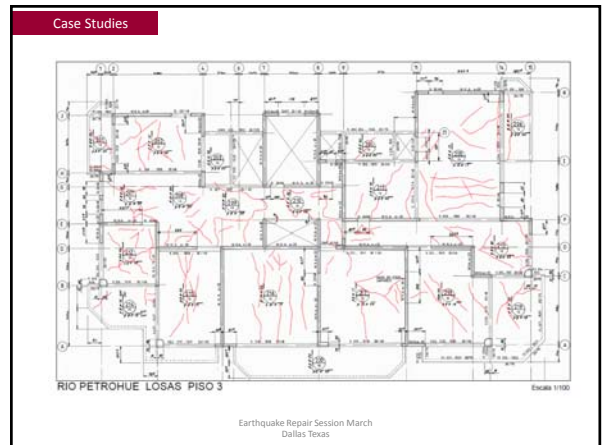
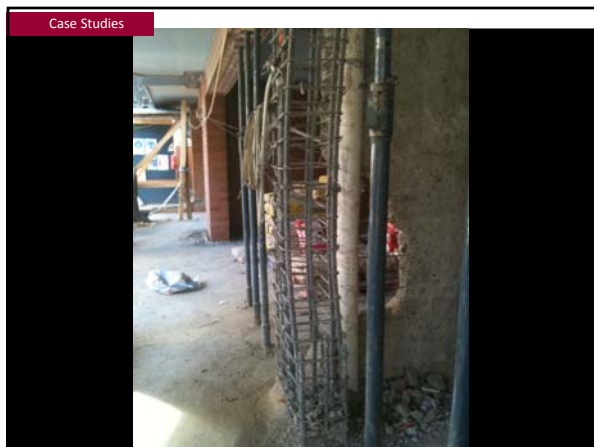
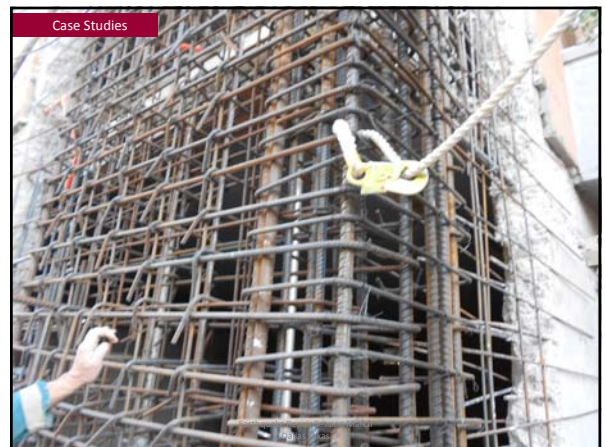
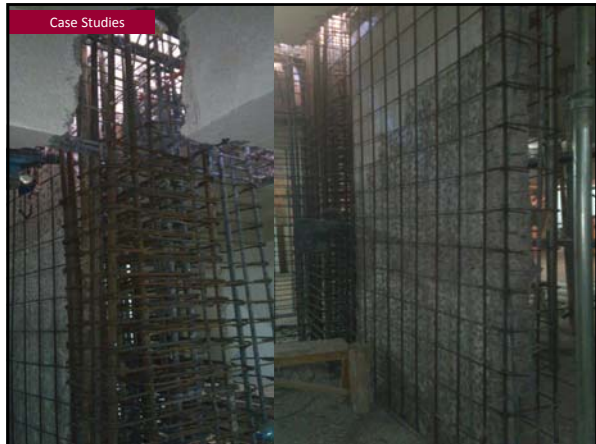
Río Petrohué

- 6860 m², 17 stories
- Total repair cost = \$2 565 000
- Structural repair cost = \$ 941 000
- Structural repair cost/Total repair cost = 0.3
- Total repair cost / Replacement cost= 1/3

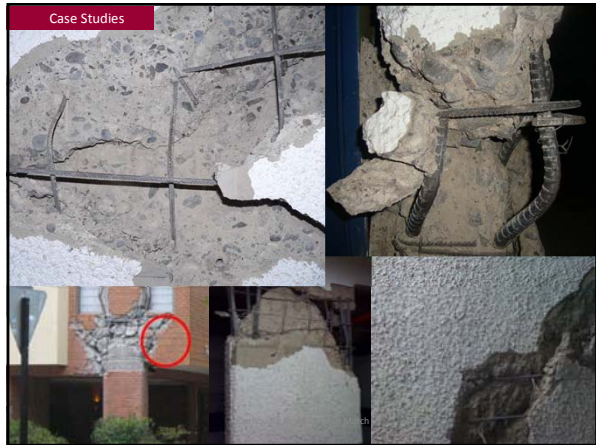
Edificio Trichahue

- 5000m², 12 stories
- Structural repair cost = \$ 1 500 000
- Structural repair cost = \$ 600 000
- Structural repair cost / Total repair cost = 0.4
- Total repair cost / Replacement cost = 1/3
