THEORY VERSUS REALITY IN CONCRETE AIRFIELD PAVEMENT ENGINEERING

Presented for the Shiraz Tayabji Honorary ACI Session

Ray Rollings
Beaufort SC

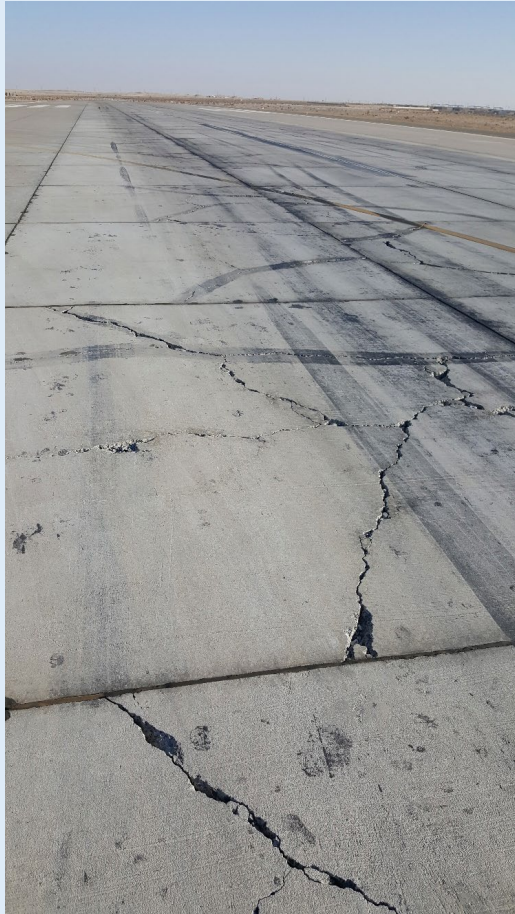
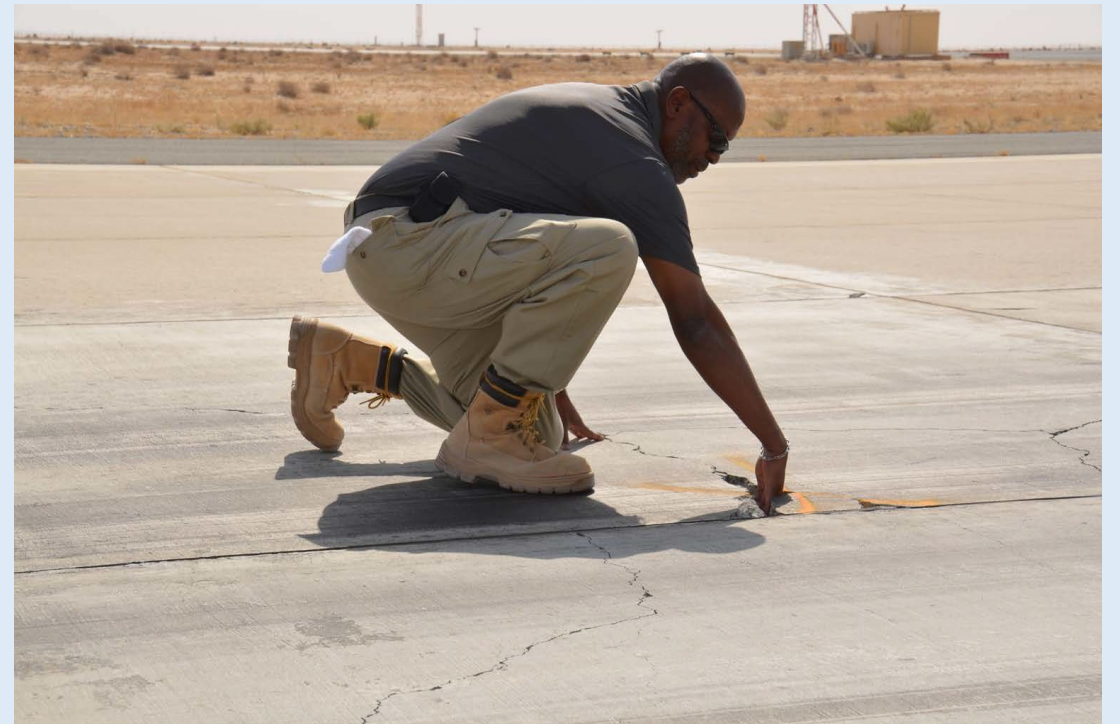
SERIOUS PROBLEM PAVEMENT CLOSED TO A/C

- F-15s flew combat missions without full fuel & munitions load
- Cracks – structural, lack of load transfer (design used 25%)
- Runway keel “re-replaced” 2018
- Why did this failure happen?
 - Contractor inexperience
 - Translation issues
 - Lack of QA/QC
 - Inexperienced government QA, project engineer, & manager (construction side of the house)

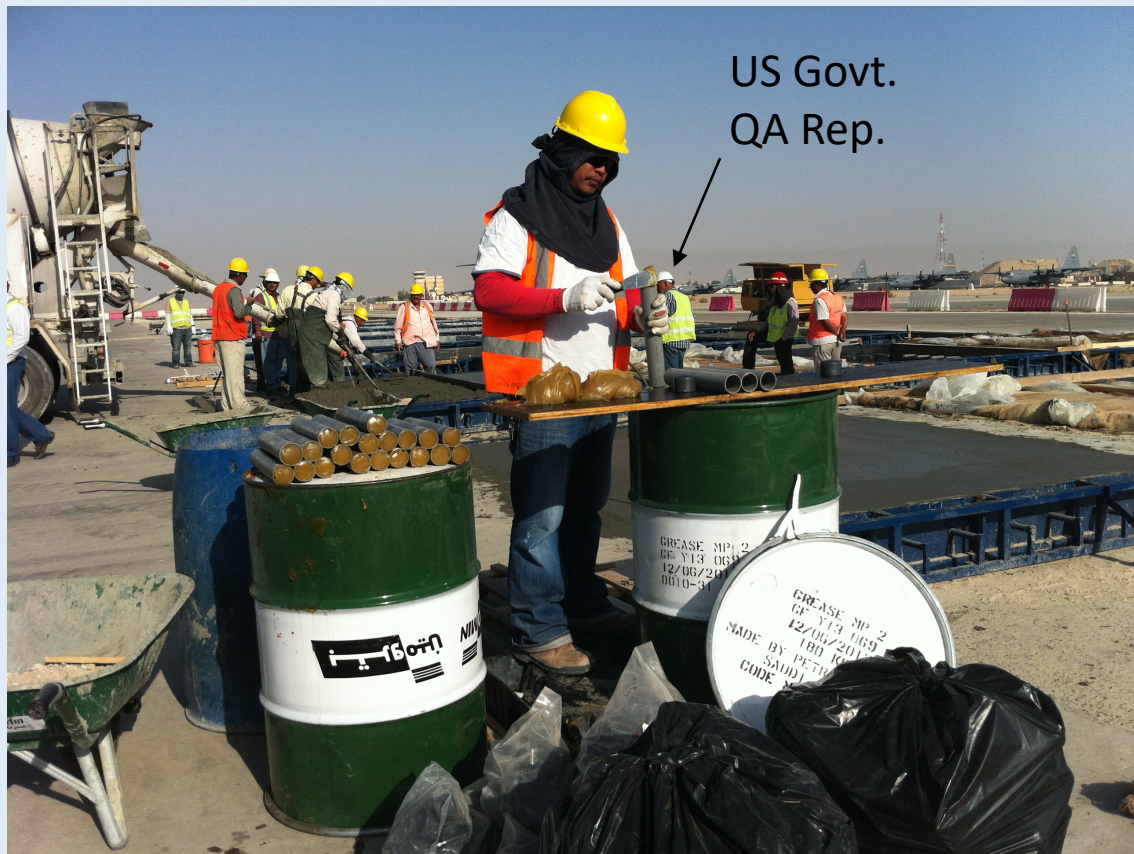
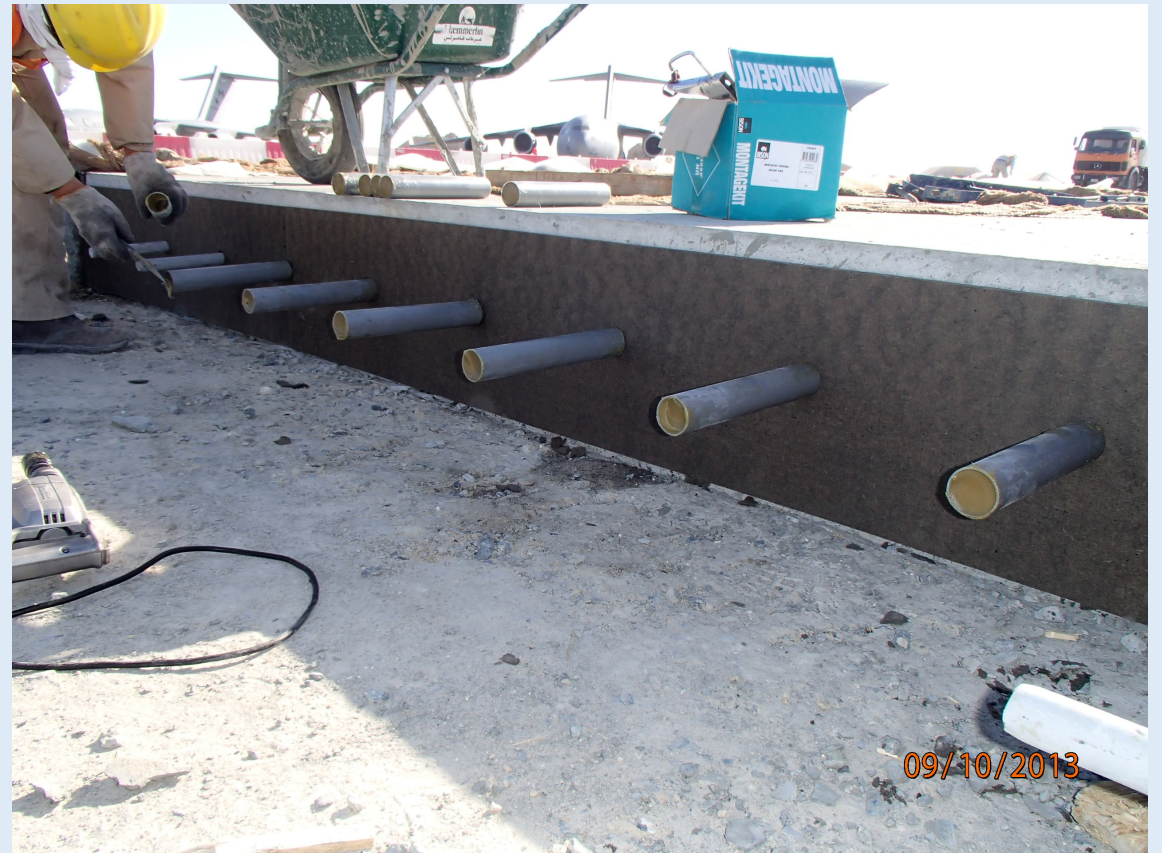
English specification for *greased epoxy-coated dowel bar* became
in Arabic *dowel inserted in grease-filled plastic pipe*

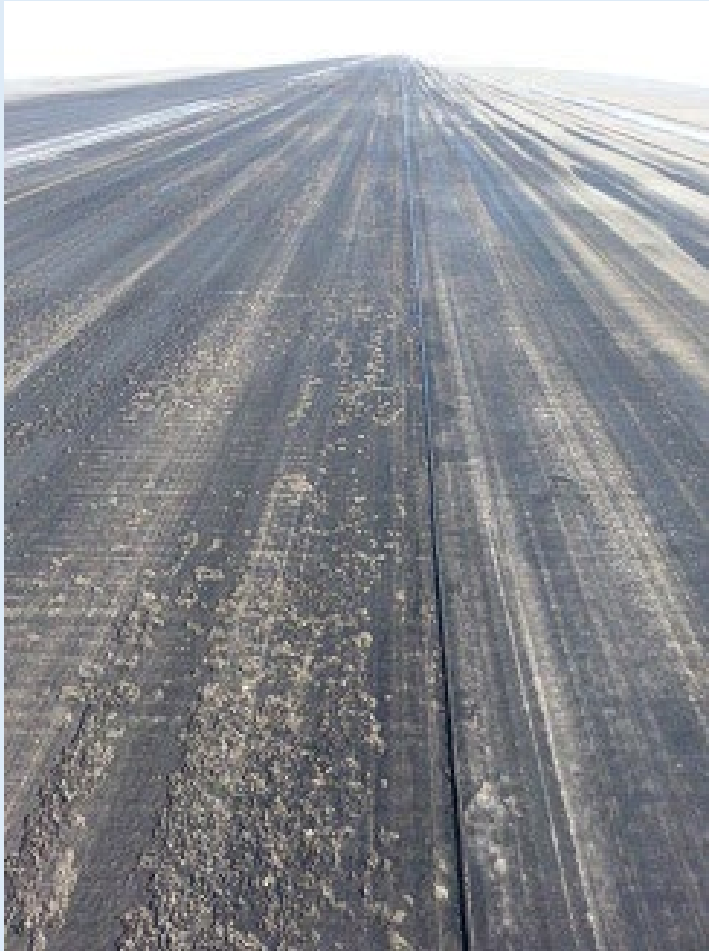
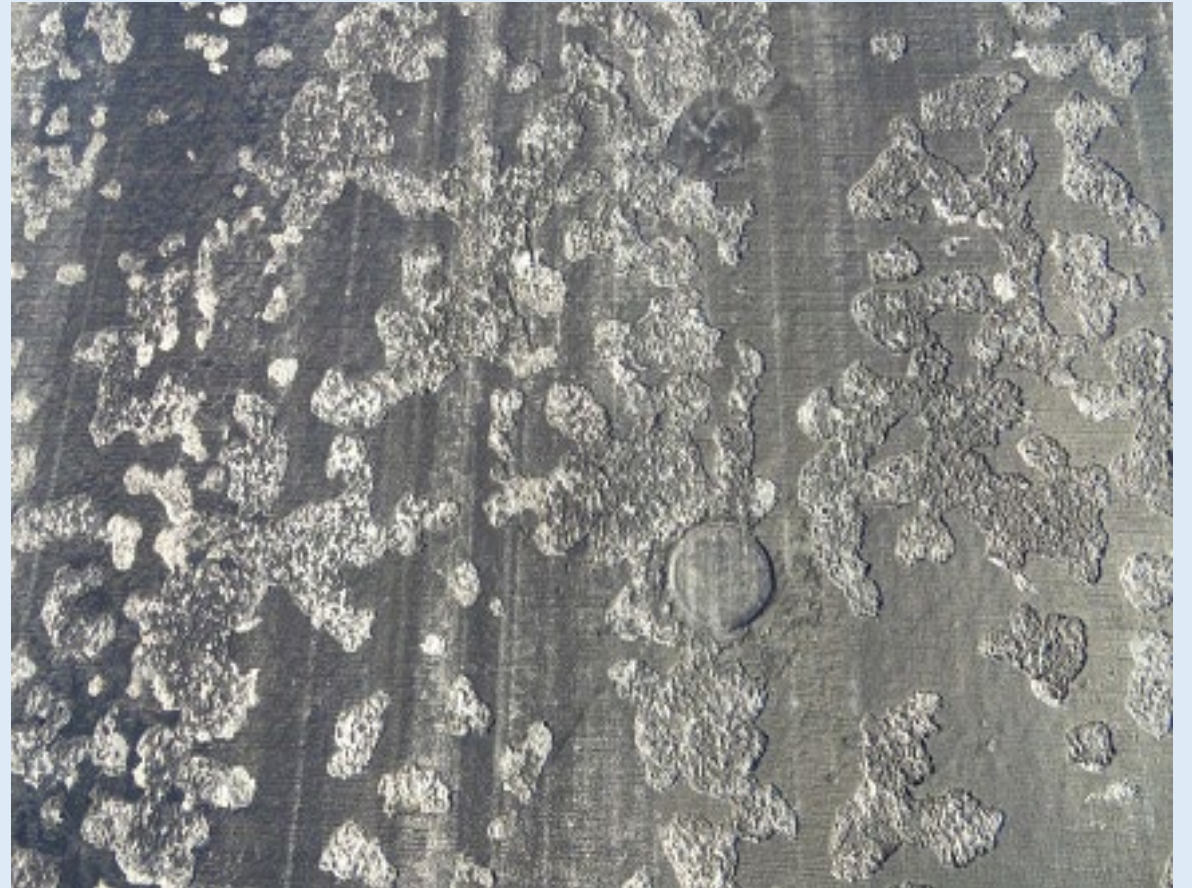
EXTENSIVE SCALING DEVELOPS ON PHASE I

- 18 Aug. 2012 – phase 1 runway end opened to traffic
- Immediately minor scaling appears in touchdown areas
- Worsens during 2012-2013 winter
- Appearing in both trafficked and untrafficked areas
- Traffic suspended from damaged areas (last 3,000 ft of runway) because of FOD hazard

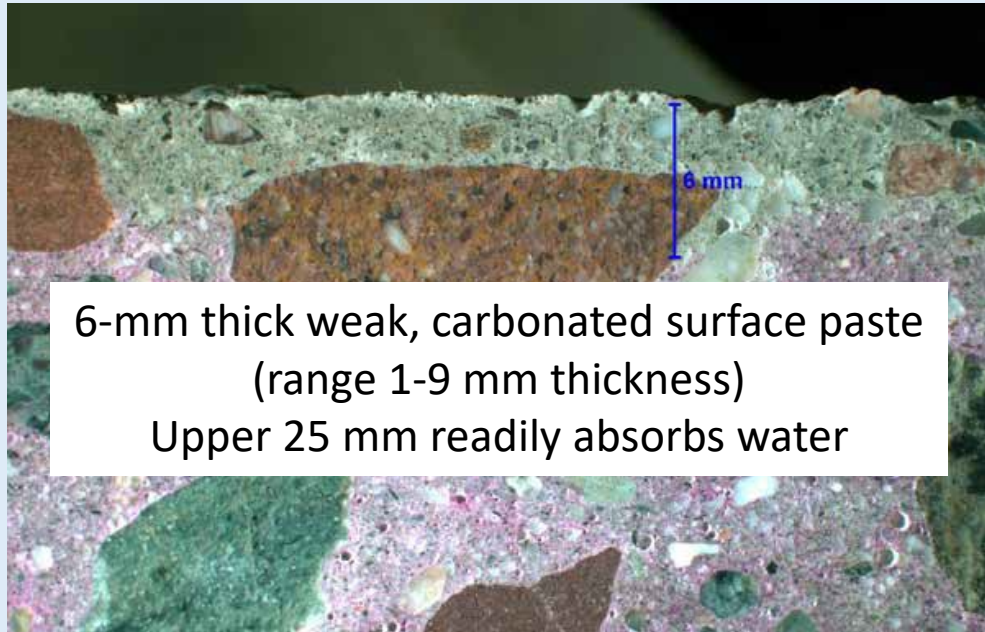
6-mm thick weak, carbonated surface paste
(range 1-9 mm thickness)
Upper 25 mm readily absorbs water

Poorly cured surface of silica fume concrete left a thin, weak, nondurable surface paste that crushed under aircraft (initial prewinter scaling) and suffered damage from freezing and thawing in the 1st winter

- Grind 6-mm from surface to remove failing surface paste
- US subcontractor brought in
 - Surface smoothness out
 - Some scaling areas missed
 - Some grinding > 20mm
 - Popouts appearing
 - Revealed widespread wood & clay balls
 - Same contaminants in sand stockpiles to be used in phase II

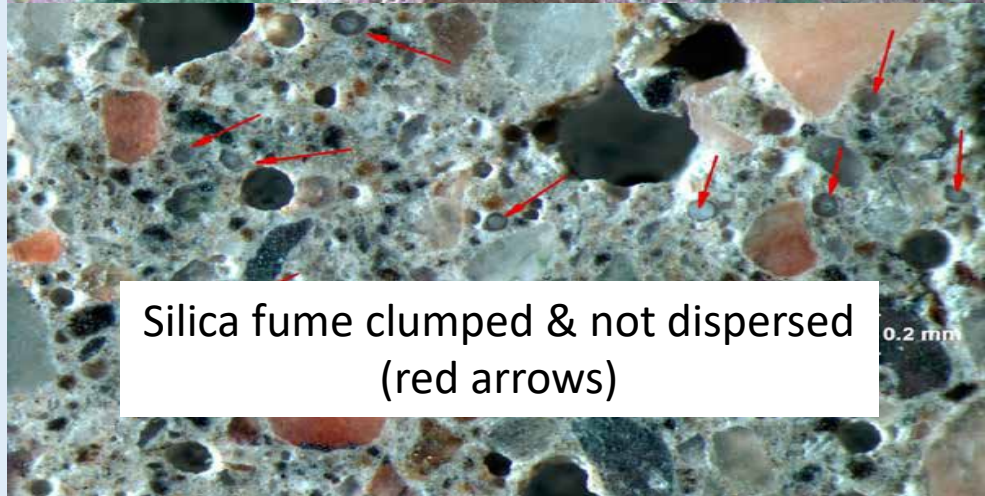
Silica fume clumped & not dispersed
(red arrows)

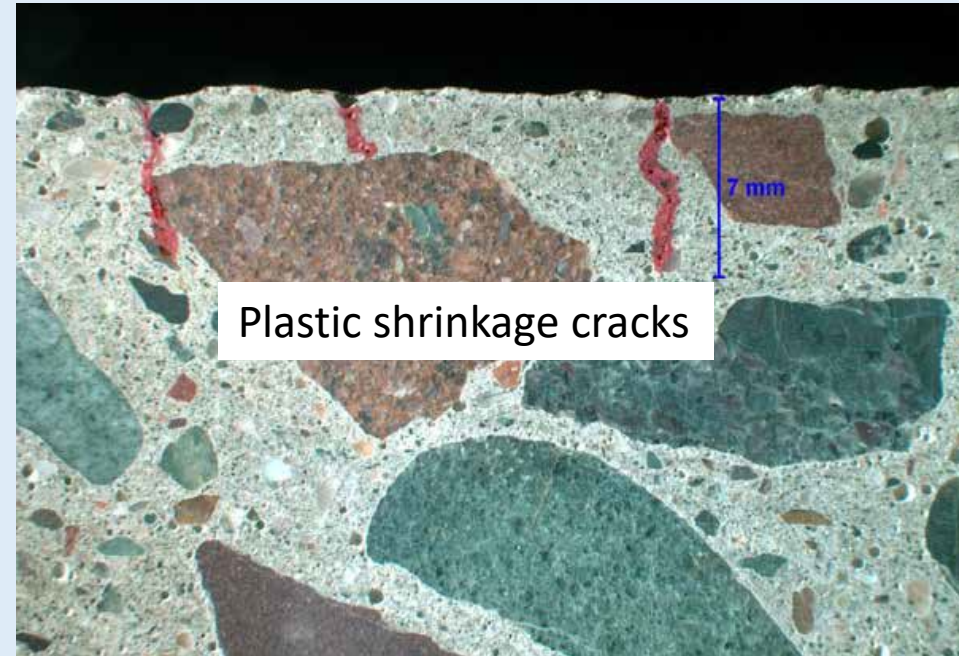
Plastic shrinkage cracks

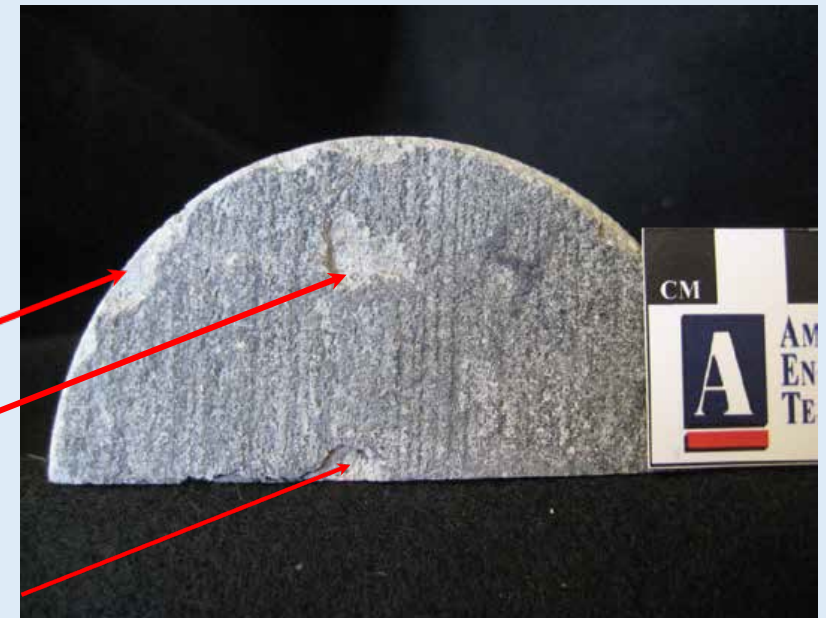
Despite passing test to 301 cycles thin mortar surface scales off as early 23 cycles

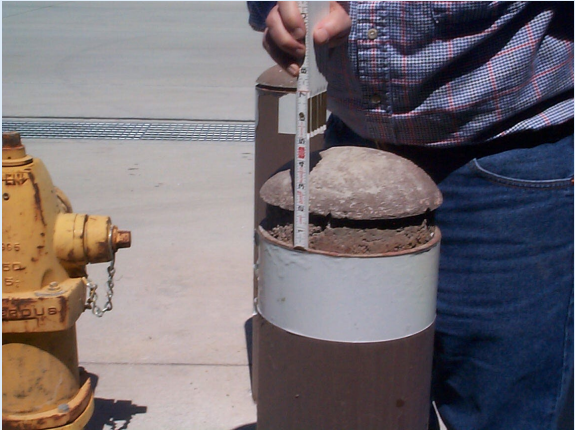
Concrete-filled bollard founded in recycled base

- Microscopy & x-ray diffraction
 - Calcium sulfate hydrate (gypsum) abundant
 - Ettringite & thaumasite (expansive minerals in sulfate attack) present in recycled base but not elsewhere
- Heaving
 - 1 inch in 24-inch thick recycled base areas
 - Up to 3 inches in thickest base course areas
 - Scattered locations but most prevalent where ample moisture and fill thickest
- Why would this happen with recycled concrete with Type V cement?
 - Performed fine as a pavement for 38 yrs.
 - Crushing
 - More permeable (water is driving agent for sulfate attack)
 - Abundant water under paved areas and hangar
 - Crushing exposes more of alumina in Type V cement
- All evidence indicates the recycled concrete base/fill is undergoing classical sulfate attack on concrete

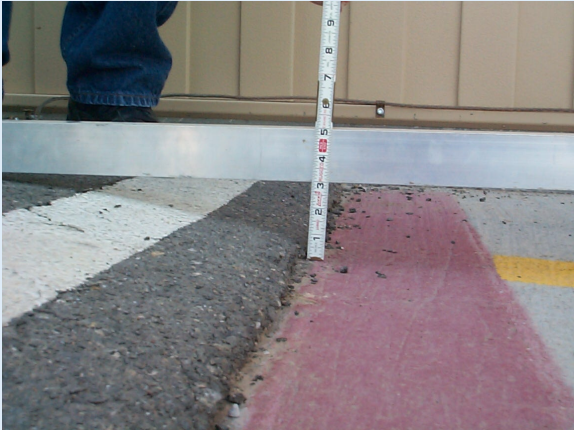
Pavement on left with recycled base, on right without

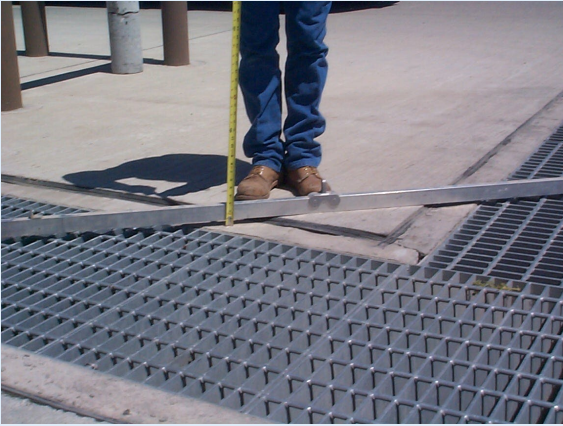
Heaving of apron on recycled base
Fuel trench founded below recycled base.

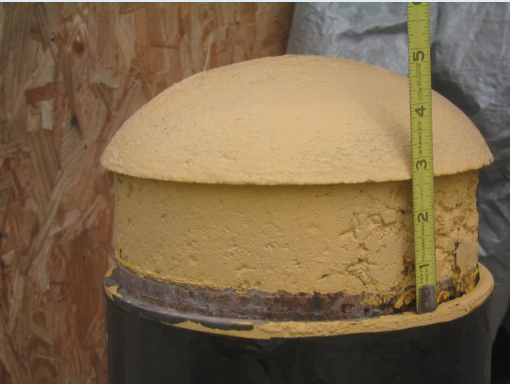
Continuing to grow (2004)

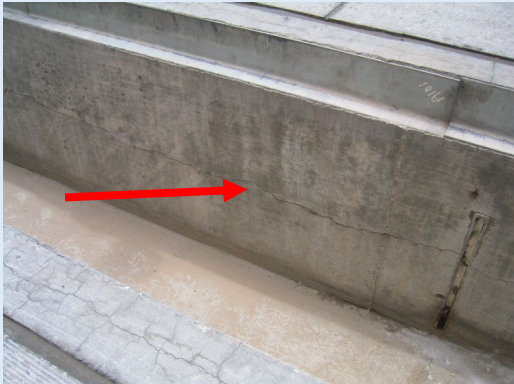
Expansion in base cracking fuel trench wall (2004)

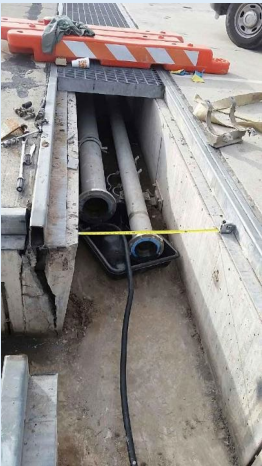
Fuel trench wall failures (2017)
