Repaired Reinforced Concrete Wall Buildings in Chile After 2010 Earthquake

M. A. Hube¹, H Santa María¹, H.A. Gálvez², R. Jünemann³

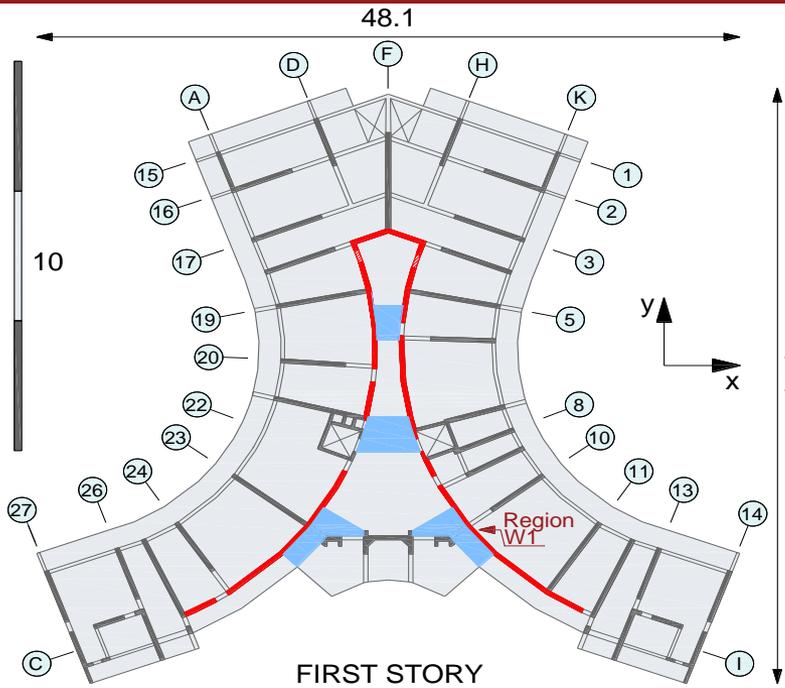
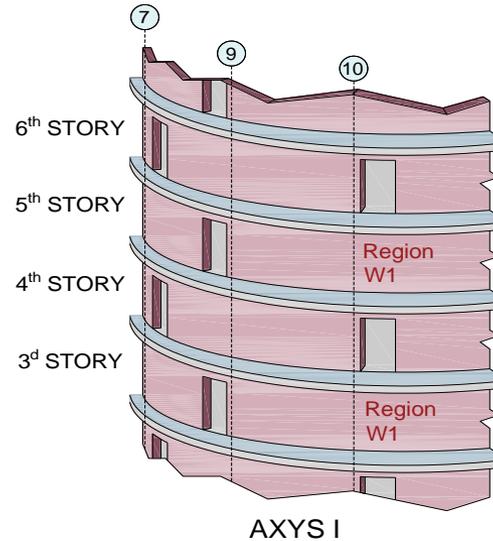
Building 1

DAMAGED WALLS
AFTER 1985 EARTHQUAKE
DAMAGED SLABS
AFTER 2010 EARTHQUAKE

- Located in Viña del Mar
- 15 story
- Constructed in 1970
- Damaged after 1985
- Suffered less damage after 2010 earthquake

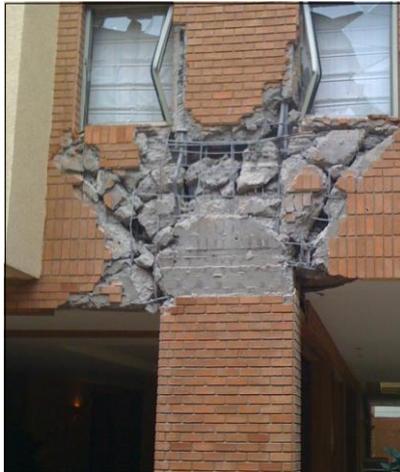
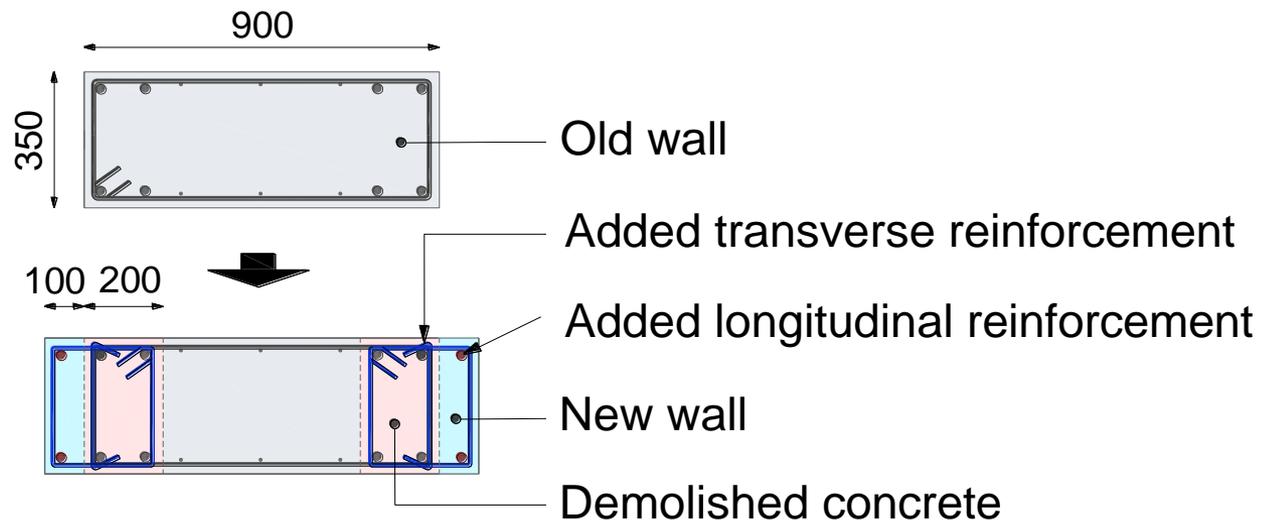
- Located in Viña del Mar
- Built in 1998
- 11 stories and one basement
- Damage concentrated mainly in two walls

- Flexural strength and deformation capacity of unconfined walls was improved by adding special boundary elements.

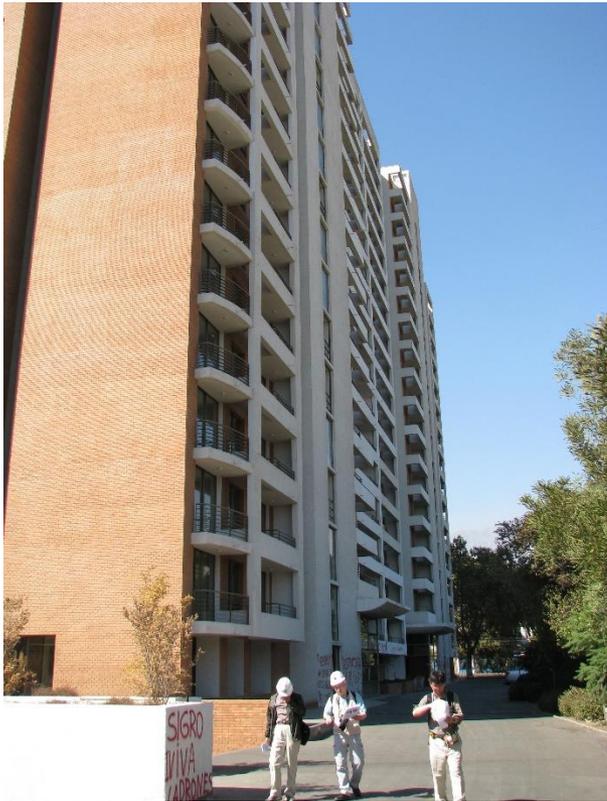
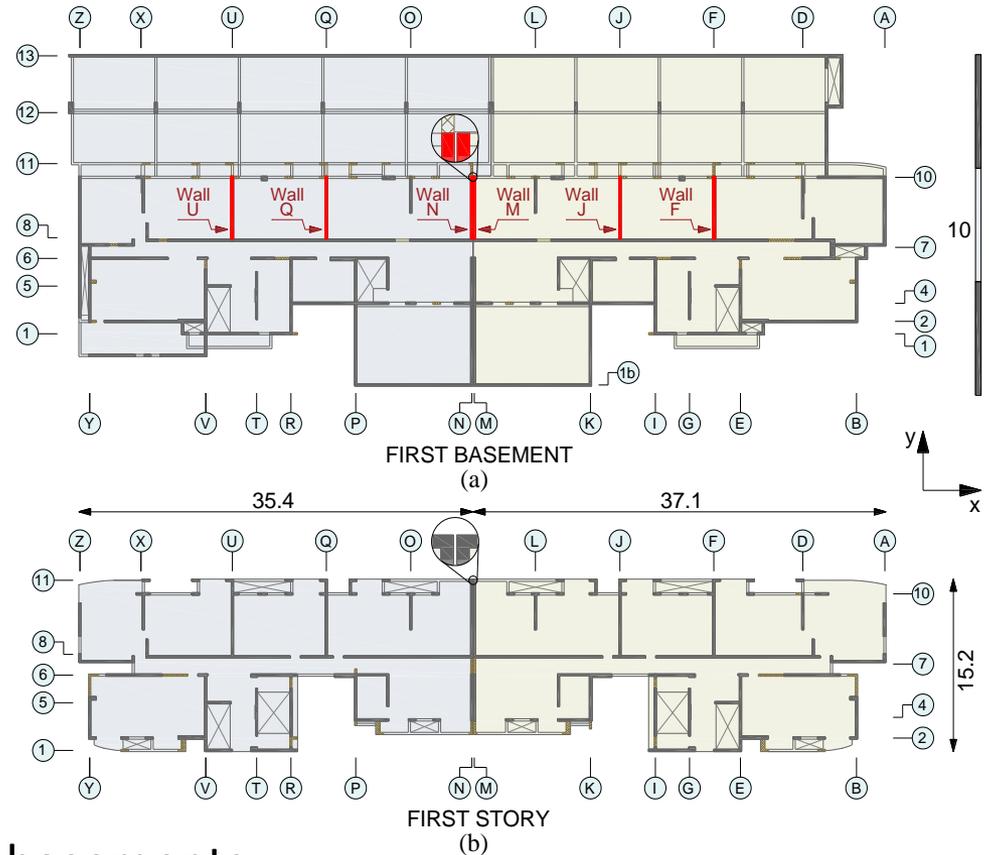
- Two towers of 18 stories and 2 basements
- Built in 2007
- Severe damage in walls

- Walls were repaired and strengthened by adding boundary elements and increasing the wall thickness
