QuakeCoRE
NZ Centre for Earthquake Resilience

Damage to Concrete Buildings with Precast Floors in the 2016 Kaikoura Earthquake

Rick Henry and Ken Elwood
University of Auckland
New Zealand

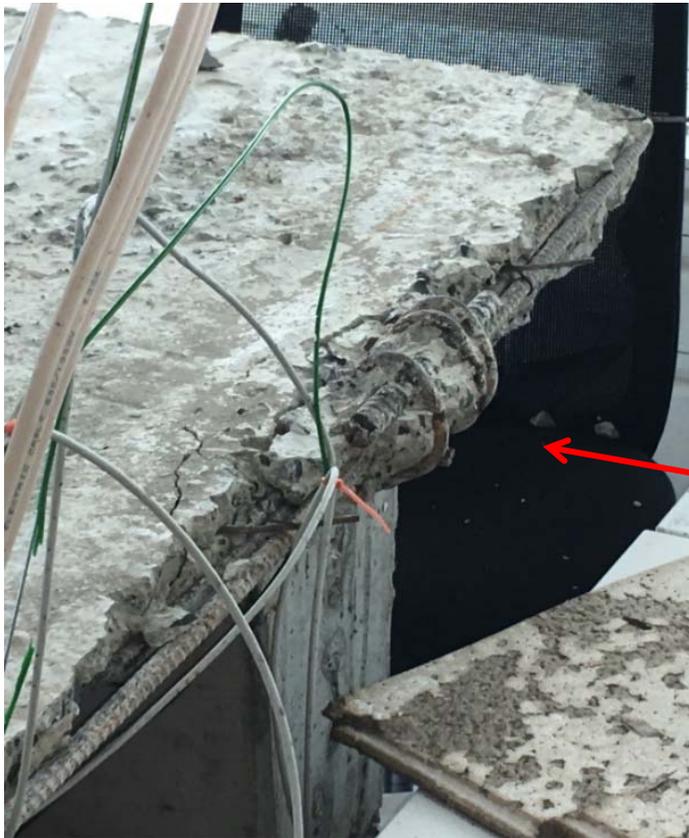
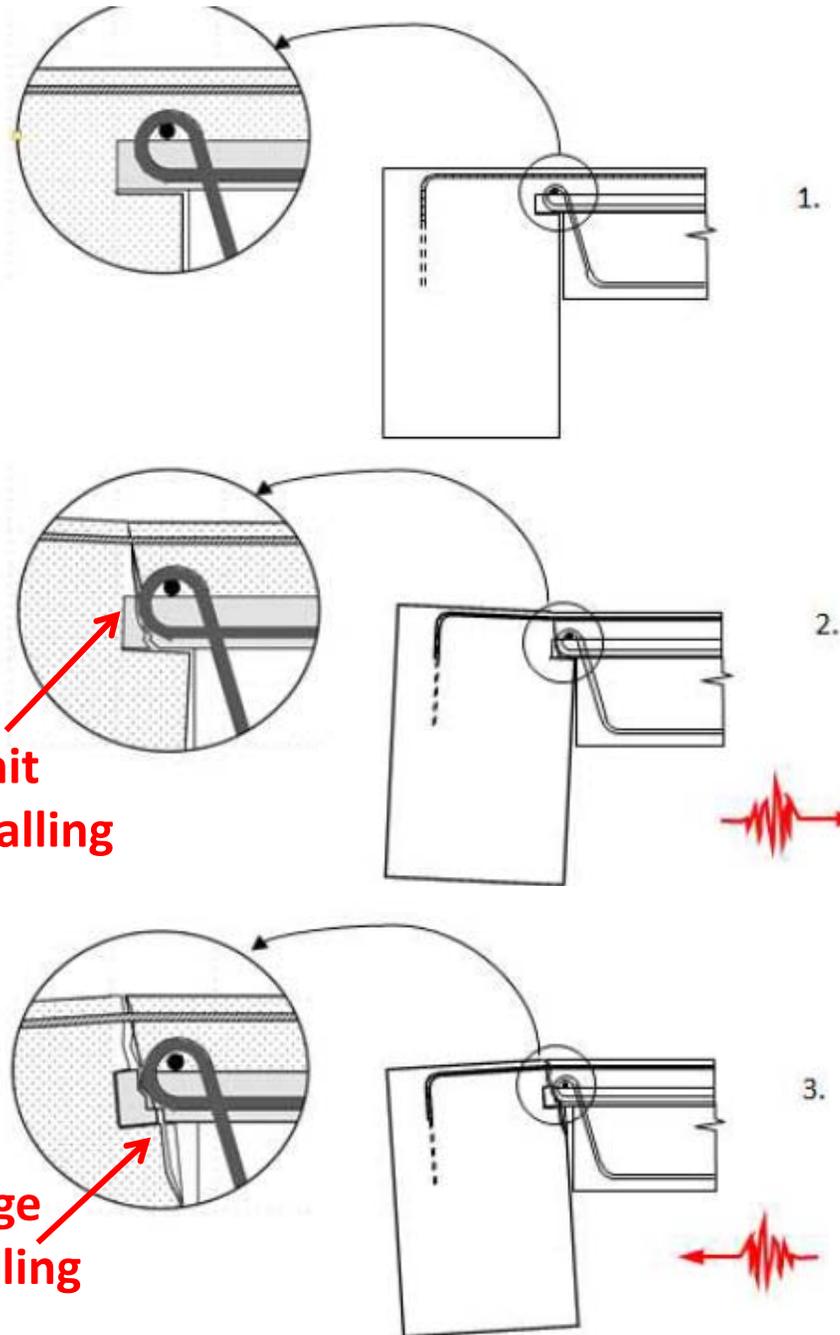
Statistics House

Double tee units collapsed from L1 and L2

Unit
spalling

Ledge
spalling

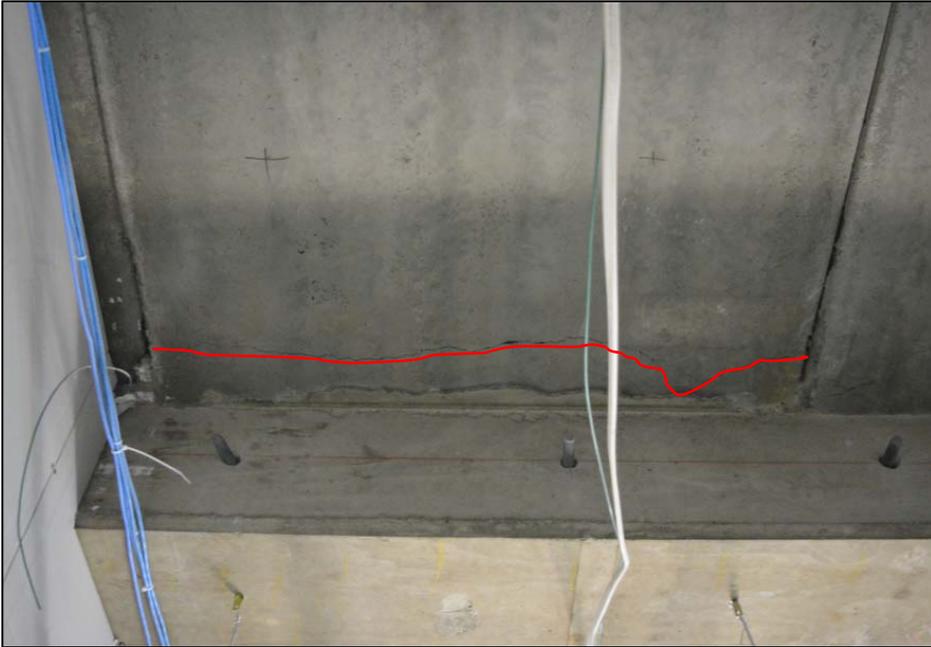
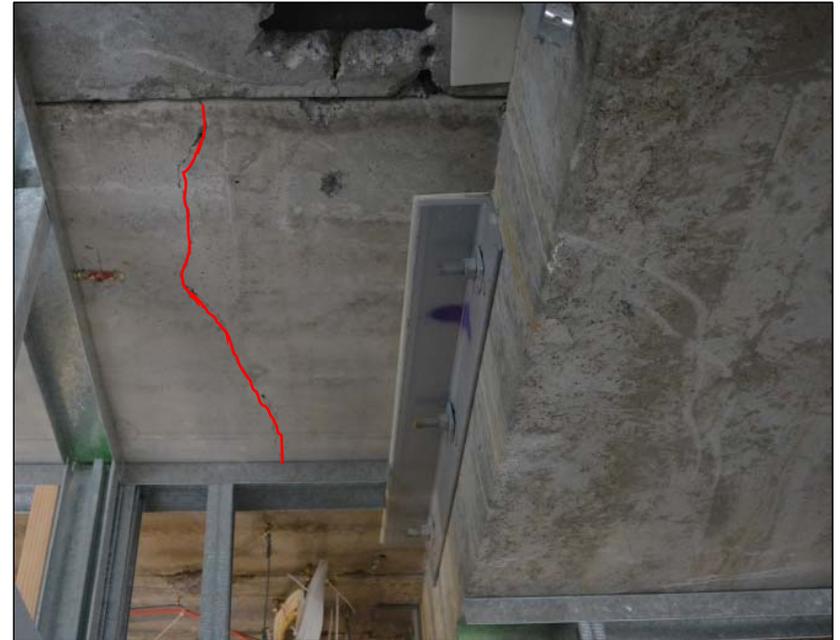
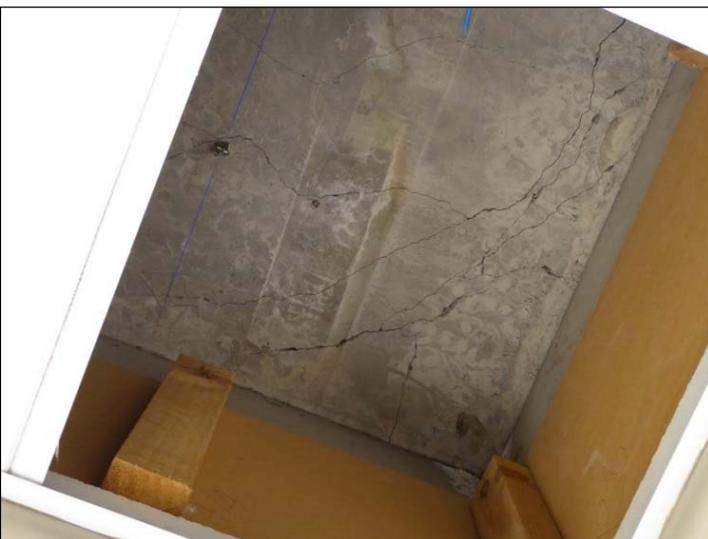
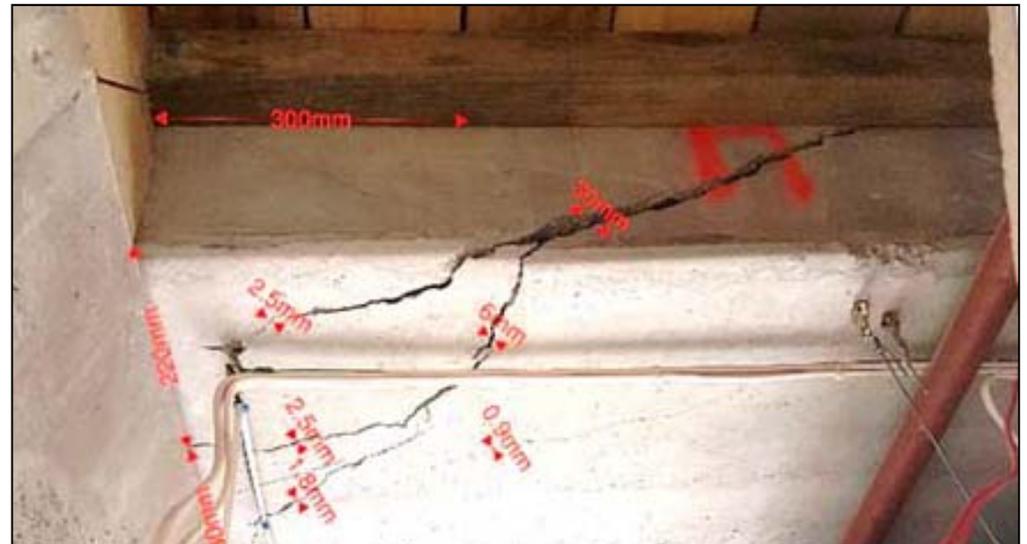
Hollowcore floor damage

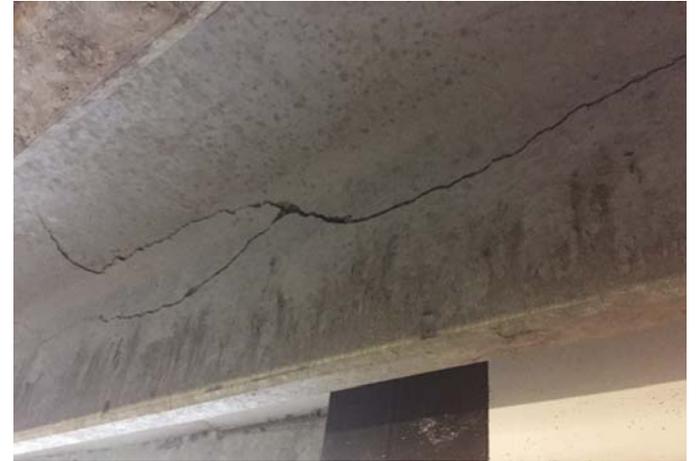
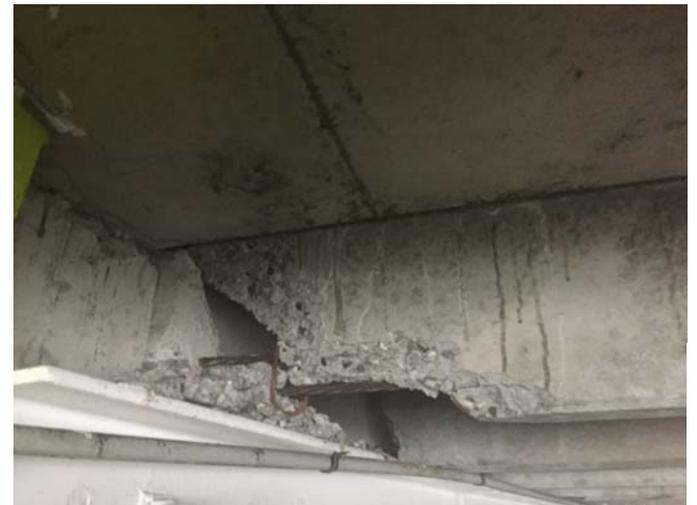
Kaikoura EQ damage

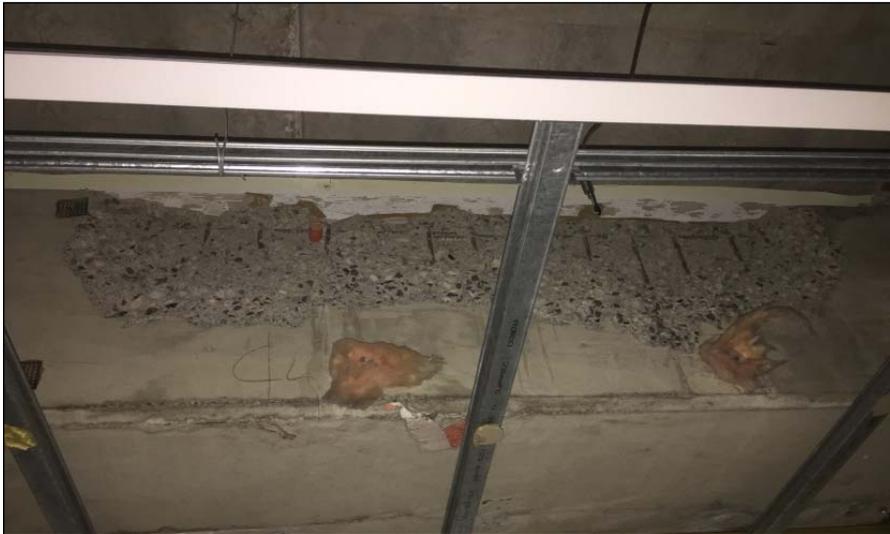
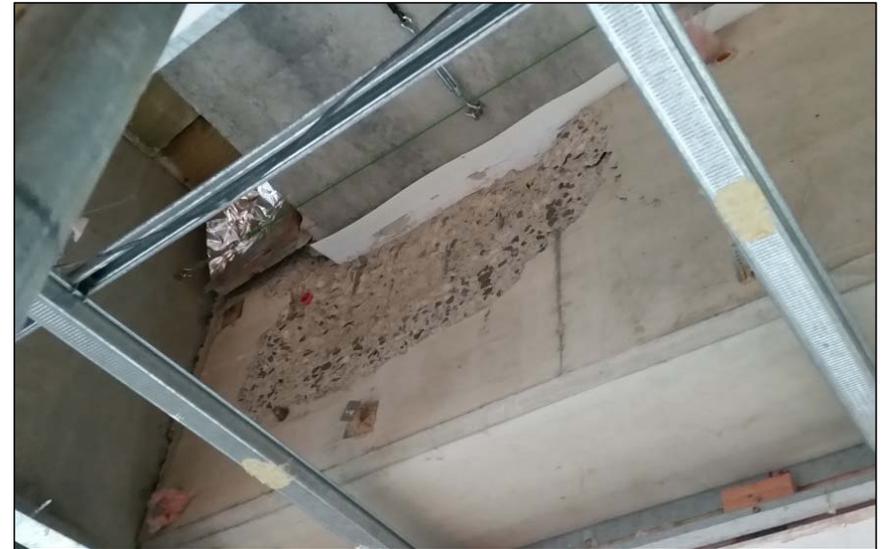
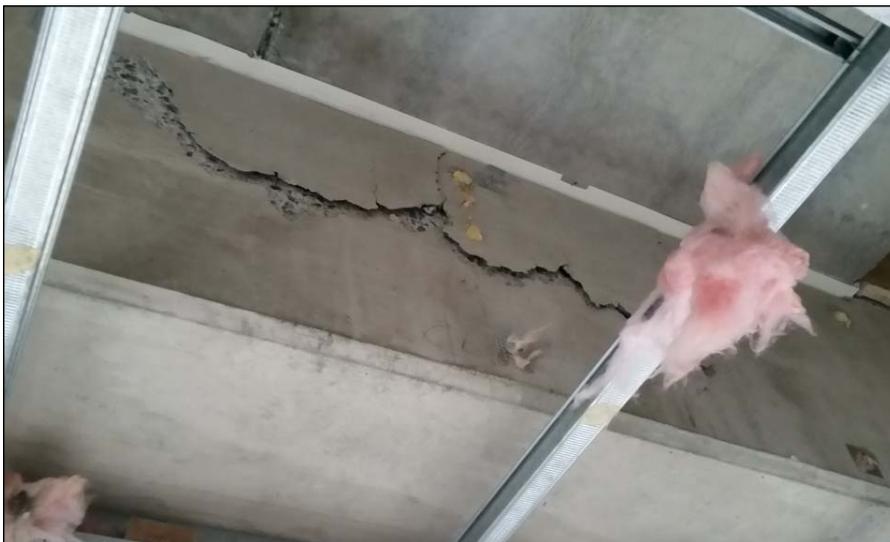
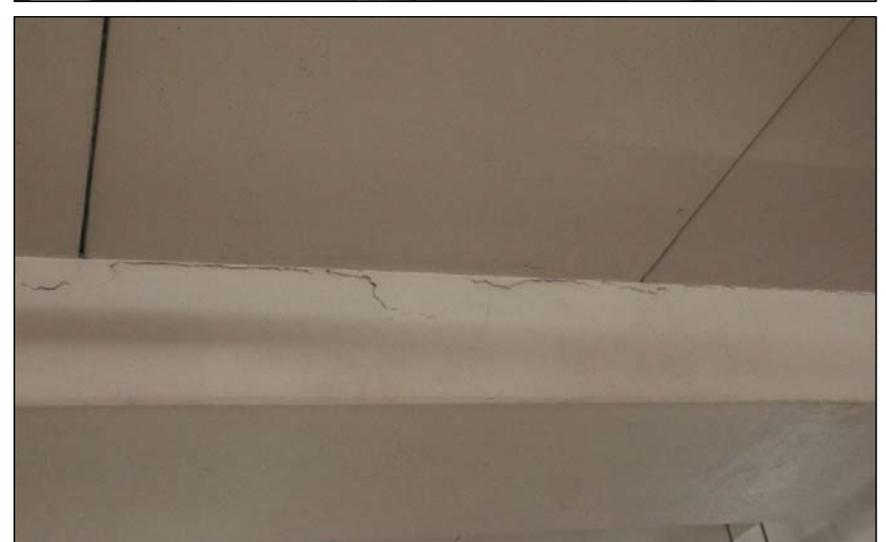
Loss of Seating (LOS) - Spalling

- Kaikoura evidence

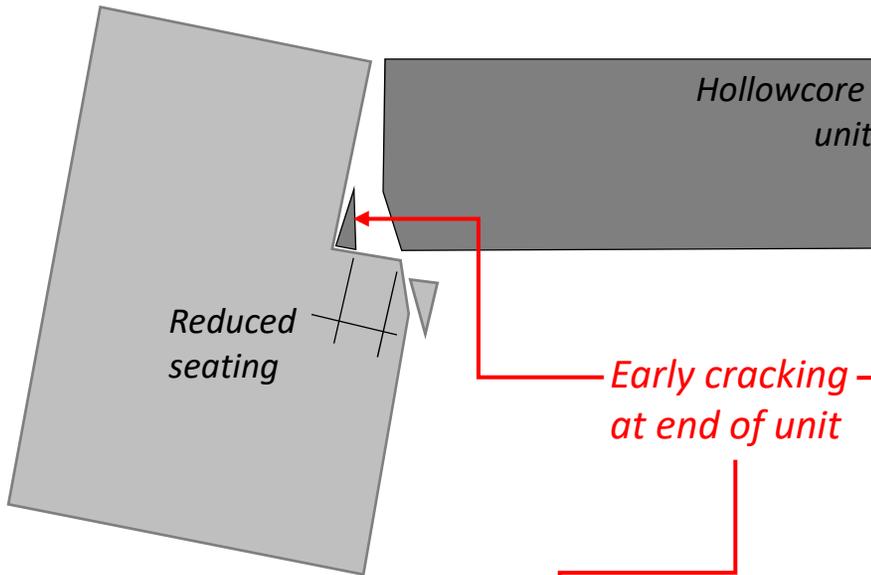
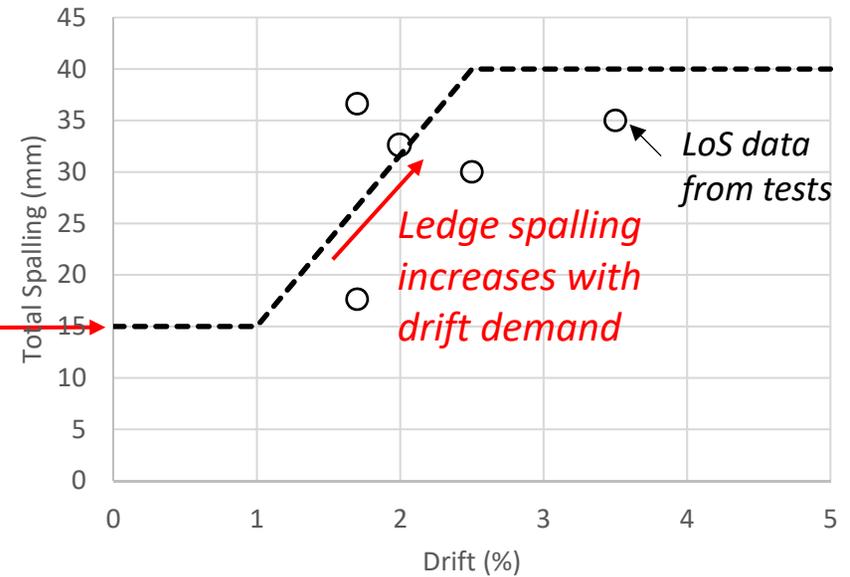
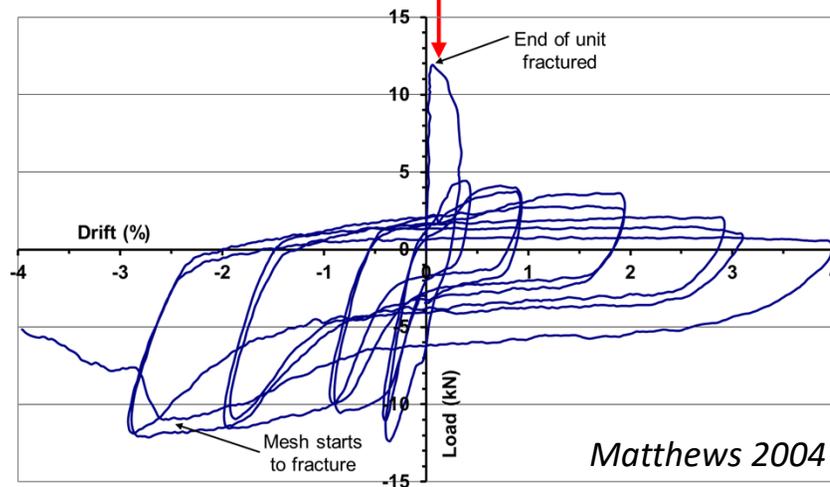
Loss of Seating (LOS)

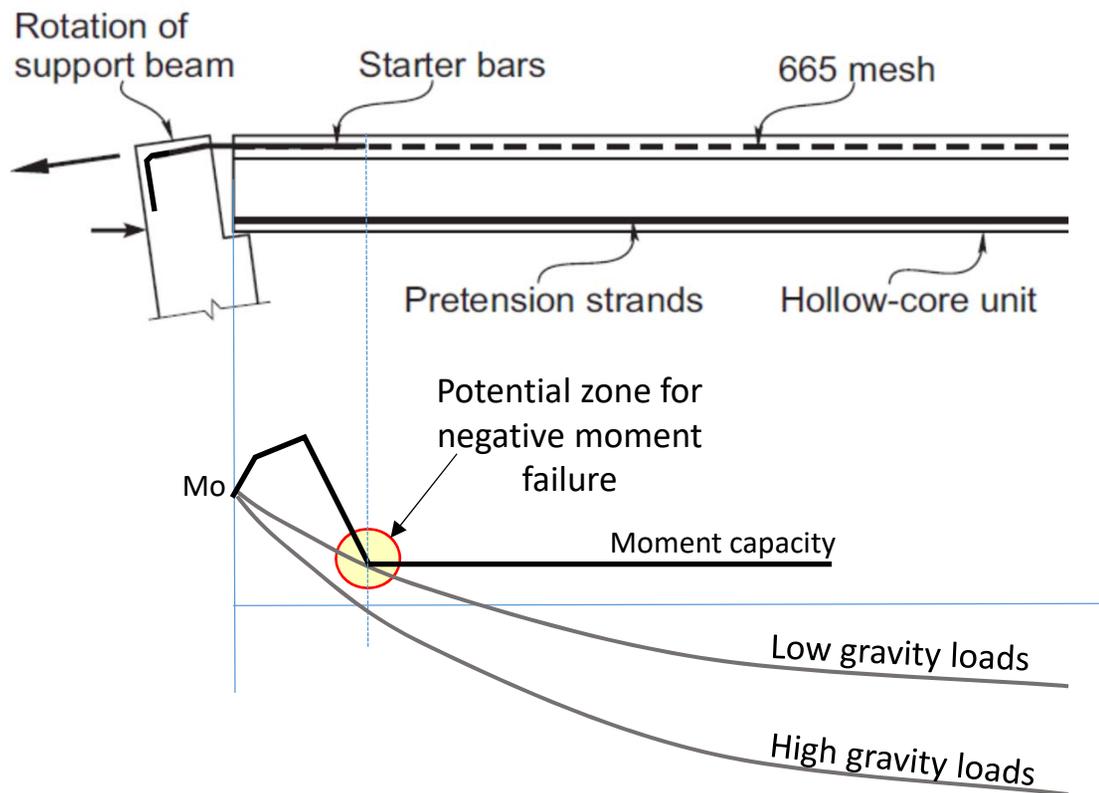
Kaikoura EQ damage

Negative Moment Failure (NMF)

If NMF triggered
→ **Limiting drift = 1%**

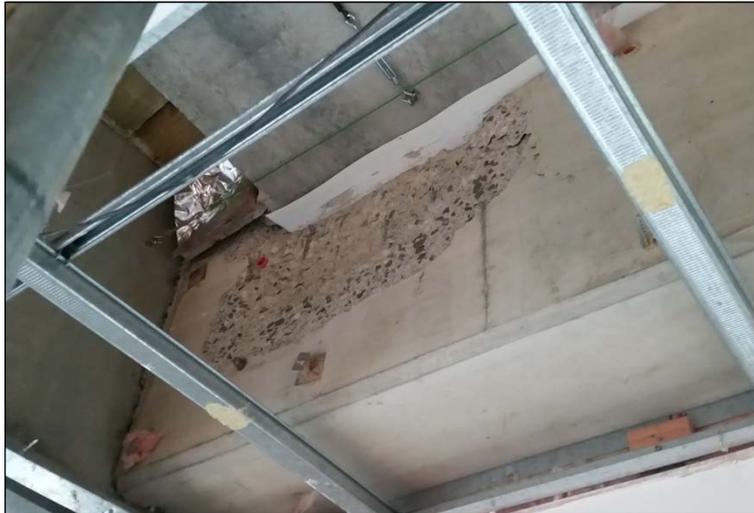
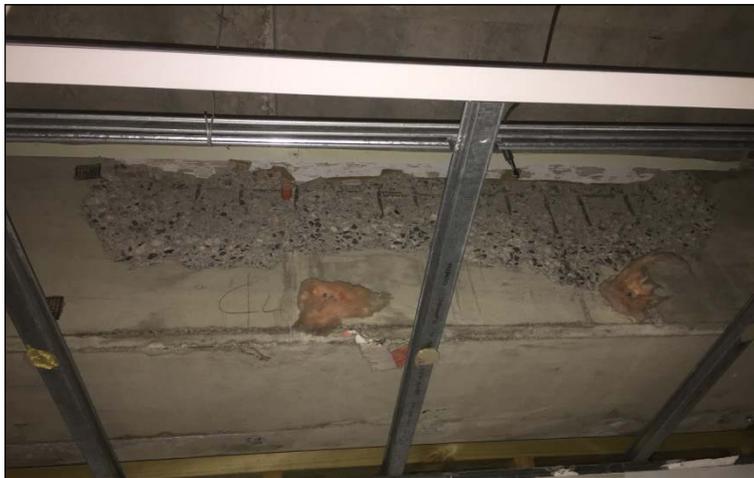
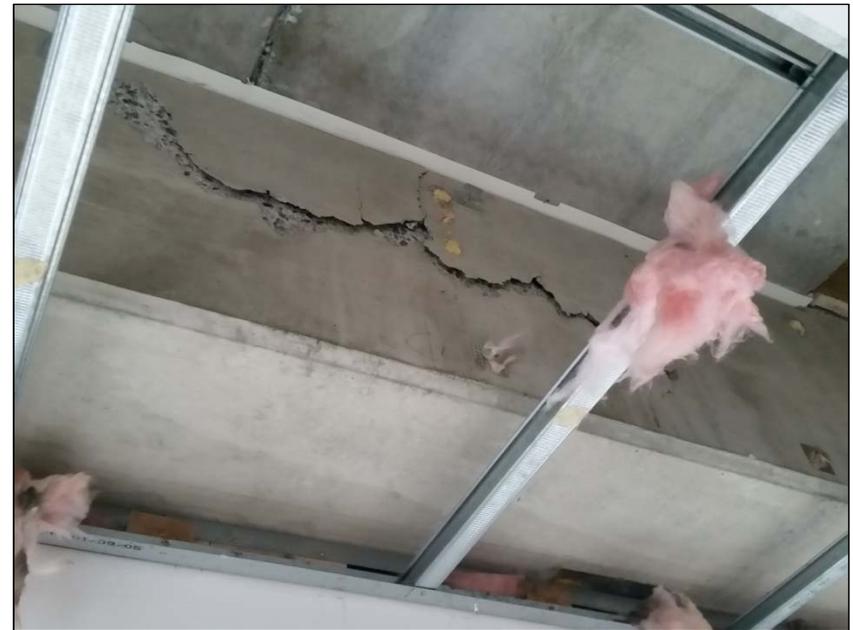
Examples: Support Damage

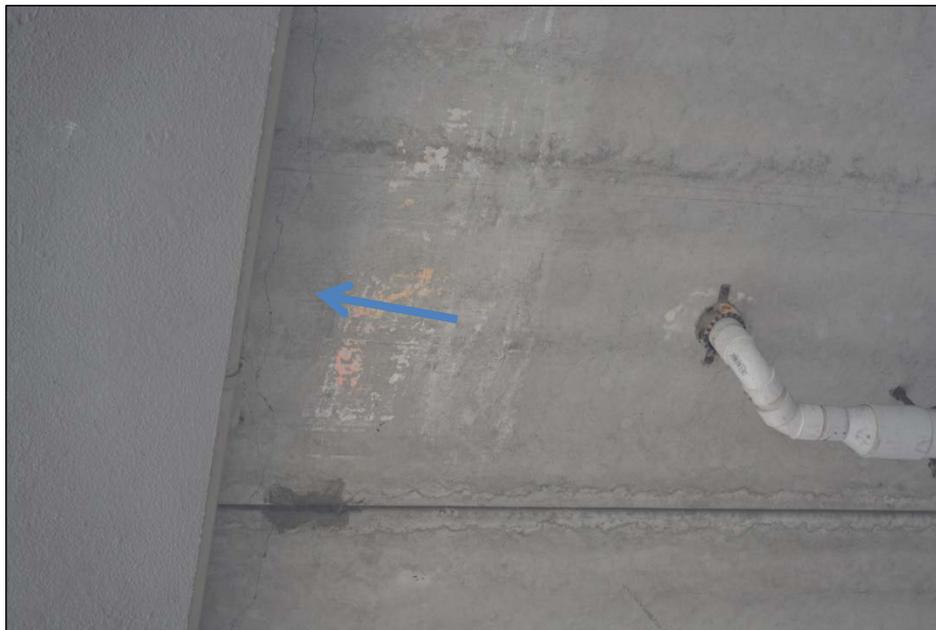
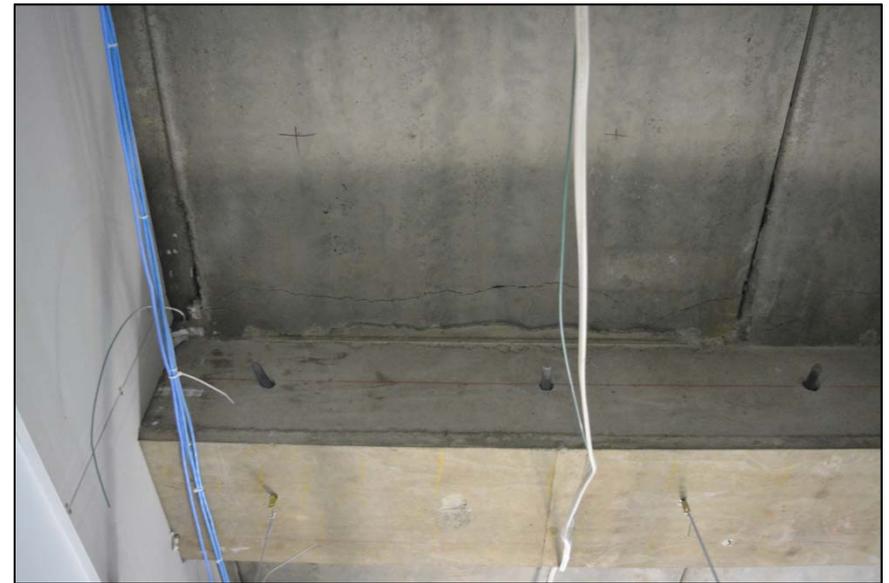
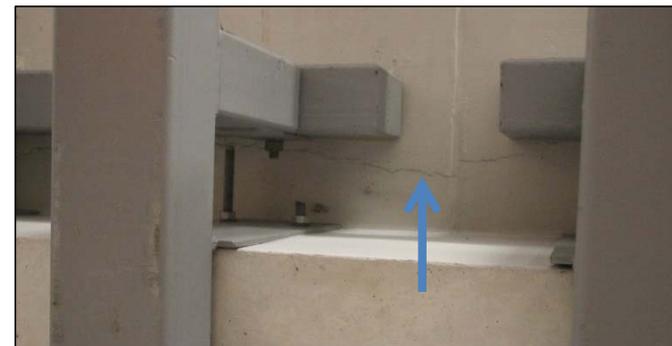
Examples: Transverse Cracks

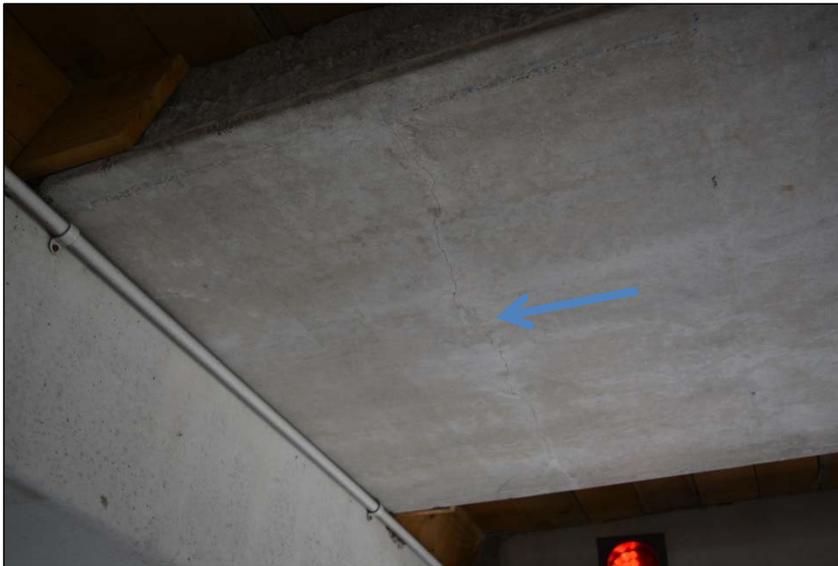
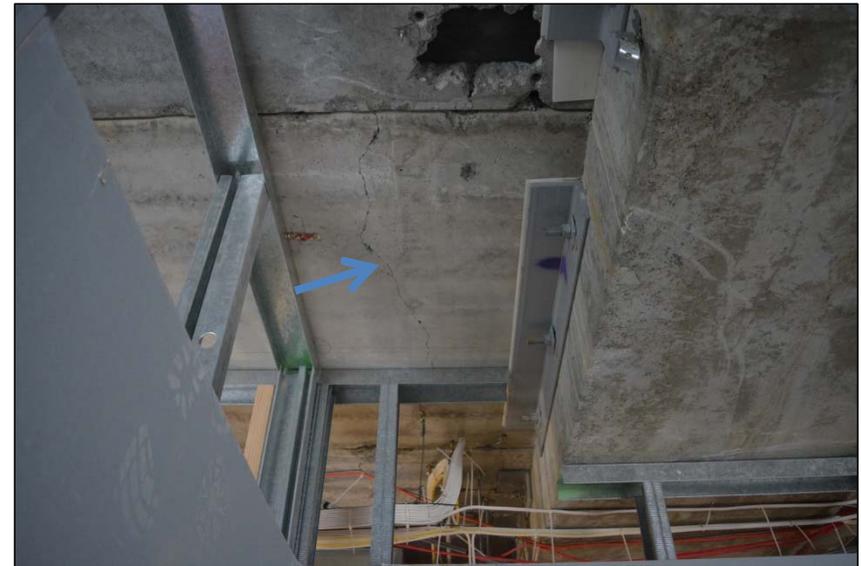
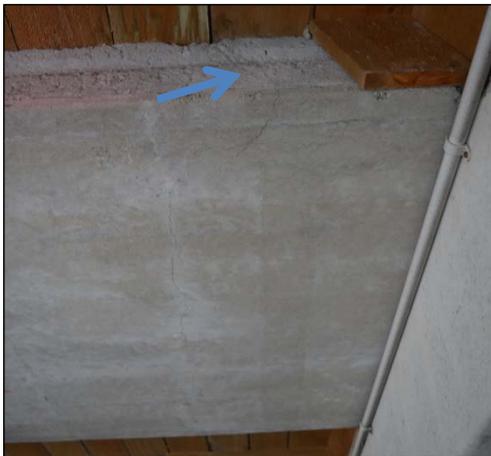
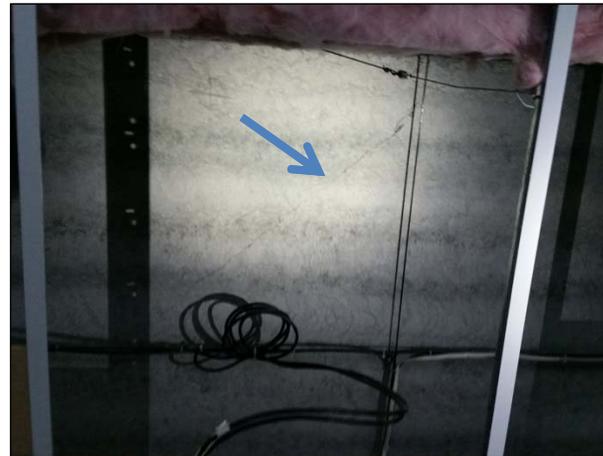
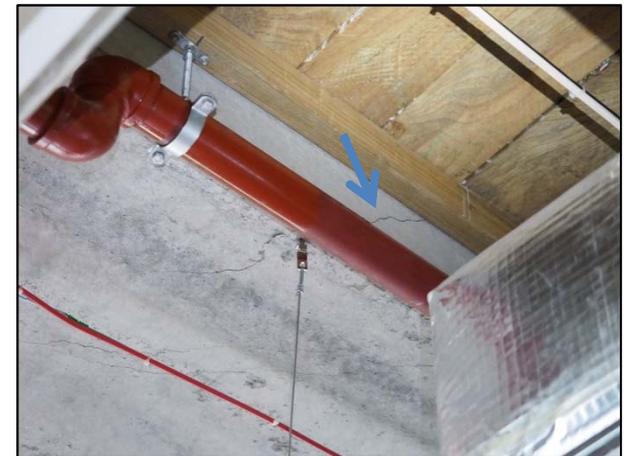
Examples: Transverse Cracks

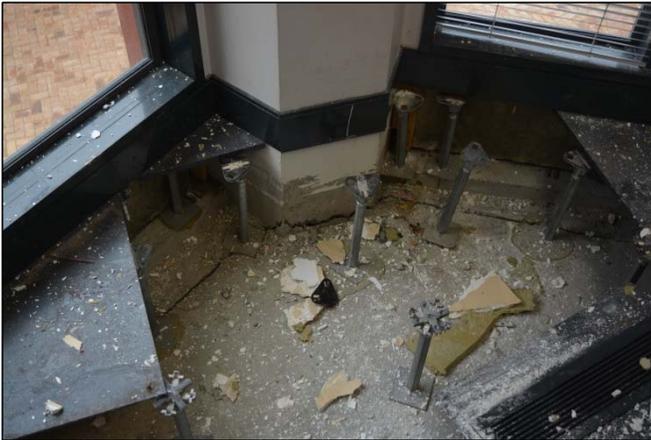
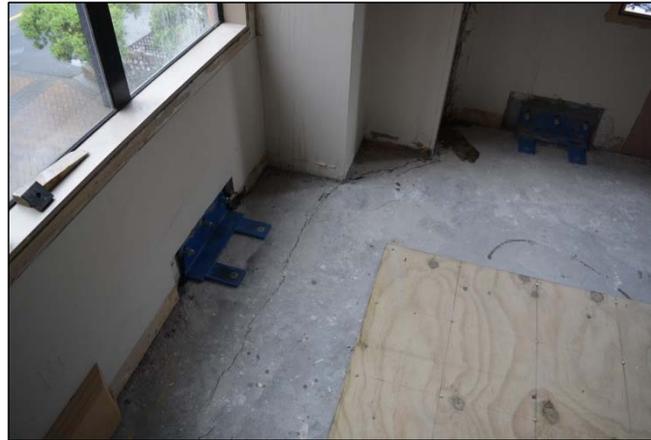
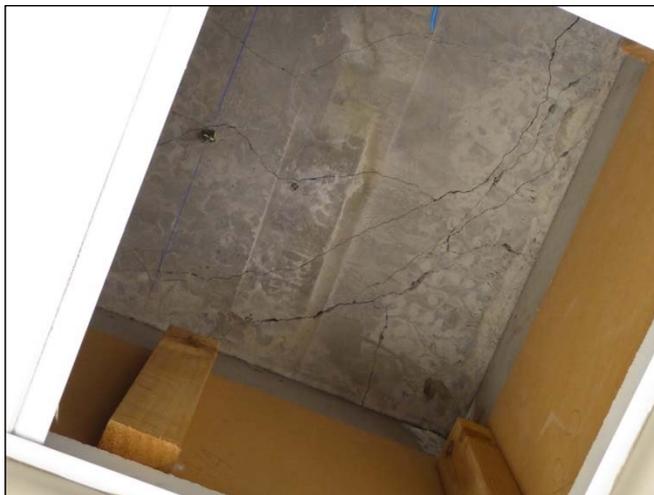
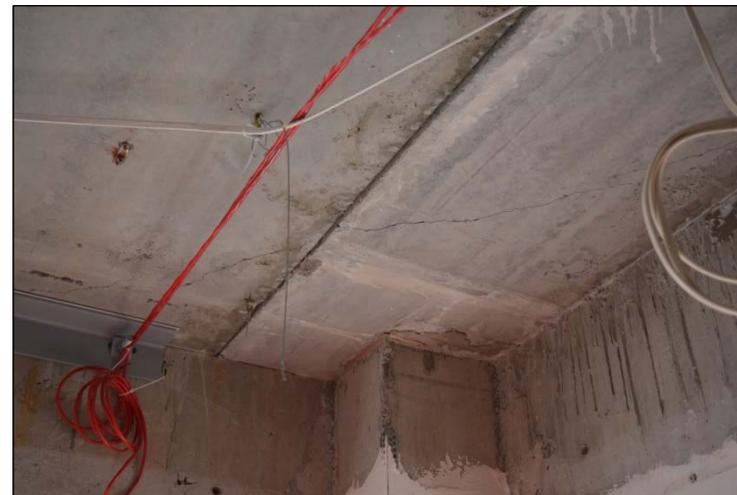
Examples: Transverse Cracks

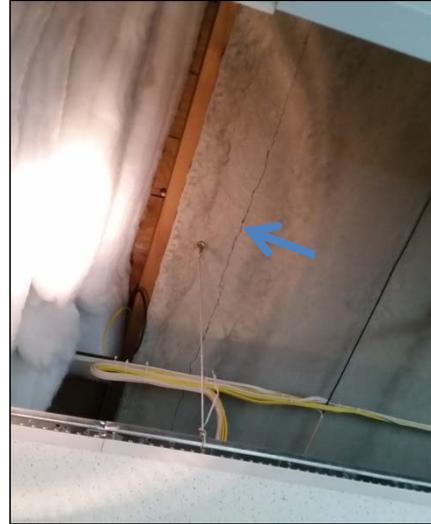
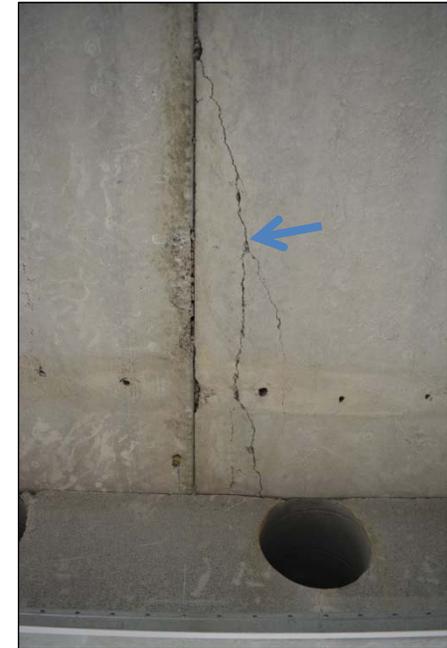
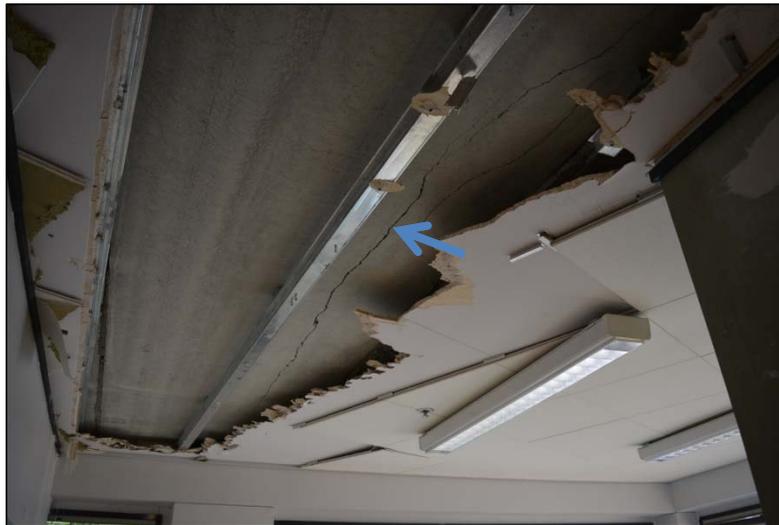
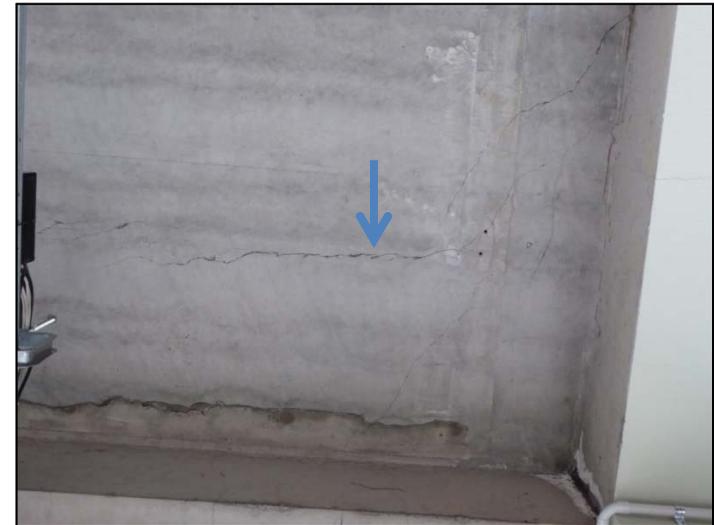
Longitudinal Cracks in Hollowcore

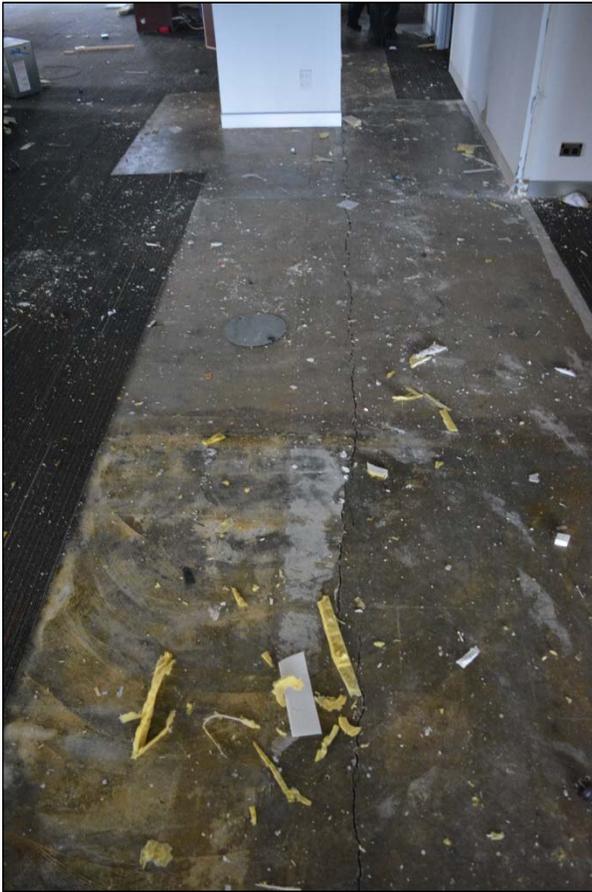
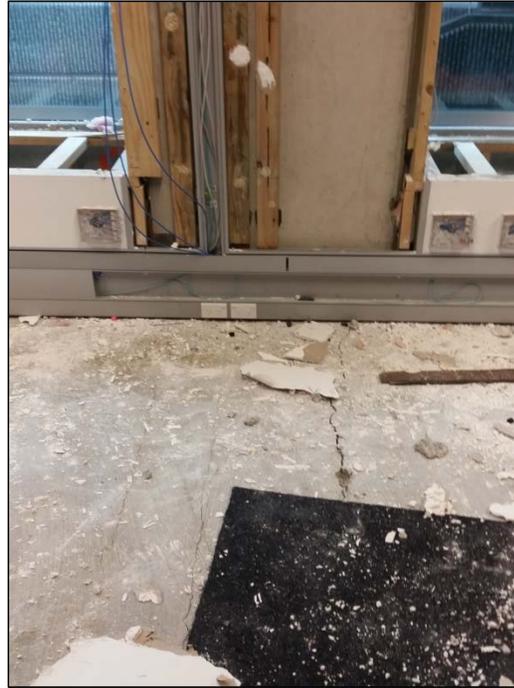
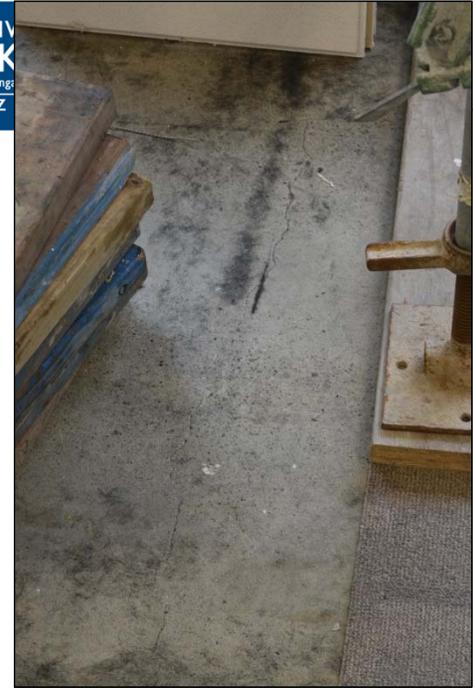
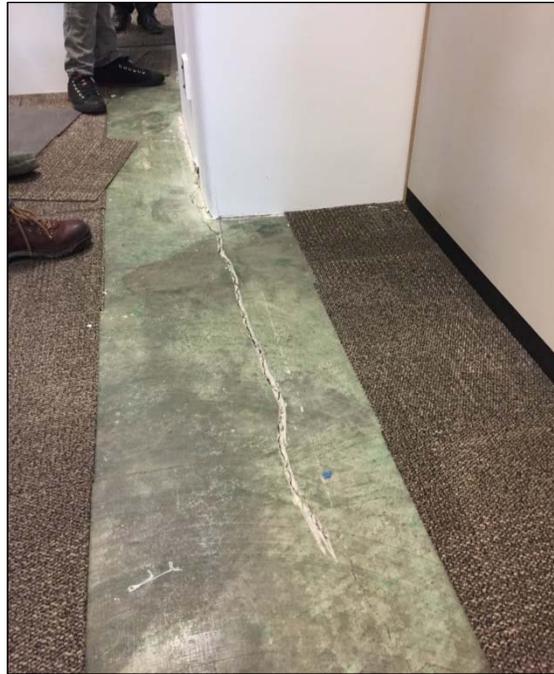
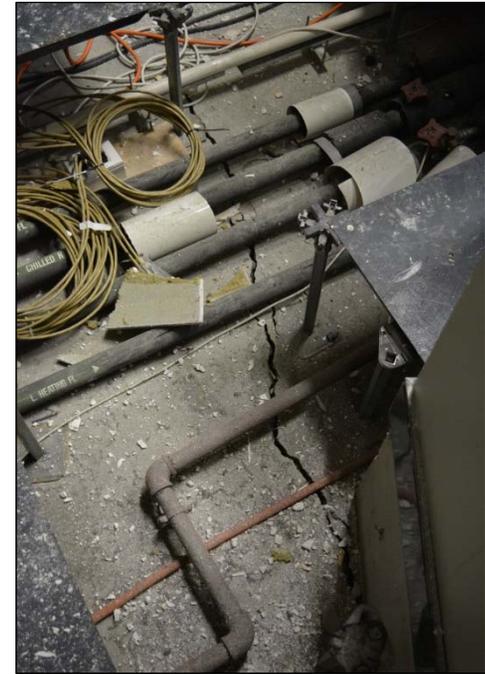
Topping Cracks
