BUILDING PRESERVATION
— MATERIAL TECHNOLOGIES —
RESTORING THE PAST, BUILDING THE FUTURE

***Structural and Architectural Restoration of the
Puerto Rico Capital Dome***

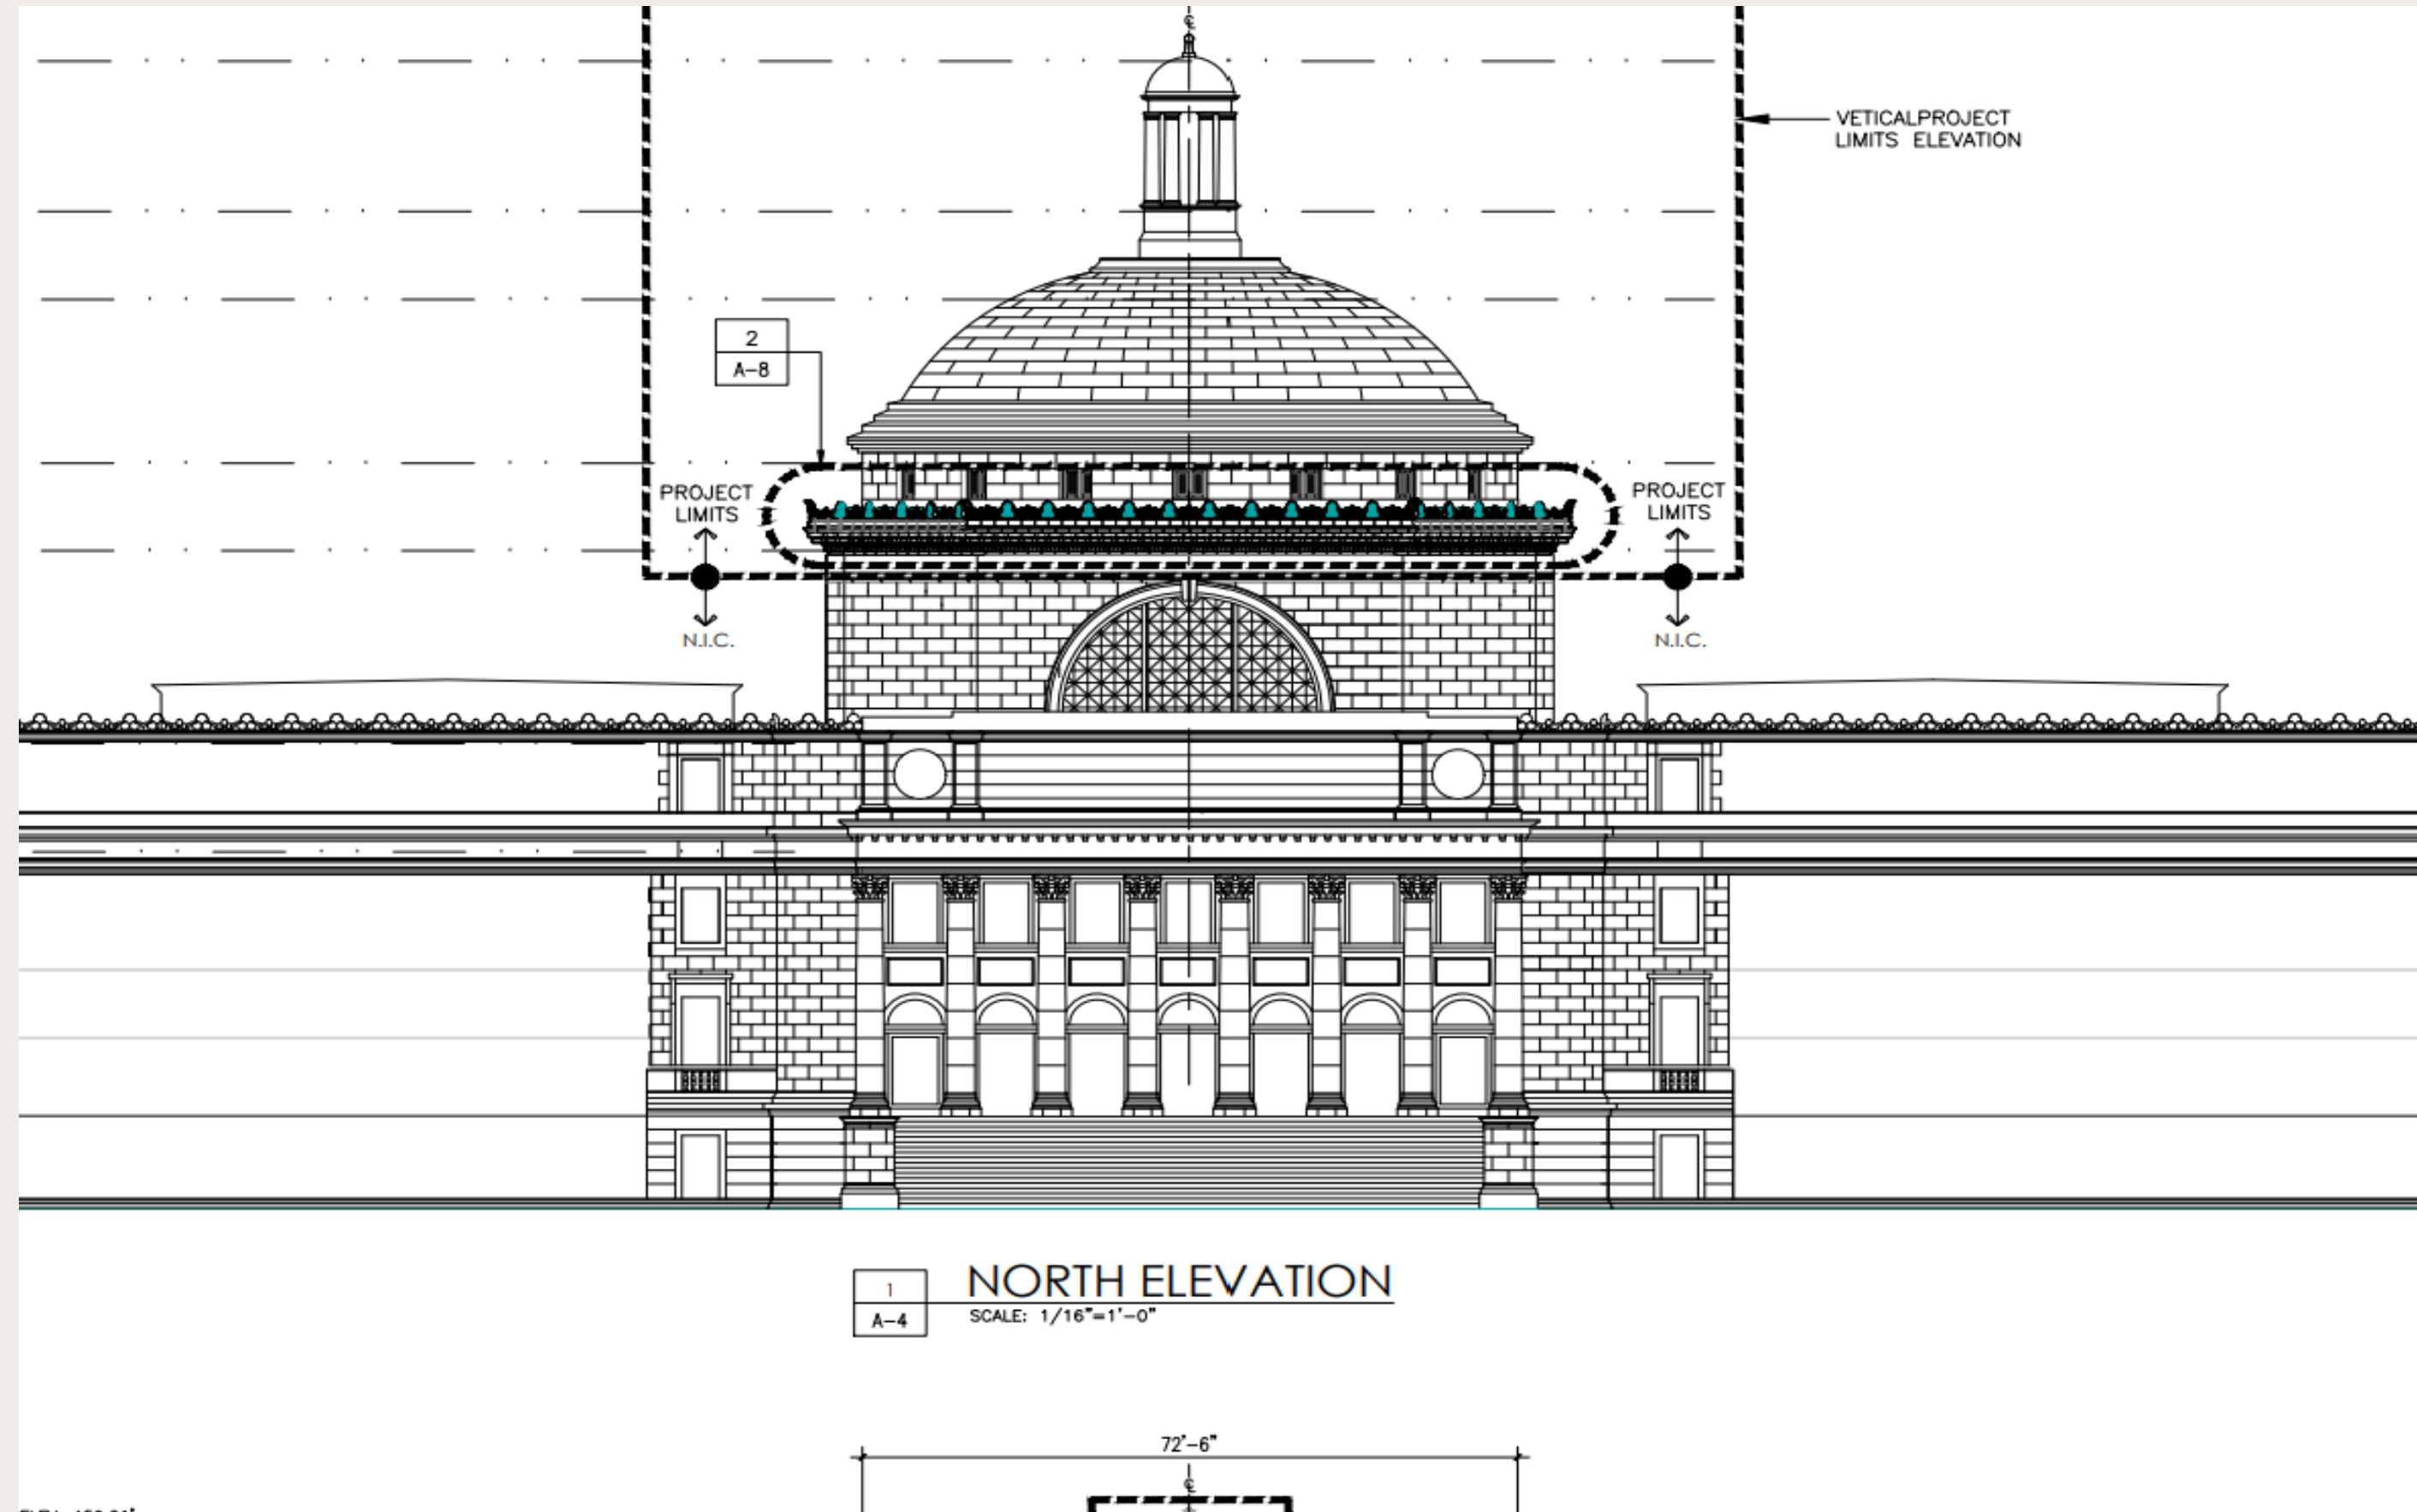
Dome Exterior

- *Concrete
Segregation of
Exterior Dome*
- *Concrete
Delamination*
- *Terracotta
Façade Distress*

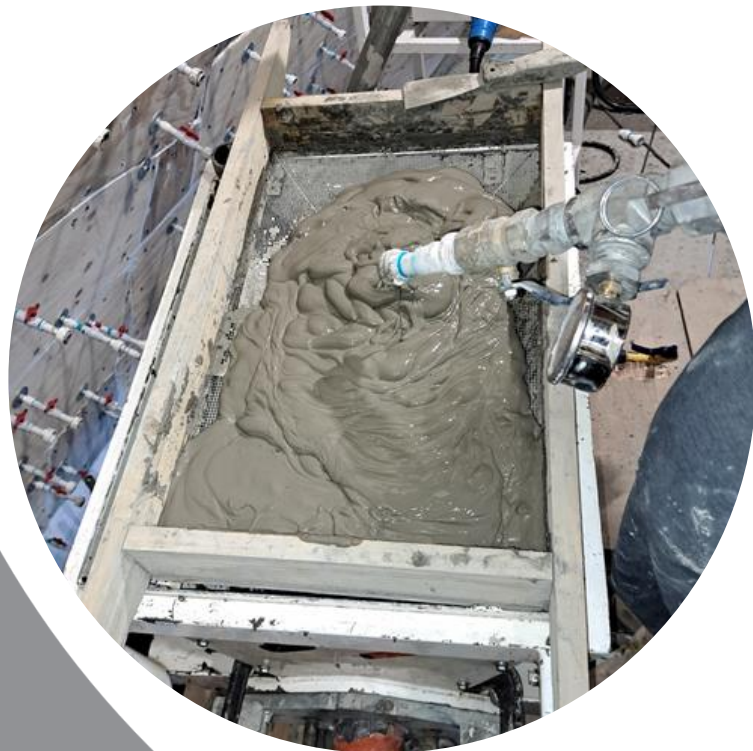
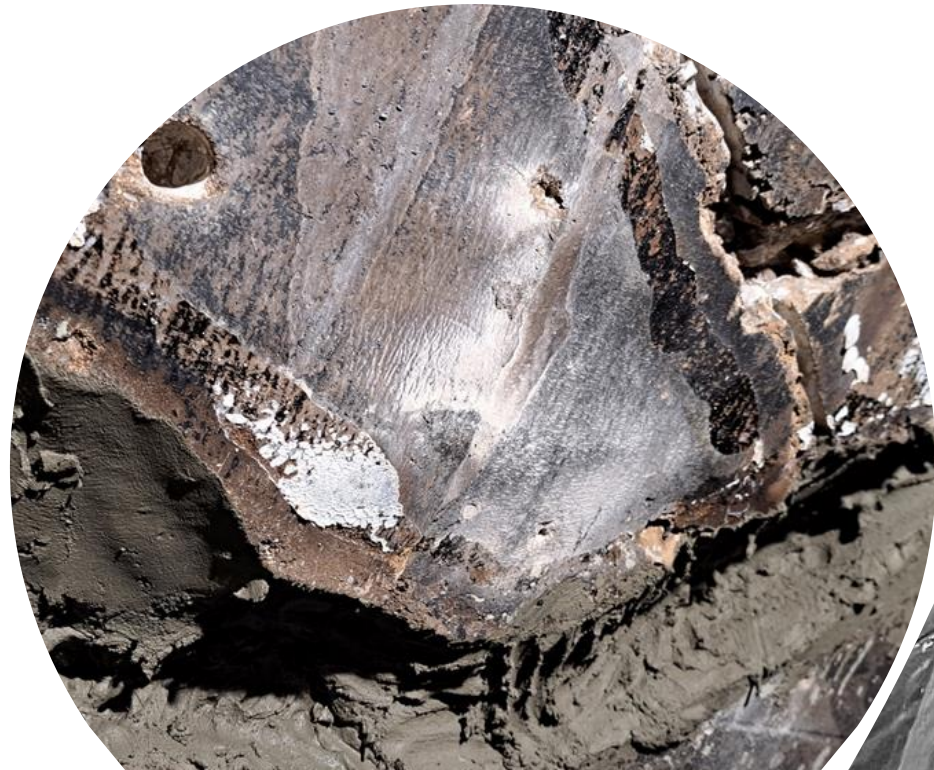
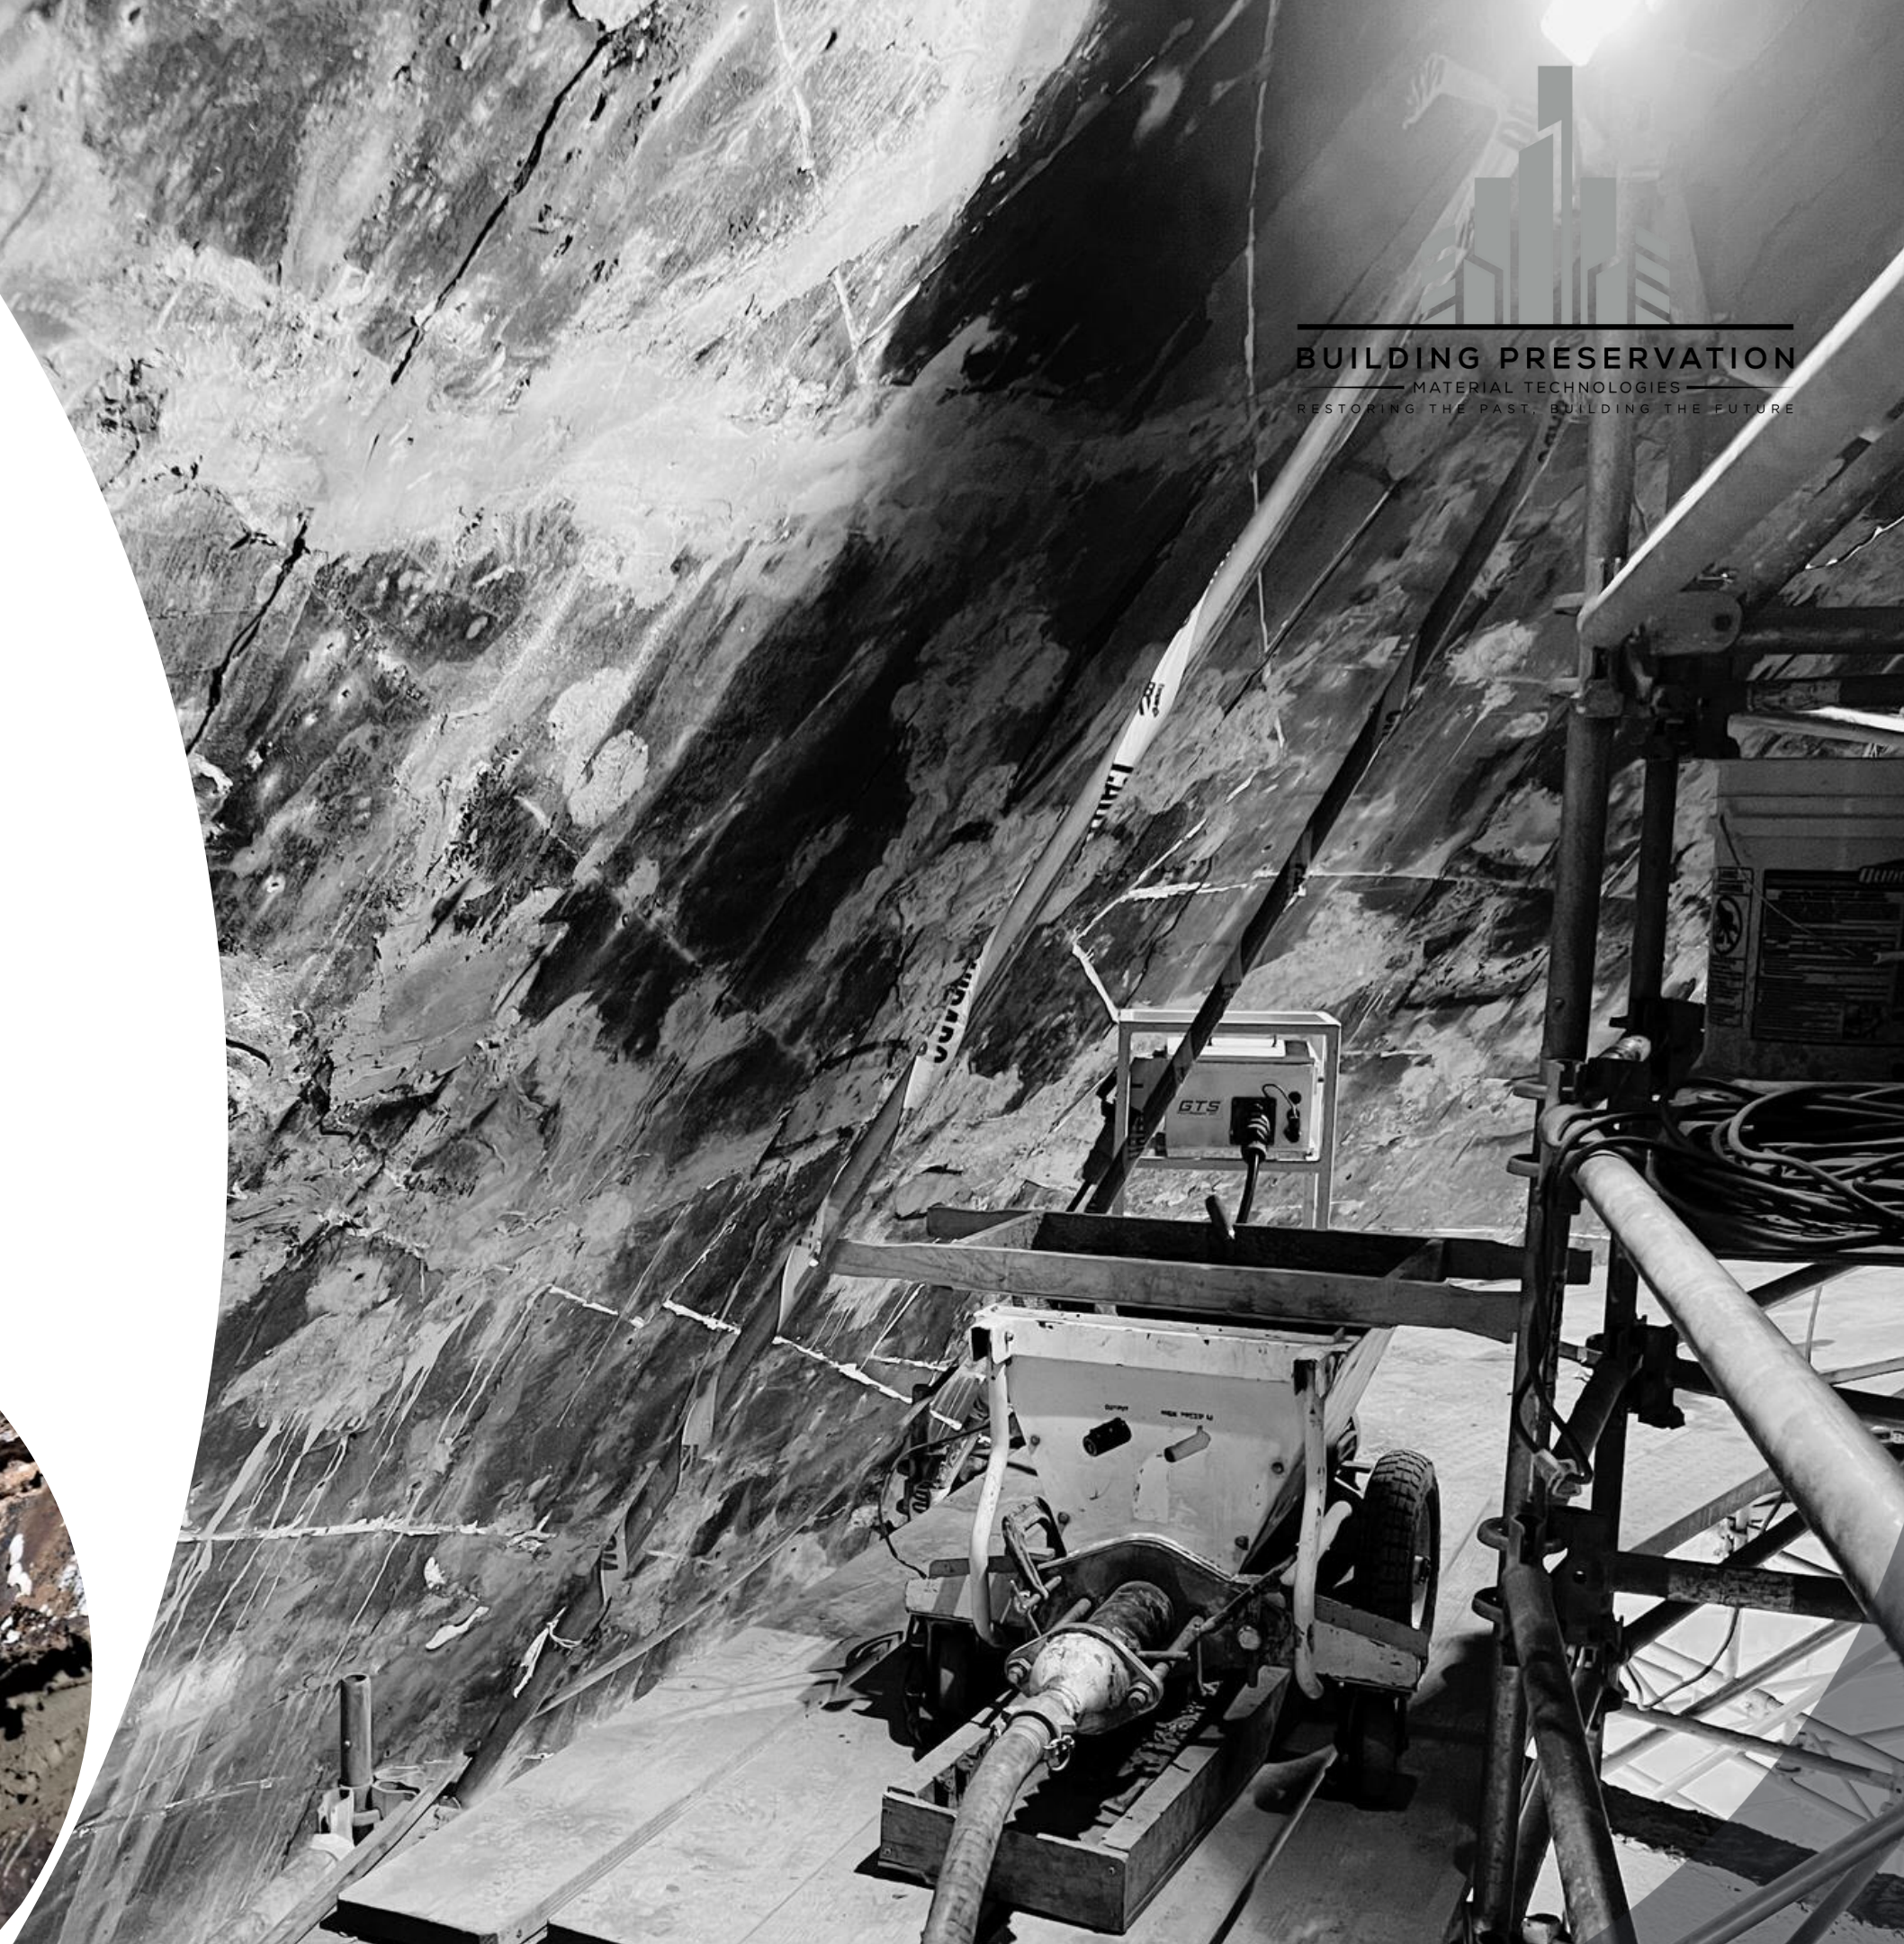
- Principal Challenges
 - Access
 - Concrete Segregation
 - Unforeseen
 - Repair Application:
 - Micro-Cement Injection

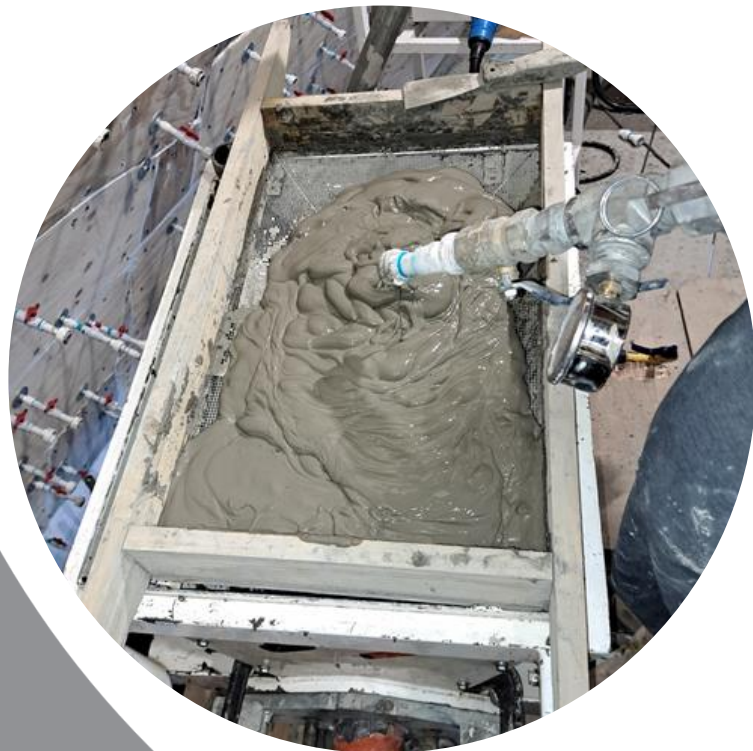
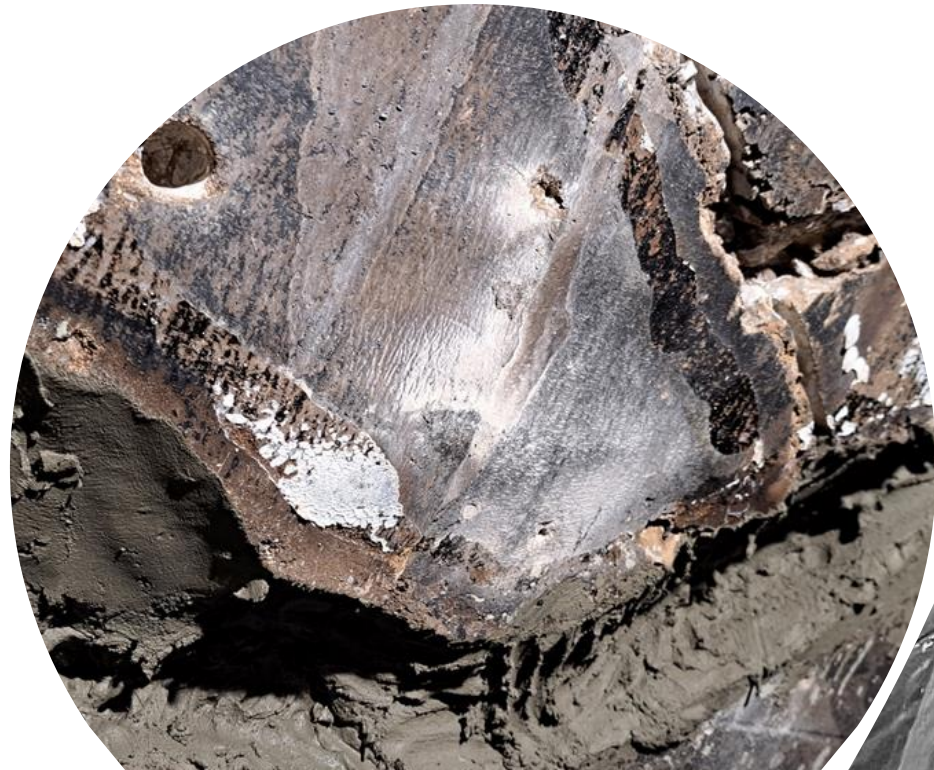
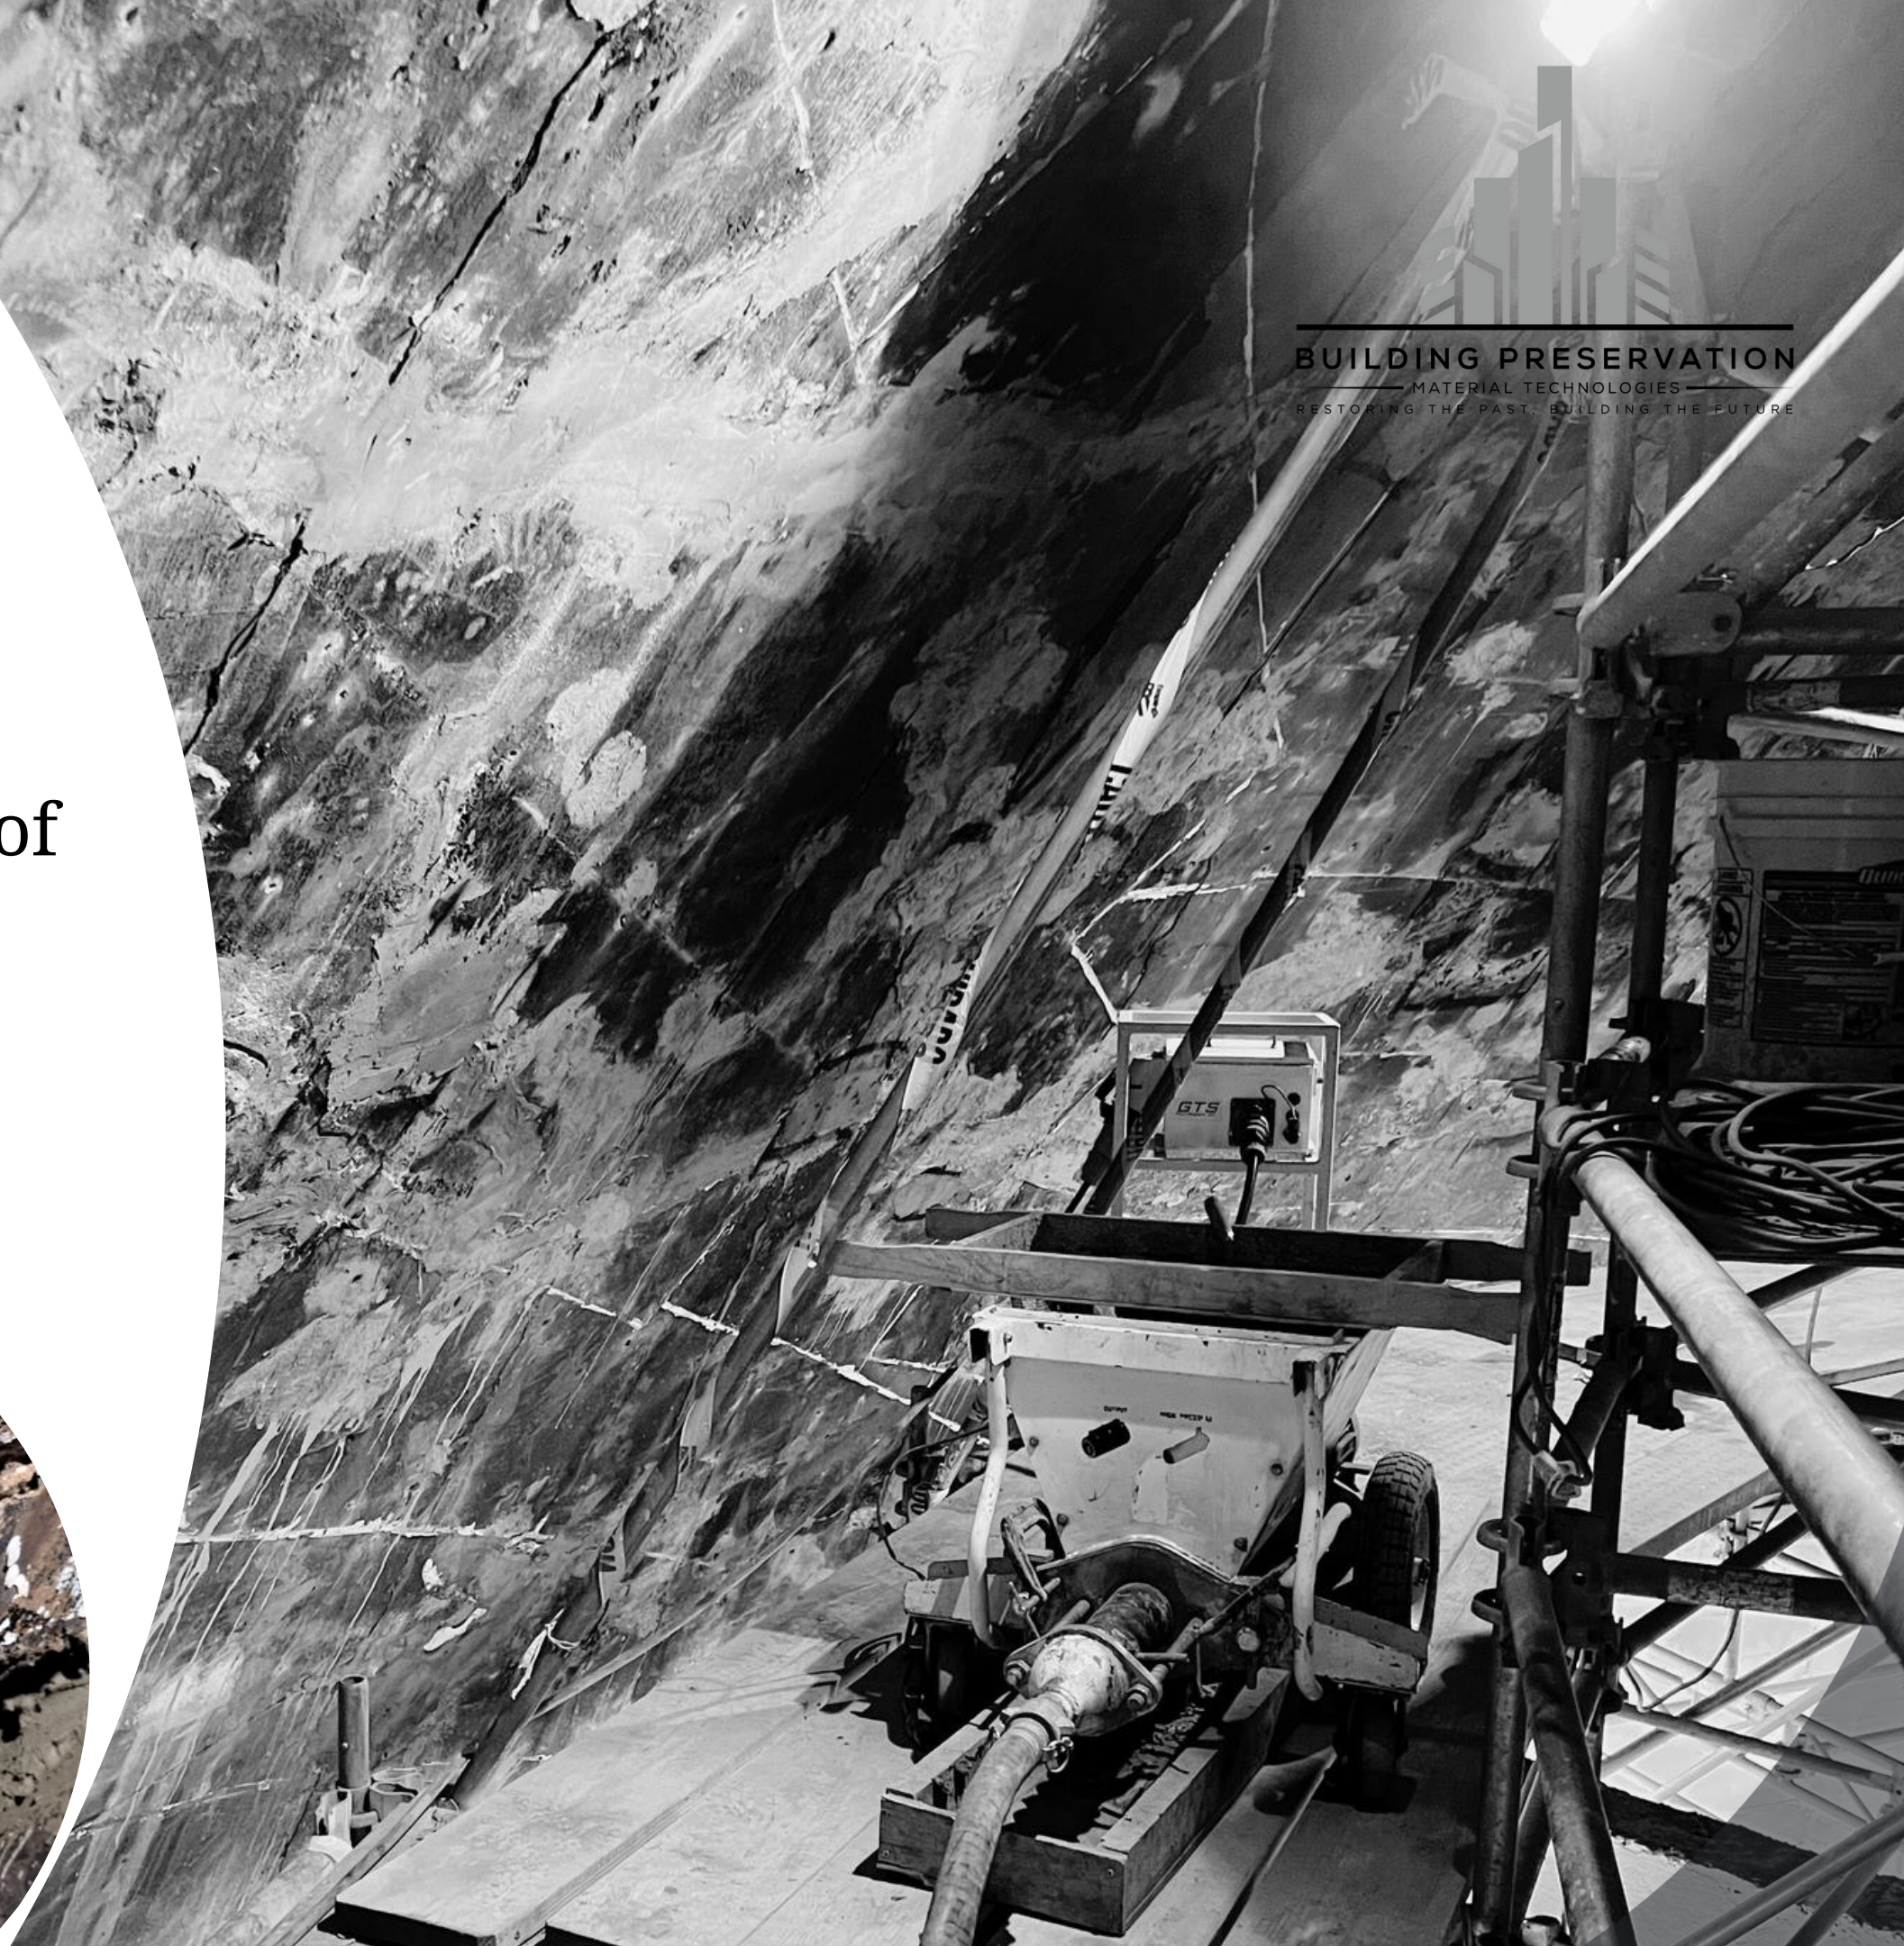
- Equipment:
 - Rotor Stator Pump
 - Low Pressure (30 psi max)
 - Performance: Filled 8% (approx.) of total volume
 - Materials: MasterRoc 900 SR

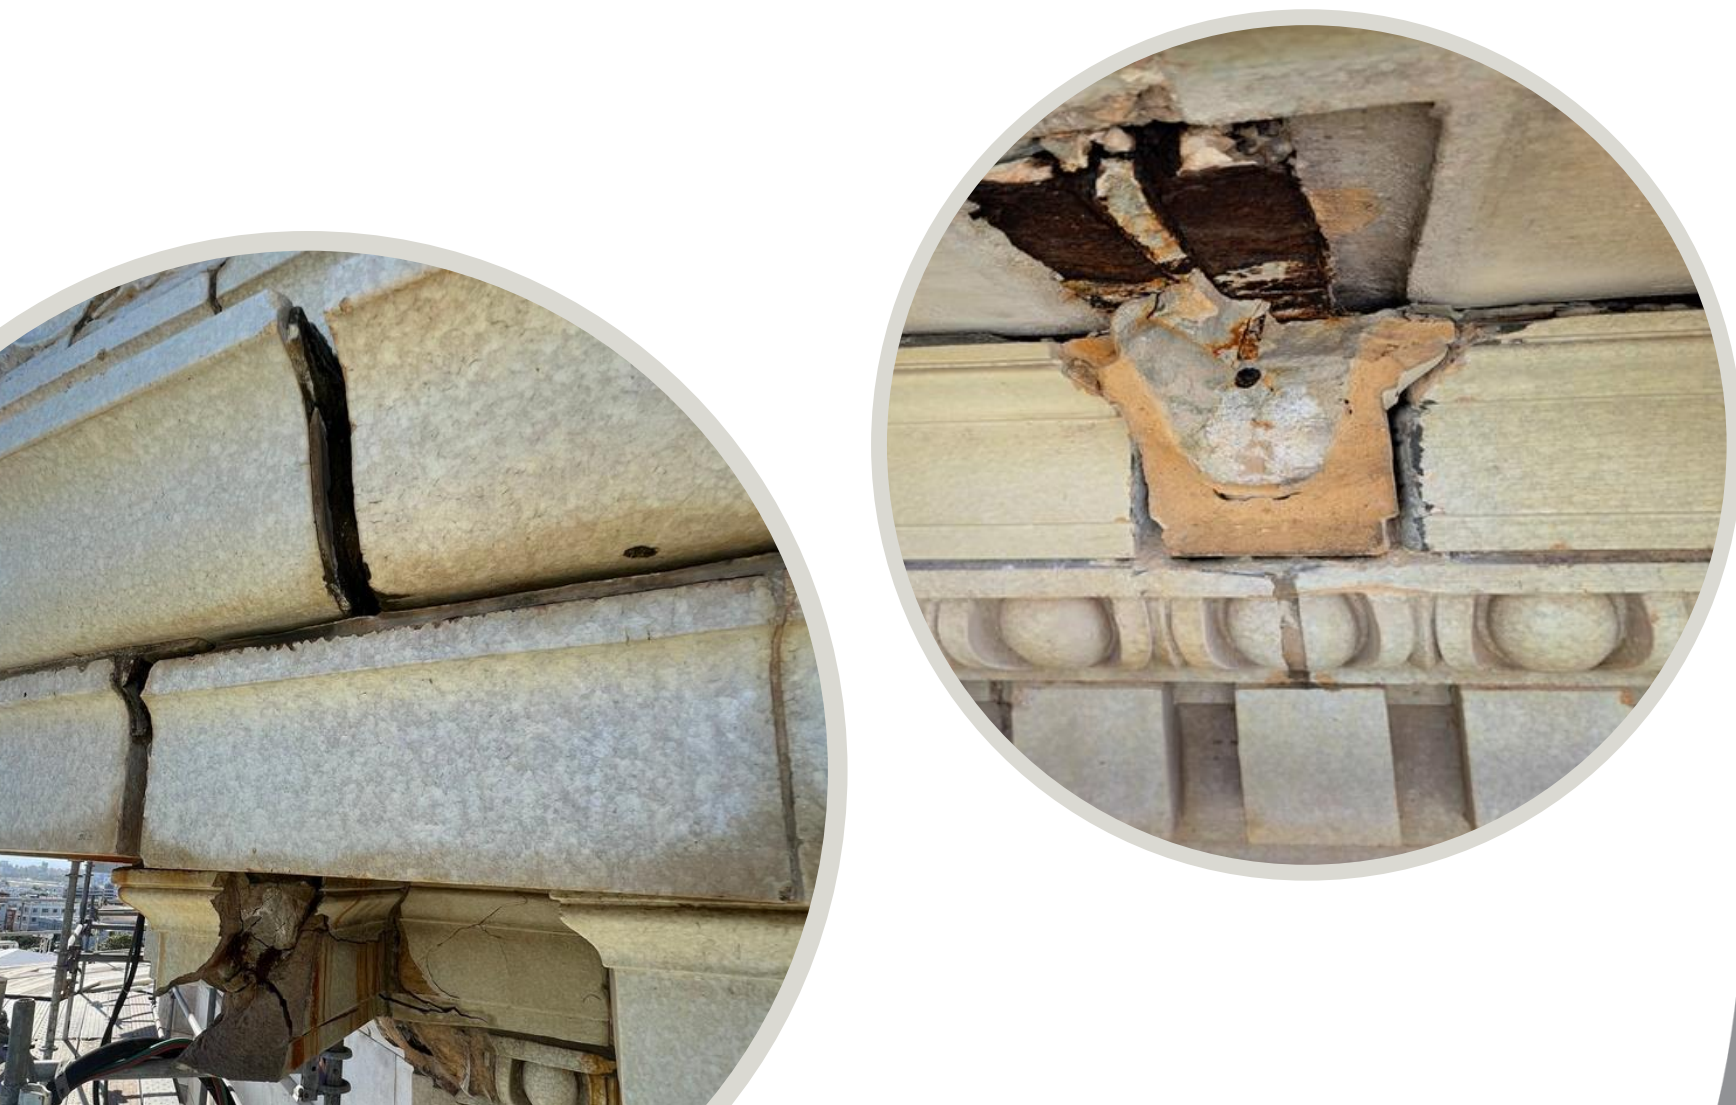
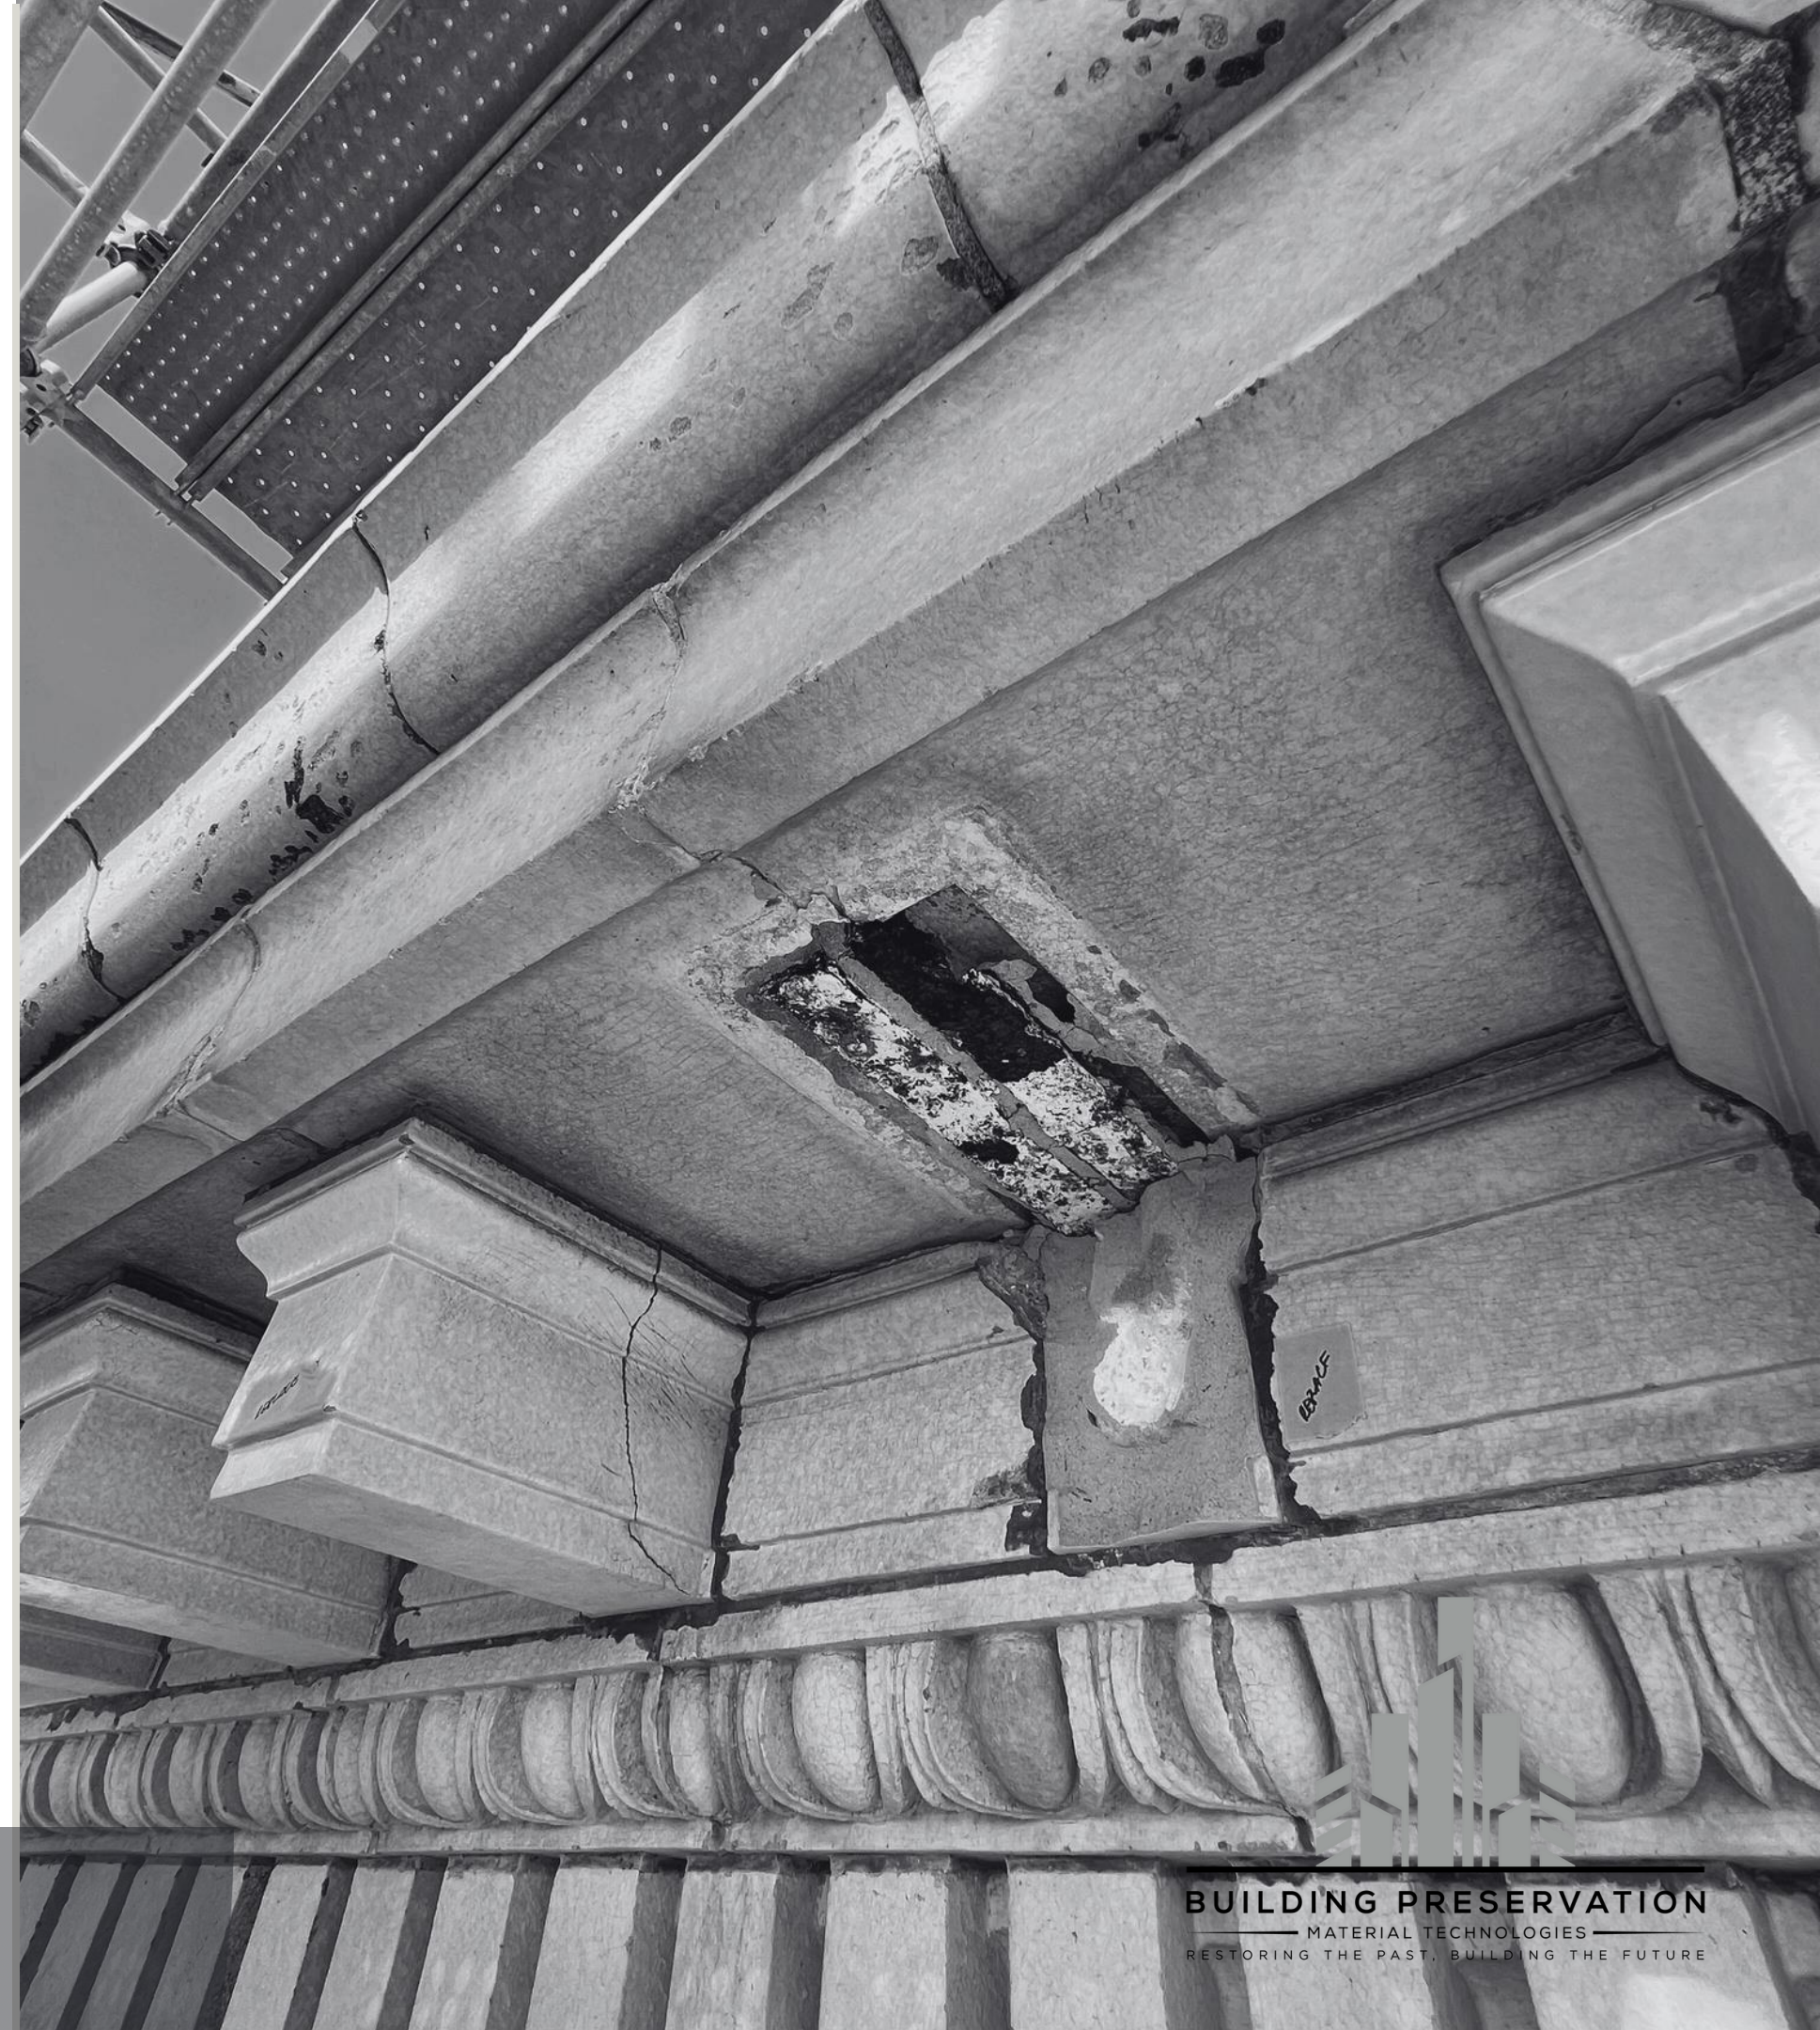
Existing Conditions

- Corroded Support System
- Collapsed Individual Pieces
- Grout Filled Terracotta individual Pieces
- Previous Repair Attempts

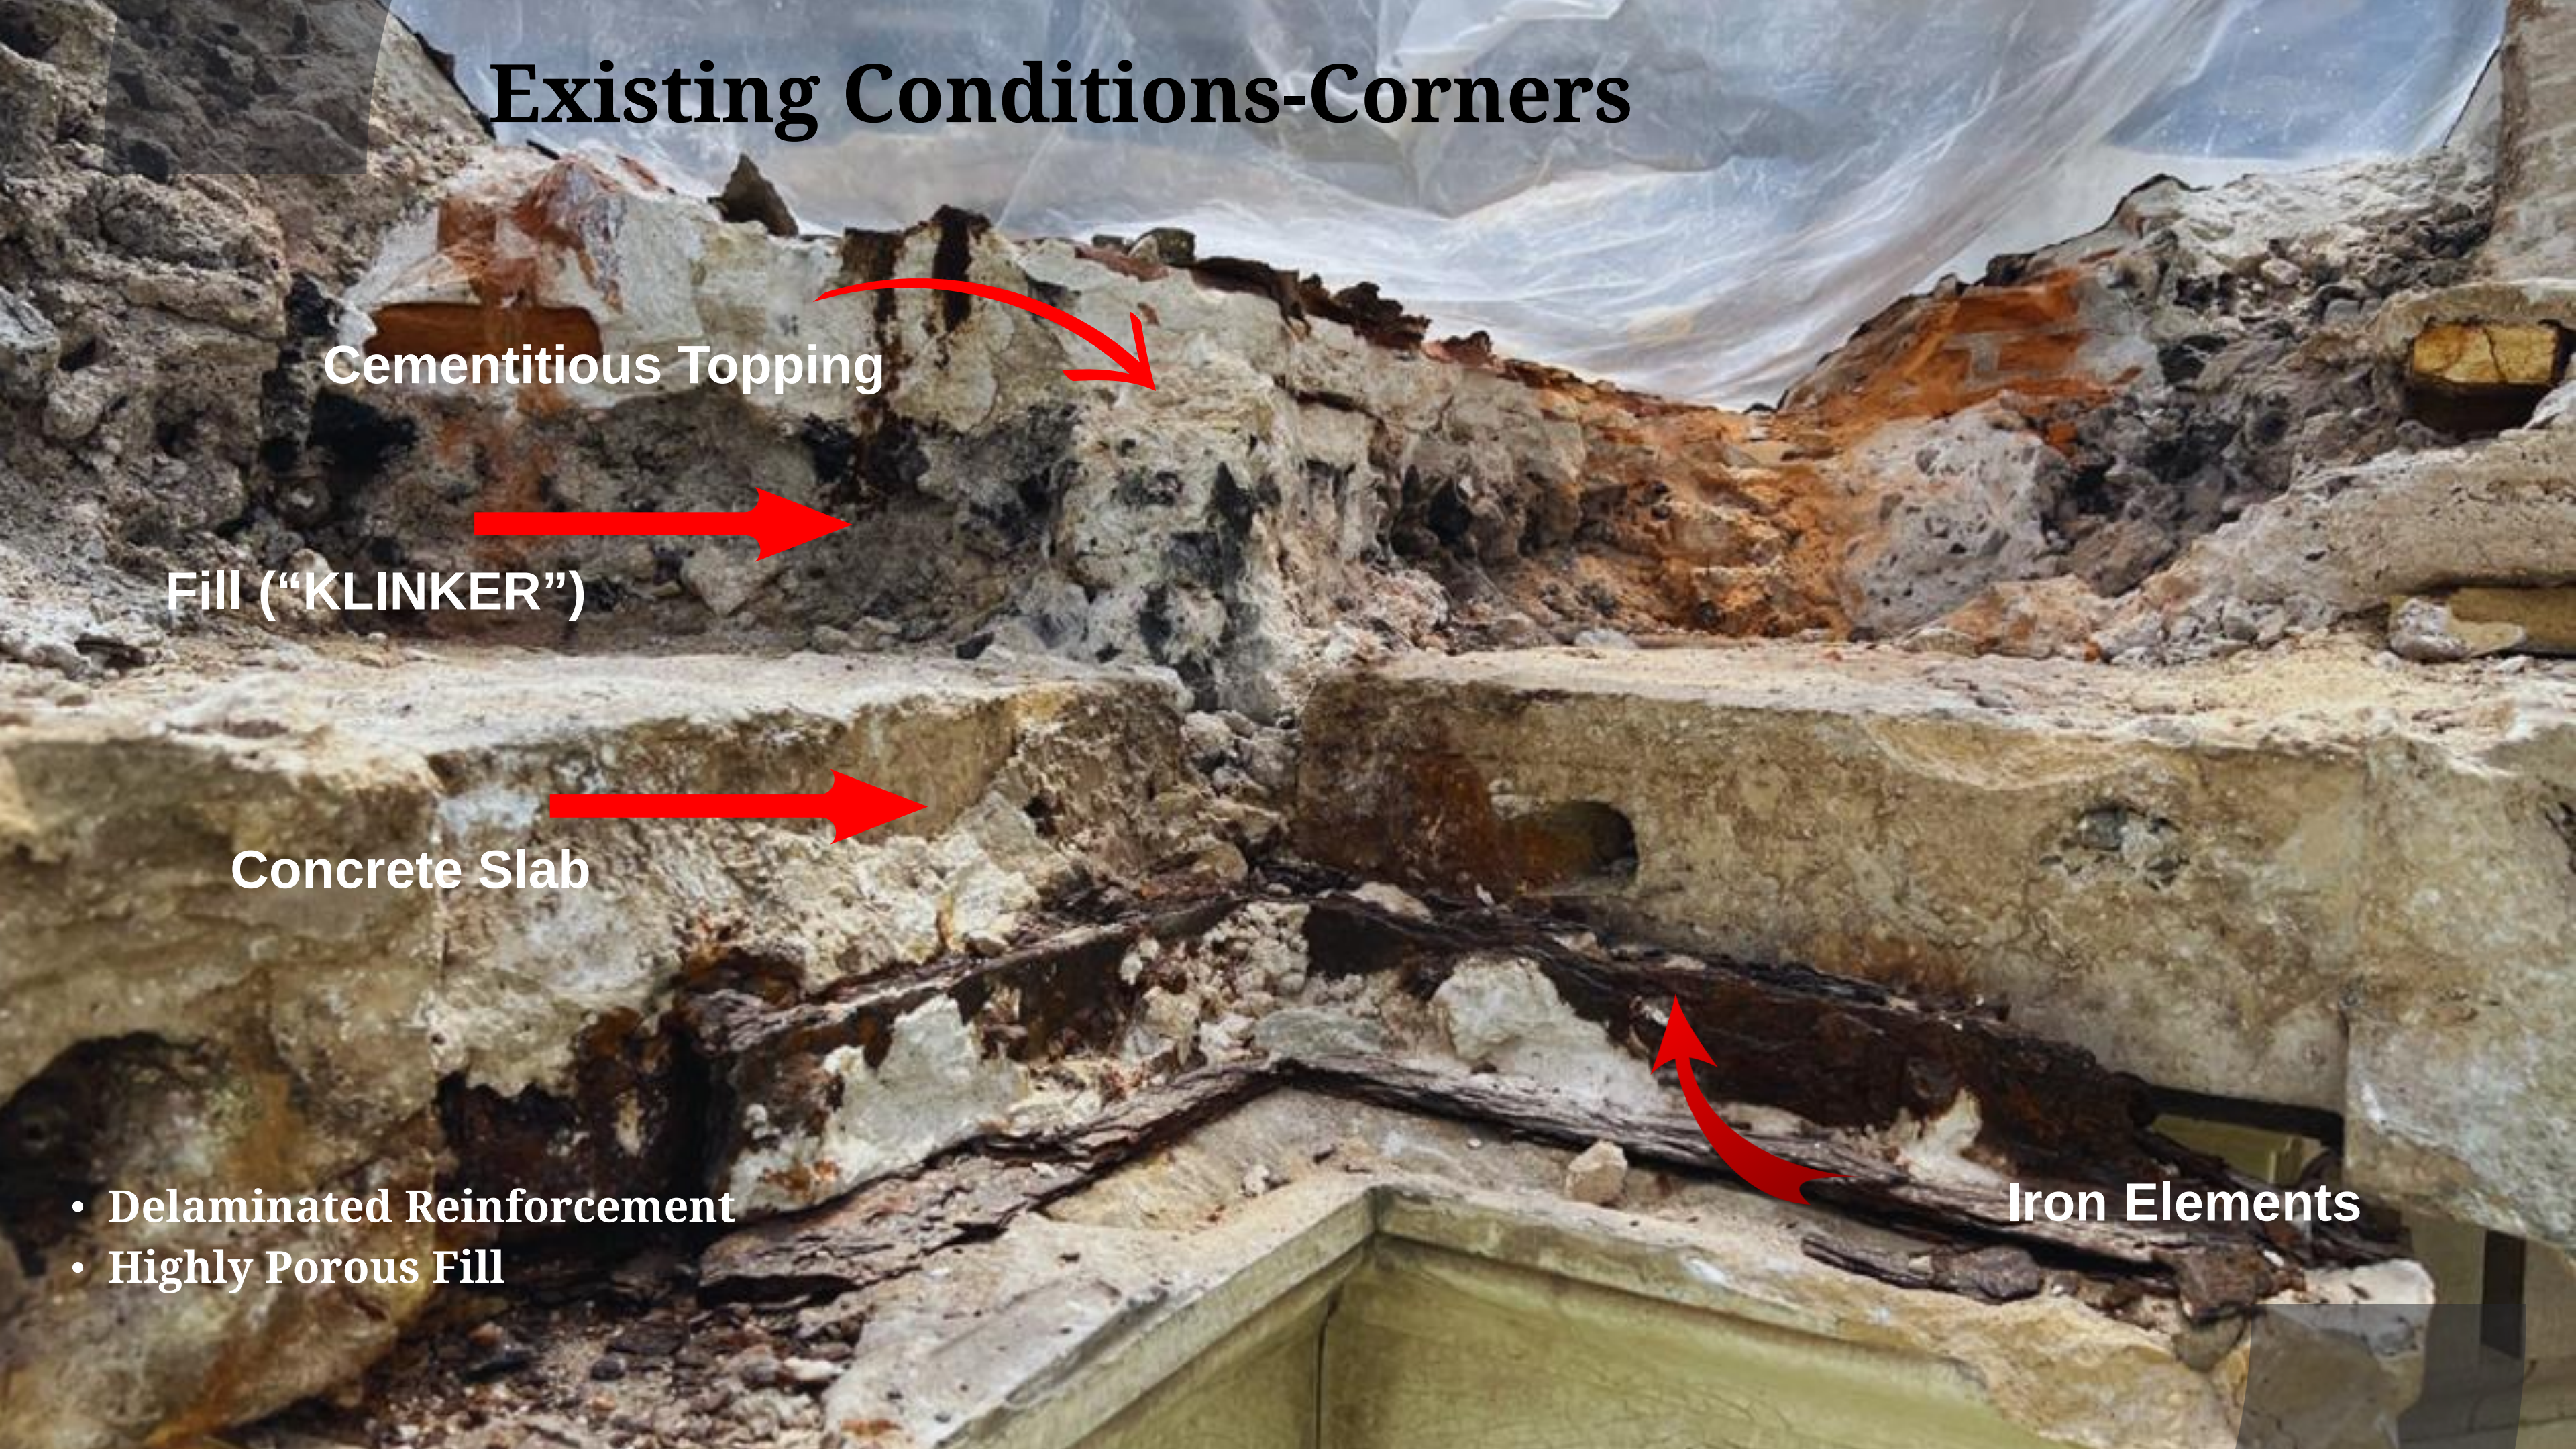
Existing Conditions-Corners

Cementitious Topping

Fill ("KLINKER")

Concrete Slab

- Delaminated Reinforcement
- Highly Porous Fill

Iron Elements
