BUILDING PRESERVATION
— MATERIAL TECHNOLOGIES —
RESTORING THE PAST, BUILDING THE FUTURE

***Structural and Architectural Restoration of the
Puerto Rico Capital Dome***

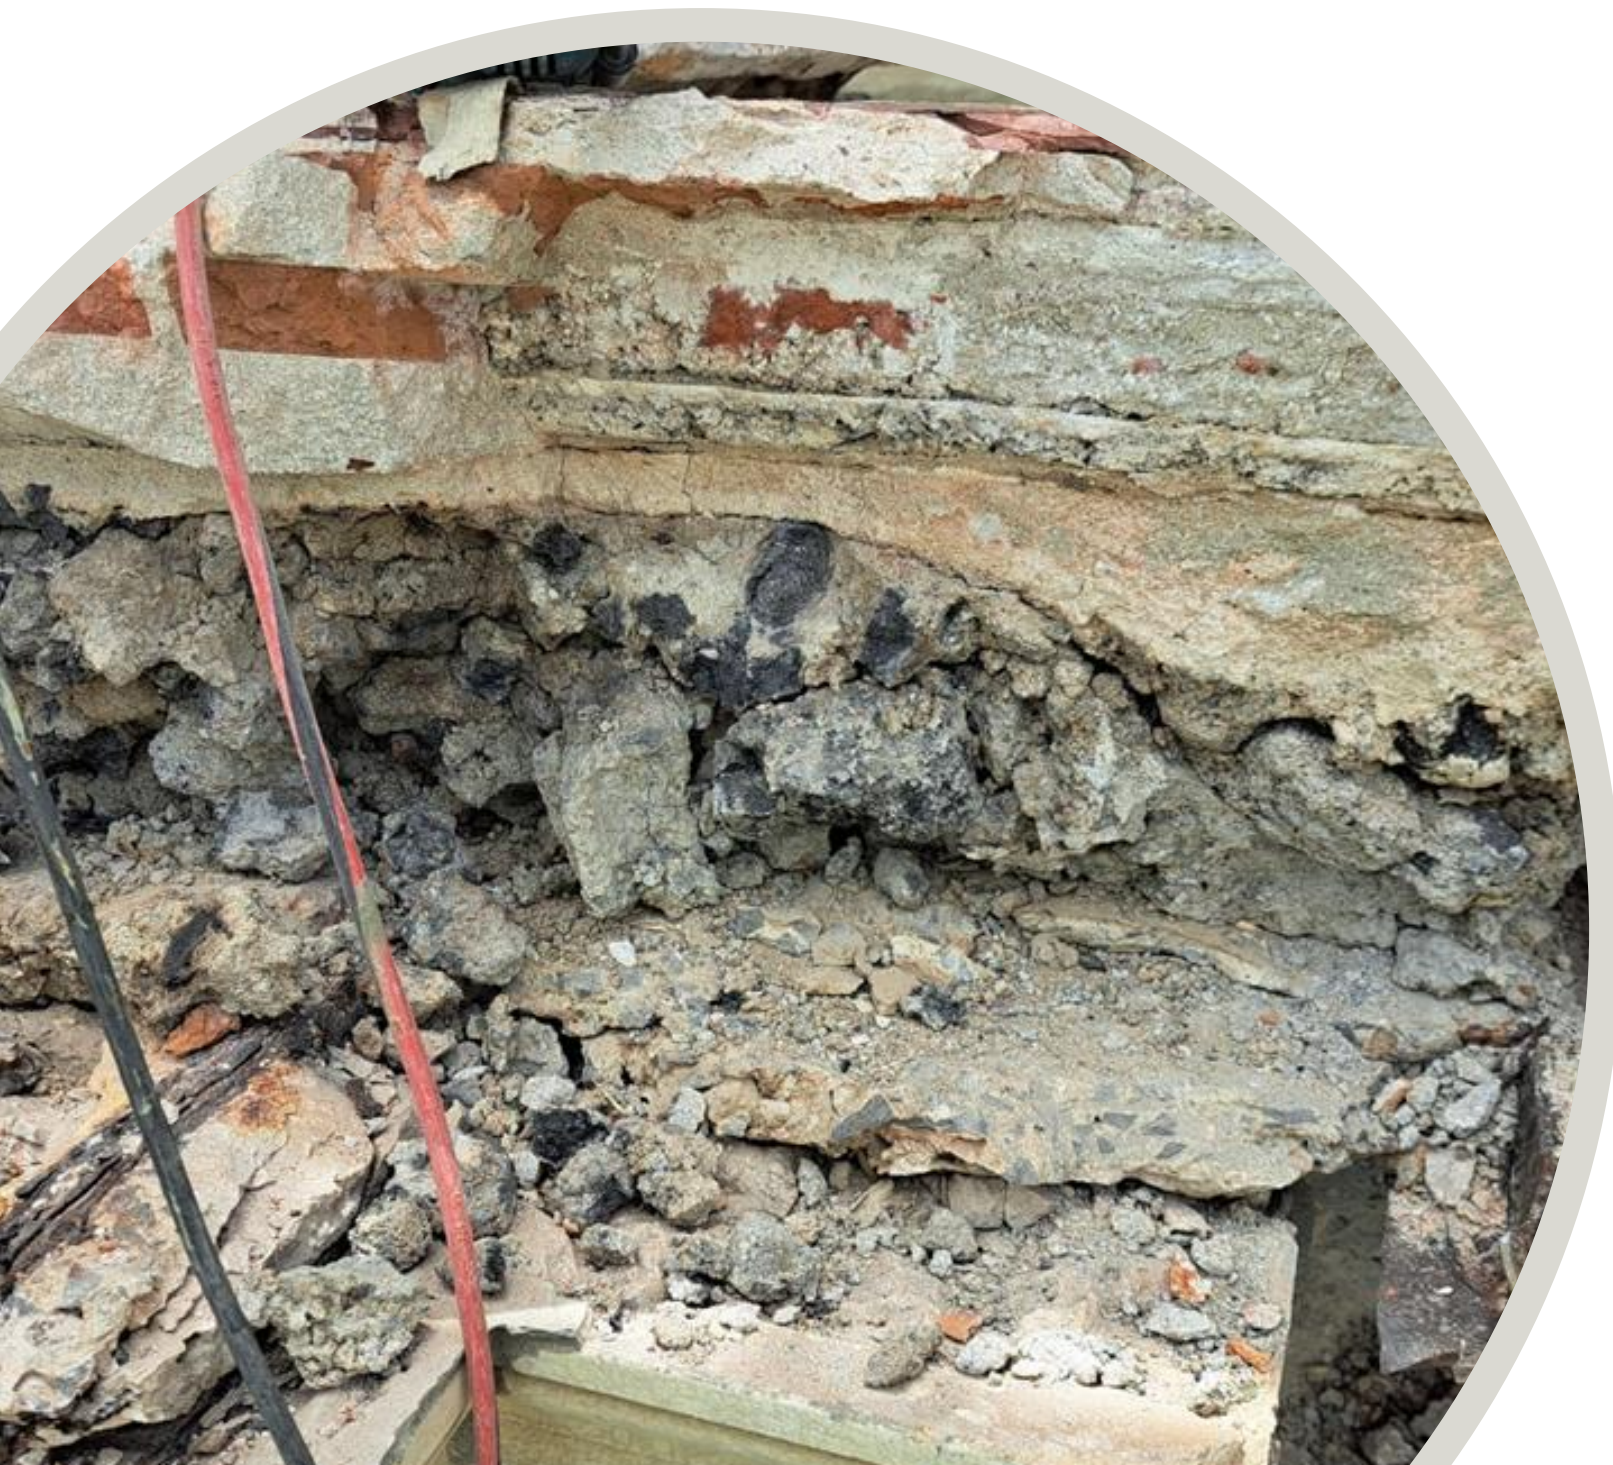
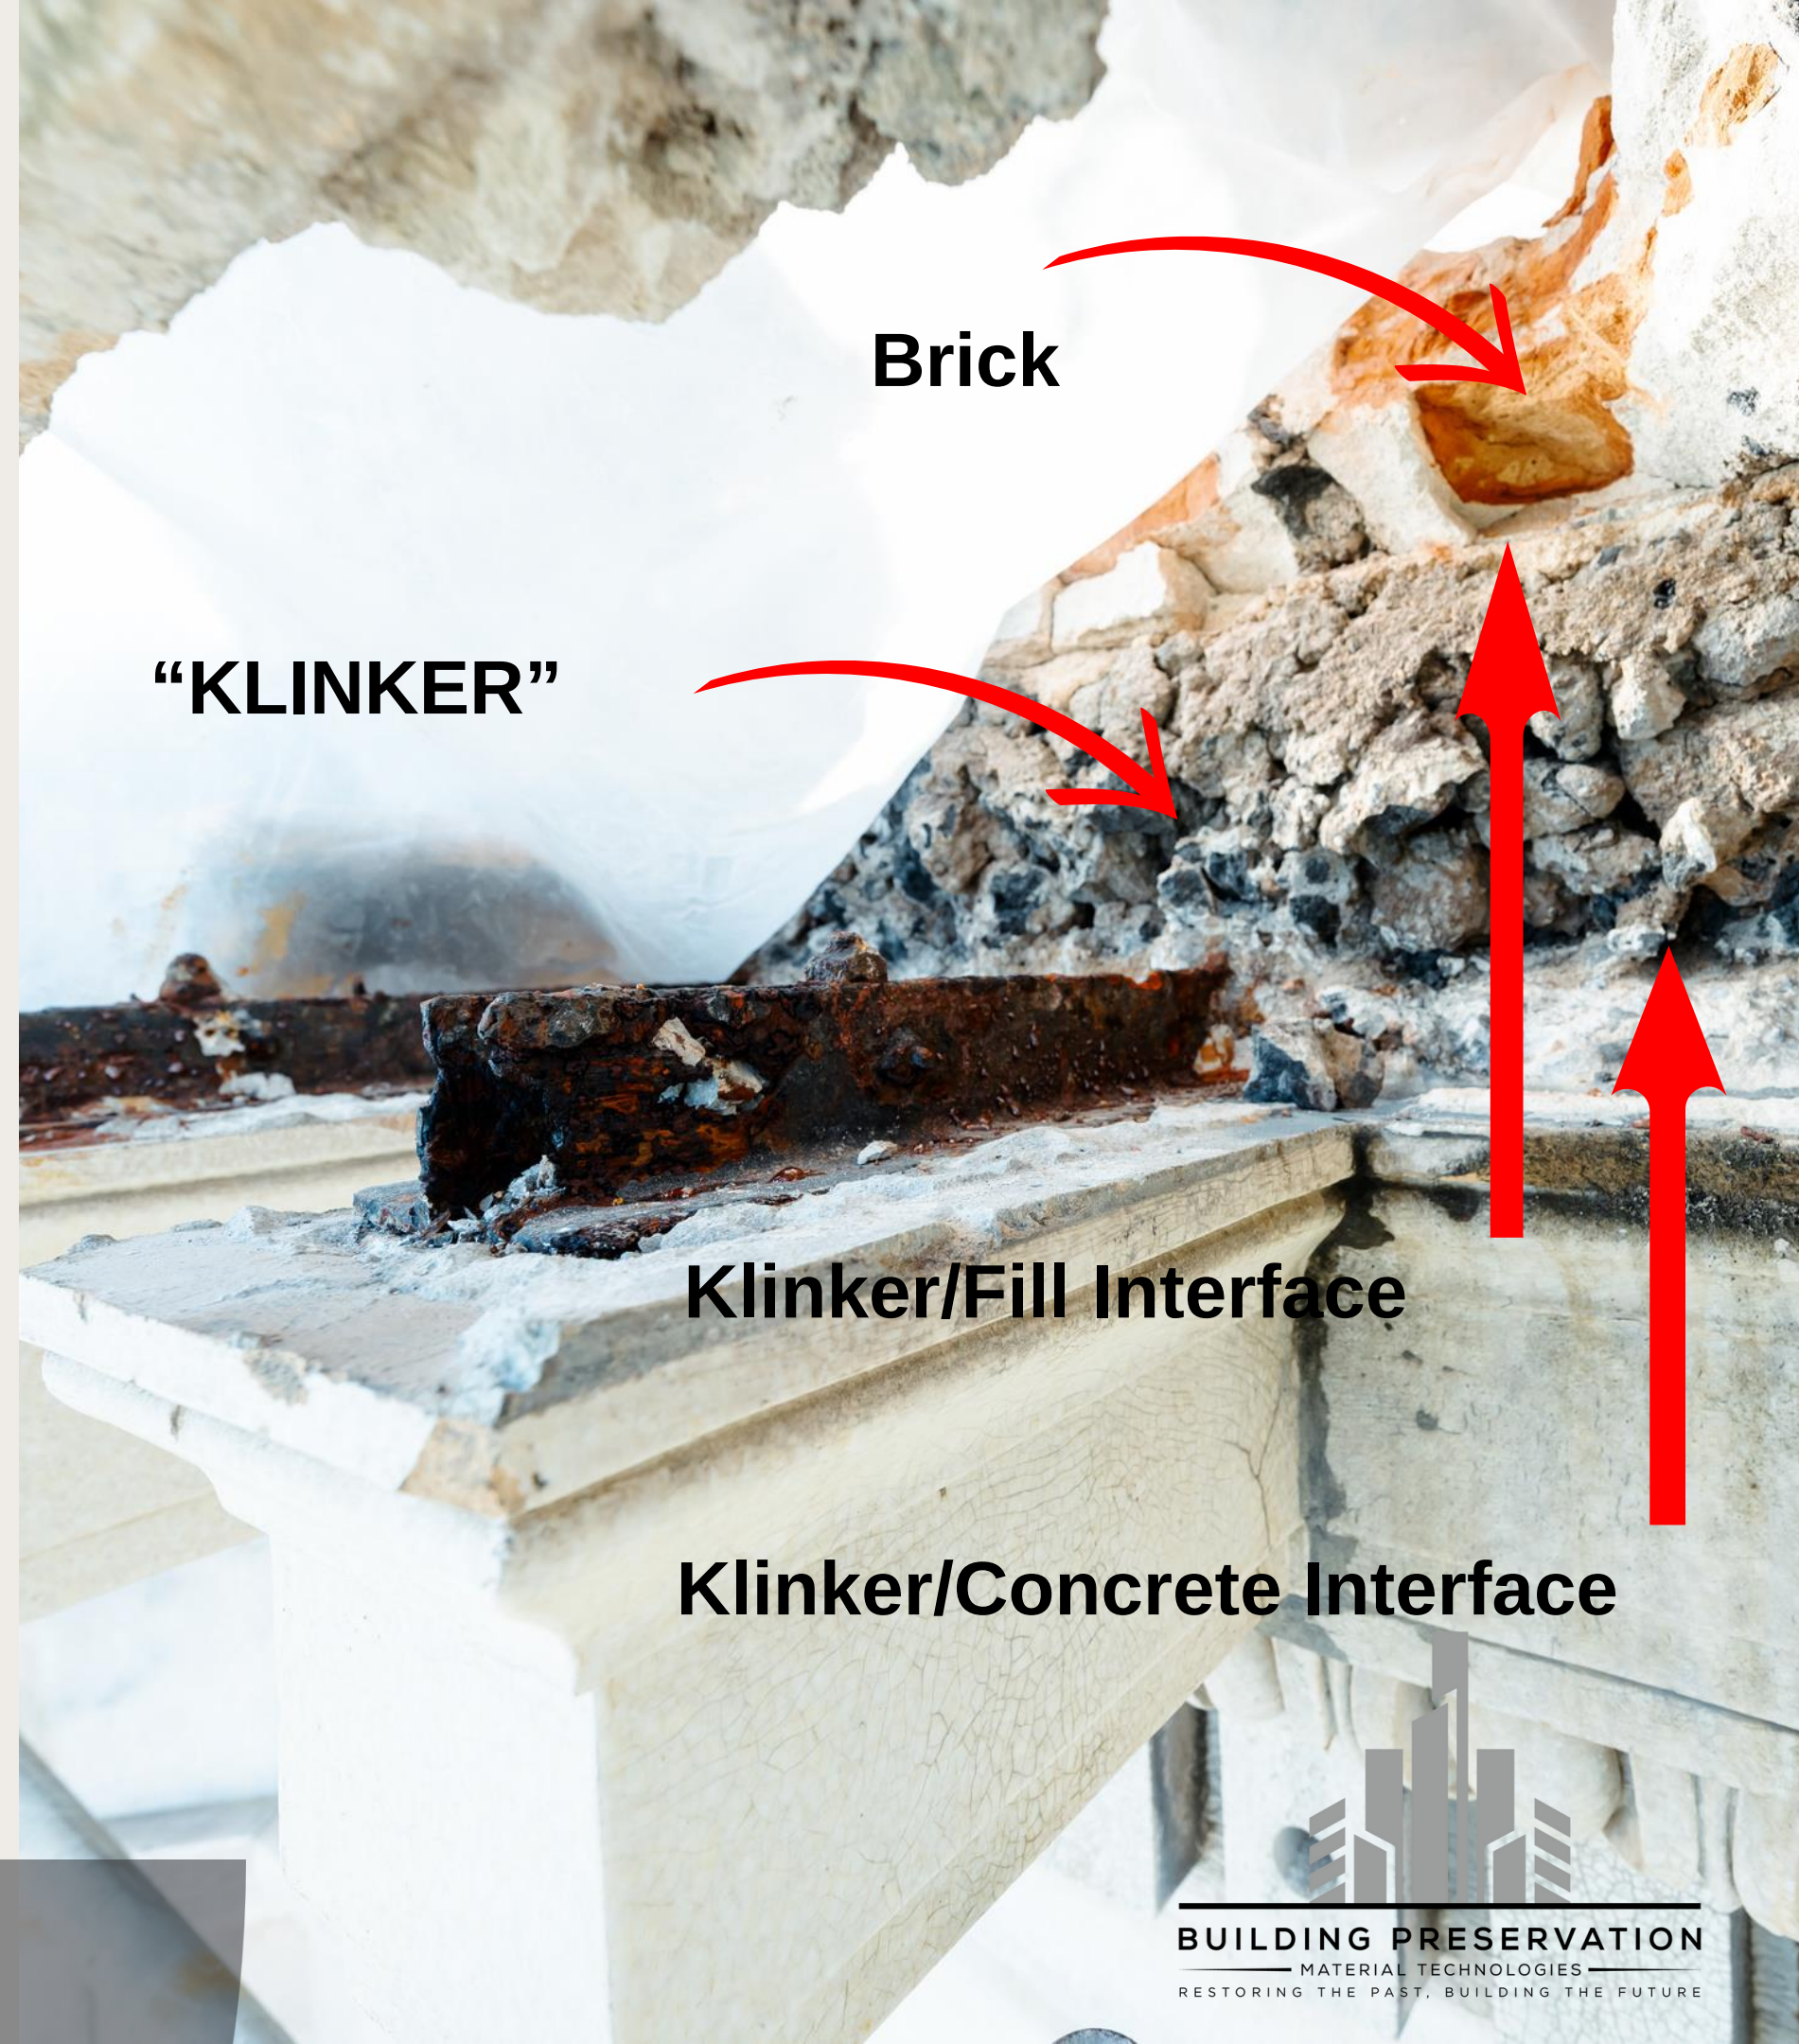
Existing Conditions

- Multiple Joints

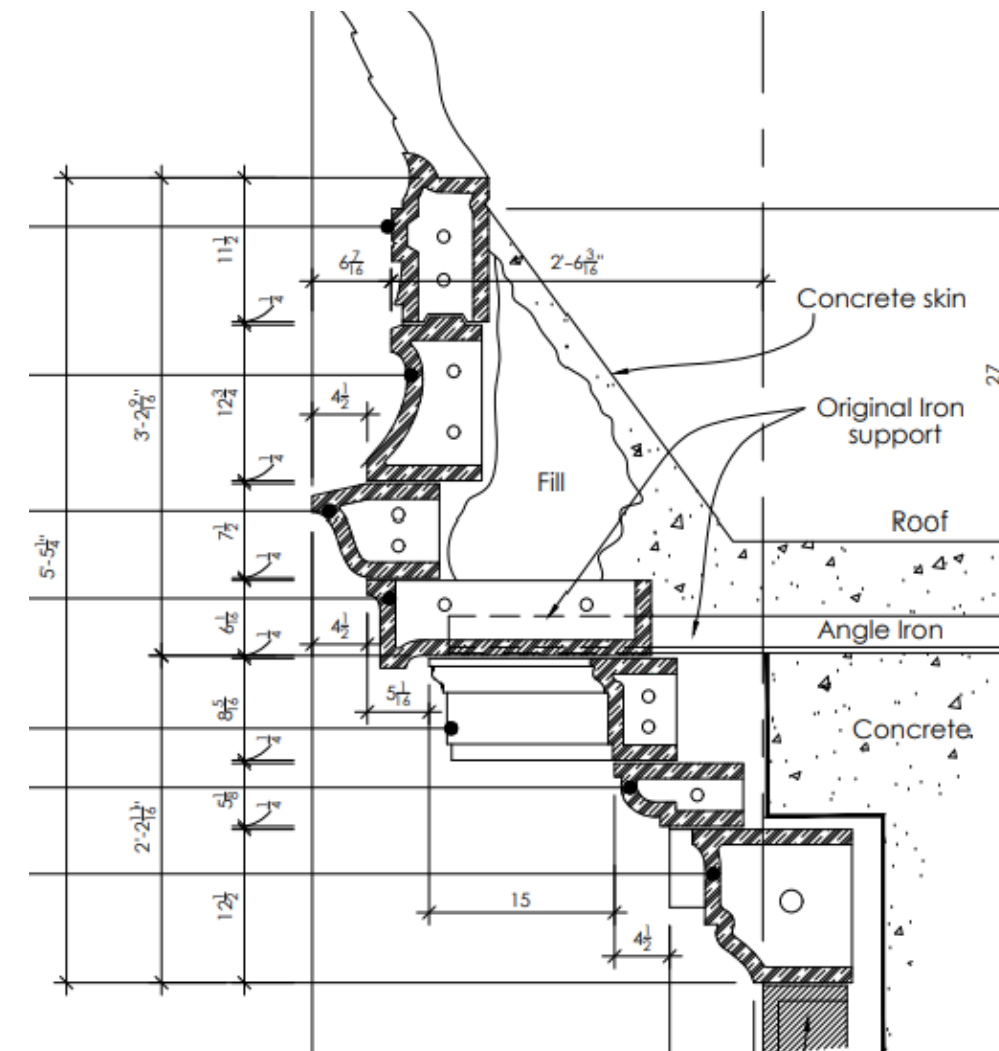
Structural System

- Façade supported by Iron Angles at 18" spacing
- Unfilled Terracotta Pieces
- “Klinker” serves as base
