Cathodic Protection and Concrete Repairs at Sound of the Sea II Condominiums

Assessment after a decade indicates long-lasting success

by David G. Tepke, Clement A. Firlotte, and Stephen P. Robinson

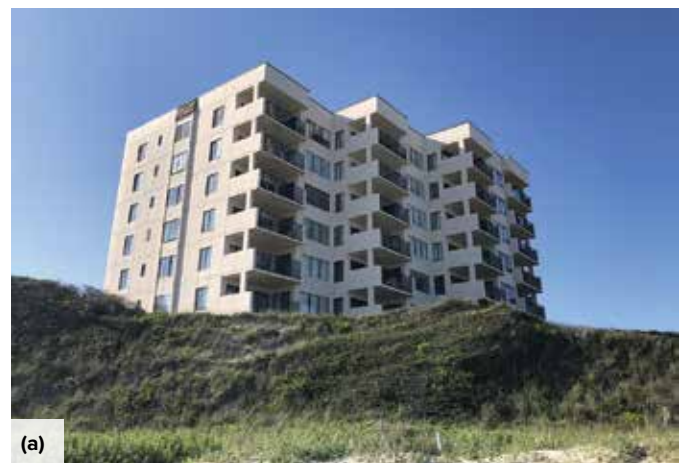
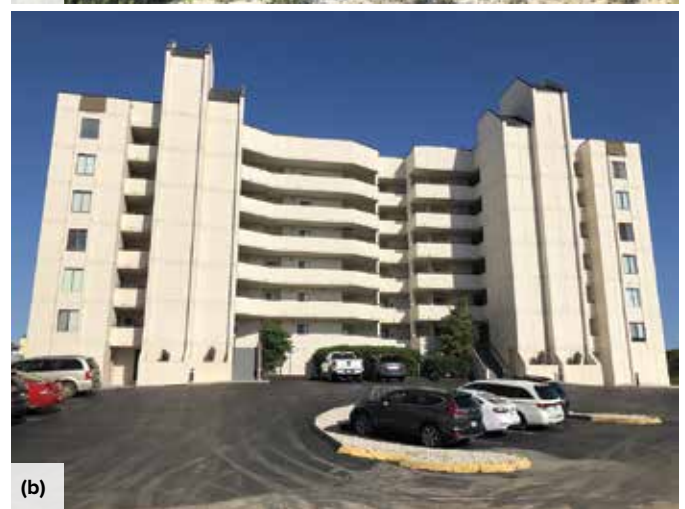
Fig. 1: Sound of the Sea II condominiums: (a) viewed from the beach; and (b) viewed from the front parking lot in 2019 (more than 10 years after repairs)

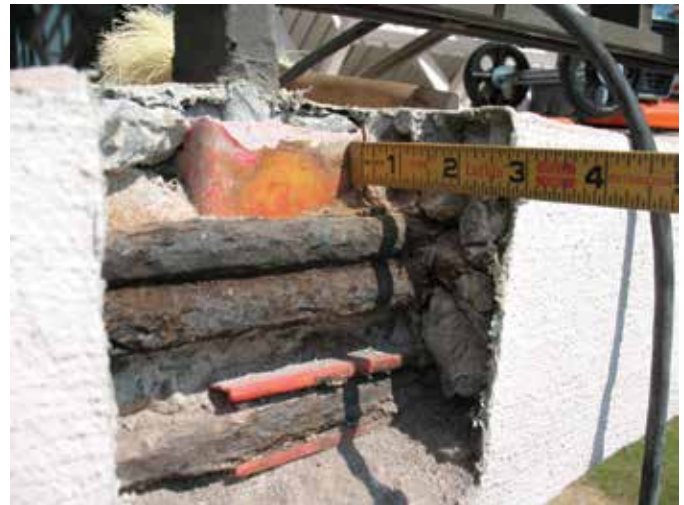
In 2007, excavations were made as part of the design effort to review embedded steel and structural conditions. Core samples were extracted from one corridor area and one balcony for resistivity testing by a third party. Resistivity was found to be relatively low and thus conducive for active corrosion for both samples. Of note, the balcony sample (4800 ohm-cm as received; 3000 ohm-cm after 12 hours of saturation and removal from bath) had about 60% the resistivity of the sample taken from the corridor (7700 ohm-cm; 4700 ohm-cm). Excavations revealed significant reinforcing steel corrosion (Fig. 2).

Fig. 2: Example of test excavation during 2007 assessment

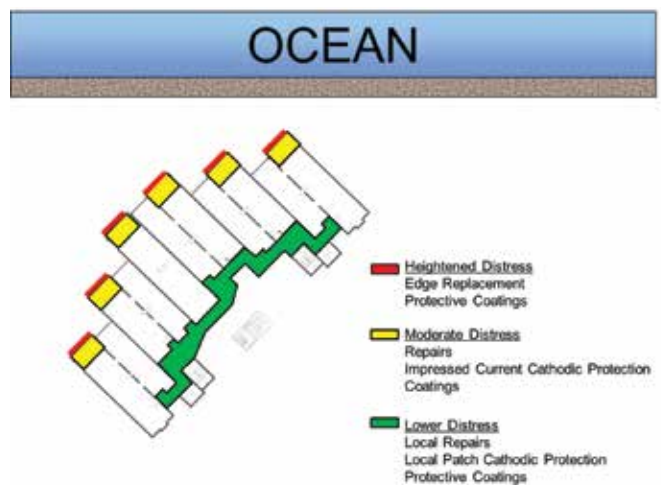
Fig. 3: Schematic showing tower position and final repair strategy

Budget was of the utmost importance to the owners. Thus, it was necessary to evaluate repair/preservation options that would extend service life but not be overconservative and cost prohibitive. The designers discussed the merits of global ICCP and GCP with the owners. Given the spatial differences in exposure, identified differences in magnitude of distress, budgetary constraints, and the owners' directives, two separate approaches for repair and protection were adopted. Concrete repair—an alternate for ICCP—and cementitious deck coatings were specified for balconies where distress was more severe. Limited concrete repairs, urethane deck coatings, and an alternate for localized GCP were specified for corridors where distress was more sporadic and exposure somewhat less severe. Alternates were provided in the bid for CP to provide flexibility for the owners. A general overview of primary repairs to the corridors and balconies is summarized in Fig. 3.

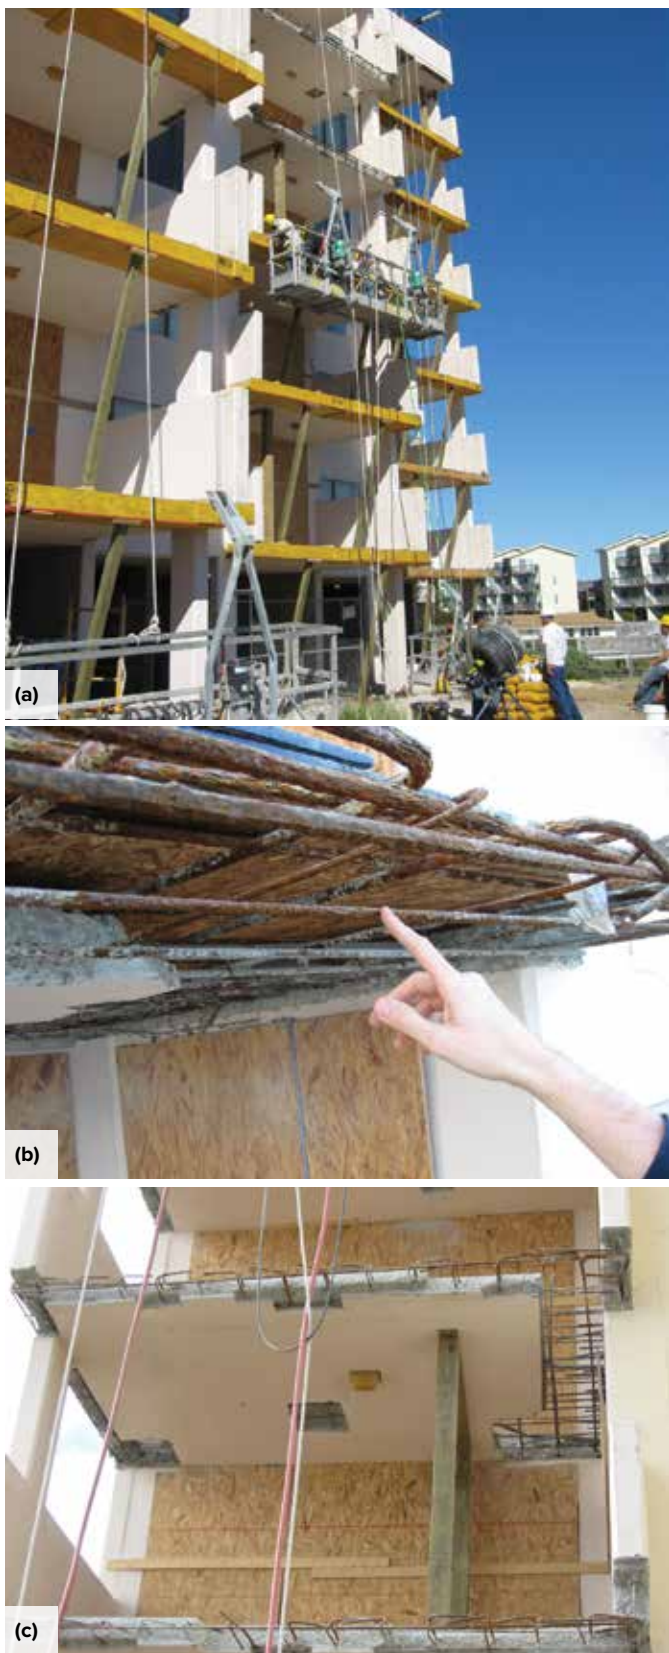
Fig. 4: Balcony repairs: (a) general construction access with visible swing stage; (b) extent of distress; and (c) one of the more severely distressed balconies requiring shoring. Note demising walls at balcony sliding glass doors

Swing stages were used for balcony access (Fig. 4 (a)). Due to project logistics and the amount of uncovered distress (Fig. 4(b)), it became immediately evident that the most efficient and cost-effective manner to address slab edges was to remove the entire slab edge. Although some sound concrete was removed, this method was less complicated and allowed for more efficient installation of supplemental reinforcement to address severely corroded reinforcing steel. It also allowed for effective coordination and installation of drip edges and guardrail posts after repairs. A significant challenge to the project was to minimize damage to guardrails during removal, storage, and reinstallation, and to make sure that slab edge installation was coordinated with new precisely located post pockets.

In general, less concrete removal than typical was necessary due to the use of ICCP. However, some balconies required full-depth repairs over substantial areas that required temporary support (Fig. 4(c)). Finite element analysis was used during the project to evaluate conditions for making field decisions. Mechanical splices and adhesive anchors were used where severely corroded reinforcing steel or inadequate steel was encountered and limited space was available for lap splicing. This also allowed for reduced quantities of concrete removal.

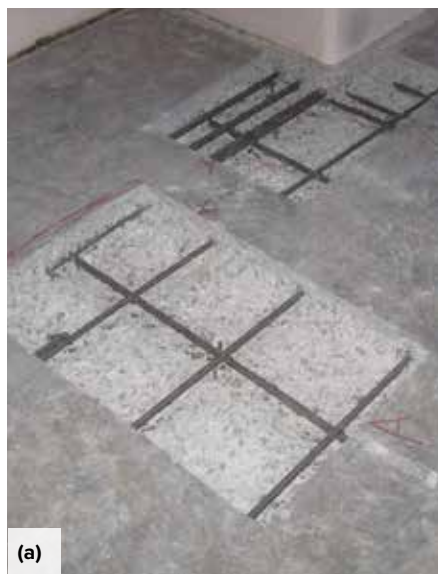
Lift and foot access were used on corridors. Repairs at corridors (Fig. 5(a)), columns, and walls were less frequent and generally smaller than those at balconies. Repairs at roof parapets (Fig. 5(b) and (c)) were variable. Commercially available alkali-activated galvanic zinc anodes were embedded in patch repairs to help prevent incipient anodes directly outside repair areas and associated distress. Anodes were tied to reinforcing steel within patches and all reinforcing steel and anodes within patches were confirmed electrically continuous. Reinforcing steel was coated with a cementitious/epoxy anticorrosion bonding agent. This had the likely added effect of diverting current from the anode to the existing substrate concrete.

Fig. 5: In-progress repairs: (a) exposed reinforcement in corridor; (b) exposed reinforcement in parapet; and (c) GCP and formwork installed at parapet repair

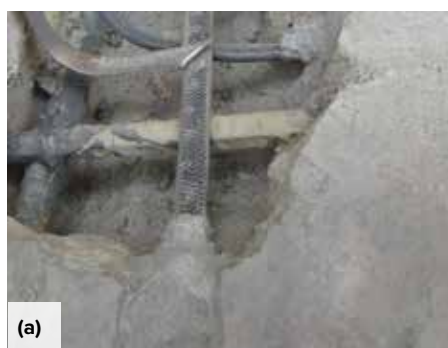
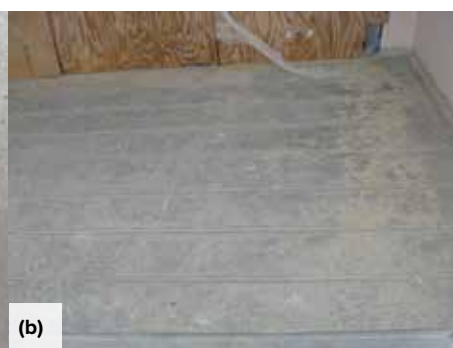
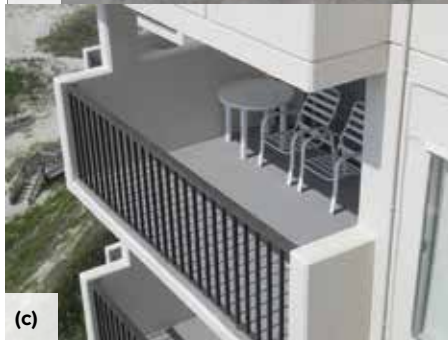
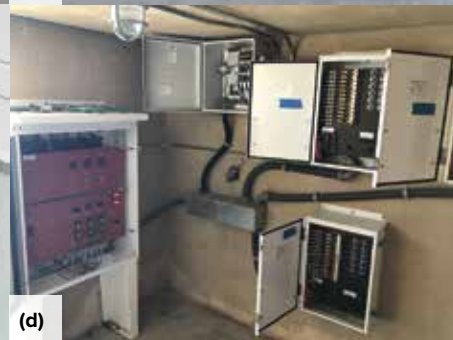
Fig. 6: ICCP system features: (a) anode and isolation from low-cover reinforcing bar; (b) grouted anode slots; (c) balcony deck as finished with vertical conduit (photo taken 2010); and (d) control and power system components (May 20, 2019)

The ICCP system (Fig. 6) was designed by the manufacturer to meet project and contract requirements during the project and was installed by an experienced specialty contractor. It includes 3/8 in. (10 mm) wide titanium/mixed metal oxide (MMO) mesh ribbon anodes with a current rating of 0.85 mA/ft (2.79 mA/m) grouted into 9/16 in. (14 mm) wide and 1/2 in. (13 mm) deep slots spaced approximately 12 in. (305 mm) on center and connected to 1/2 in. wide titanium headers. Testing was conducted to confirm continuity of reinforcement and separation of reinforcement from anodes. Embedments were grounded to the system negative. Where anodes and reinforcement were found to be continuous, they were isolated. System negative and anode connections were led through concrete to a junction box at each of the 36 balconies and then to the constant voltage transformer/rectifier in

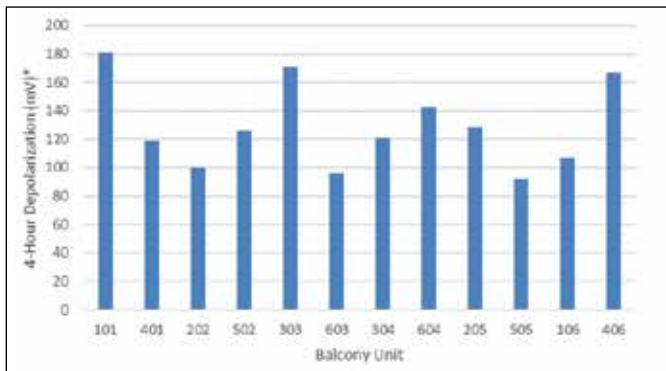
The system was commissioned and adjusted in September 2008 with approximately 60 mA current delivered to the average balcony (approximately 0.73 mA/ft²_{steel, design} [7.86 mA/m²_{steel, design}]; 0.48 mA/ft²_{concrete} [5.17 mA/m²_{concrete}]; 0.41 mA/ft²_{anode} [1.35 mA/m²_{anode}]). Depolarization testing per NACE Publication 35108¹ over a 4-hour period was used to evaluate the system, with 100 mV depolarization being considered

Fig. 7: Four-hour depolarization (September 25, 2008) (Note: Unit 505–97 mV at 6.25 hours; Unit 603–102 mV at 5.25 hours)

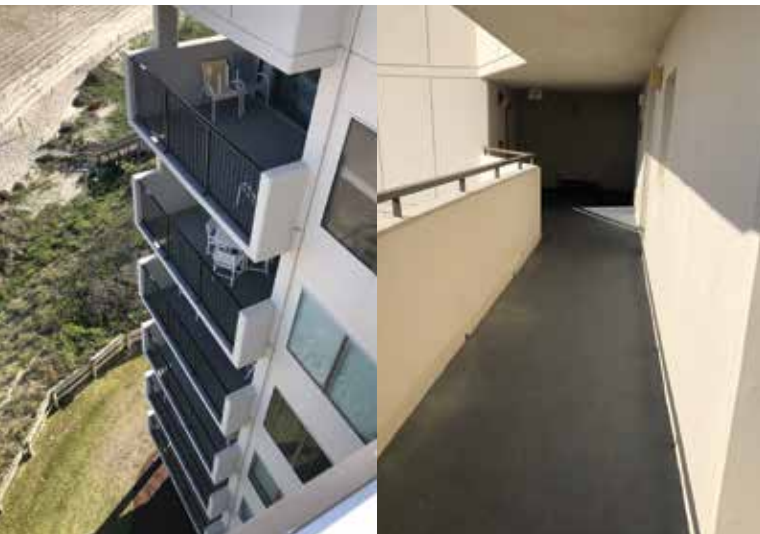
Fig. 8: Typical balconies and corridor area as of May 20, 2019

During visits in 2019, it was observed that critical ICCP system components were functioning to protect reinforcing steel within the original design parameters. While some small discrete corrosion stains and one small delamination were observed on balcony soffits, likely associated with discontinuous steel embedments, no major concrete distress was observed on balconies repaired and protected with ICCP in 2007/2008. The remote monitoring device had its backup battery replaced as part of routine maintenance, and the site-monitoring device and wiring conduits on the roof required maintenance after a recent major hurricane; however, these items have not affected protection. Guardrail anchorages in the concrete from the 2015 guardrail replacement project had variable connectivity, demonstrating the need for coordination of all repairs to concrete subjected to ICCP. Some concrete distress was observed on walkway areas and roof parapets where ICCP was not installed, and some isolated deck coating damage was observed, but installed repairs and coatings generally have performed well. Balconies and corridor areas as of May 2019 are shown in Fig. 8.
