A Case Study of Concrete Pavement Deterioration by Alkali-Silica Reaction in Korea

Abstract: The concrete pavement of the Seohae Highway in Korea has suffered from serious distress, only four to seven years after construction. Deterioration due to Alkali-Silica Reaction (ASR) has seldom been reported per se in Korea, because the aggregate used for the cement concrete has been considered safe against alkali-silica reaction so far. The purpose of this study is to examine the deterioration caused by an alkali-silica reaction of concrete pavement in Korea. The investigation methods included visual inspection and Automatic Road Analyzer (ARAN) analysis of surface cracks, coring for internal cracks, stereo microscopic analysis, scanning electronic microscope (SEM) analysis, and electron dispersive X-ray spectrometer (EDX) analysis. The results are presented as follows: the crack pattern of the concrete pavement in Korea was longitudinal cracking, map cracking or D-cracking. Local areas of damage were noticed four to five years after construction. The cracks started from edges or joints and spread out to slabs. The most intensive cracking was observed at the intersection of the transvers

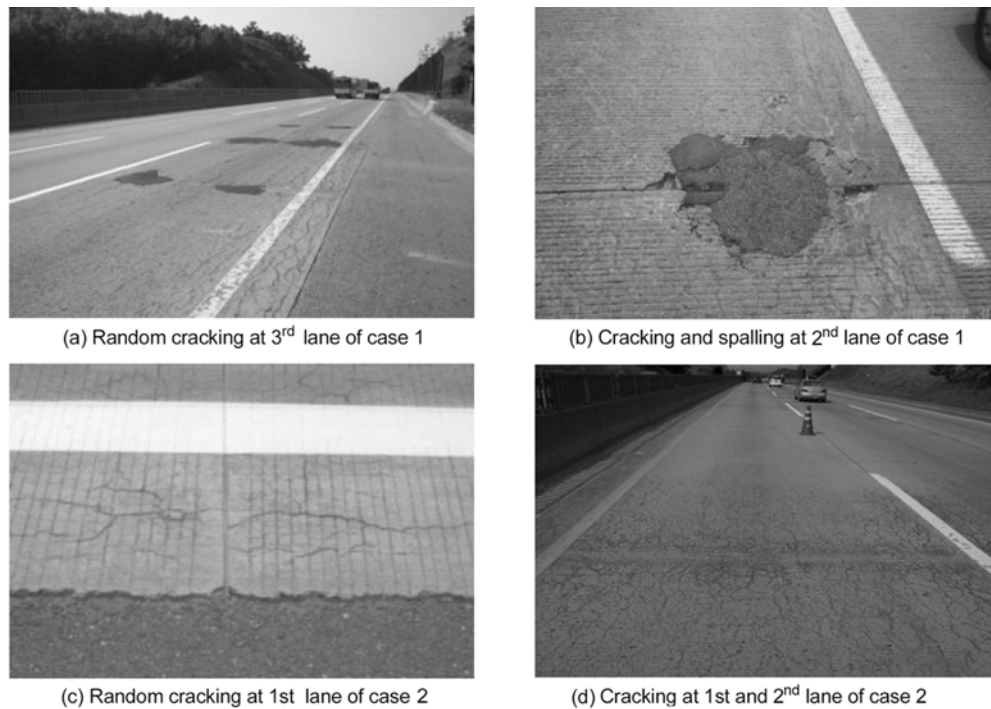
The concrete pavement of Case 1 and Case 2 on Seohae Highway was visually inspected, as illustrated in Fig. 1. Cracks were found distinctively at the third lane of Case 1 and the first and second lanes of Case 2, as shown in Fig. 1(a) and (d), respectively. This development was likely due to the fact that the first and the second lanes of pavement in Case 1 were constructed first and the third lane was paved later due to the aforementioned paver constraint. The cracking patterns were somewhat like longitudinal cracking, map cracking or D-cracking especially observed at the joint.

Figure 1(a) shows the longitudinal cracking; the orientation of predominant cracks on transversely crossed jointed pavement was longitudinal. The cracking pattern certainly showed that more prominent cracks occurred in the longitudinal direction of the pavement. This cracking pattern developed uniformly across the width of the pavement in general, although cracks in wheel paths were more apparent due to the infiltration of dirt and crumbling of crack edges to create apparently greater width.

Map or random cracking has no predominant orientation, meaning the various cracks show no strongly preferred direction. Severe map cracking brought about spalling at joints or pop-out at the surface, and a white deposit or gel was visible as depicted in Fig. 1(b). The width of cracks varied widely while the widest cracks were usually visible on some edges of the pavement. White deposit was observed, which will be further evaluated to identify its chemical composition.

The cracks started from edges or joints and spread out to slabs. The most intensive cracking occurred at the intersection of the transverse and longitudinal joints. Where cracking was most intense, pieces of concrete and aggregate had spalled away from the top surface and the joint interface area. The pattern and location of the cracking was of so-called "D-cracking", named after the shape of the cracked area. Cracking pattern resembling D-cracking was more severe or appeared initially along joints. Cracking along the joint was usually perpendicular to the joint and was associated with a fainter map-cracking as shown in Fig. 1(c). D-cracking was caused by ASR or freeze-thaw damage or both.

Fig. 1 Surface cracking and spalling in the concrete pavement.

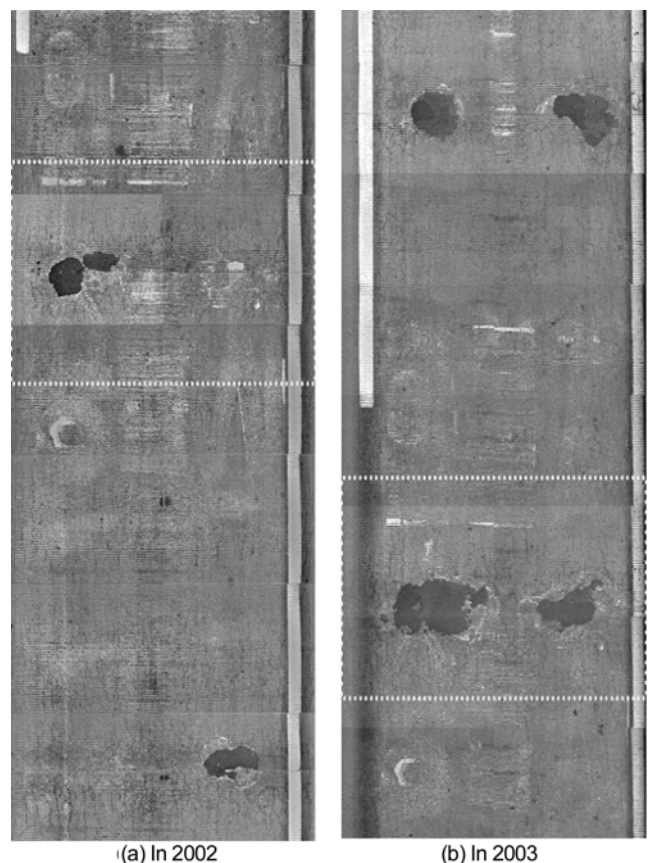
An automatic crack inspection was performed by ARAN⁷. ARAN collected the images of concrete pavement surface conditions in 2002 and 2003 in order to compare the deterioration progress as shown in Fig. 2. The photos show that the pavement had severe random cracking and some portions of the pavement were patched by bituminous mortar. The dotted-line boxes in Fig. 2(a) and (b) indicate the same portion taken in 2002 and 2003, respectively. The patched area enlarged as the deterioration progressed even though it was only one year later. The deterioration was indeed very rapid.

Fig. 2 Progress of deterioration in the pavement, images taken by ARAN.

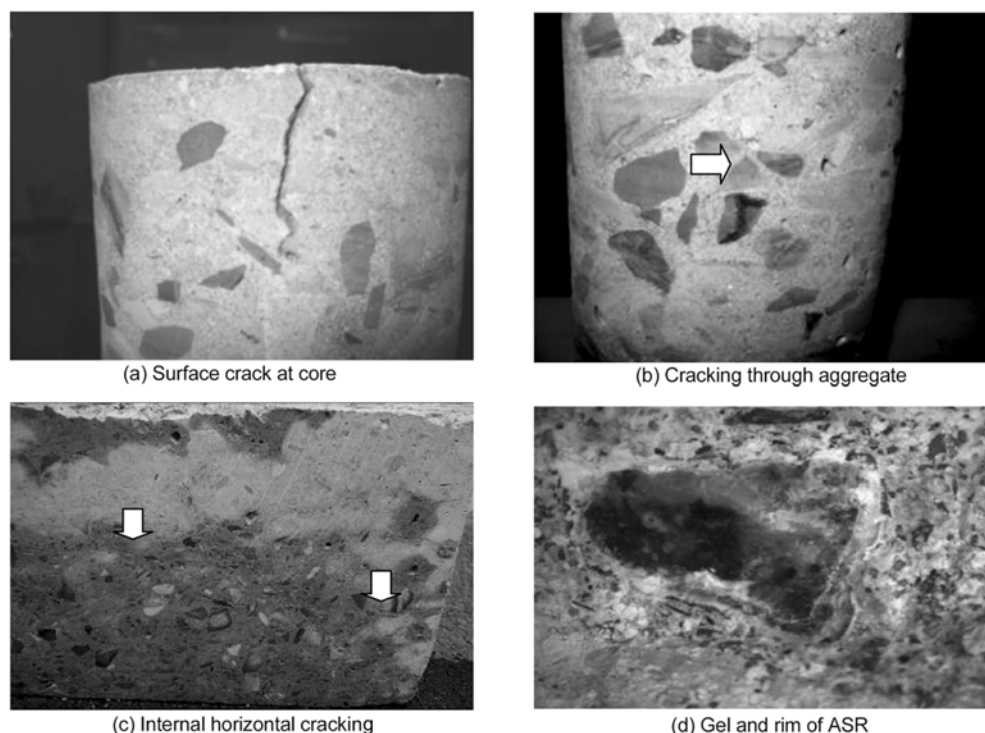
Cores were taken from severely distressed locations of the pavement in order to investigate the internal distresses, as shown in Fig. 3. It was impossible to test the strength of the cores because of the transverse or vertical cracks developed inside the concrete. The surface crack had vertically progressed from top to bottom as shown in Fig. 3(a). The crack was filled with water to show it clearly. A vertical internal crack occurred through a coarse aggregate as shown in Fig. 3(b). However, several internal horizontal cracks occurred also as shown in Fig. 3(c), and were more predominant than the others. Some of the cracks were so

Figure 3(a), which was taken by an ordinary camera, illustrates the rim of white deposit around coarse aggregate. The reaction products were white or colorless, and the product around the aggregate was whitish. The white product could be seen through

Fig. 3 Internal cracks.

simple visual inspection as the water at core surface dried out. Even small aggregate of 3 mm in diameter could be identified. Some portions of the white product were colorless. Thus, the reaction product of the analyzed pavement in Korea was very similar to a typical alkali-silica gel identifiable even with the naked eye, and the products and crack pattern were the same as those of Farney and Kosmatka.⁸

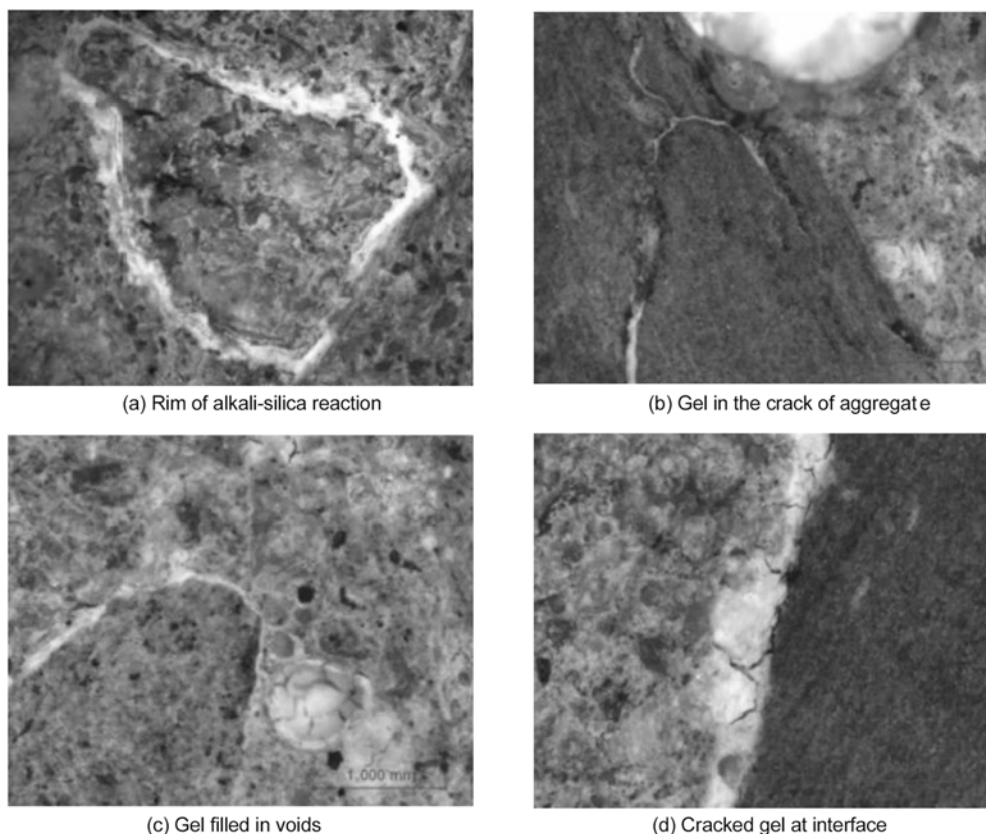
The white alkali-silica gel product was clearly identified by a stereo optical microscopy by its generally colorless, white, or very pale yellow color, as shown in Fig. 4. The typical locations for the gel were at the interface between aggregate and cement paste, as shown in Fig. 4(a), within aggregate particles in the cracks as shown in Fig. 4(b), at and the large voids in the cement paste as shown in Fig. 4(c). Some gels showed cracking at the interface between aggregate and cement interface. Most white products were found at the interface or within internal aggregates.

Microcracking, cracked aggregate particles, and gel-filled microcracks and voids confirmed that an alkali-silica reaction had occurred in the concrete. The reaction product could clearly be differentiated from the cement paste as evidenced by the grey color of the reactive aggregate. Powers⁹ reported that ASR gel filled the interface of aggregate and cement paste and also filled the voids. Adams¹⁰ reported that ARS gel was formed around the quartzite aggregate as a white rim. Thus, the white product found in this study seems the same as that of ASR reported by FHWA.¹¹

Fig. 4 Stereo optical micrographs showing white reaction products.

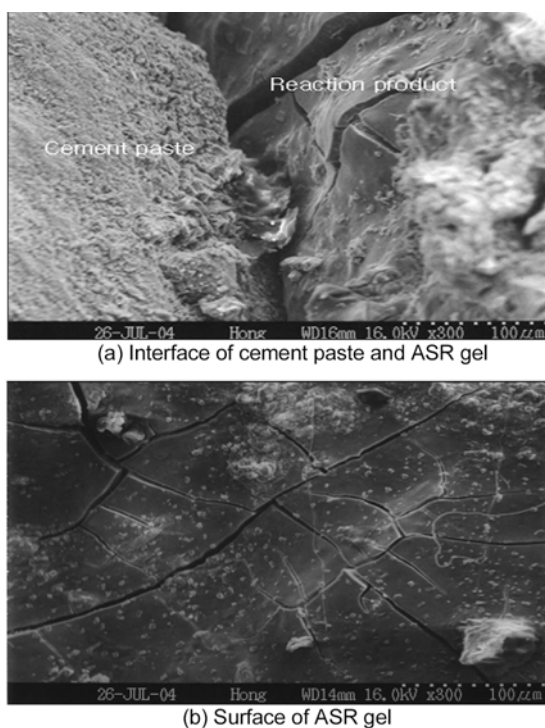
The surface of the white product was very smooth, while the cement paste was very rough as shown by the image of the scanning electron micrograph of Fig. 5(a). The white product had many cracks at the surface as shown in Fig. 5(b). Figure 6 compares X-ray spectra of cement paste (a) and reaction product (b). Figure 6(a) shows that the compositions of the cement paste are $\text{Si}^{4+} > \text{Ca}^{2+} > \text{K}^+ > \text{Al}^{3+}$ in the decreasing order of chemical composition. The compositions of the cement were very high for silicate (Si) and calcium (Ca), while the white product was mainly composed of potassium (K). These facts indicate that the white product is an ASR gel. Most cement produced in Korea has a high content of potassium (K) and low content of sodium (Na),⁵ thus, ASR might be induced by the high potassium content.

Fig. 5 Scanning electron micrographs showing ASR gel.

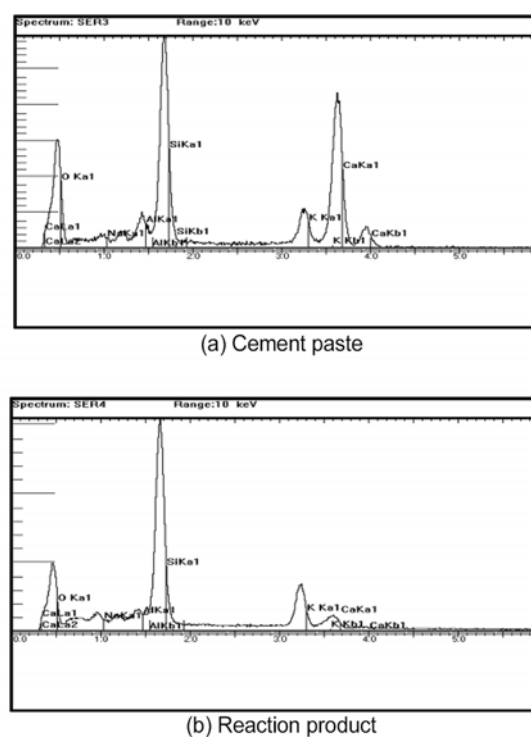
Fig. 6 X-ray spectra.

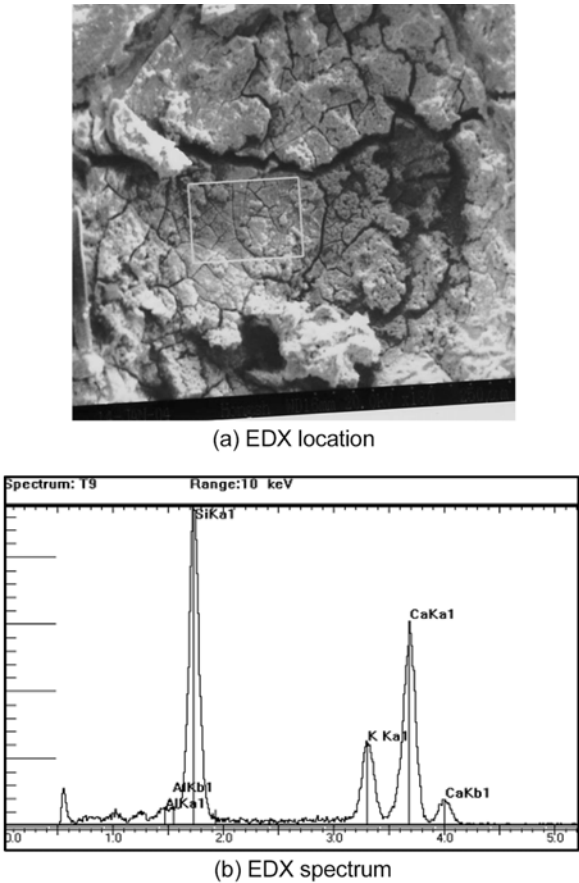
Figure 7(a) presents a SEM image of filled air voids with corres-

ponding X-ray spectrum of Fig. 7(b). The EDX analysis shows that the order of chemical composition was $\text{Si}^{4+} > \text{Ca}^{2+} > \text{K}^+ > \text{Al}^{3+}$, which was a typical composition of ASR gel.

Fig. 7 EDX location and spectra of void.

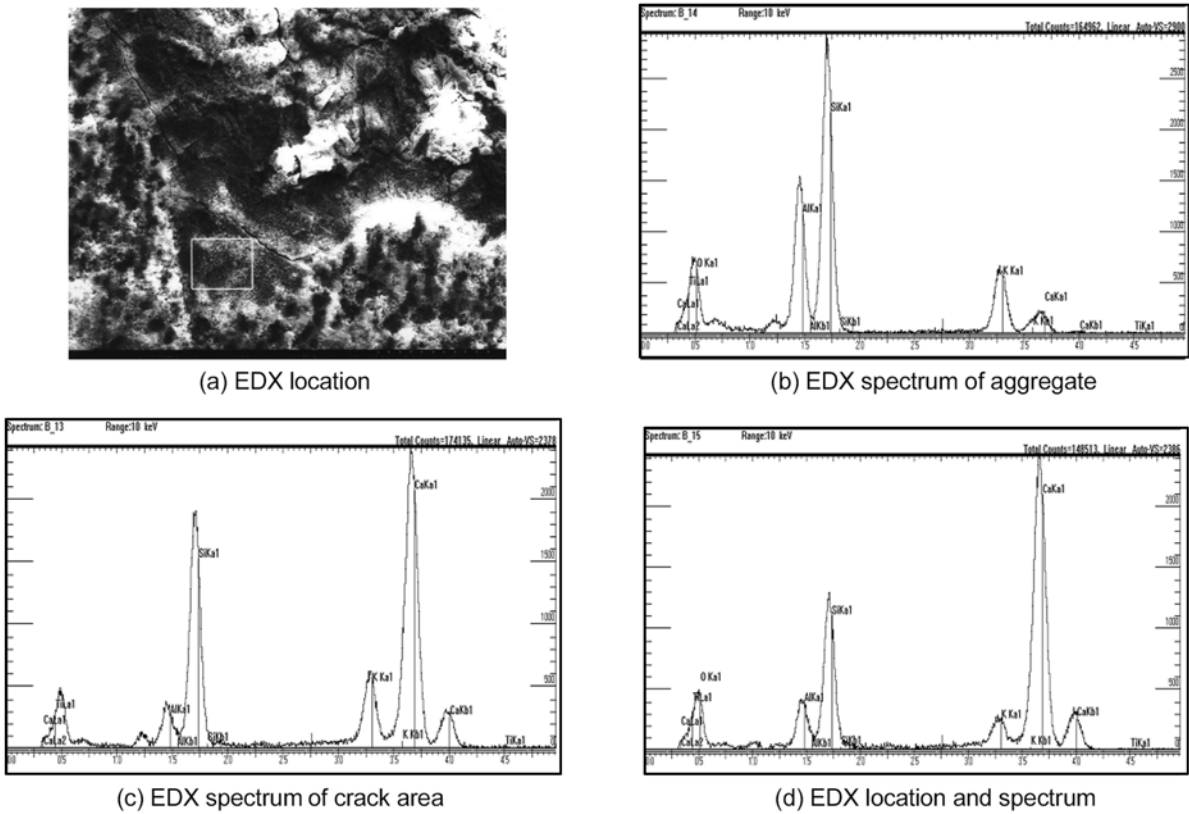
Figure 8(a) presents a SEM image of cement paste near the crack with corresponding X-ray spectra of the aggregate, cracks

at cement paste, and cement paste only. The orders of chemical composition were $\text{Si}^{4+} > \text{Al}^{3+} > \text{K}^+$, $\text{Ca}^{2+} > \text{Si}^{4+} > \text{K}^+ > \text{Al}^{3+}$, and

$\text{Ca}^{2+} > \text{Si}^{4+} > \text{Al}^{3+} > \text{K}^+$ for the aggregate, crack at cement paste, and cement paste, respectively.

Fig. 8 EDX location and spectrum.
