n. 73
August 1980
Volume XXI-2

How have concrete shell structures performed?

An engineer looks back at years of experience with shells

ANTON TEDESKO¹

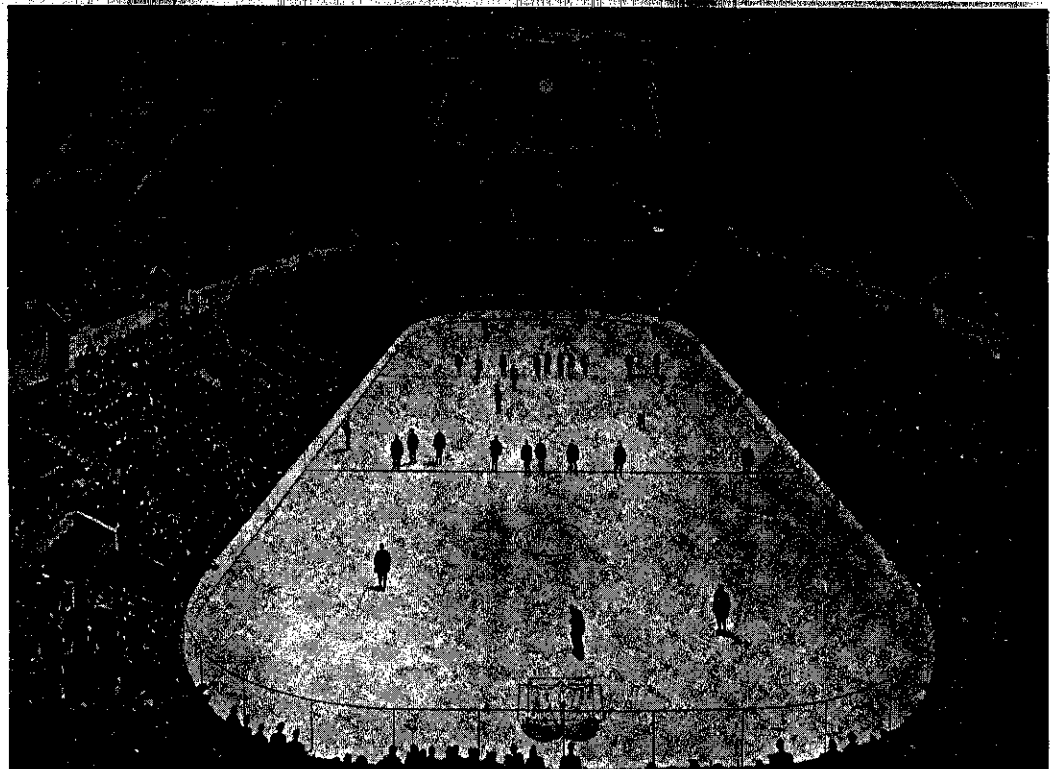
Fig. 1. Sports Arena Hershey interior view.

The *Sports Arena in Hershey, Pennsylvania*, was my first major structure¹ (Figure 1); I was on my own in deciding what rules to follow. It was the first long-span thin shell structure in the United States where the stability of the shell was an important consideration. The collapse of an airplane hangar in Germany due to creep buckling was very much on my mind at that time*. This 1934 incident was hushed up, as it involved the destruction of numerous training planes of Germany's growing air force. I was concerned with the buckling safety of the 3 1/2 in. (9 cm) Hershey shell which cantilevered 19 ft (5.8 m) beyond the supporting arches of 222 ft (68 m) span (see Figure 3).

Recently, almost 40 years after completion of the structure, the owners considered supporting a 24-ton concentrated load from the crown of the roof. They asked what provision could be made for the support of an air-conditioning system and of a sophisticated score board at the center of the arch shell structure. I examined the structure and found it in excellent condition; no cracks could be observed in the tension zones of the concrete. Concrete cores were taken and these exhibited a concrete compressive strength in excess of 7000 psi (50 MPa). Approval of the proposed installation of the additional load could be granted without any strengthening of the structure.

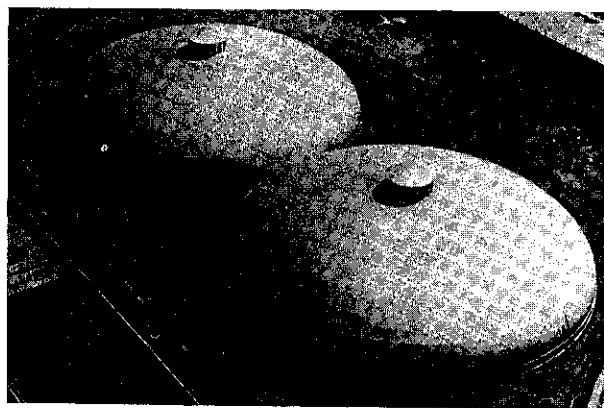
Fig. 4. Domes in Minnesota.

Domes of 150 ft (46 m) diameter were built in *Hibbing (Minnesota)* forty years ago. They are of elliptical cross section and have a rise of $33\frac{1}{2}$ ft (10 m) at the center; the shell thickness is $3\frac{1}{2}$ in. (9 cm), except that it increases to 6 in. (15 cm) at the springing line (Figure 4)². These domes serve as covers for trickling filters at a waste water treatment plant. Roof cover consisted of only an asphalt coating with an aluminum finish.

These domes should have been cast in a continuous operation but, since it was a construction operation designed to keep unemployed people busy, it proved difficult to enforce procedures which would have been quite natural for a competitively built construction project. Consequently, cold joints were left around horizontal rings.

The highly humid operating conditions inside the domes saturated the concrete shell during its early life. Furthermore, the shell was subjected to freezing and thawing during the severe winters of Minnesota. Some efflorescence appeared along horizontal rings where construction joints had been located and where the concrete did not have the desired monolithic character; the roof covering blistered and spalled off along these lines. After inspecting the domes, I recommended cleaning of the

shell ceiling and applying coats of linseed oil. For the exterior I recommended repair of the asphalt coating and the application of a roofing membrane. The concrete ceiling was soaked with linseed oil; a roofing membrane, however, was not applied, but the exterior received occasional patching with asphalt.

Recently, 35 years later, I inquired about the condition of the domes, and was told that 8 years ago the structures were rehabilitated. Defective areas of the exterior were repaired with shotcrete and the outside was then painted; freezing and thawing now causes only minor defects. The interior ceilings were sand-blasted and received an epoxy coating which prevents the saturation of the concrete by the existing vapor. The domes are now considered to be in fair condition.

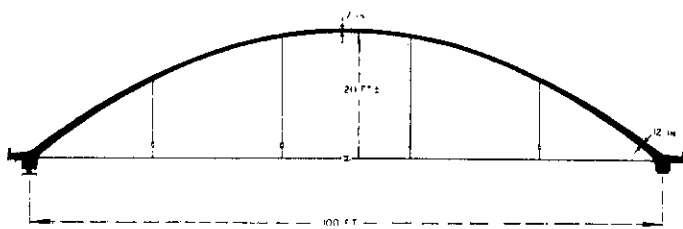
a. Arrangement of tension tie rods.

Someone had made design calculations for a barrel shell roof, thinking that the structure would carry like an arch. The designer assumed that the arch would follow the shape of a catenary and that moments due to dead load would be zero. Drawings were supplied to the builder of a form centering assumed to result in the construction of arches of the desired shape. No evidence was found of the involvement of a responsible engineer during the design and construction stages. The structures were built by a contractor who was furnished cement by the owner and who placed good concrete and reinforcing steel as indicated on available sketches.

My investigation indicated that the drawing of the form centering contained dimensional errors and that anyone following this drawing would end up with an irregularly shaped roof. This apparently was discovered by the builder who, making his own adjustments, substituted what he considered a non-objectionable, smooth shape. Unfortunately, this shape was not one that an engineer would have chosen and the structure was thus shaped with built-in dead-load moments which were much greater than the anticipated maximum live load

moments. The concrete, however, was strong, so no immediate trouble developed. The structure deformed through the years as creep continued and as live loads became much greater than anticipated. This live load came from cement dust which fell on the roof and turned into successive layers of caked-on deposits. The sizeable bending moments created deflections, which in turn created additional moments, leading to additional deflections until the geometry of the structure changed to such an extent that the roof became unstable under its own weight. The collapse took place where the cement dust collected on the roof had provided an extra heavy live load.

My rehabilitation of the structure was based on the fact that the loads on the arch were too small near the crown and too large near the quarter point. After the undesirable live load was chipped from the roof, its exact curvature was established as was the additional loading necessary to keep bending stresses within safe limits. I borrowed from the existing force in the tension tie to obtain vertical prestressing forces which would improve the stress condition in the roof shell (See Figure 5). A downward force for the shell at hanger locations near the crown was obtained by shortening these hangers 3 in. An upward force for the shell at other hanger locations was obtained

by inserting a pipe strut with a built-in screw-jack. This jack was turned so that the strut lengthened until the tension tie showed a downward deviation of 4 in. With a hammer I hit individual tension rods and recorded the sound on a tape recorder. Tuning the tension ties to a uniform pitch, I was satisfied that they would be stressed to take the same force.

Roof measurements, made every 3 months during the past 5 years, not only indicate that the dangerous increase of creep deformations was stopped but also that there was a continuing tendency towards reversal of deformations. Observations continue at regular intervals, but seem to indicate that the structure is now stable.

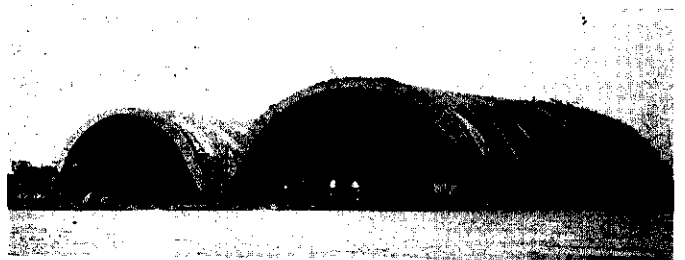
Fig. 7. Sea-Plane Hangars at San Diego.

During my earlier years, still influenced by the German buckling failure of 1934, I designed the cylindrical shells of large span structures with an increasing curvature along the shell edges. This placed a penalty on the supporting arch ribs because their shape did not fit the pressure line. The resulting sizeable bending moments controlled the dimensions of the prominent ribs in hangars of the early 1940's of which *Naval Hangars at San Diego* (Figure 7)⁴

are examples. These hangars encountered earthquakes without damage, leaving us with the feeling that we had provided more than ample stiffness. A curious accident occurred some years ago: a missile was shot by accident from within one of these hangars. It passed through the roof and left as its only evidence a clean-cut round hole in the roof shell of the hangar.

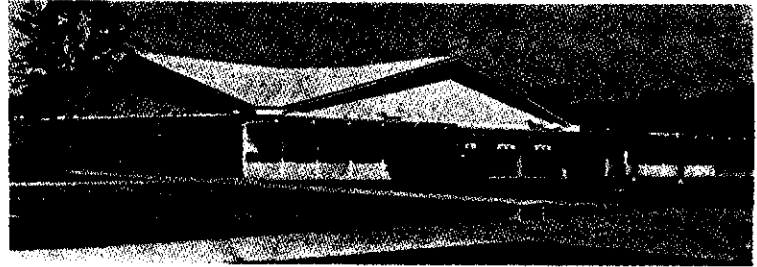
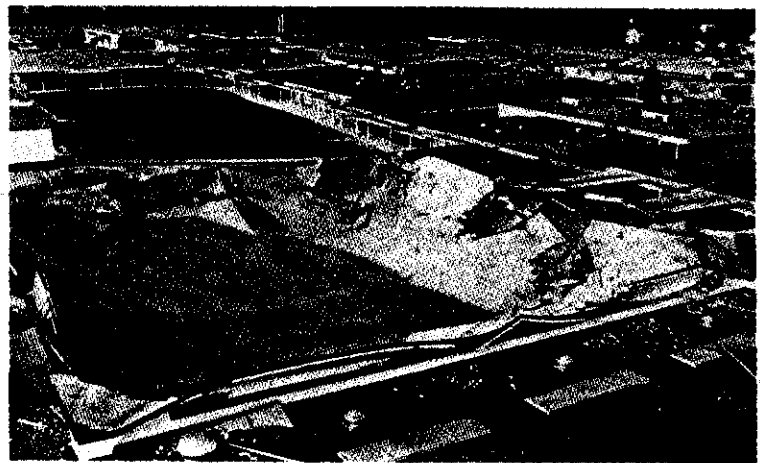
Fig. 12. Collapsed Shell in Virginia.

A similar but flatter *Hyperbolic Paraboloid Shell* of only 100 ft (30 m) span built in Virginia 17 years ago, collapsed 8 years after construction (Figure 12)⁸. Crown deflections due to

yielding supports, creep, shrinkage, and the use of light-weight concrete contributed to the stability failure of this shell. The designer remembers asking for my comments on his drawings when they were made, and he remembers my telling him that I considered his shell too flat.

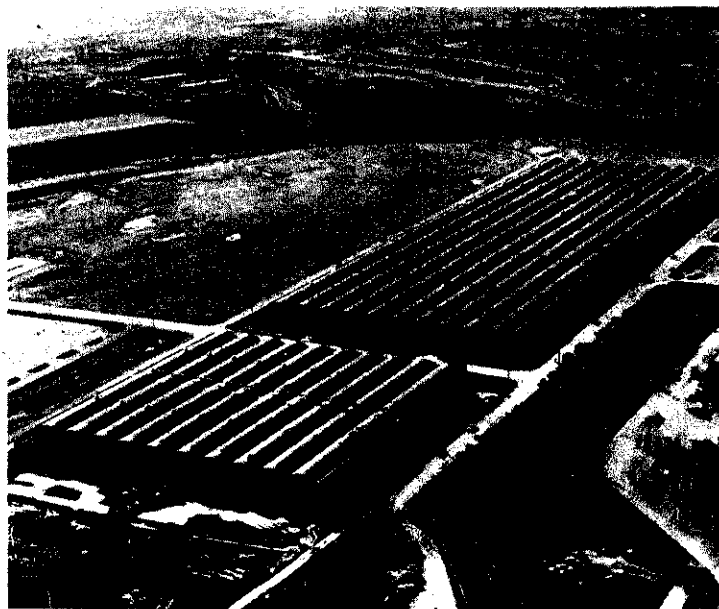
Fig. 15. Industrial Installation in Pennsylvania.

Many millions of square feet of covered roof area of *Industrial Shell Structures* stood up well through the years without distress (Figure 15)¹⁰. These shells usually were roofed by composite tar-felt coverings; two layers of felt required maintenance or replacement after about 10 years; a 4-ply tar-felt roof was as-

sumed to have a 20-year life. Where these roof coverings and flashings were kept in good repair or were renewed, the condition of concrete shell roofs after a service life of 40 years appeared as good as at the very beginning of their lives. Thin shell installations without roof coverings I do not recommend, not even for warm and dry climates. Examples exist, however, of a few well-executed structures where the shell was left unprotected and the concrete does not show signs of deterioration.
