Long-Term Durability of GFRP Internal Reinforcement in Concrete Structures

The Concrete Convention
and Exposition

Field Structures: Walker Box-Culvert Bridge

Field Structures: Southview Bridge

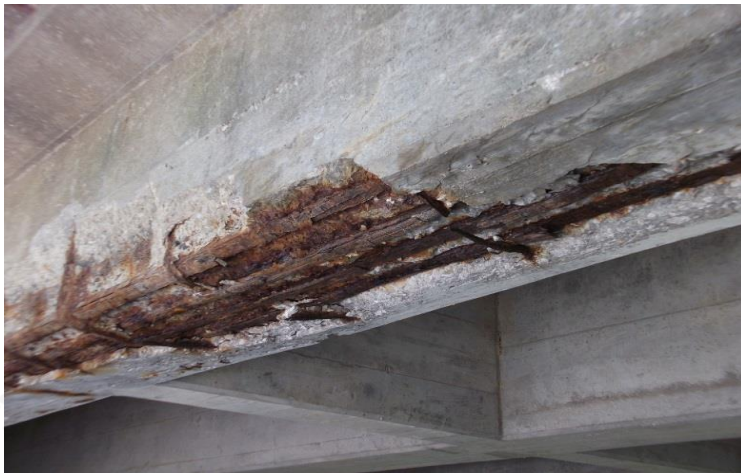
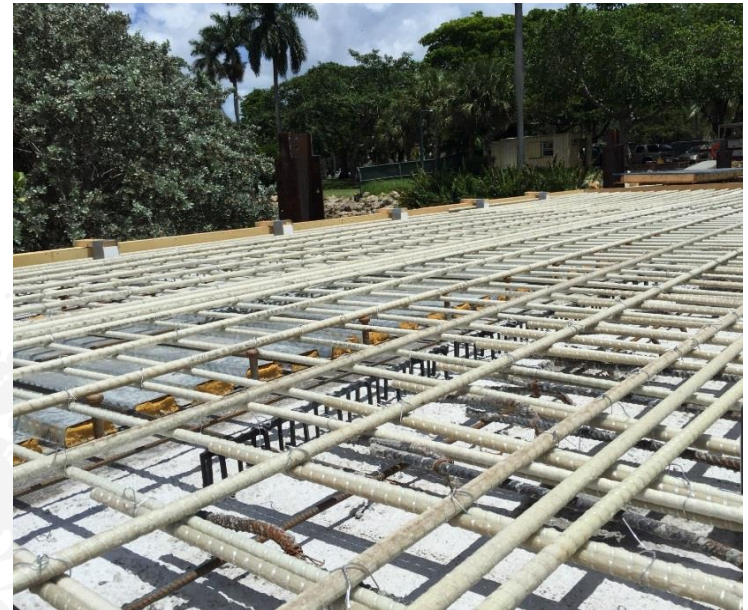
- Glass fiber reinforced polymers (GFRP) bars are made of glass fibers (E, E-CR) as the load carrying member and the resin (Vinyl ester, polyester) to protect the fibers and transfer the load
- Steel is still the most common reinforcement for concrete but it suffers from corrosion problem

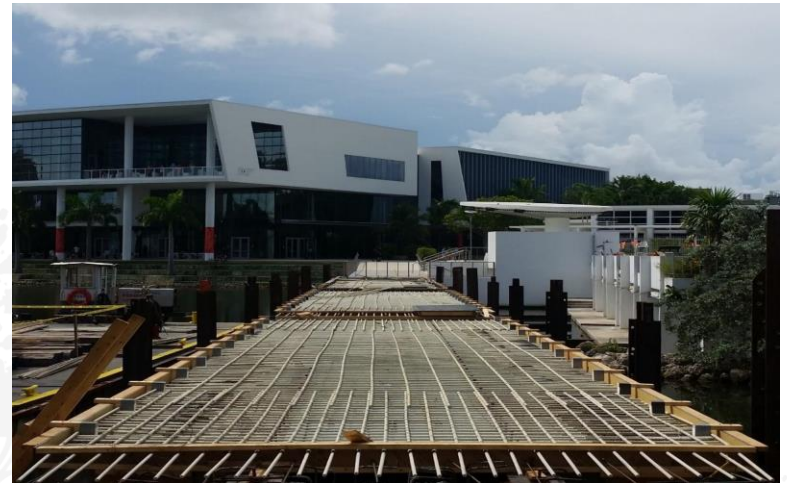
- GFRP bars are emerging as an effective alternative for traditional steel reinforcement
 - High strength-to-weight ratio
 - Corrosion resistance
 - Higher service life of the structure
 - Magnetic transparency
 - Ease of demolishing

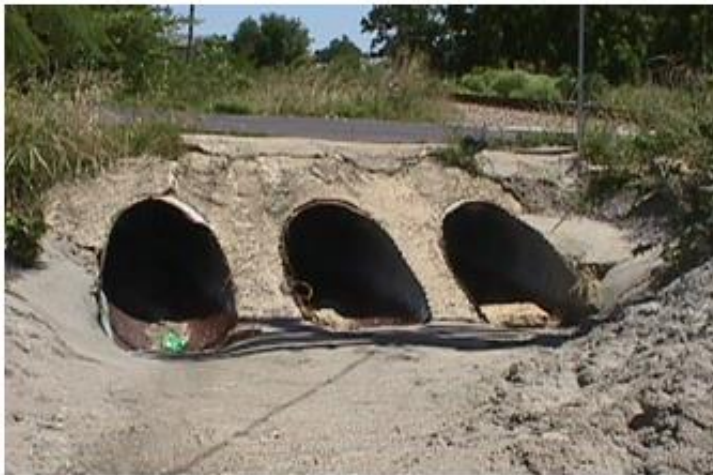
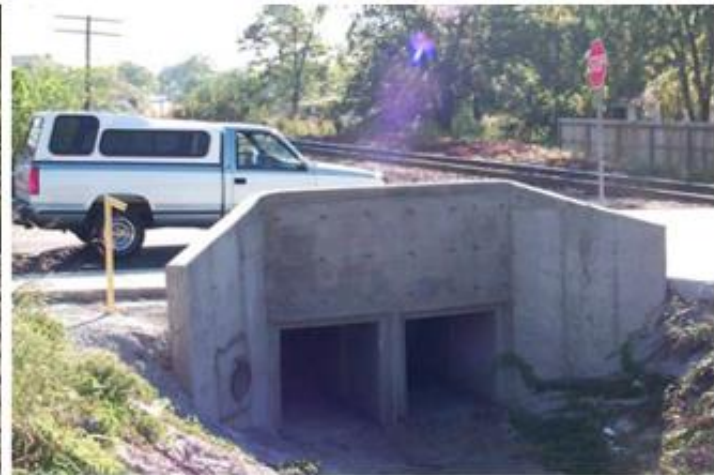
- It was built in 1999 on Walker Avenue in the City of Rolla, Missouri to replaced the old bridge (concrete with three encased steel pipes) which was unsafe to operate due to extensive corrosion of the steel pipes
- The new bridge is 10.97 m (36 ft.) wide consisting of 18 boxes of 1.5 by 1.5 m (4.92 by 4.92 ft.) and the thickness of 150 mm (5.90 in.)

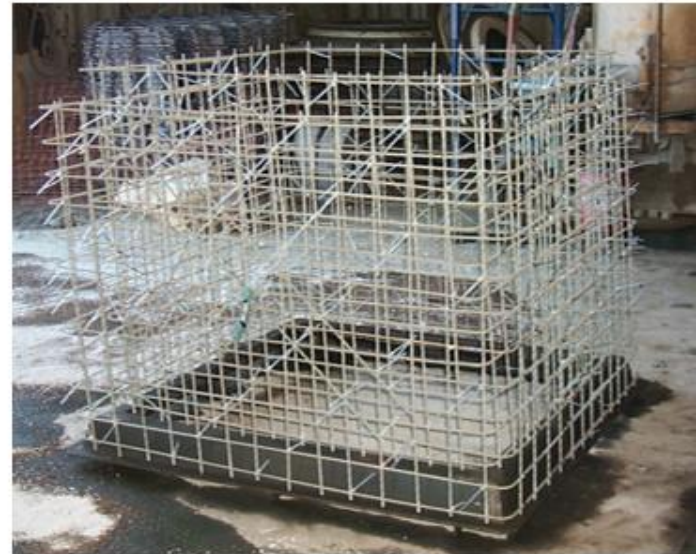
- The RC boxes were entirely reinforced with No. 2 GFRP bars (E-glass & Polyester) pre-bent and cut to size by the manufacturer
- The bridge operates under the following environmental conditions: thermal range of -6 to $+32$ °C (21 to 90 °F), wet and dry cycles, freeze-thaw cycles and exposure to de-icing salt

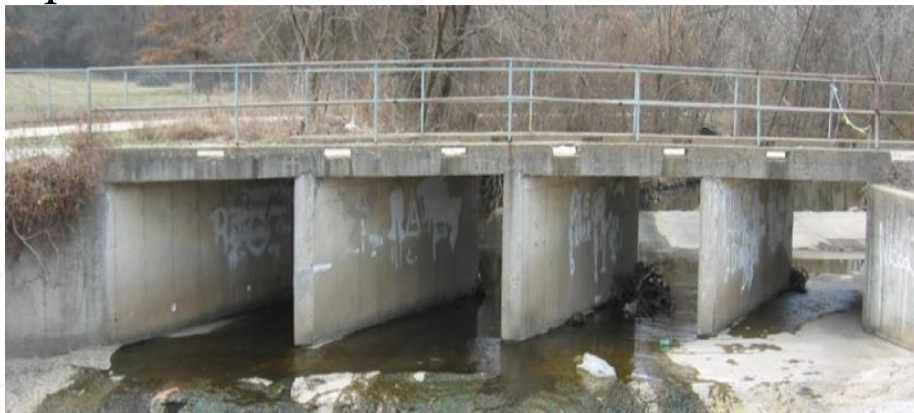
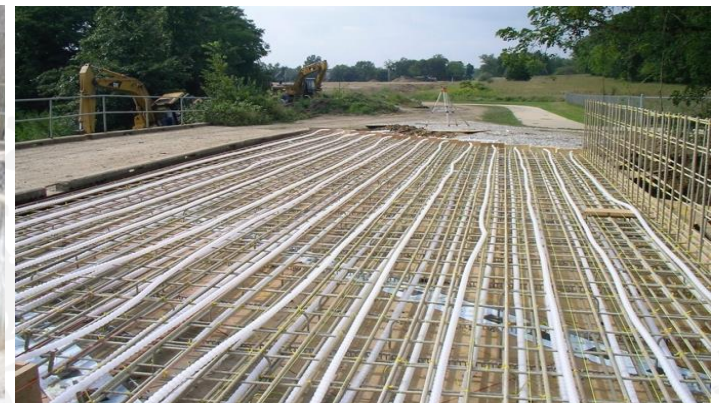
- Initially included four-cell steel reinforced concrete (RC) box-culverts
- The RC bridge slab went through an expansion in 2004 which included the construction of an additional lane and a sidewalk
- The new deck was built on three conventional RC walls as for the existing structure. The concrete deck of the complementary part implemented Nos. 3, 4 and 6 GFRP bars (E-glass & Vinyl ester) and No. 3 pre-stressed CFRP tendons

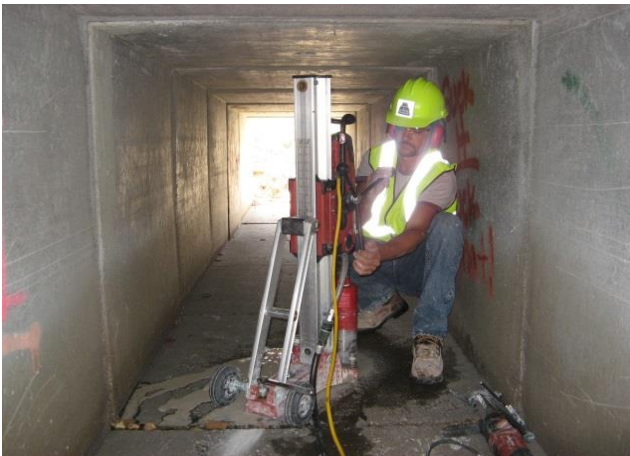
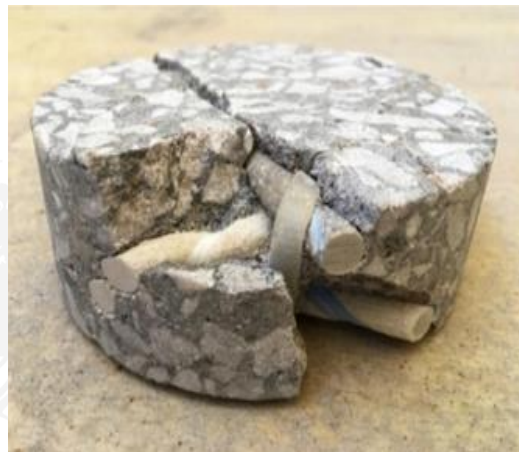
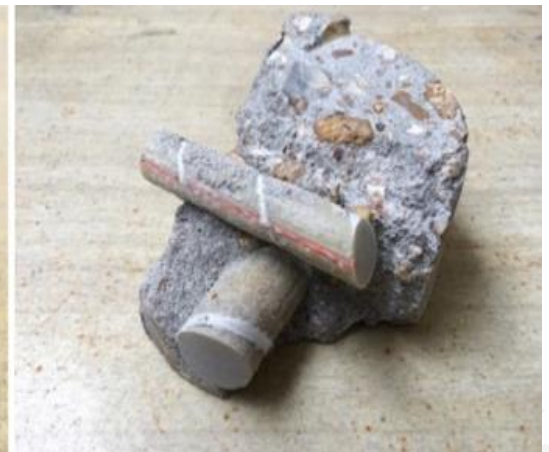
- Expert personnel performed the sample extraction in 2016 for further investigation.
- Samples were extracted from the bottom surface of two of the boxes of Walker and from the deck of the Southview bridge
- GFRP coupons were properly prepared and polished for microscopic examination and mechanical tests
