Evaluation & Assessment of Concrete Structures Prior to Rehabilitation

ACI Committee 364

David A. VanOcker, PE, FACI
CVM Professional

Fall 2019 Convention
Cincinnati, Ohio

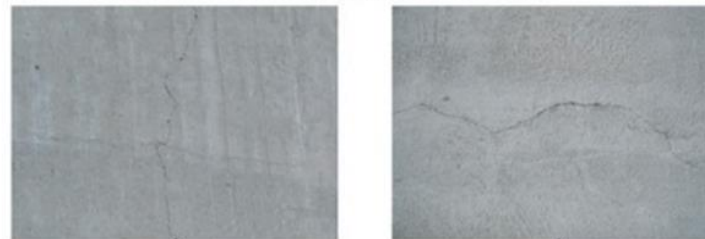
vertical and horizontal cracks along the silo wall

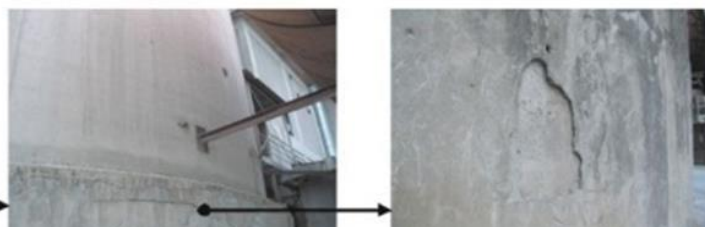
spalling of concrete cover at the silo bottom due to temperature actions from kiln

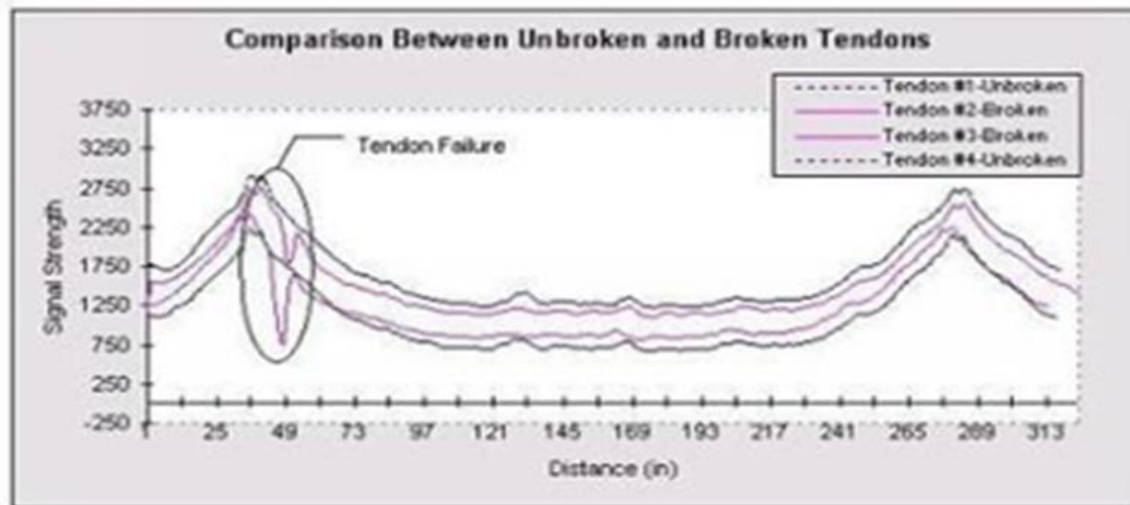
This graph indicates failures at two of the four tendons. The main peaks of the graph indicate concrete beams.
