Environmental conditions in concrete housing foundations walls incorporating reactive sulfide-bearing aggregates: Results from on-site monitoring over a year period

Rodolfo Castillo Araiza, PhD. Candidate
Benoît Fournier, PhD. – Supervisor
Josée Duchesne, PhD. – Co-supervisor
Pierre Luc Fecteau, MsC. – Research Professional

Fall 2023, Oct 29th to Nov 2nd – Boston, USA.

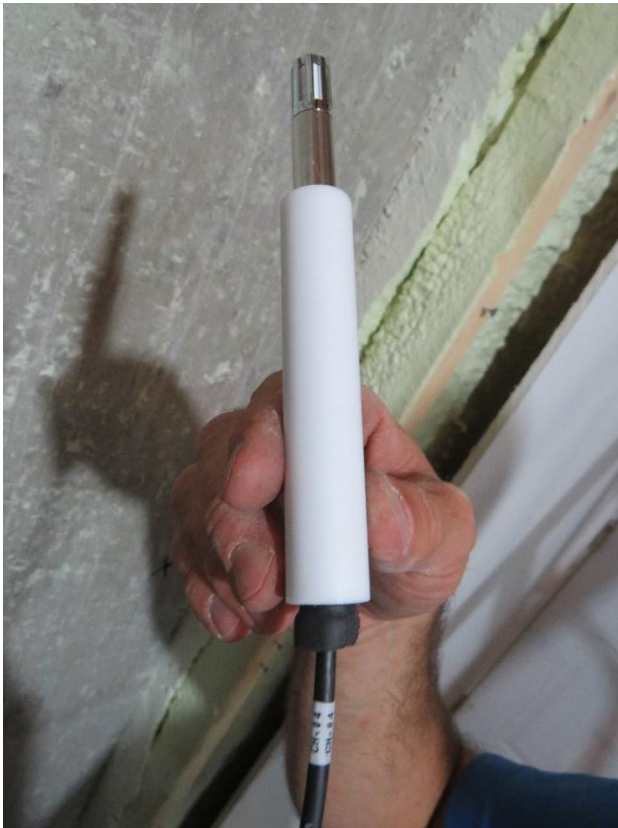
Temperature and Relative Humidity Sensor (Vaisala)

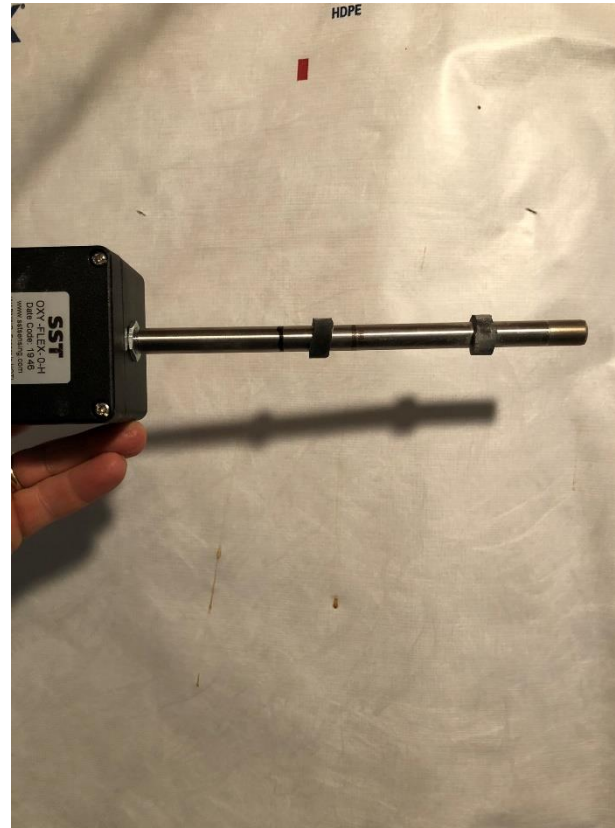
Oxygen Sensor (SST)

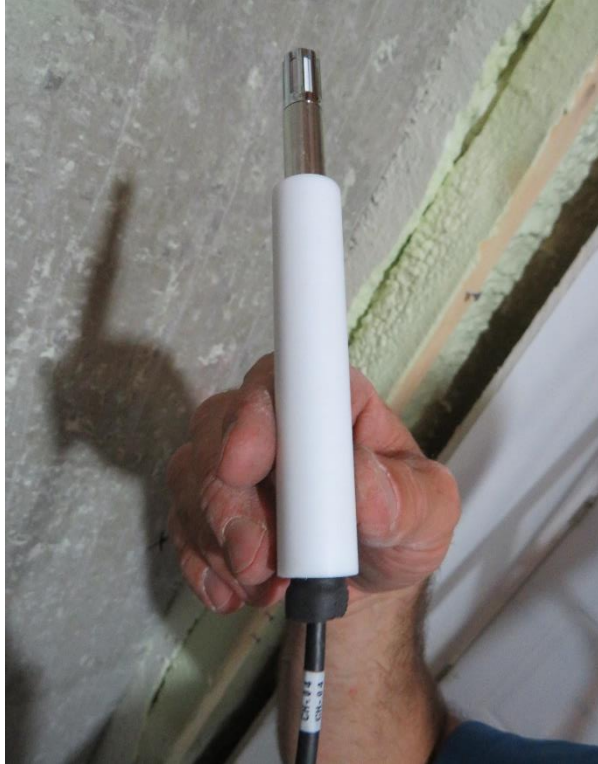
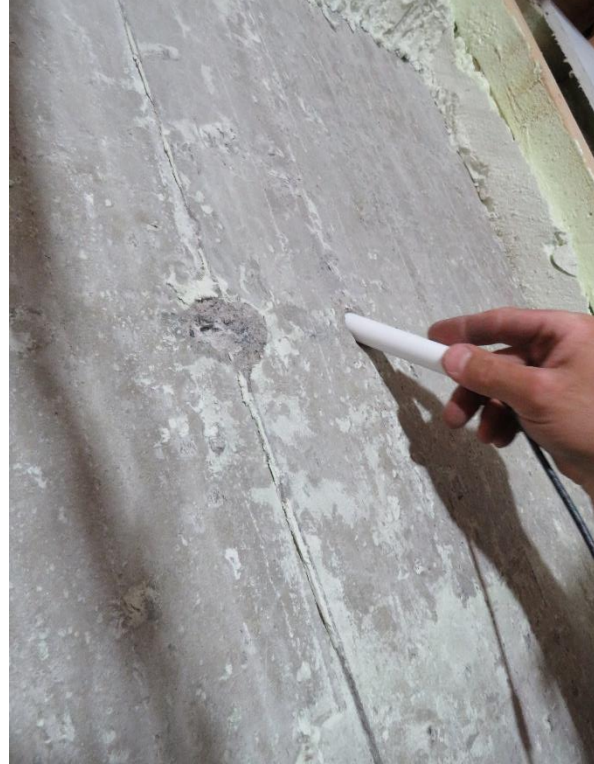
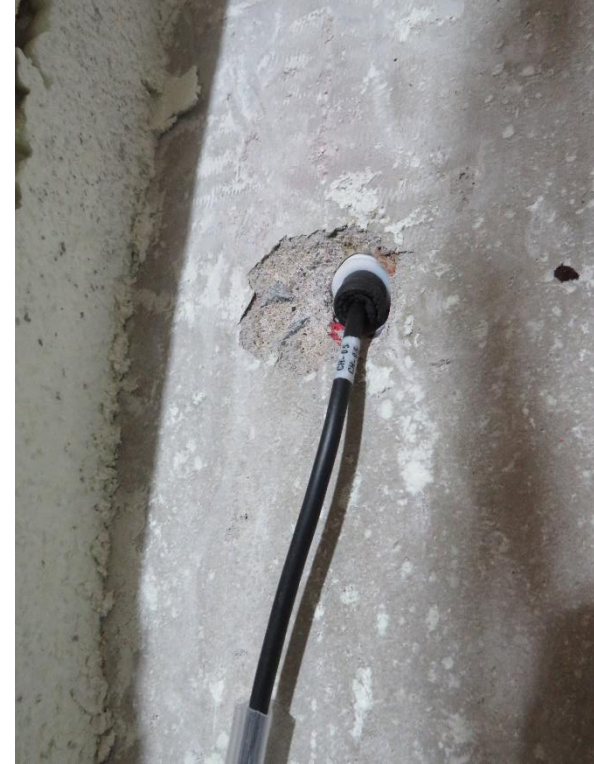
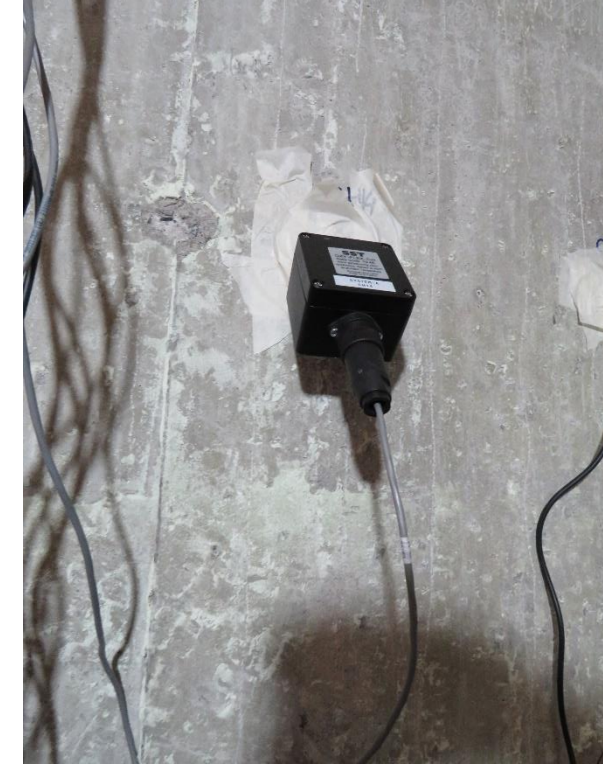
Sensors installation

- Drill 4 inches in depth (\approx center)
- PVC tube.

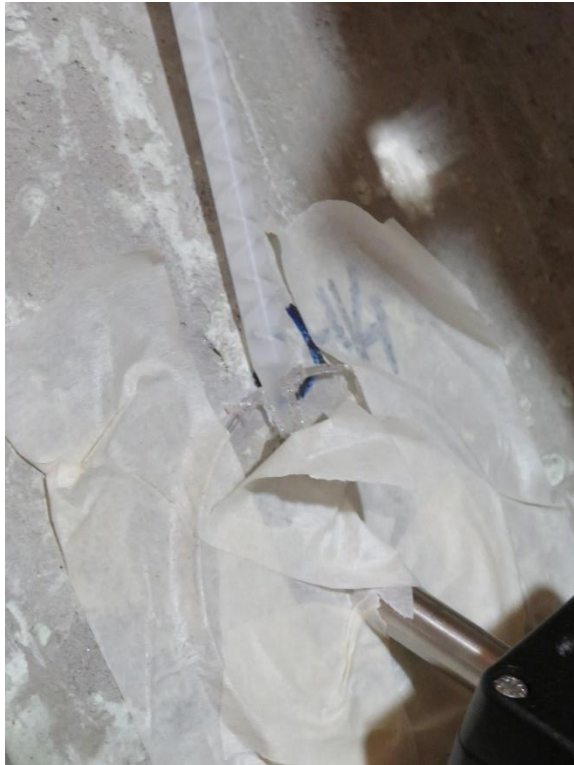
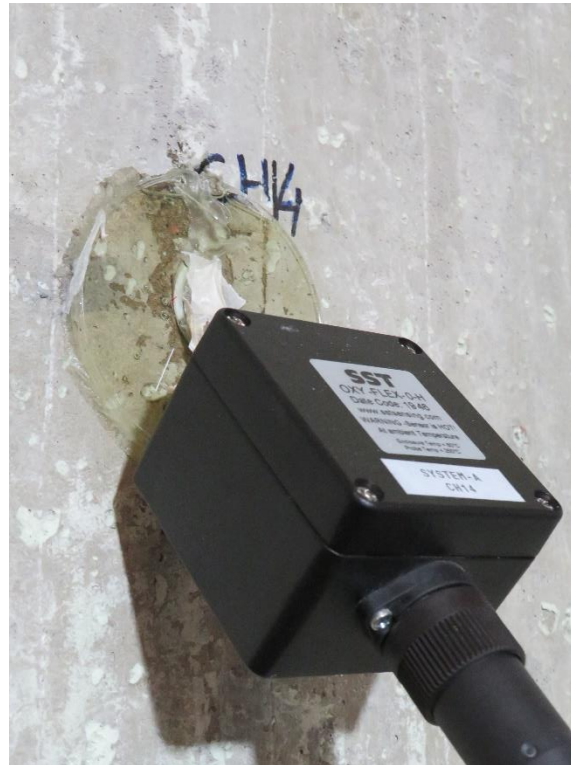
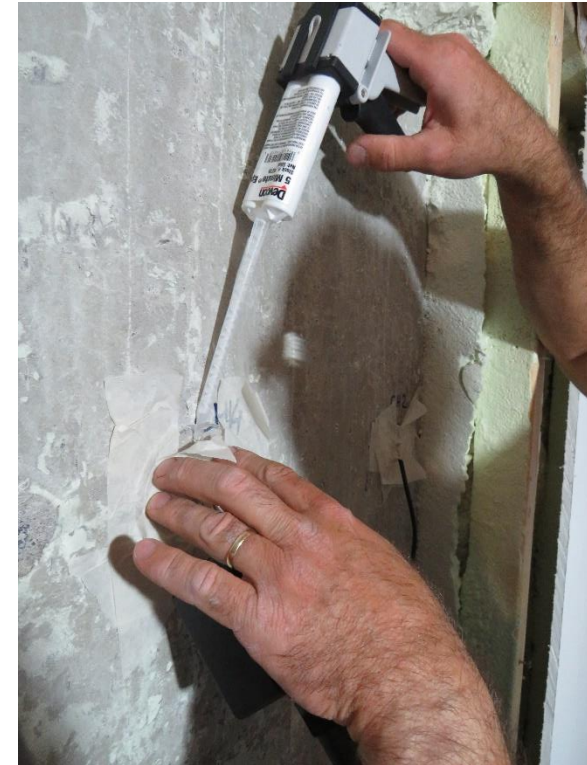
- Round plastic cover
- Fast-drying epoxy (~ 5 min)

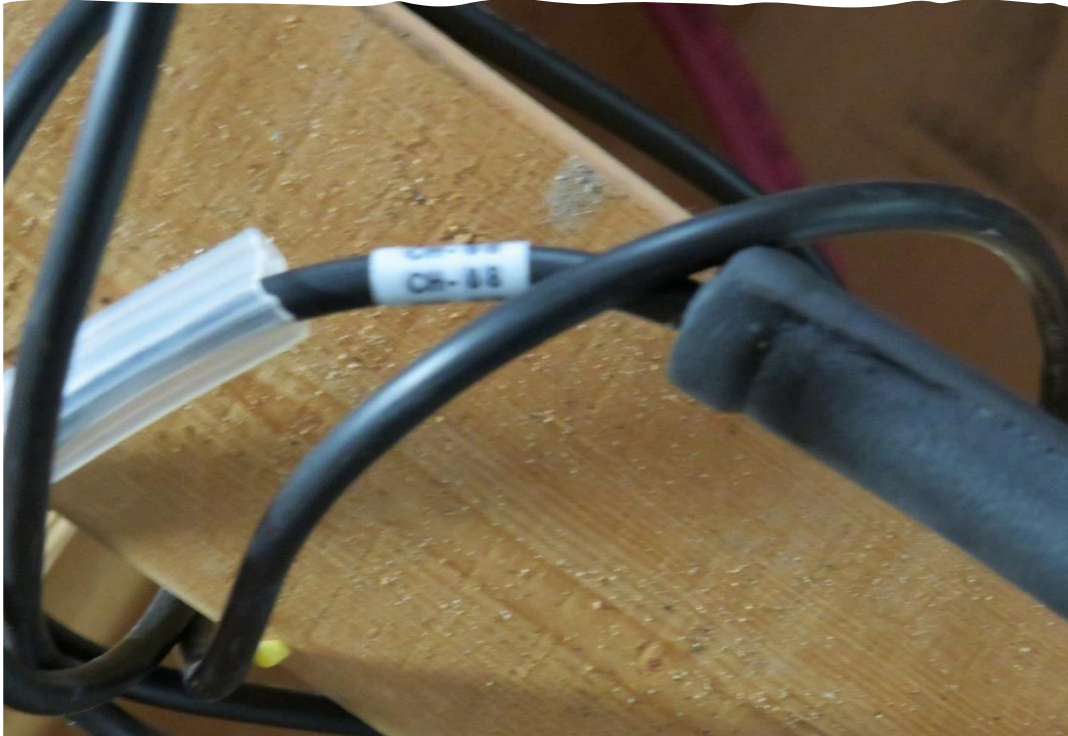
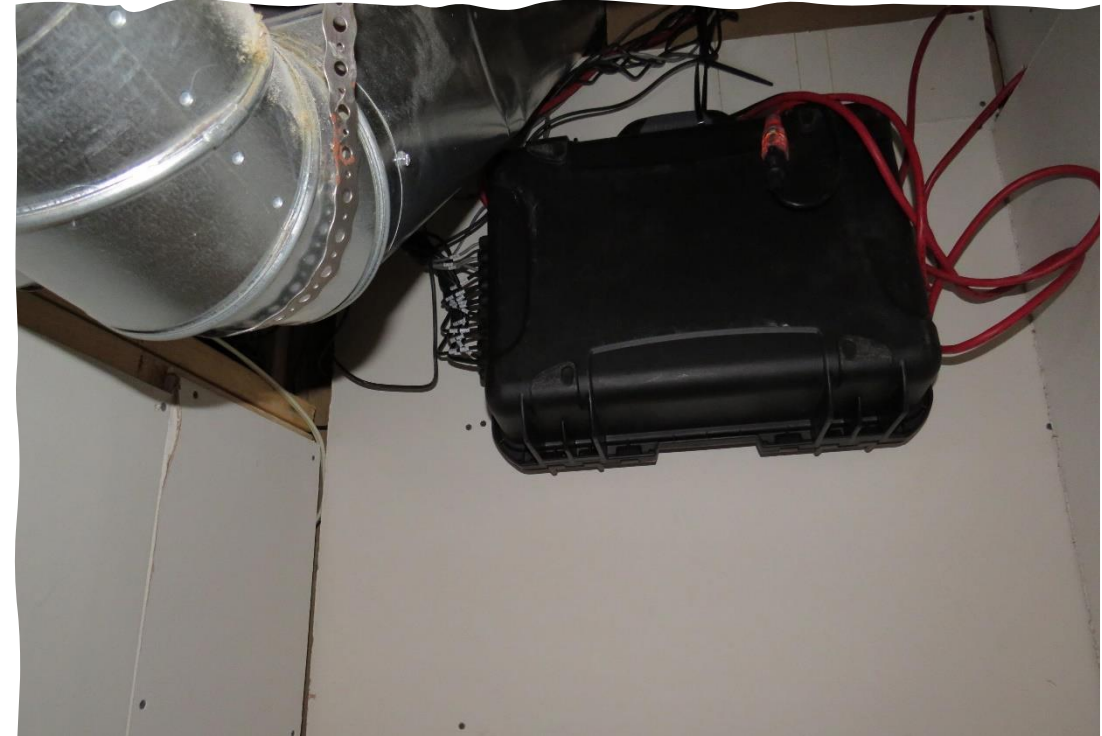
- Identification of sensor.
- Acquisition boxes system.

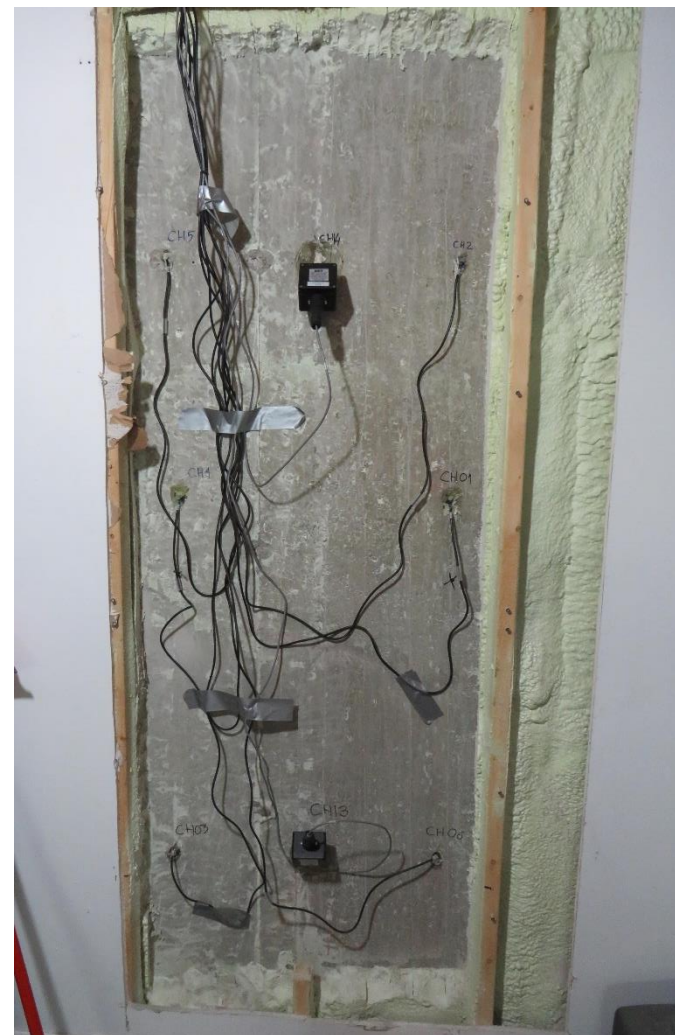
In this wall:

- Exposed to housing **heating system** (Electric forced air heating system with air ducts in every room).
- Wood stove on 1st level (rarely used).
- Air conditioning in the summer (central air ducts).
- Basement 80% finished; one wall in the unfinished section.

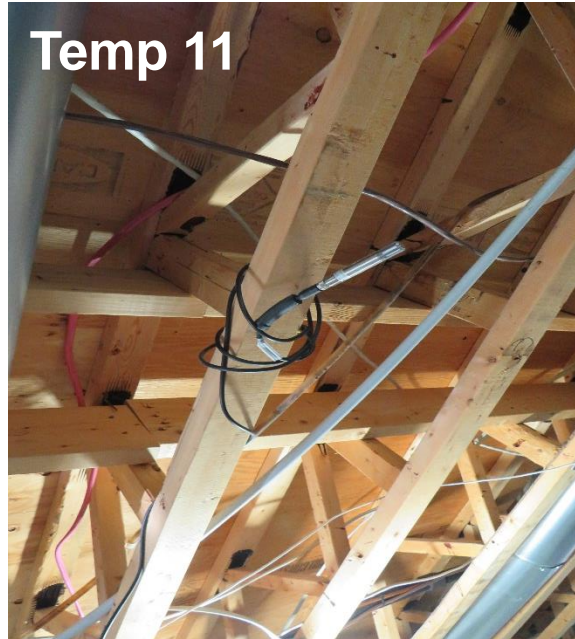
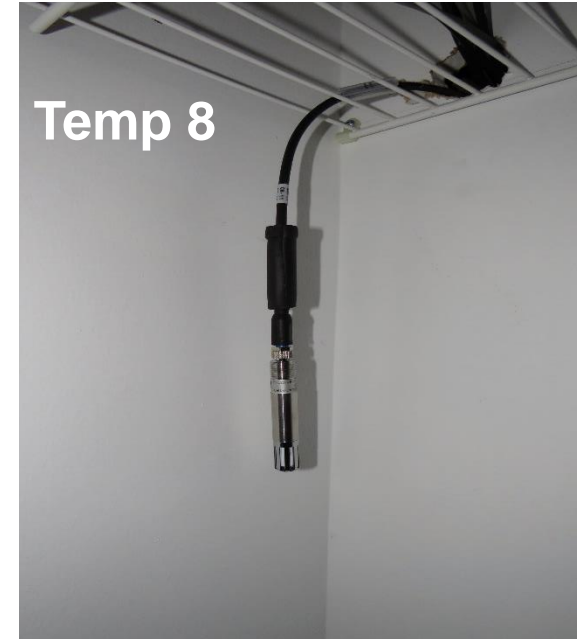
- Both sensors in the basement :
 - Closet near the northwest wall (Temp 11)
 - Roof of the room near the southeast wall (Temp 8)

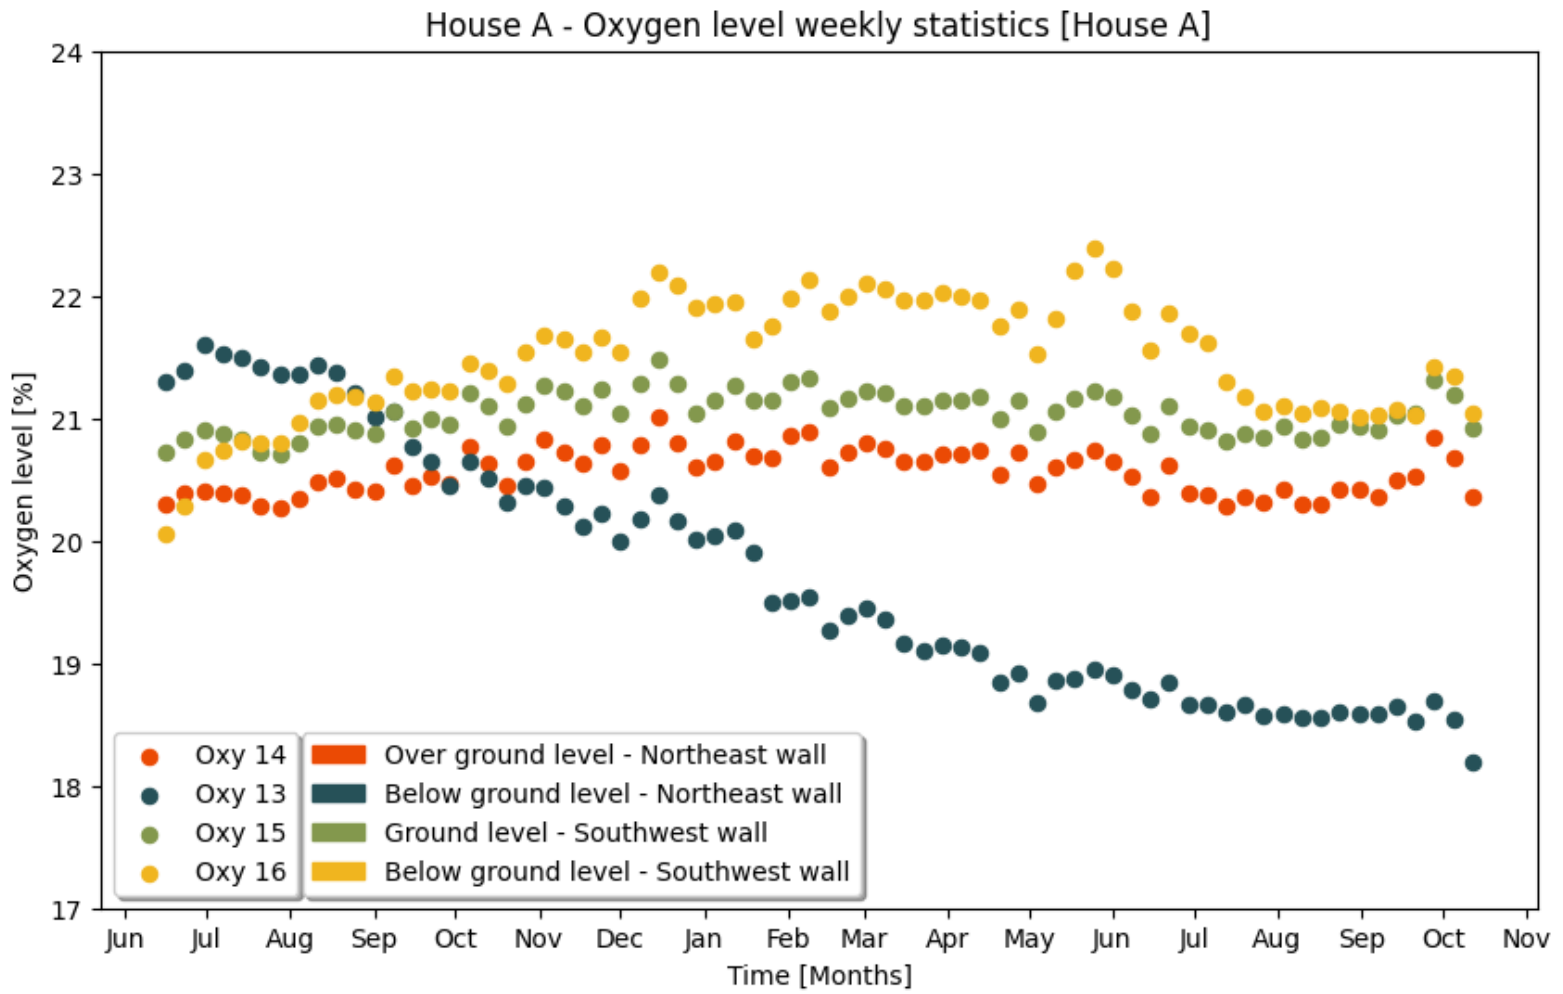
House A – Oxygen Level (%) [per week]

- In terms of **temperature**:
 - Inside slightly affected
 - Outside clearly affected.
- **Relative humidity** is strongly affected in both.
- Soils protection (keep high R.H.); however, above ground level, can reach 65% at 4 inches (100 mm) depth in concrete.
- O₂ sensor **Oxy 13** → the only one (all monitored homes) with decreasing trend over time (around 3%).

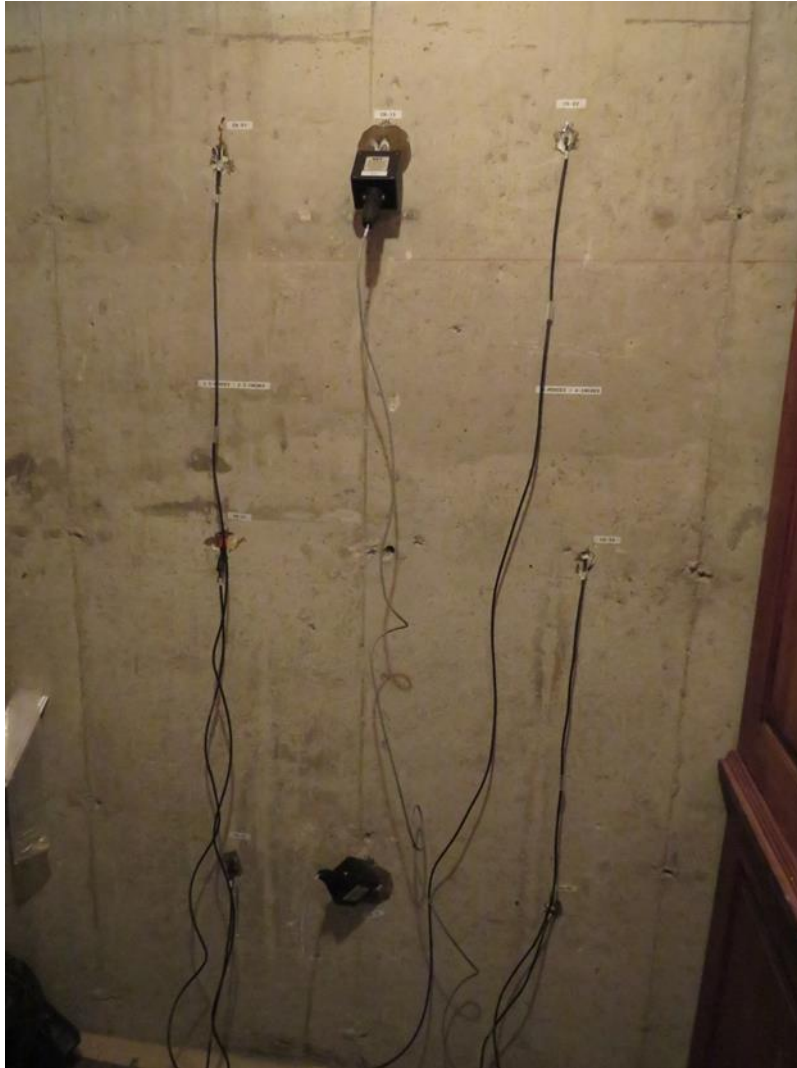
- Measurements of temperature ($^{\circ}\text{C}$), RH (%) and oxygen (%) \rightarrow every hour (52 weeks).
- Sensors \rightarrow inner and outer walls (Northeast direction).
 - 3 temperature and RH sensors installed 2.5 inches (≈ 64 mm) in depth
 - 3 sensors at 4 inches depth (≈ 100 mm) (same angle as house A)

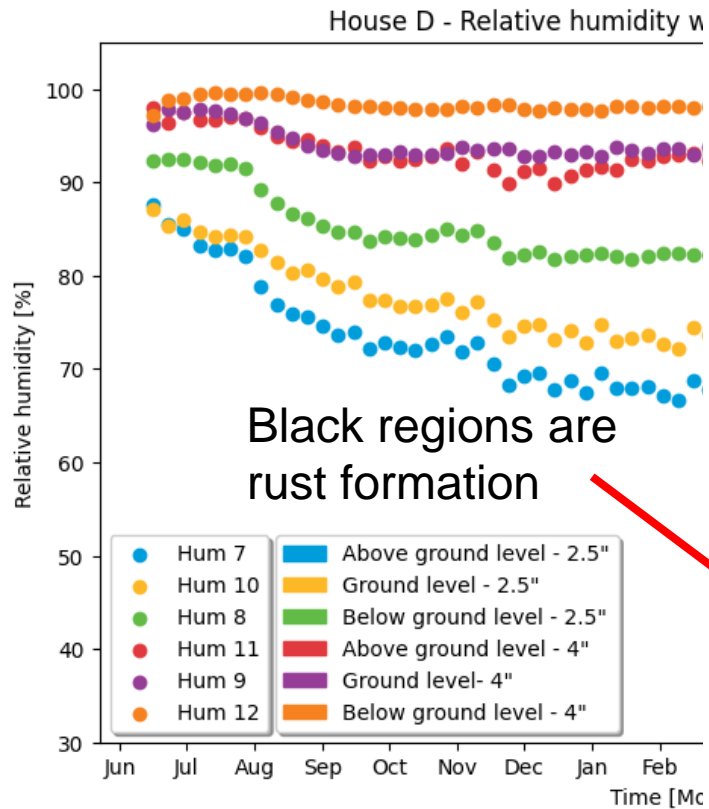
Effect of the heating system

±10-15 %
