Structural Design, Analysis, and Full-Scale Testing of Ultra-High Performance Concrete Girders

Amreen Fatima, Hyeonki Hong, Tevfik Terzioglu,
Mary Beth Hueste, John Mander,
Stefan Hurlebaus, Anol Mukhopadhyay

Sponsored by Texas Department of Transportation (Project 0-6982)

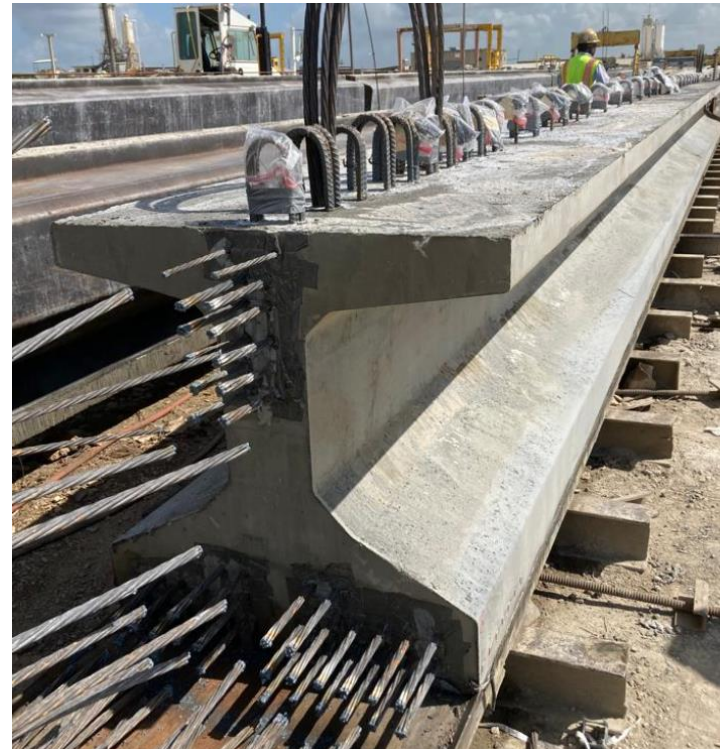
Tx34-2 Girder after release of strands

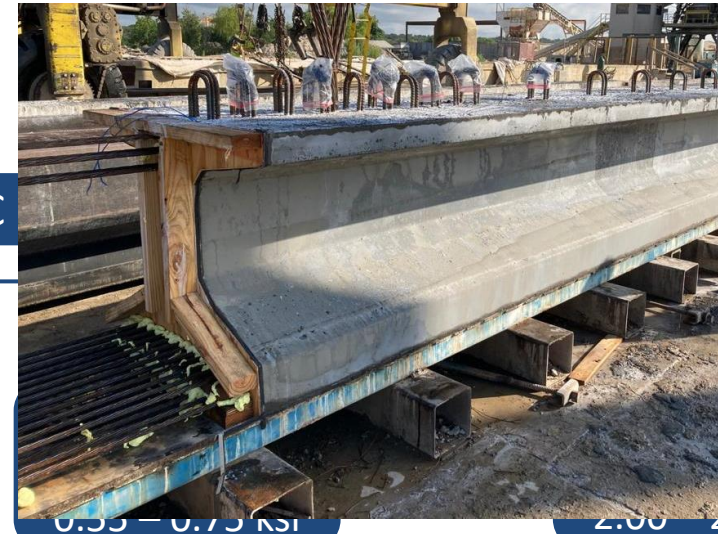
Tx34-1 before transfer at precast plant

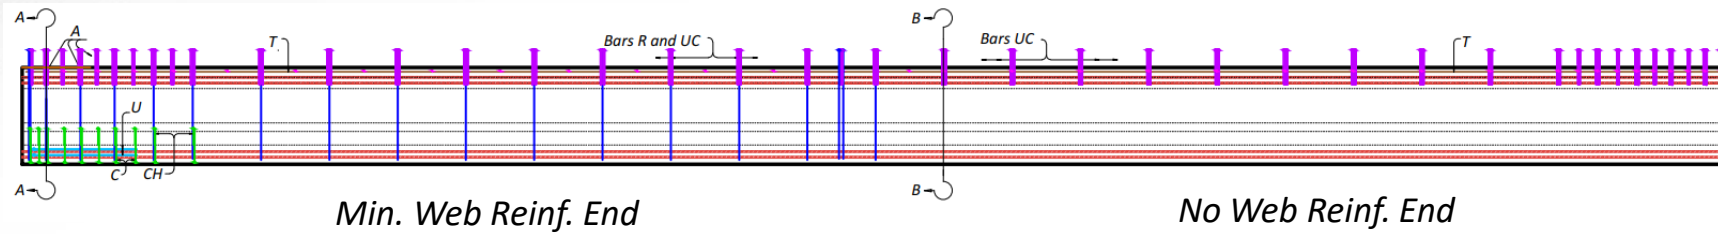
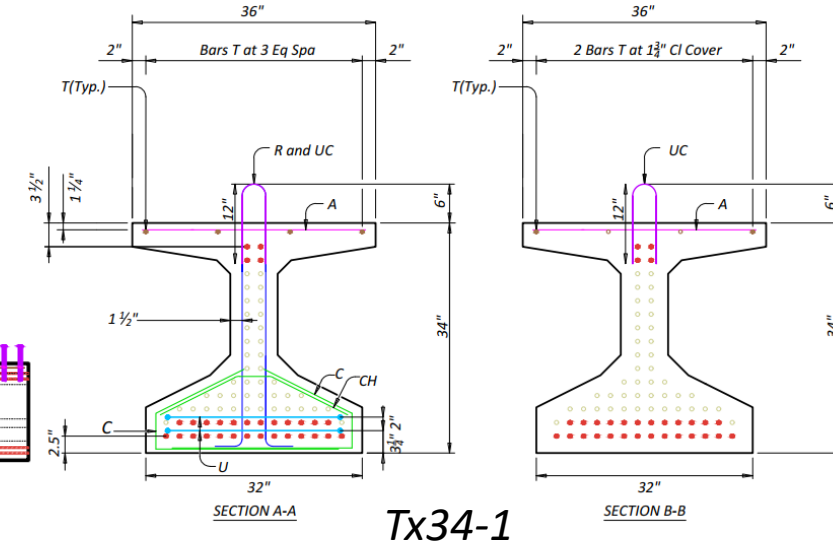
Parameter	Tx34-1
Prototype Span Length	77 ft
Specimen Length	48.5 ft
No. of Strands	30 total (all straight)

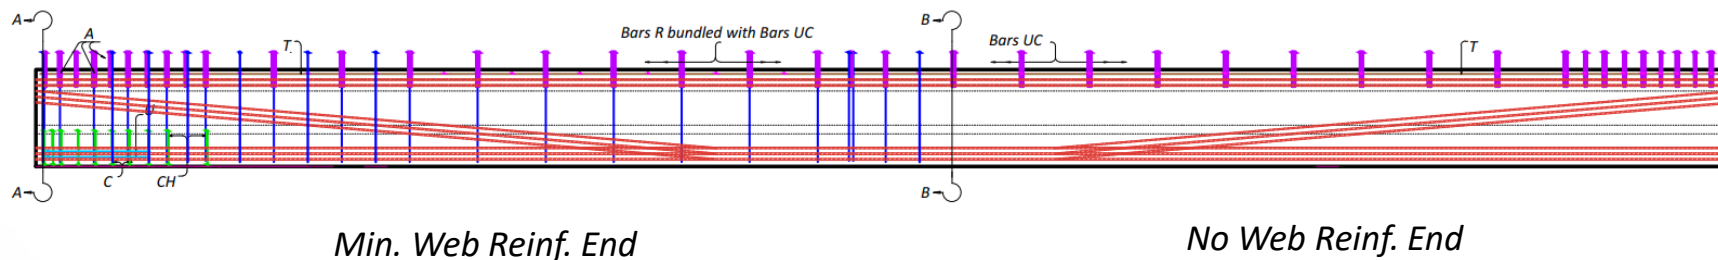
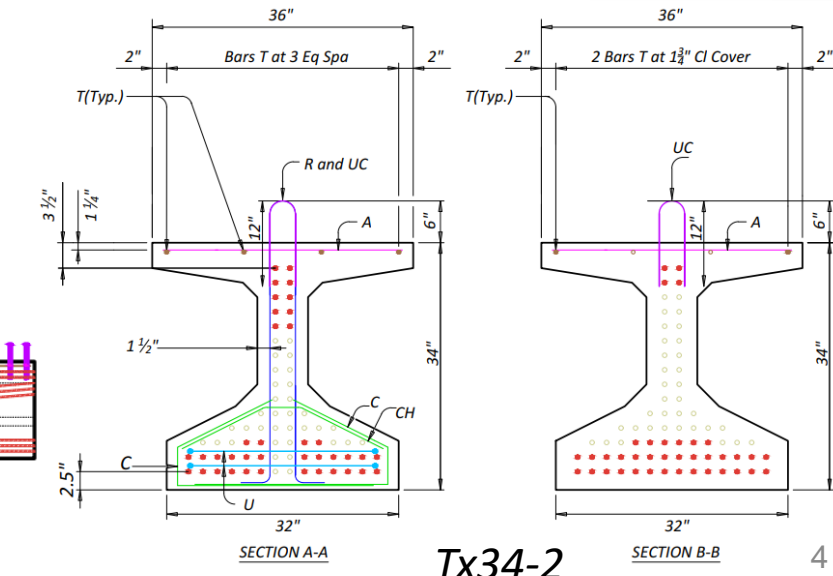
Bars R = #4, Bars UC = #5, at 24 in. spacing at midspan and 12 in. spacing at ends (closer spacing of 3 in. for bursting resistance)

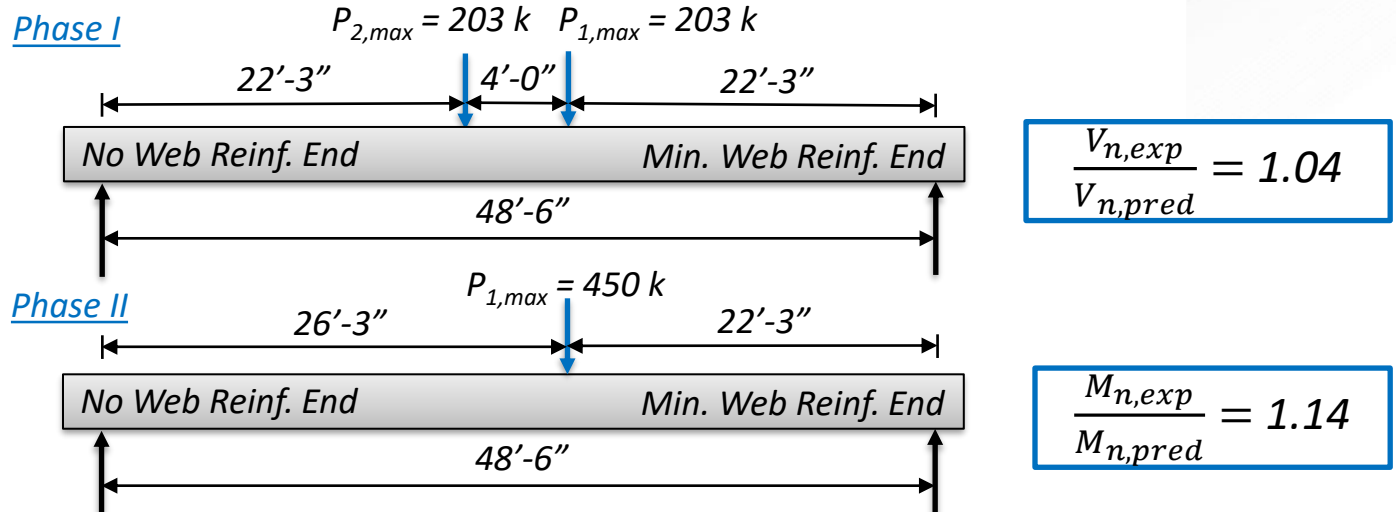
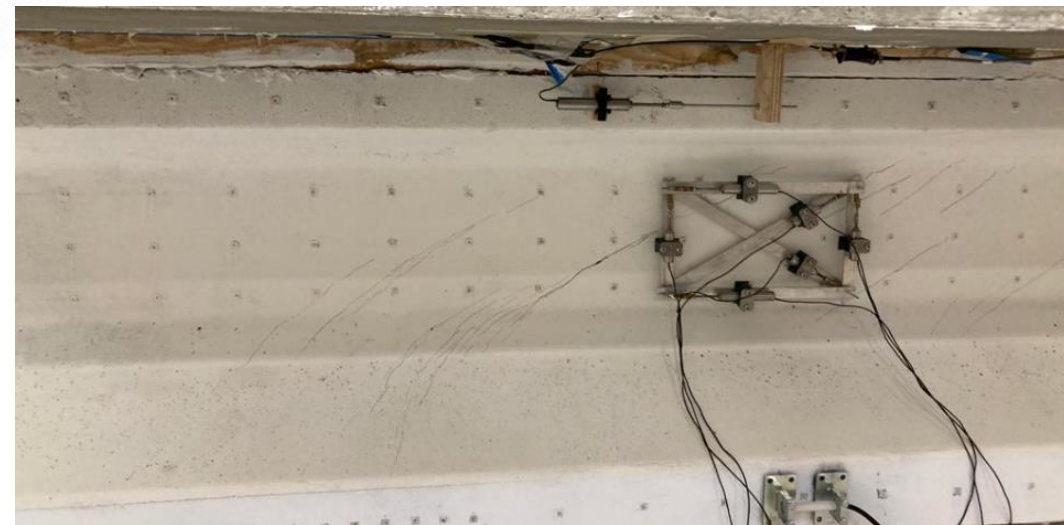
Tx34-1 Flexure Test Results

*Shear Cracks at end without transverse reinforcement
(end of Phase 1 testing)*

Tx34-1 end without shear reinforcement was critical zone for shear failure during flexure test.

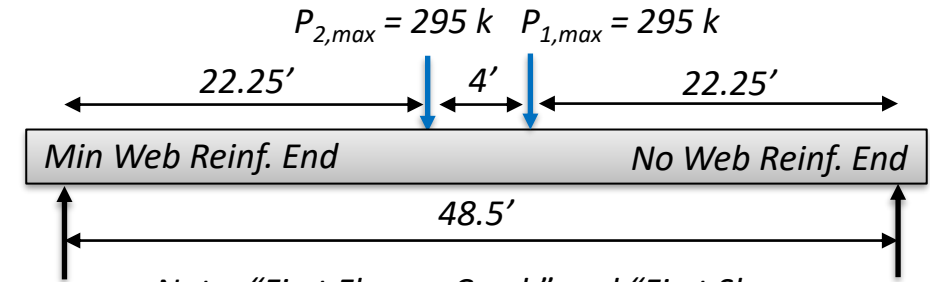
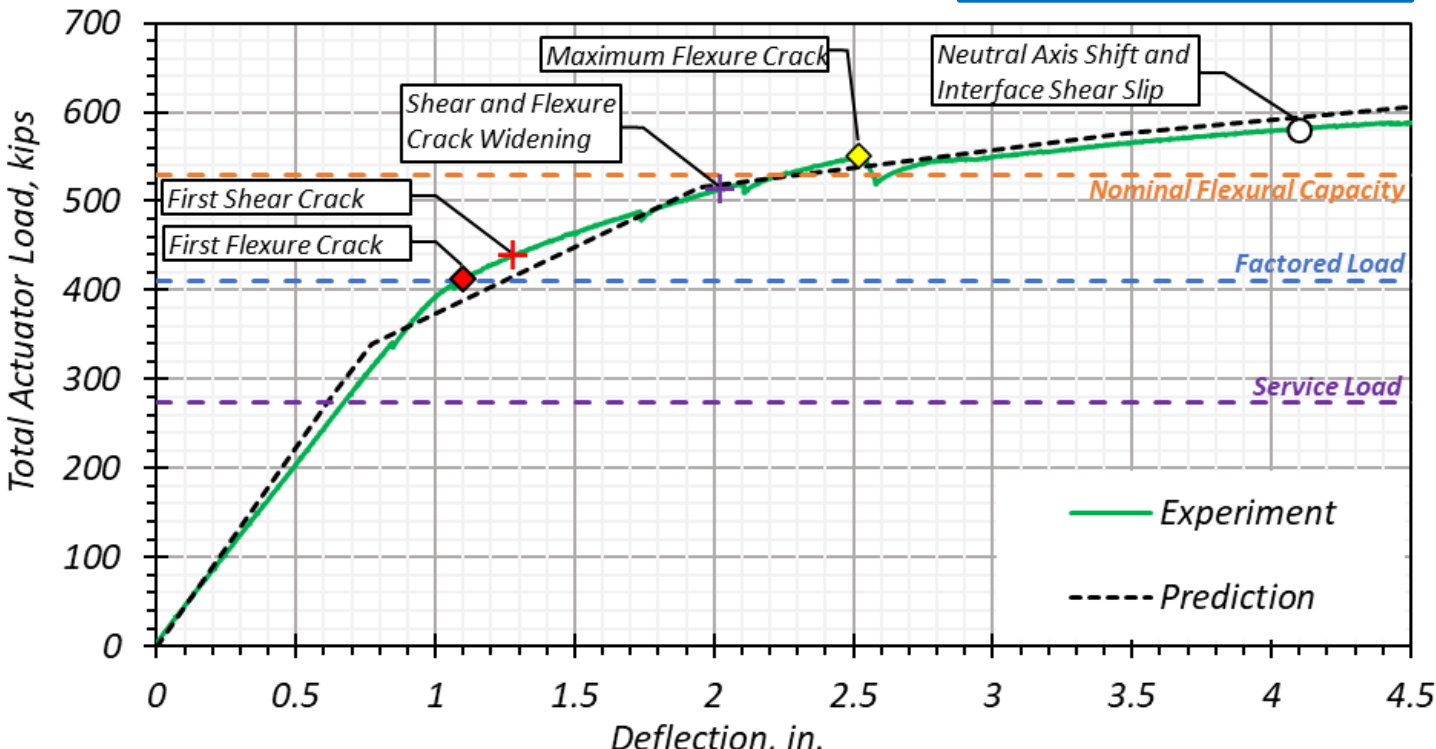
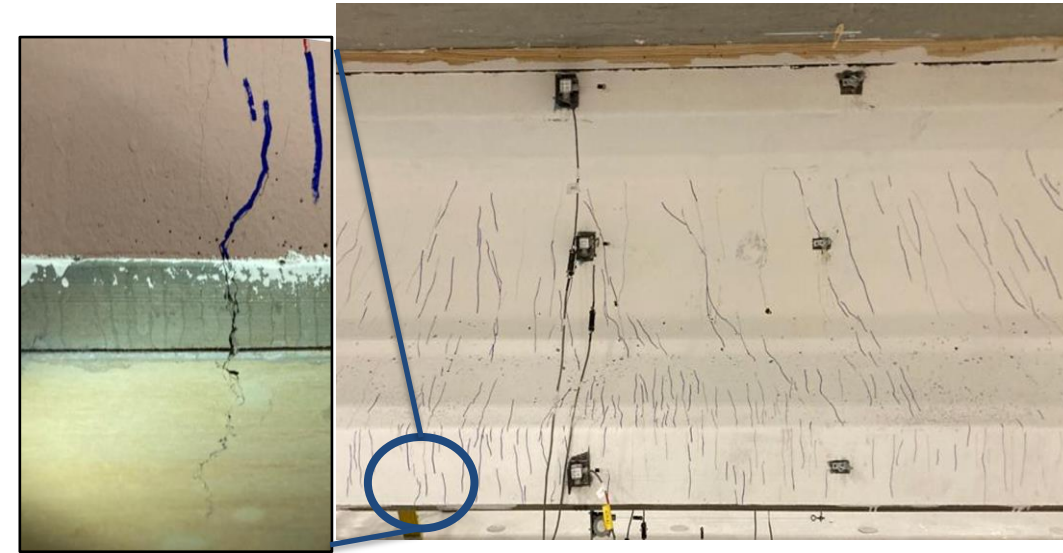
Tx34-2 Flexure Test Results

- Flexure crack occurred at 413 kips (total actuator load)
- Shear crack developed at the ends at 440 kips
- Flexure and shear crack formation increased at 513 kips
- Potentially some interface shear slip between deck and girder at 550 kips and 580 kips after which steel engages.

Note: "First Flexure Crack" and "First Shear Crack" are based on change in strain

$$\frac{M_{n,exp}}{M_{n,pred}} = 1.08$$

Flexure Cracks Tx34-2

- At service load: cracks were not visible
 - At factored load: hairline cracks were observed
 - At failure, max crack width: 4 mm
 - Near the max load, Tx34-2 exhibited initial slip at interface of CIP concrete deck slab and UHPC girder

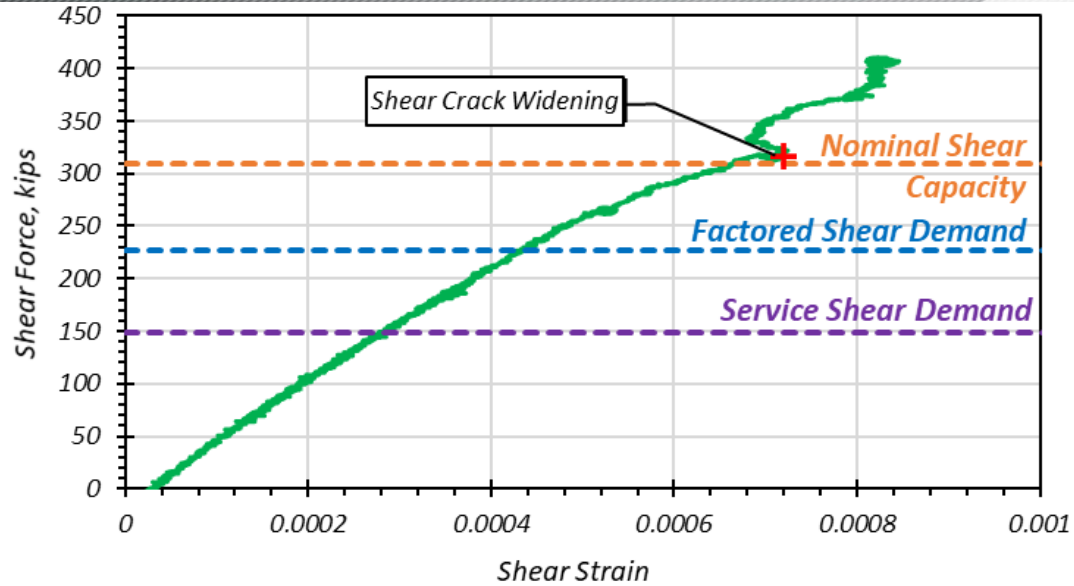
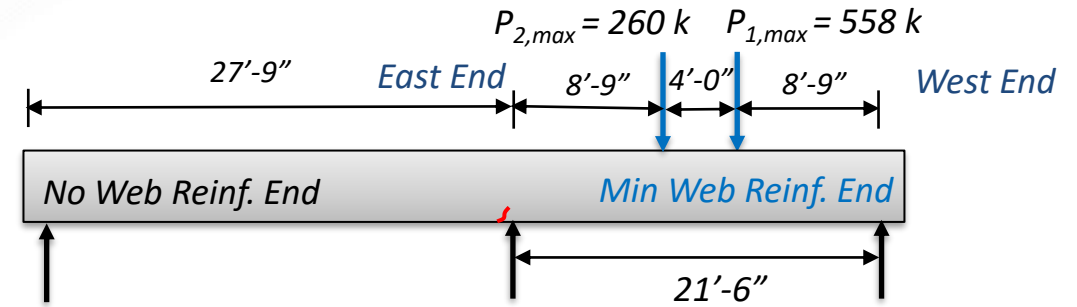
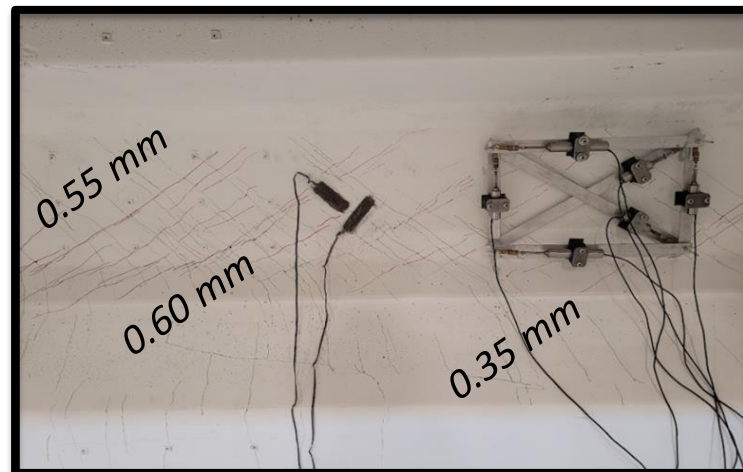
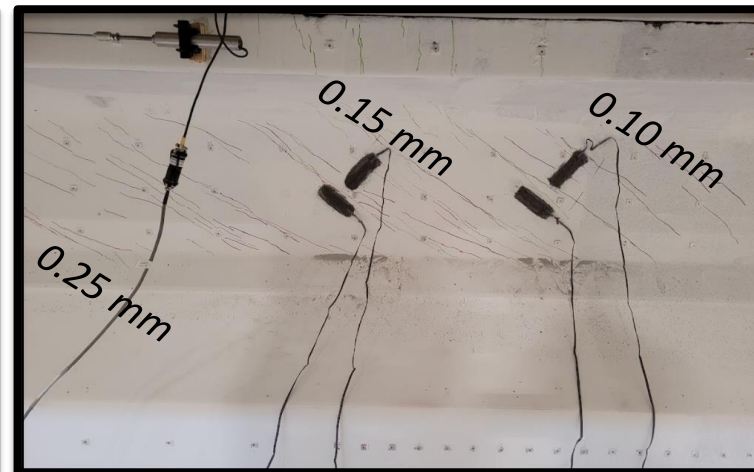
Tx34-1 Min. Web Reinforcement End Shear Test Results

$$\frac{V_{n,exp}}{V_{n,pred}} = 1.02$$

$$\text{Shear span/depth ratio} = 2.36$$

Note: Uniaxial Tensile Strength = 0.55 ksi

Shear Force vs Shear Strain at Shear Cracks (5'-0" from West End)

East End (min. web reinf. end)

West End (min. web reinf. end)

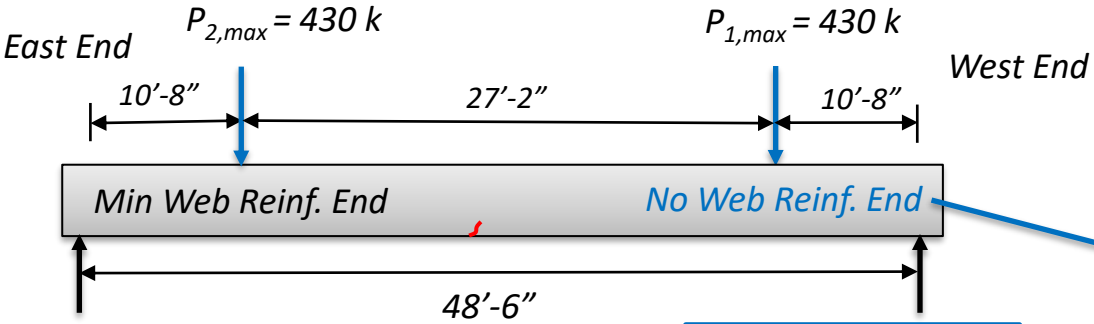
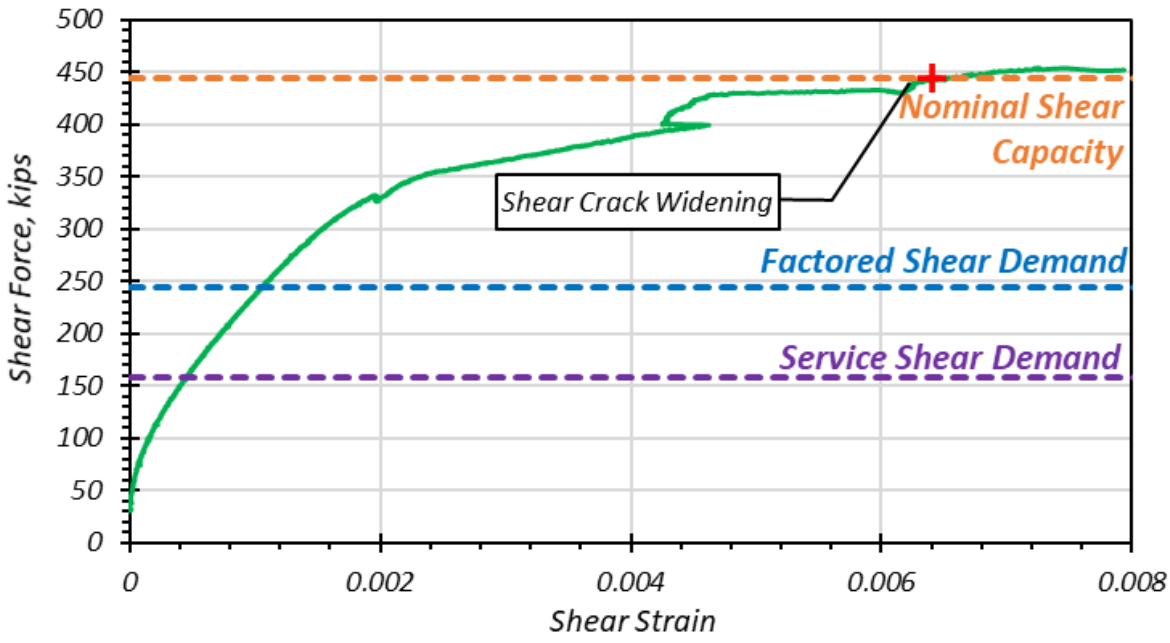
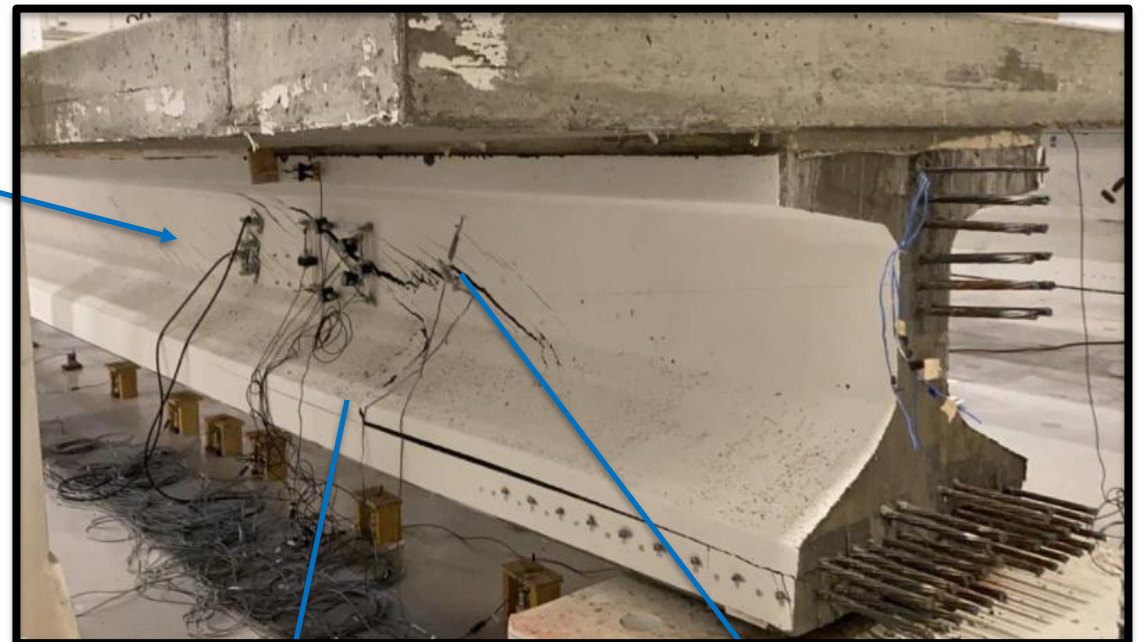
Tx34-2: No Web Reinf. End Shear Test Results

Shear span/depth ratio = 2.88

$$\frac{V_{n,exp}}{V_{n,pred}} = 1.02$$

Note: Uniaxial Tensile Strength = 0.63 ksi

Shear Force vs Shear Strain at Shear Cracks (at 5'-0" from West End)

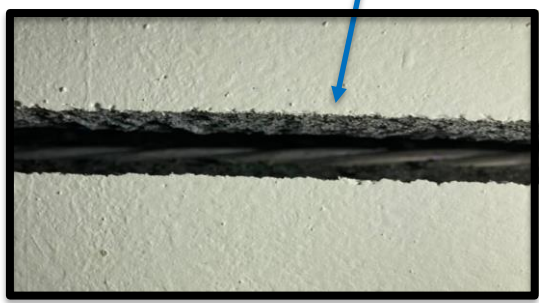
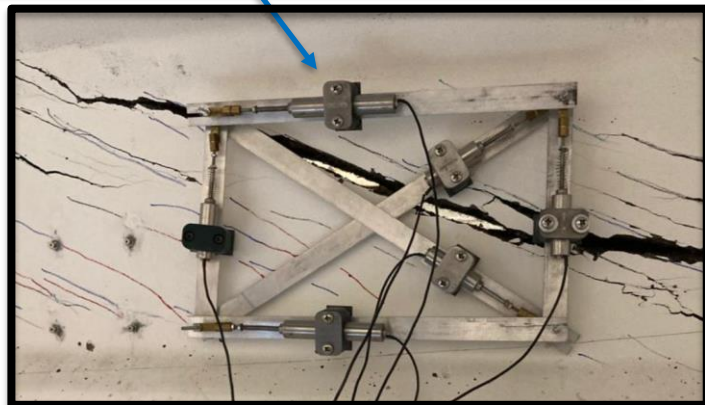
Shear crack and exposed prestressing strand

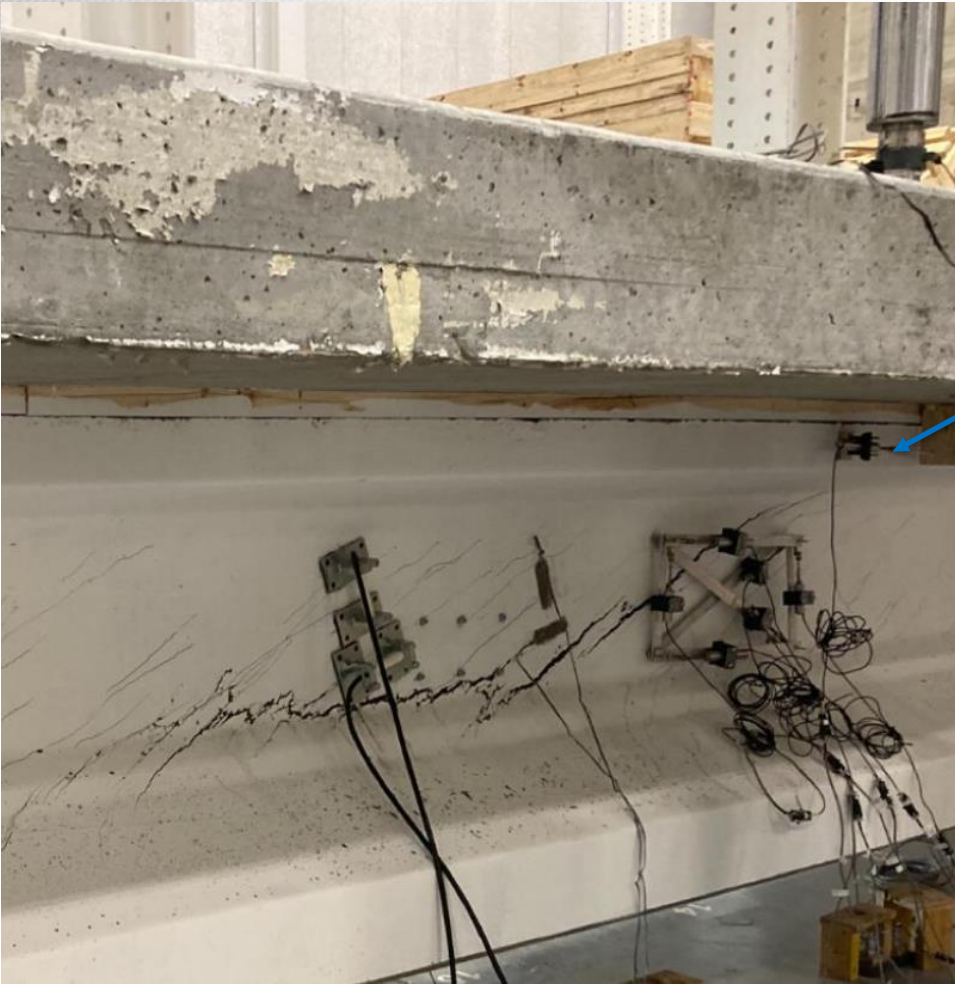
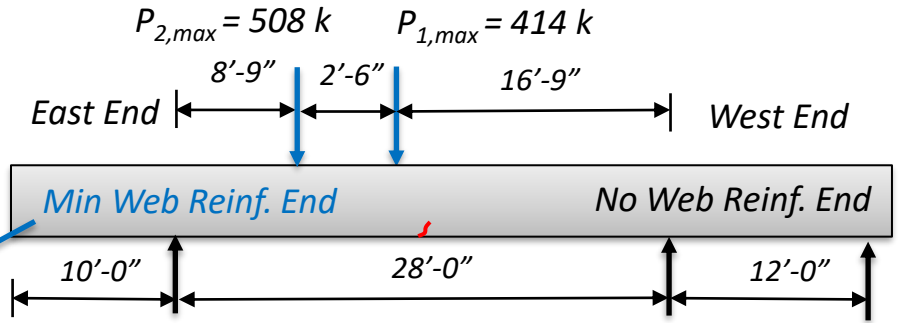
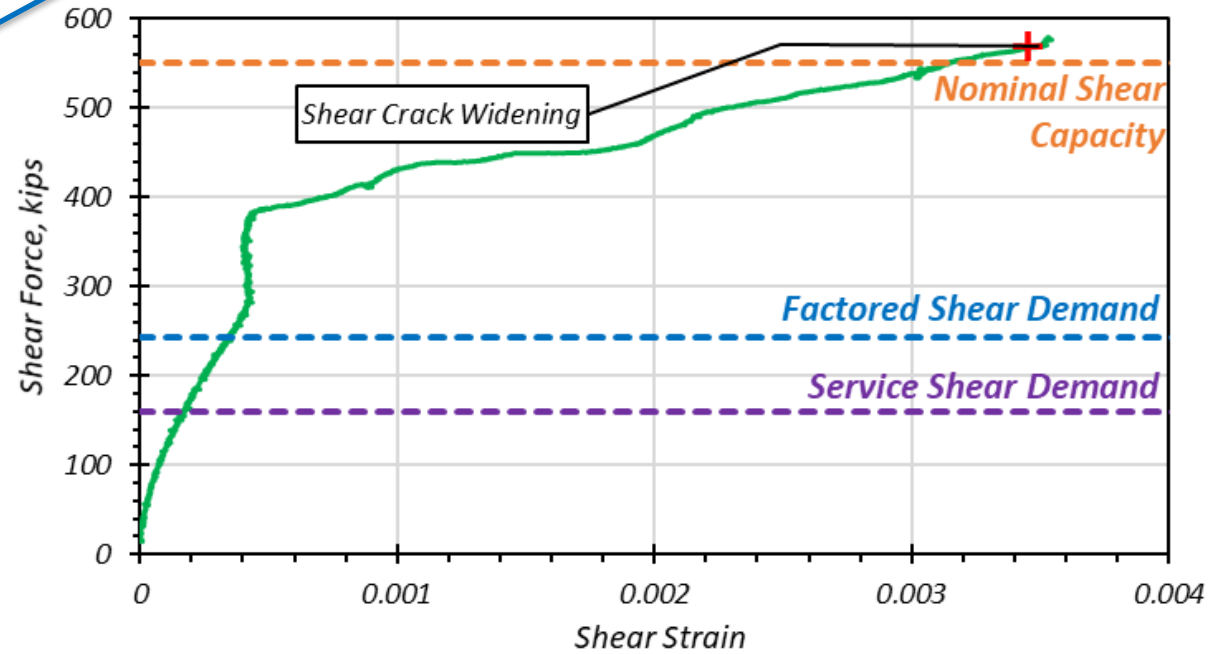
Tx34-2 Min Web Reinf. End Shear Test Results

Shear span/depth ratio = 2.36

Note: Uniaxial Tensile Strength = 0.63 ksi

$$\frac{V_{n,exp}}{V_{n,pred}} = 1.04$$

Shear Crack Tx34-2 at Minimum Web Reinf. End

Shear Force vs Shear Strain at Shear Cracks (4'-6" from East Support)

- At factored load: hairline cracks were observed
 - At failure load, maximum crack widths: 0.6 mm (Tx34-1) and 8 mm (Tx34-2)
 - Tx34-2: harped tendon profile and increased UHPC tensile strength improved shear capacity.
