# **Evaluation & Minimization of Bruising (*Microcracking*) in Concrete Repair (364. 7T)**

**Rehabilitation Tech Notes**

**Michael Sprinkel, P.E.**

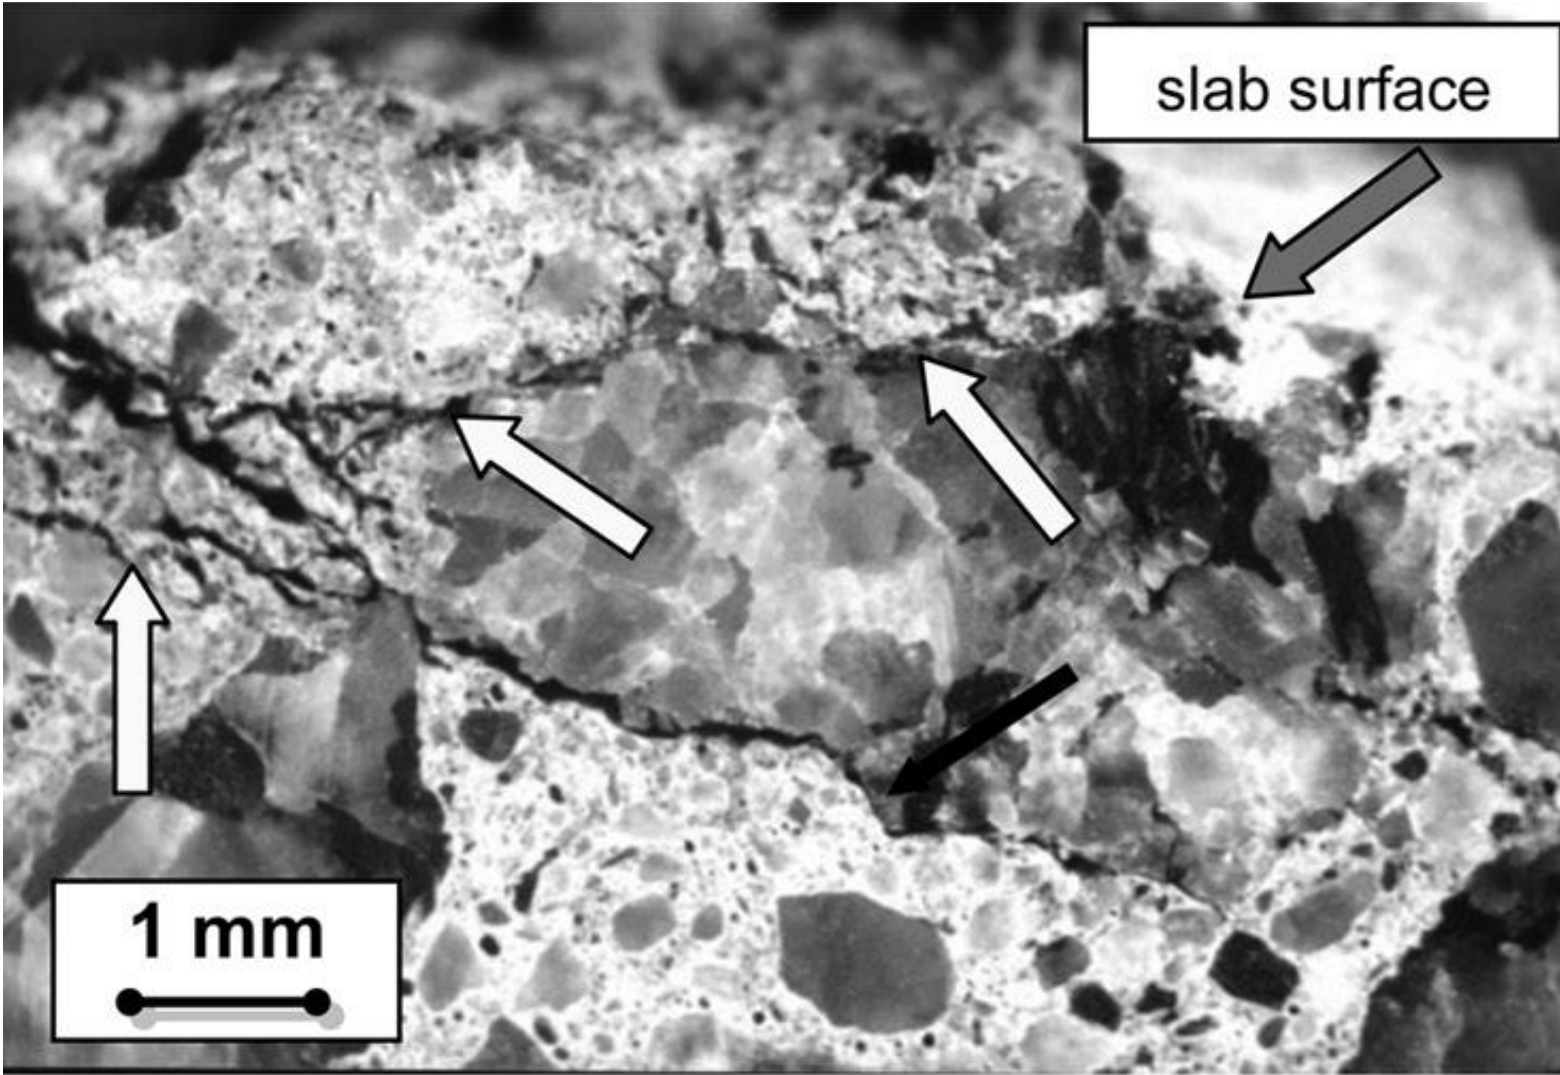
Fig 1a, Slab Prepared with 30-lb Breaker (6)

Figures 1 and 2 show optical microscope images of concrete core cross sections exhibiting bruising below the surface.

Microscopic examination can further be used to assess remedial actions taken to eliminate bruising of the concrete. To identify bruising, a polished surface needs to be magnified 20 to 100 times, depending on the width of the cracks (Fig. 1 and 2 shown earlier).

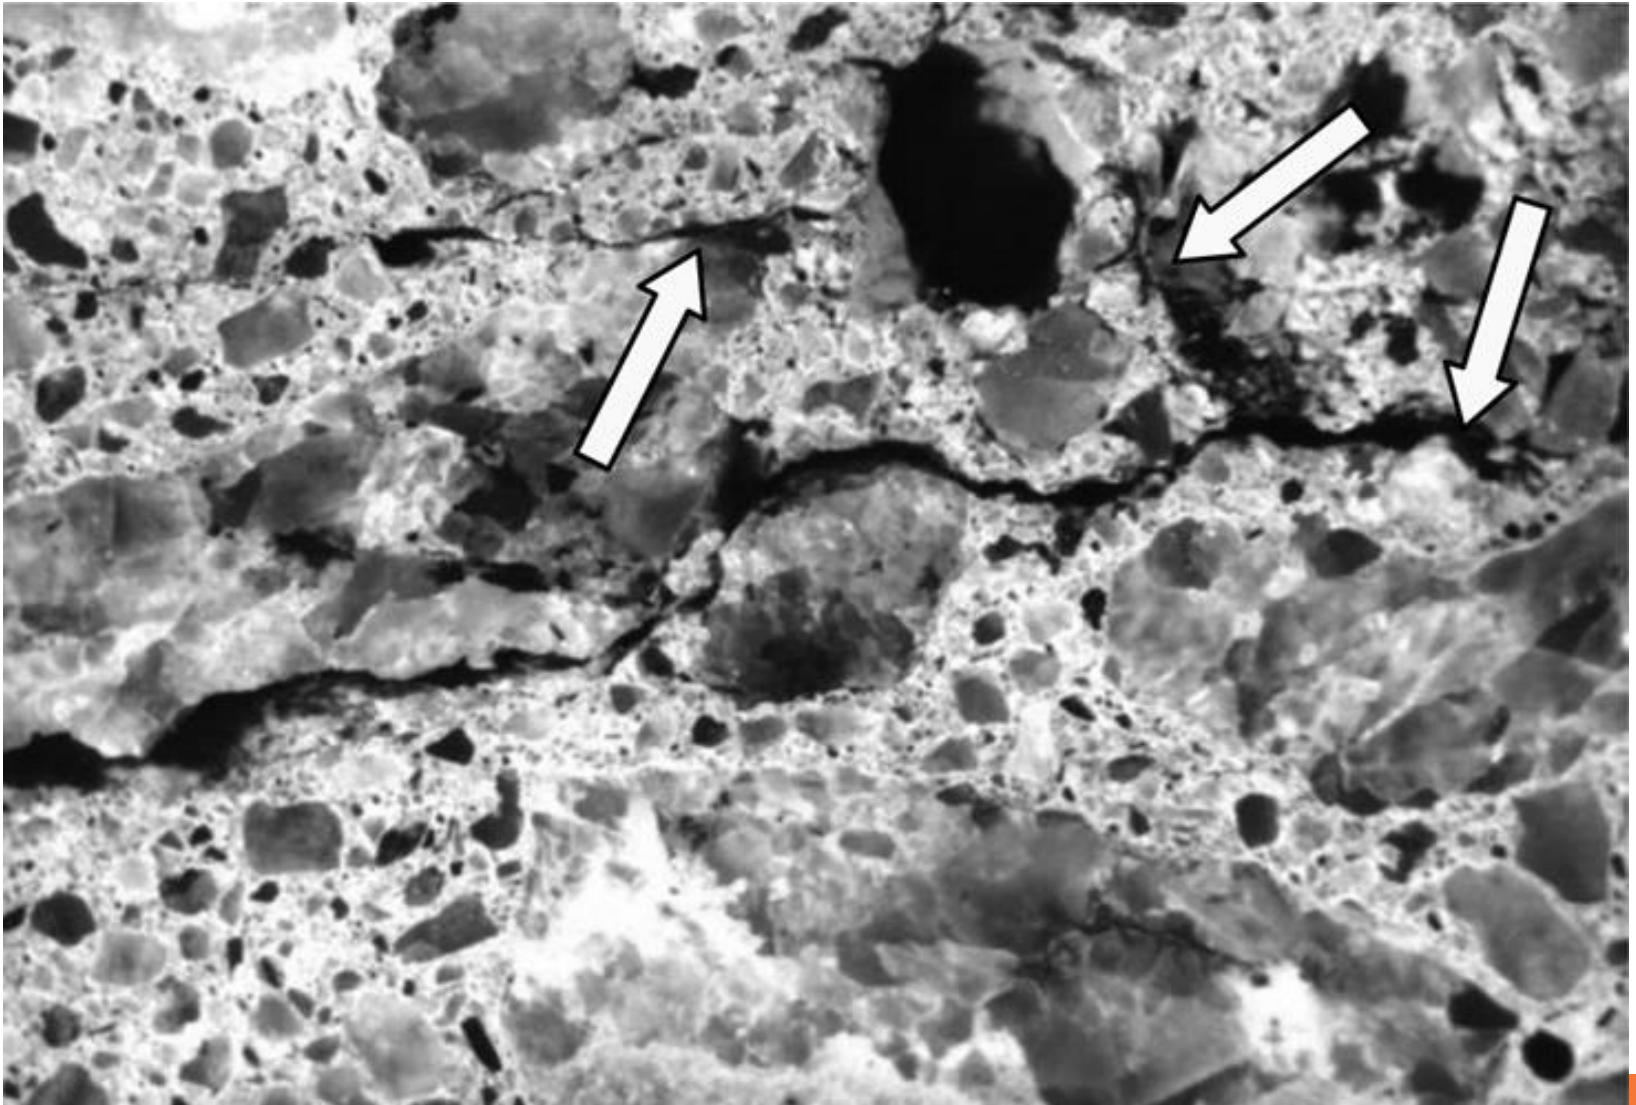
Fig 1b, Slab Prepared with 45-lb Breaker (6)

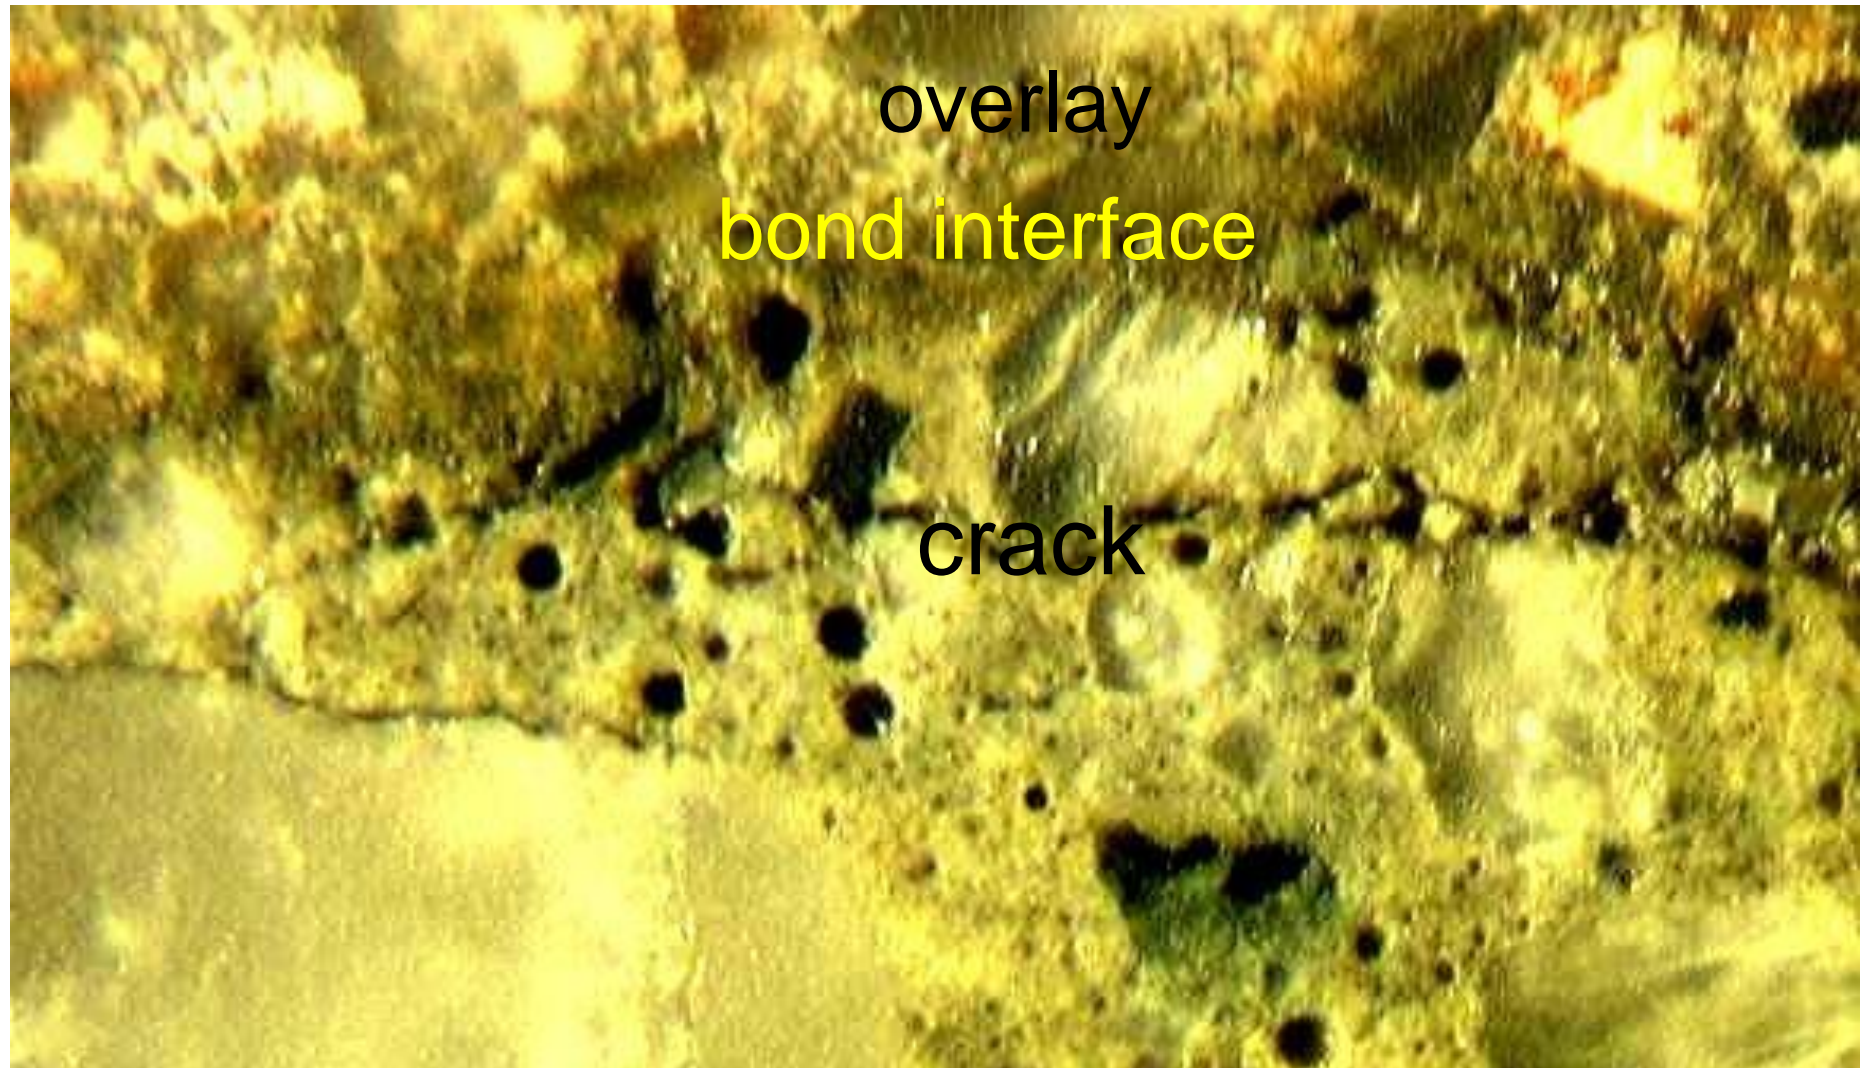
Fig 2, Slab Prepared with milling machine

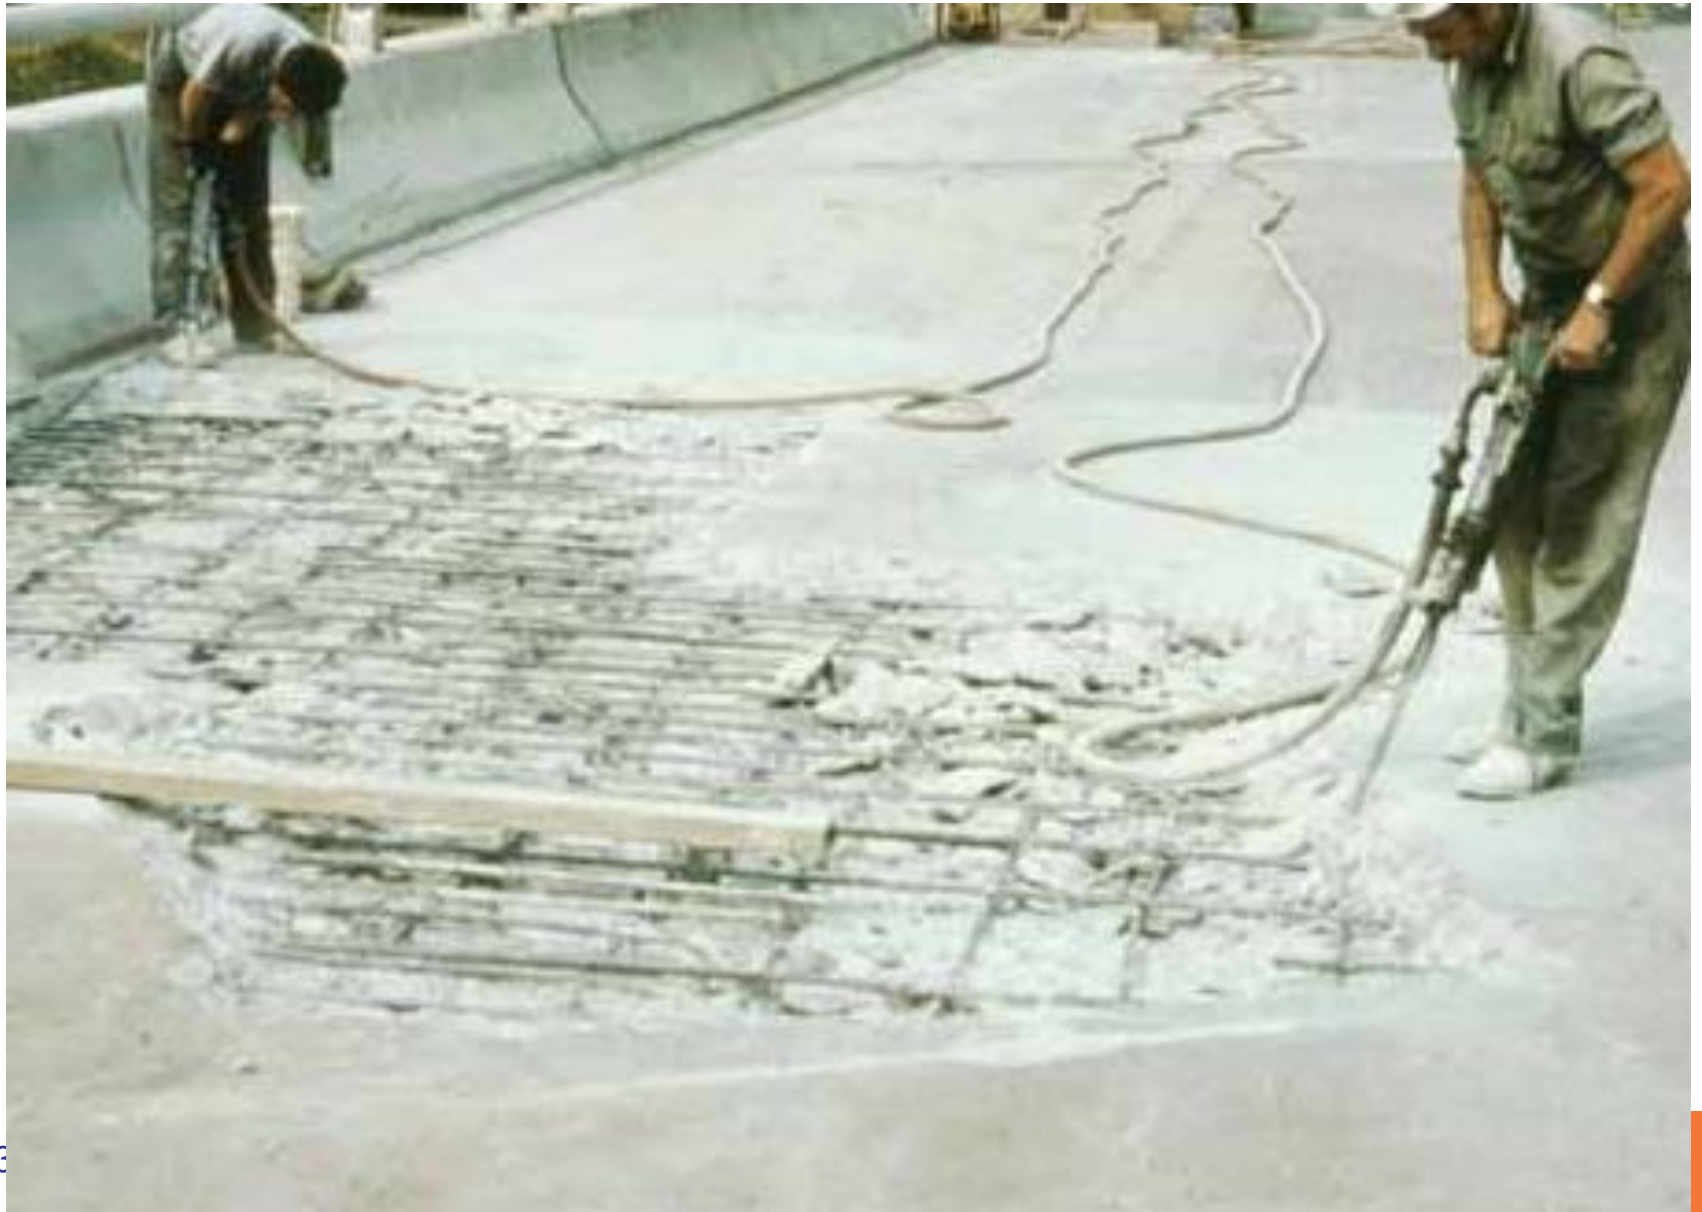
Fig 3, Chipping hammers

Concrete can be removed using a variety of methods such as chipping hammers, milling, abrasive blasting, and hydrodemolition (Fig. 3 - 8). Removal of unsound and sound concrete subjects the concrete substrate to a wide range of impact and dynamic loads, and the resulting bruising will depend on the method used and the quality of the concrete. The depth of the bruised layer varies, but is usually superficial (typical depth of the order of 1/8 in. [3 mm]). There are no criteria yet for the degree of bruising that reduces service life.

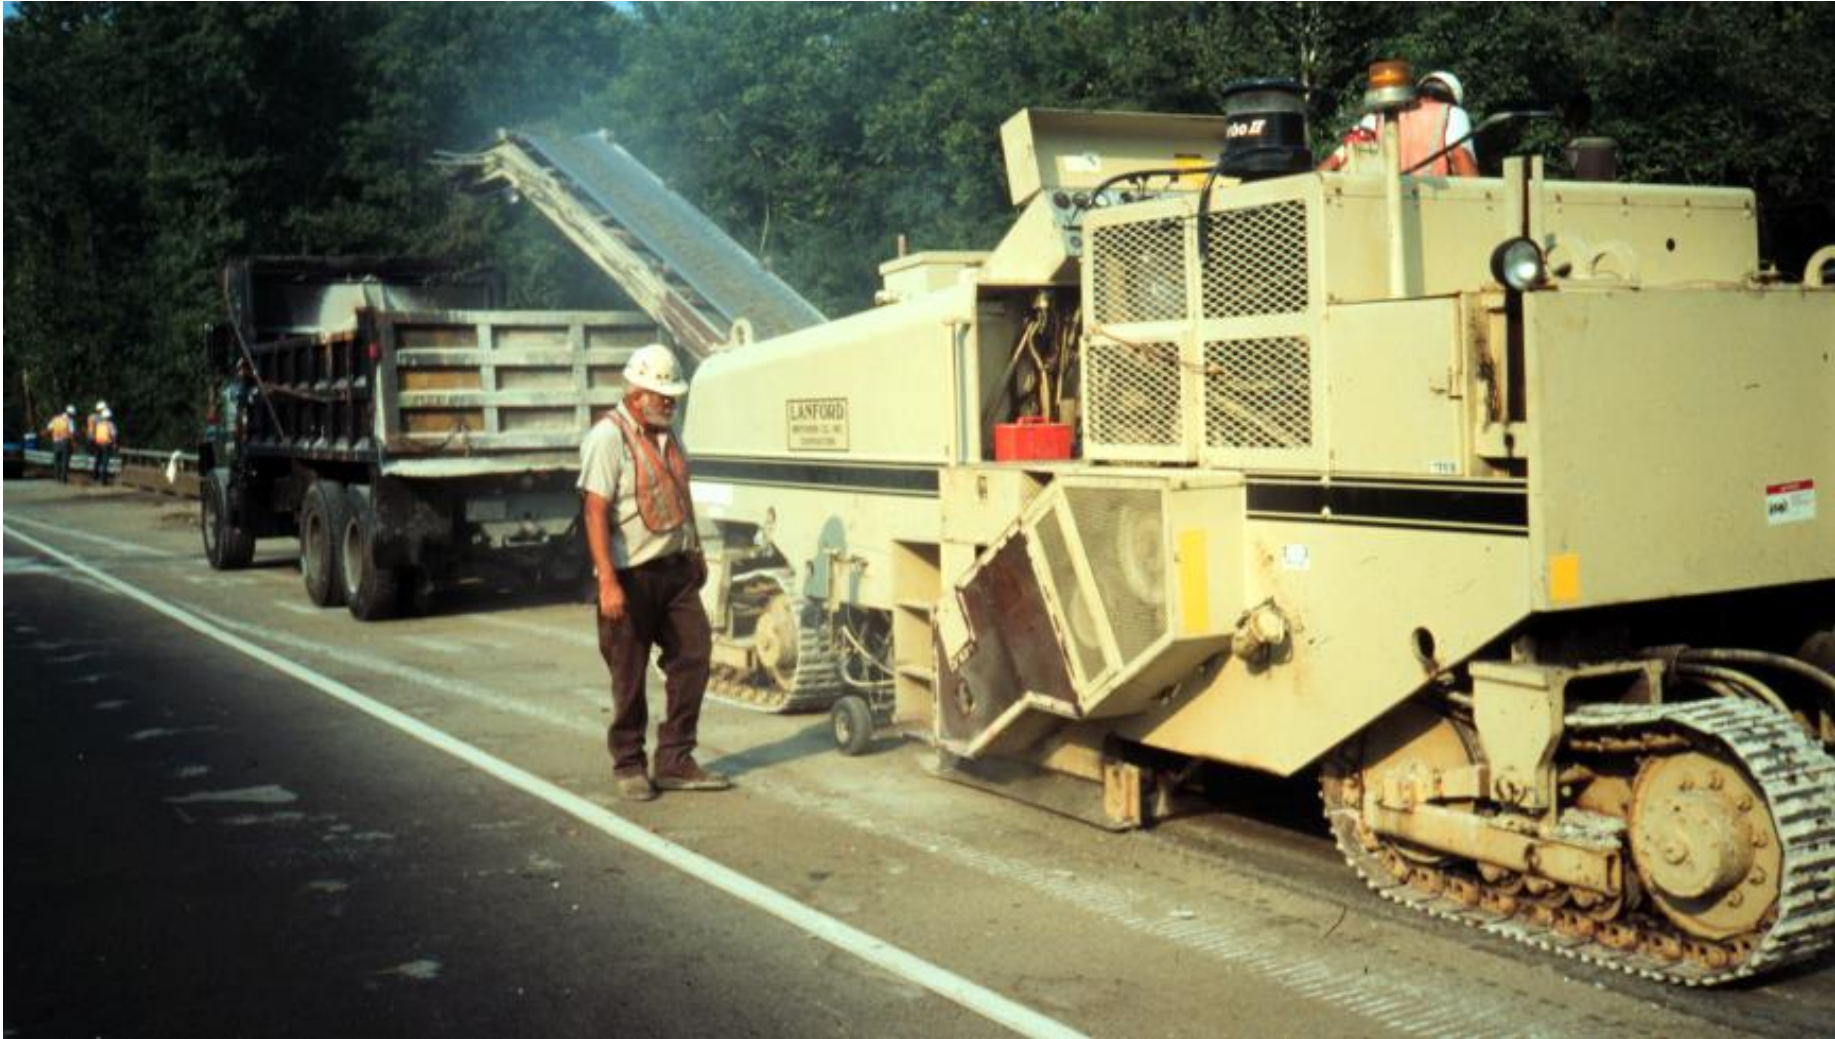
# Fig 4, Milling Machine

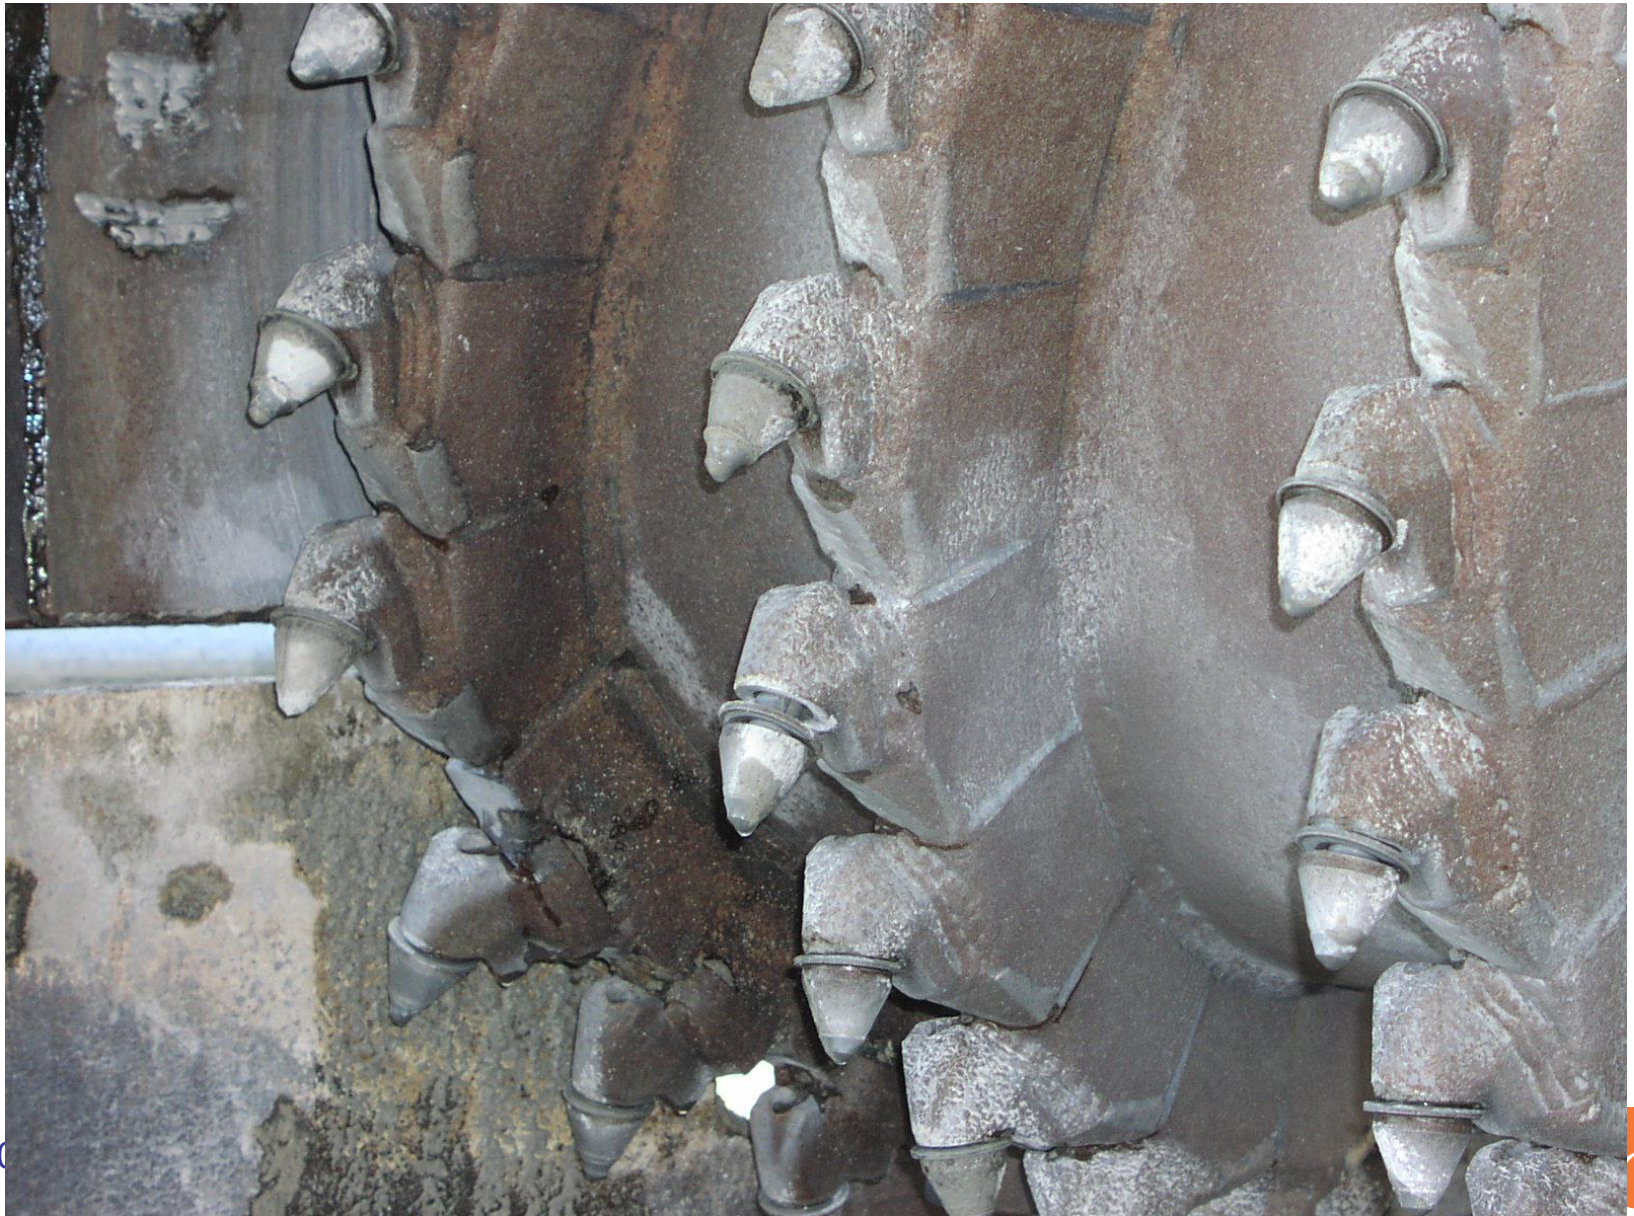
Fig 5, Micro milling heads do less damage

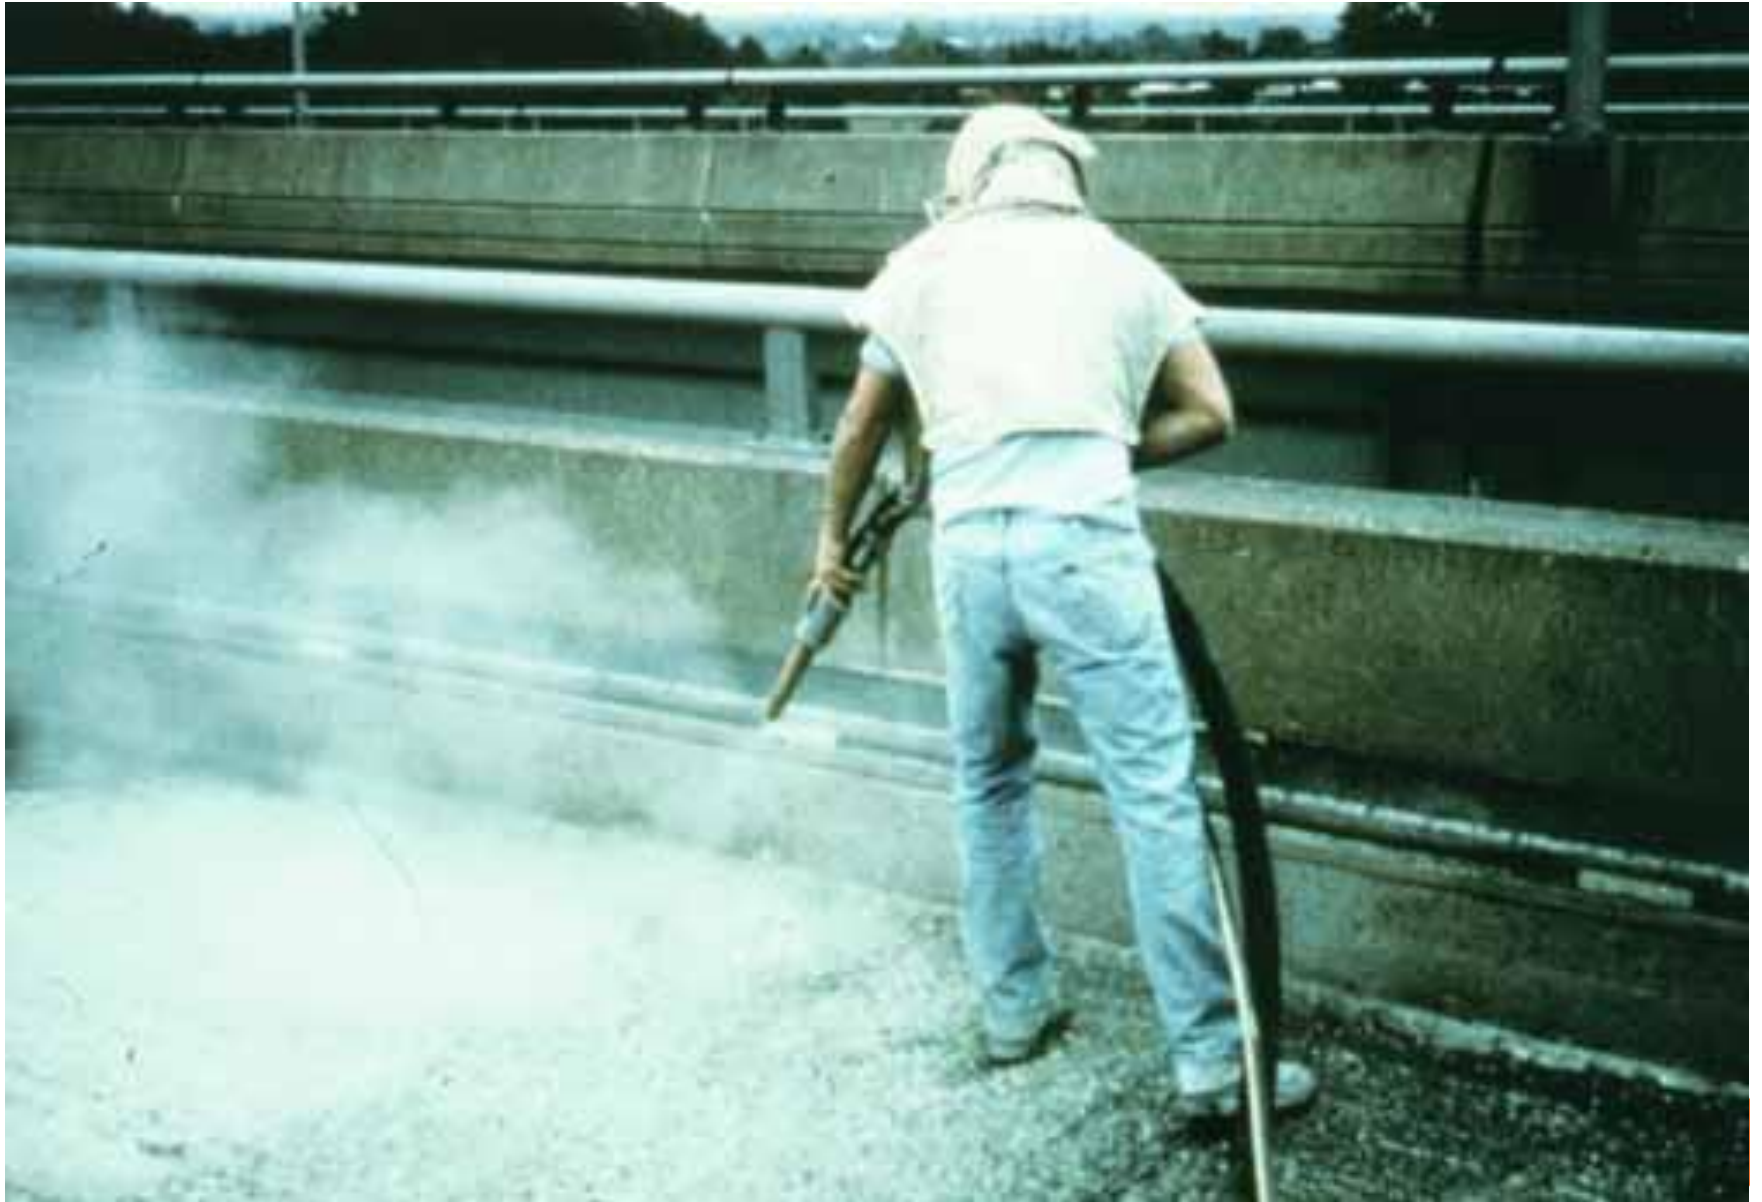
Fig 6, Abrasive blasting

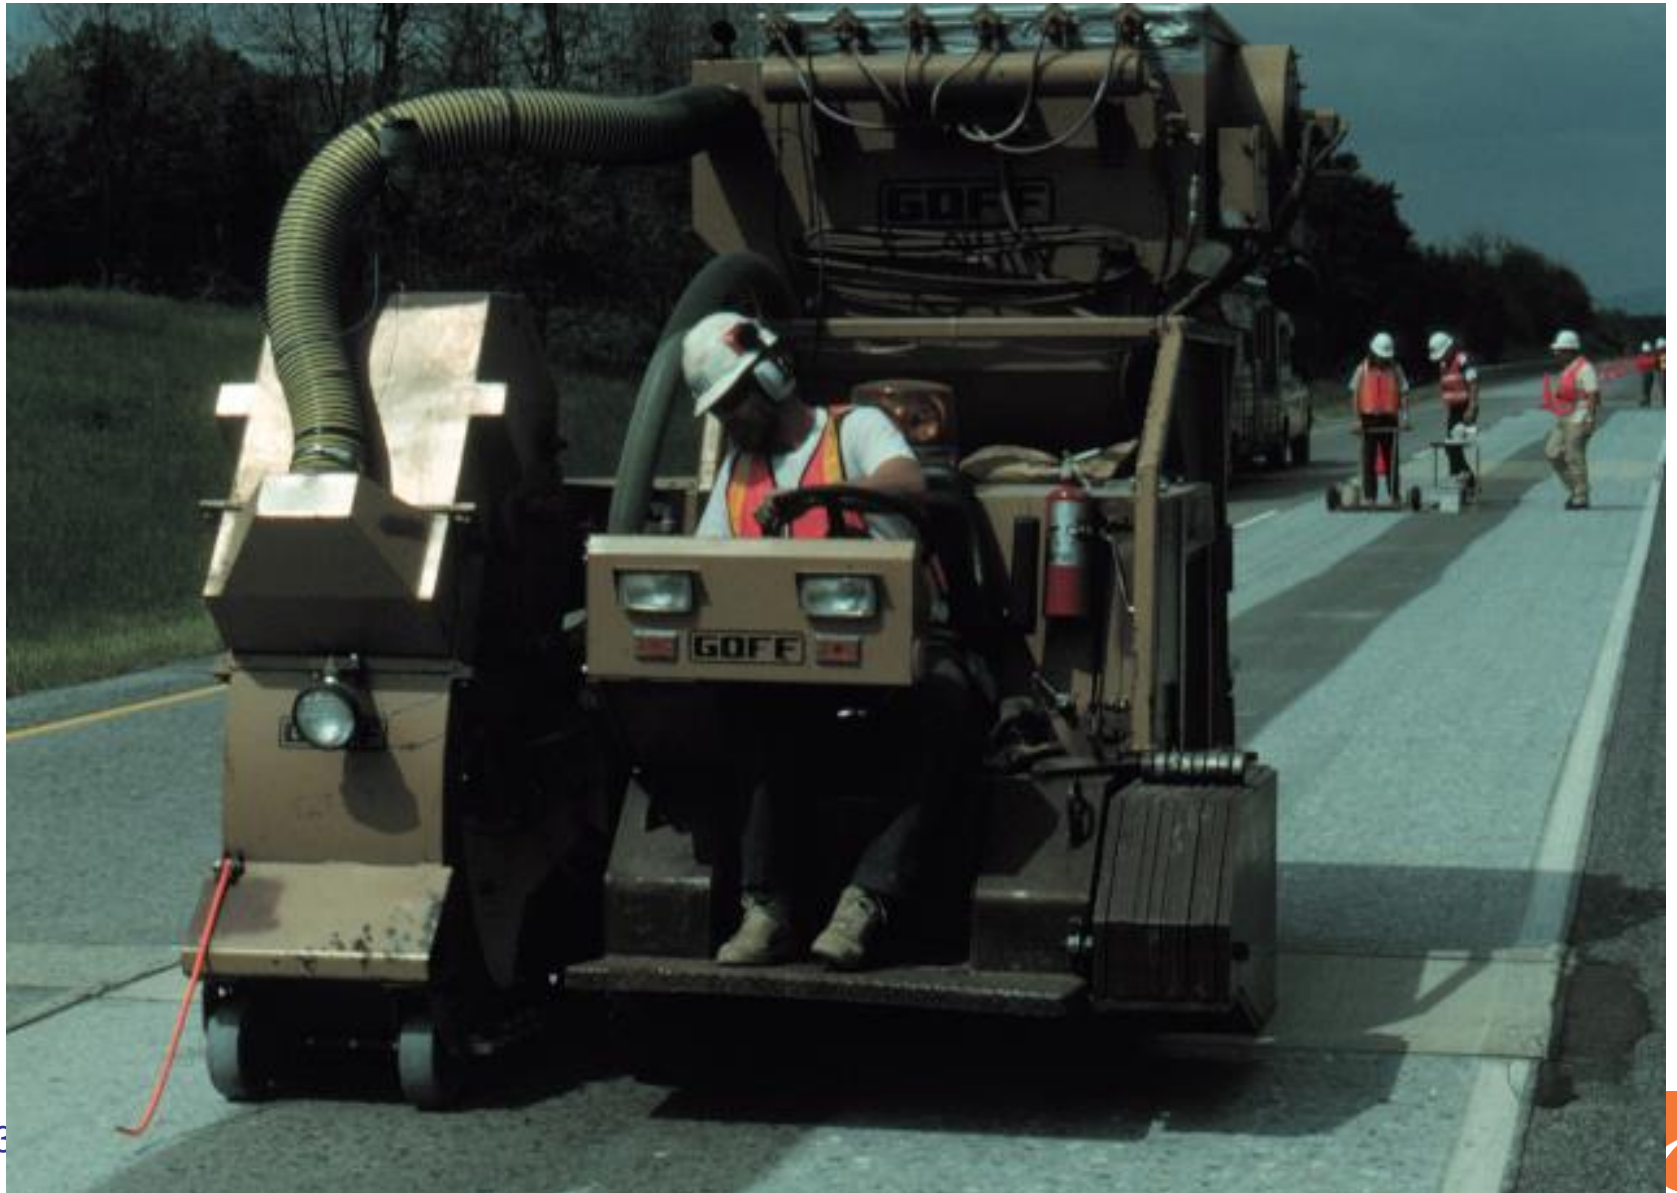
Fig 7, Abrasive shot-blasting

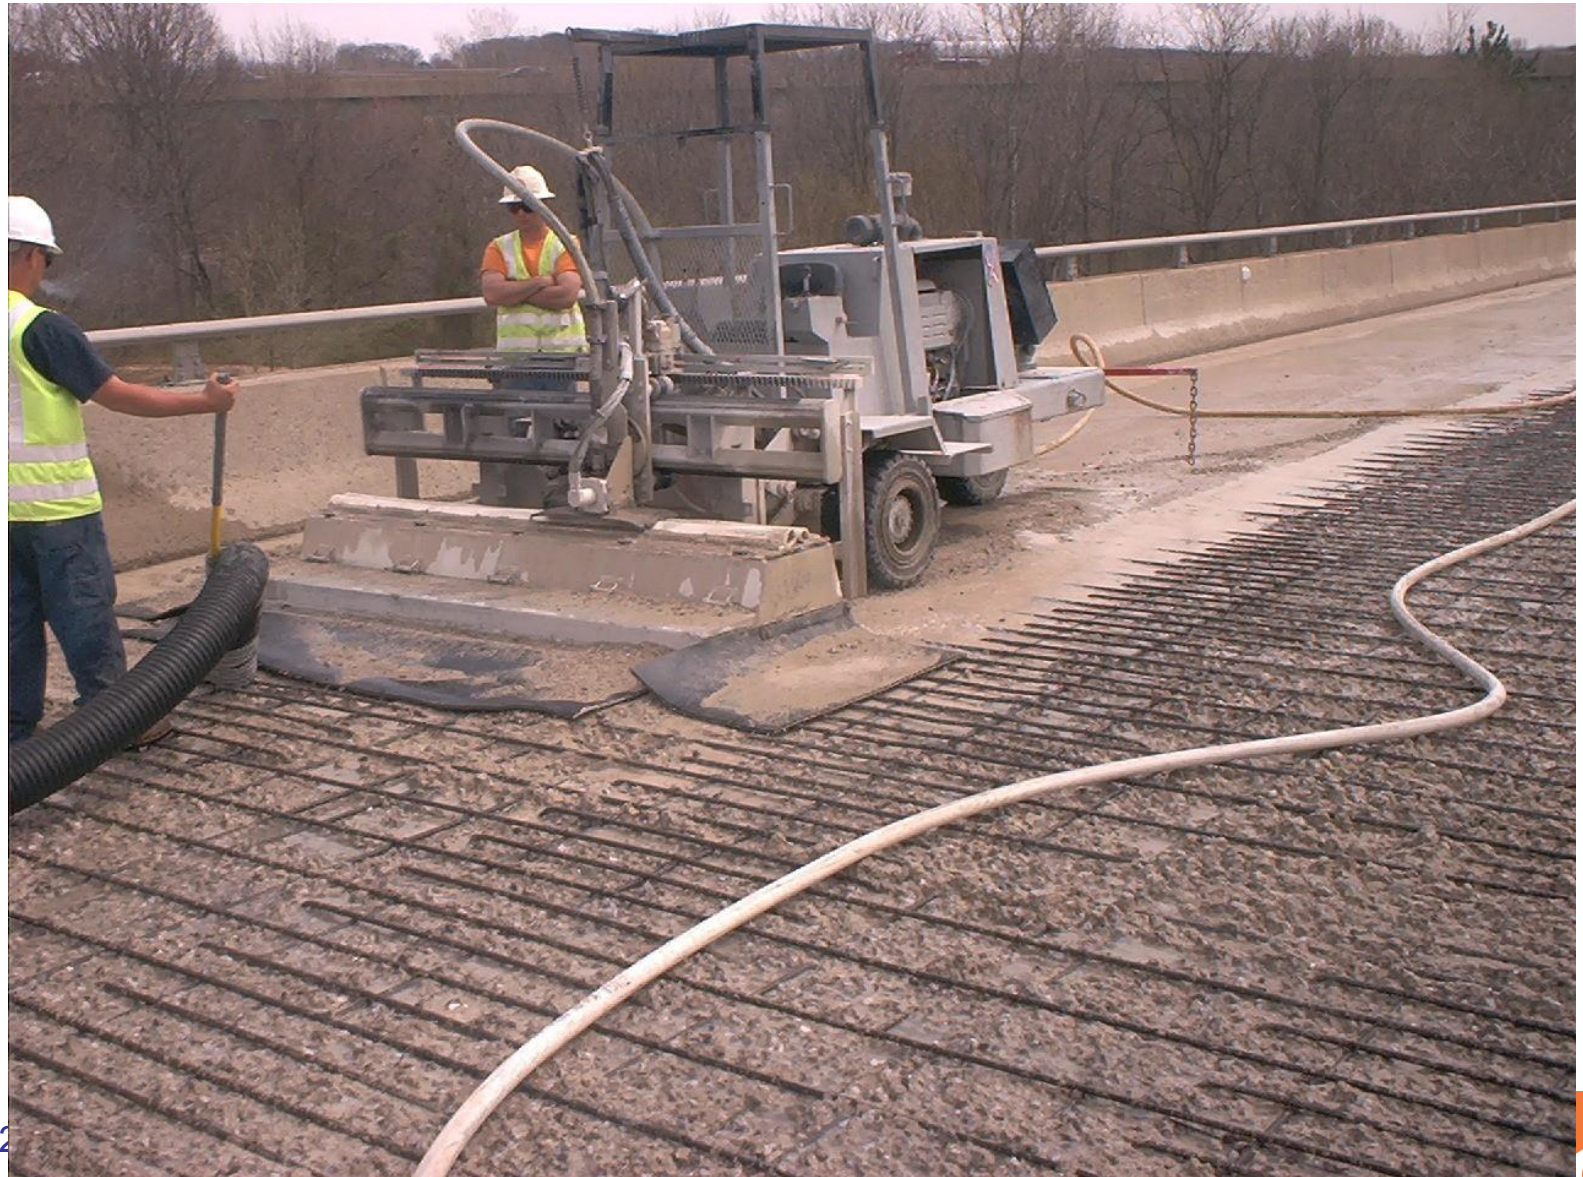
# Fig 8, Hydrodemolition
