Potential impact of chloride-based deicers on the deterioration of joints in concrete pavements

Jan Olek
Hyun Gu Jeong
Nancy Whiting
Parth Panchmatia
Jason Weiss

PURDUE
UNIVERSITY

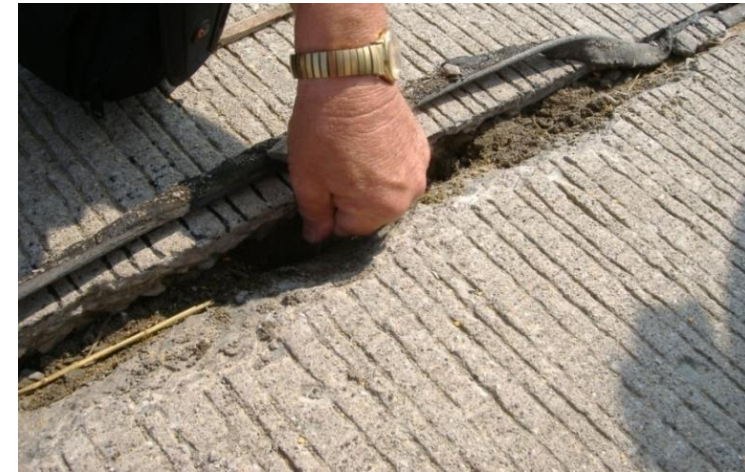
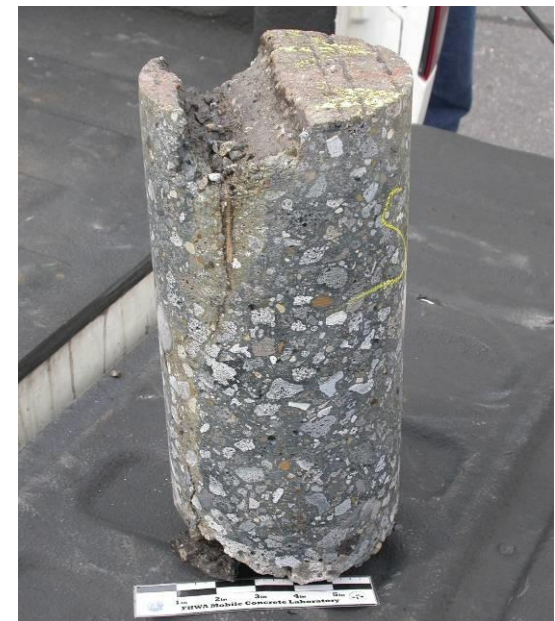
- **Most deterioration taking place at or near:**
 - transverse joints
 - longitudinal joints
 - Intersection of transverse and longitudinal joints

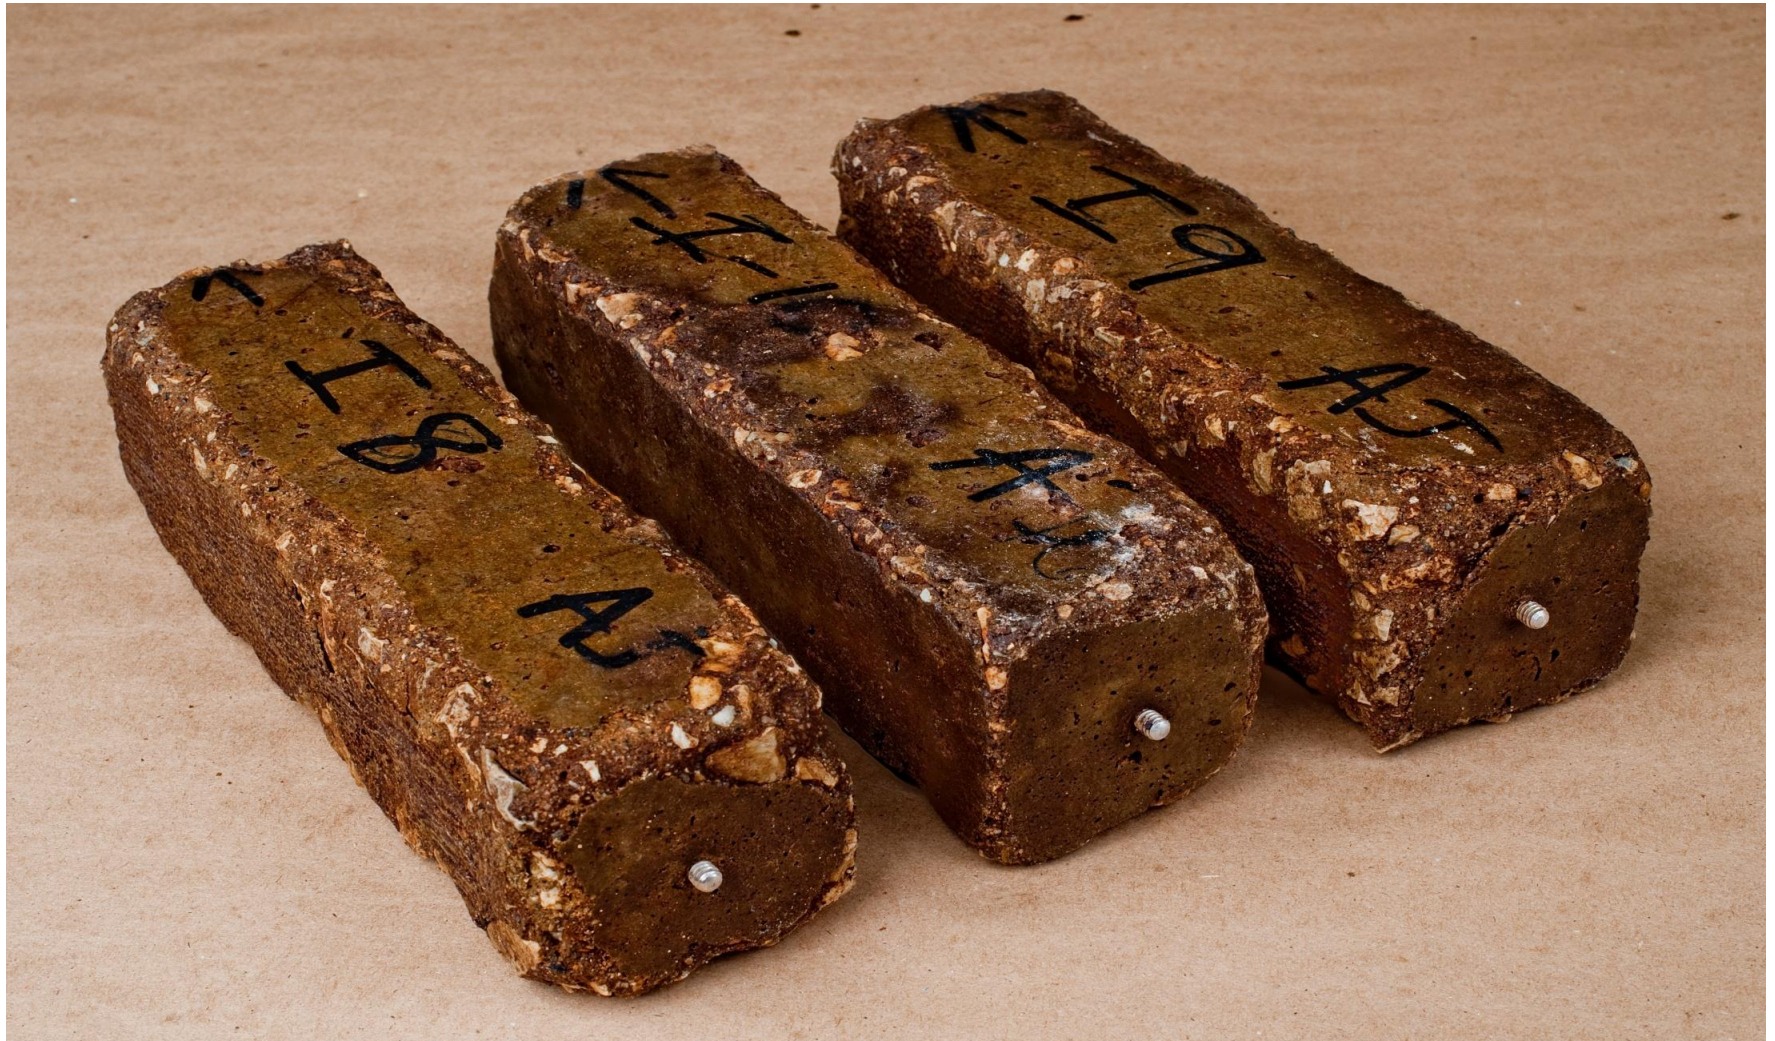
Type I specimens after 168 W/D cycles in 28% CaCl_2 solution

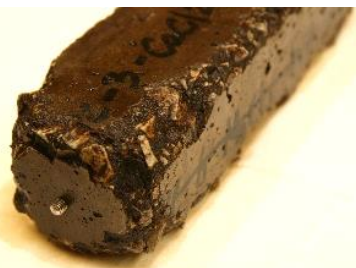
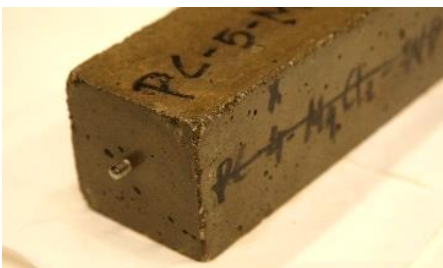
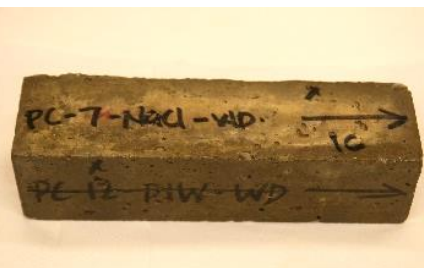
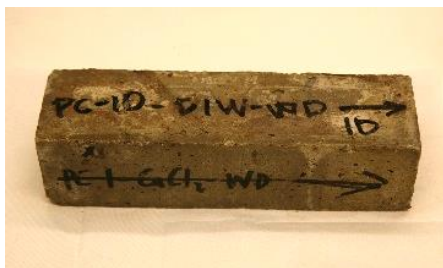
Visual appearance of the specimens (W/D)

<p>PC-CaCl₂-W/D-350cycles</p>	<p>PC-MgCl₂-W/D-350cycles</p>	<p>PC-NaCl-W/D-350cycles</p>	<p>PC-DIW-W/D-350cycles</p>

- Most visibly damaged specimens (cracking and lost of material along the edges)
- Highest (15~17%) reduction in RDME
- Gypsum, CH, and Friedel's salt deposits in the matrix
- Lowest compressive strength – PC after 350 FT cycles (~2,350psi)

- Reduction in RDME ~14% (F/T), 10%(W/D)
Onset of the reductions in RDME occurred later than in case of CaCl₂ exposure
- Some spalling along the edges
- Lowest compressive strength - PC after 350 FT cycles (~6, 000 psi)
- Deposits of brucite in the near-surface region and occasional nests of M-S-H within the paste

- Initial increase in the RDME over time (dropped to its original value after 350 F/T cycles),
- No visible cracks
- Lowest compressive strength – PC after 350 FT cycles (~4,000 psi)

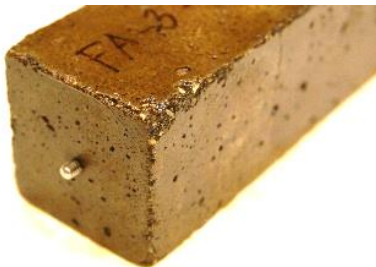
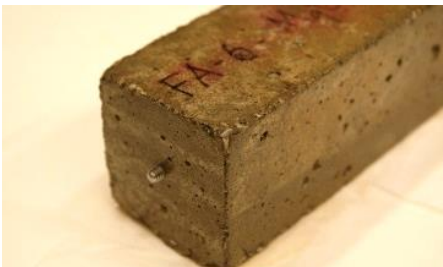
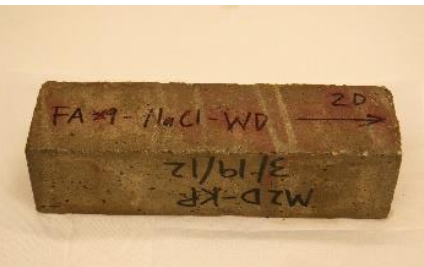
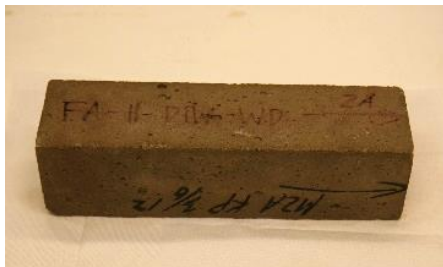
<p>FA-CaCl₂-W/D-350cycles</p>	<p>FA-MgCl₂-W/D-350cycles</p>	<p>FA-NaCl-W/D-350cycles</p>	<p>FA-DIW-W/D-350cycles</p>

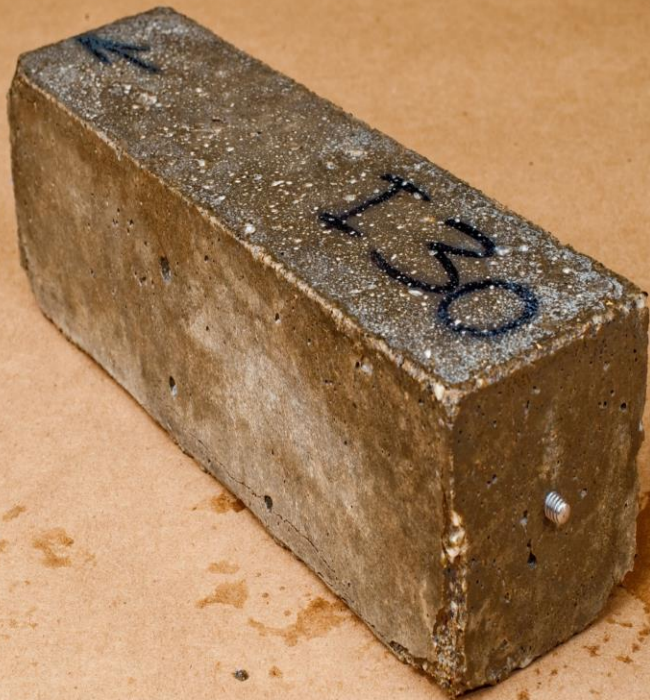
166 F/T cycles in 15% $MgCl_2$ solution

extensive surface deterioration (similar to that observed during W/D exposure)

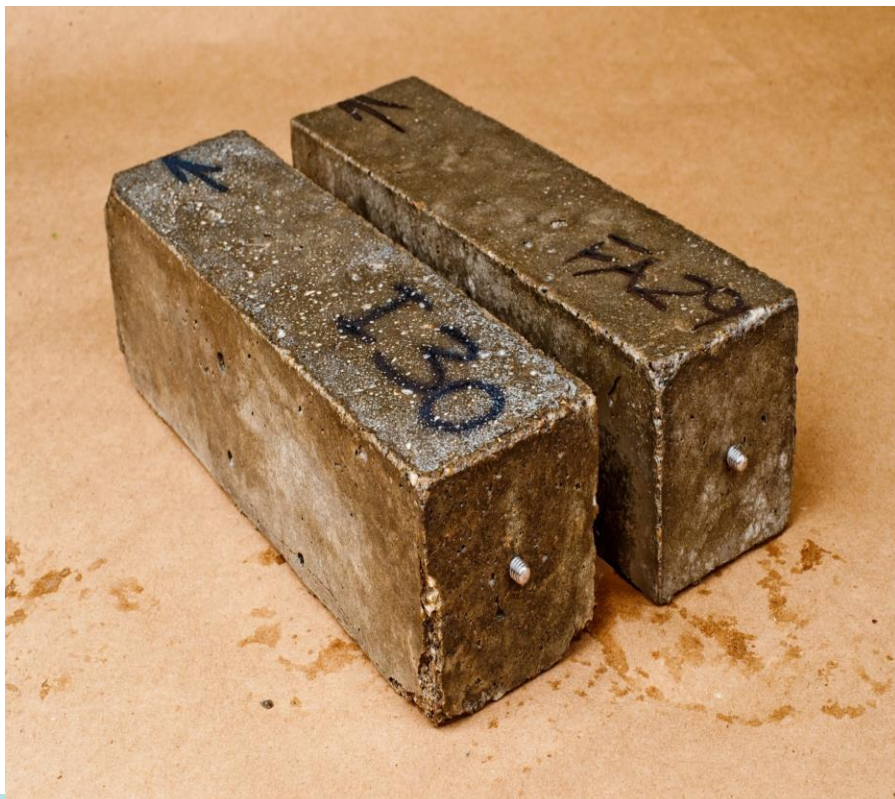
Type I & Fly Ash specimens after 166 F/T cycles in 15% $MgCl_2$ solution

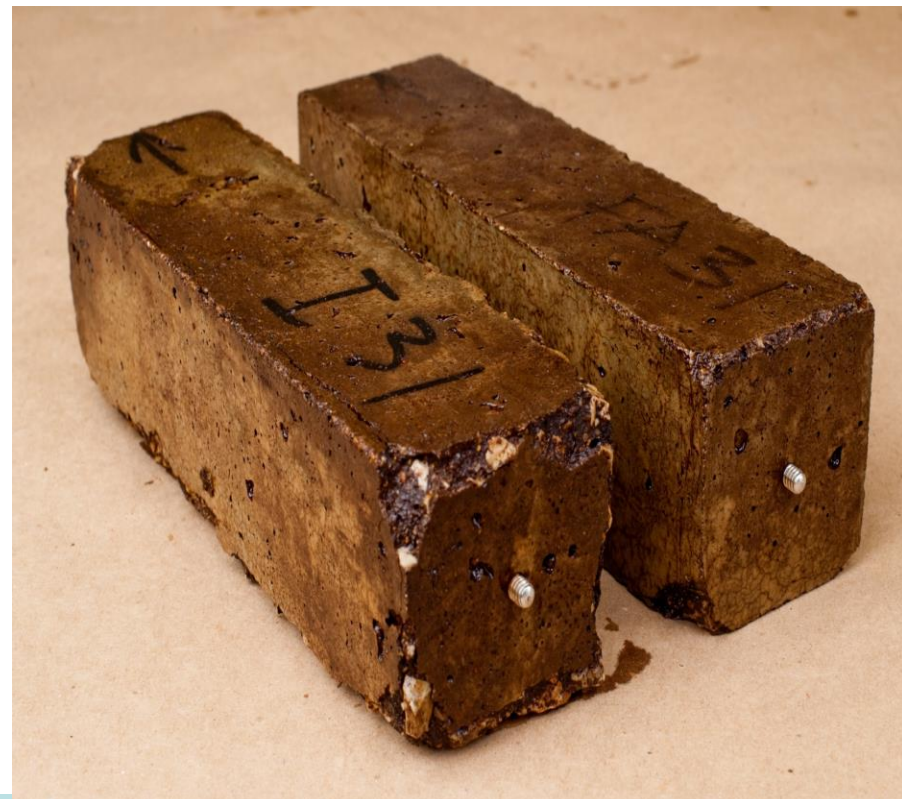
Type I & Fly Ash specimens after 166 F/T cycles in 17% $CaCl_2$ solution

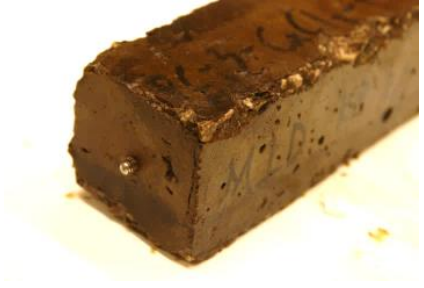
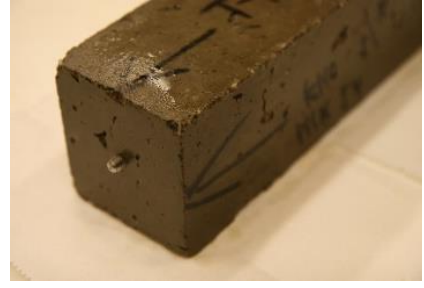
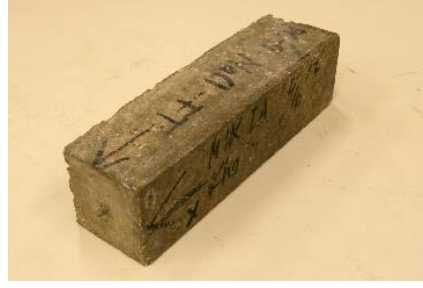
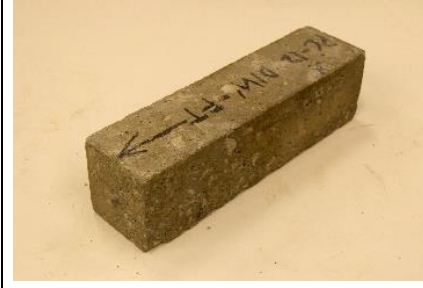
Visual appearance of the specimens (F/T)

PC-CaCl ₂ -F/T-185cycles	PC-MgCl ₂ -F/T-350cycles	PC-NaCl-F/T-350cycles	PC-DIW-F/T-350cycles

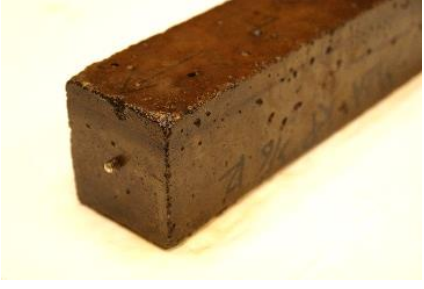
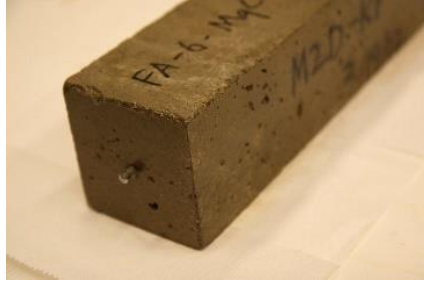
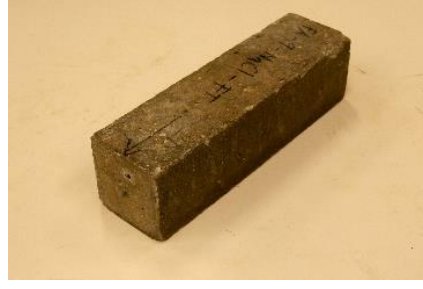
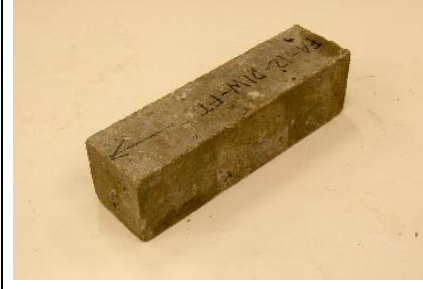
FA-CaCl ₂ -F/T-350cycles	FA-MgCl ₂ -F/T-350cycles	FA-NaCl-F/T-350cycles	FA-DIW-F/T-350cycles

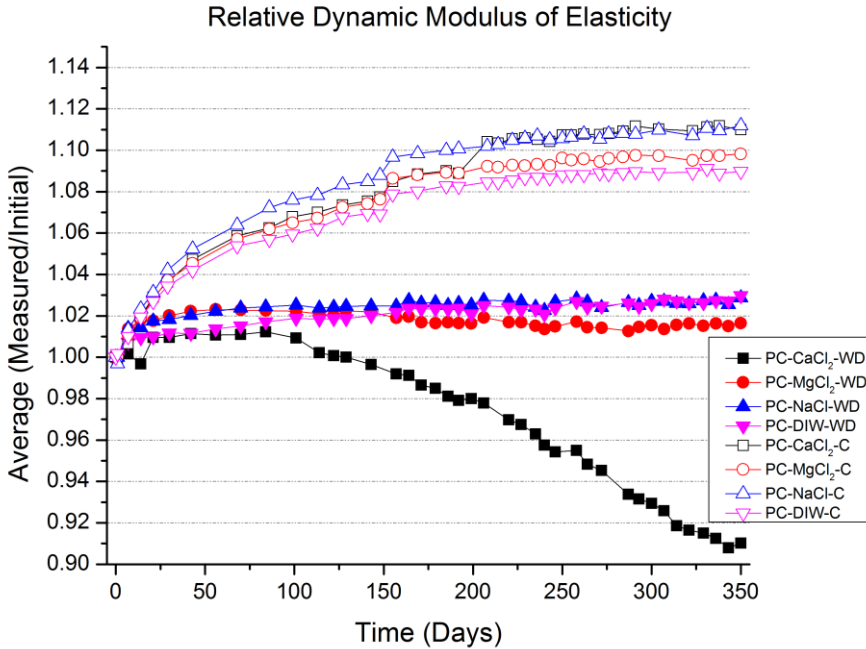
PC Series-W/D

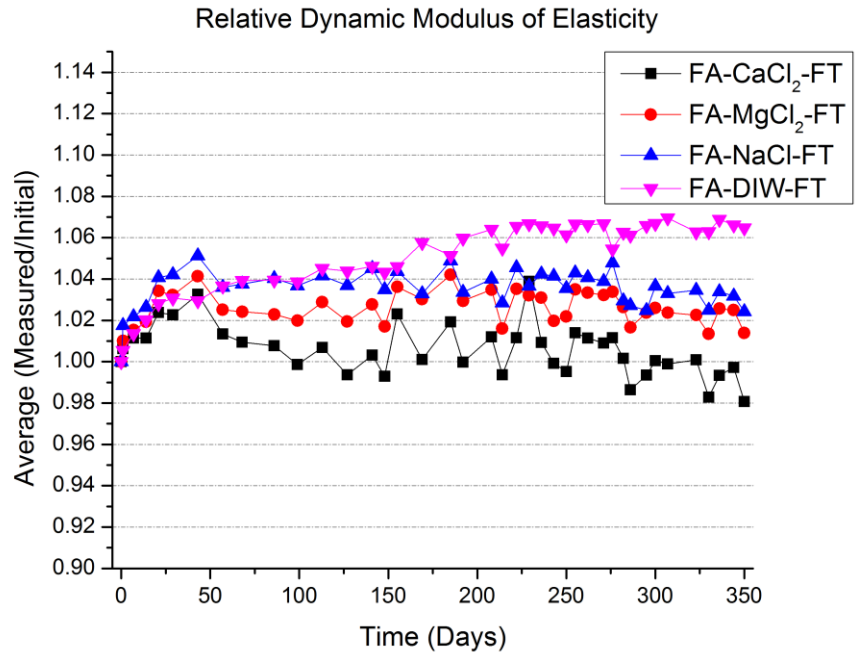
Relative DME -FA concrete - F/T and W/D (dolomite)

FA Series-F/T

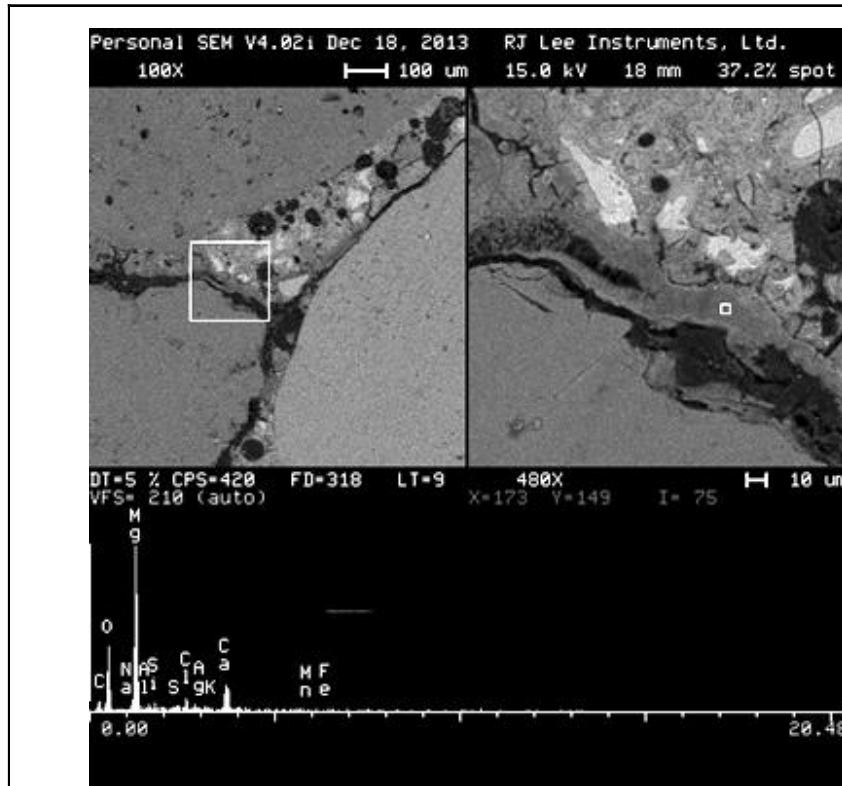
(c) Brucite (PC-CaCl₂-F/T)

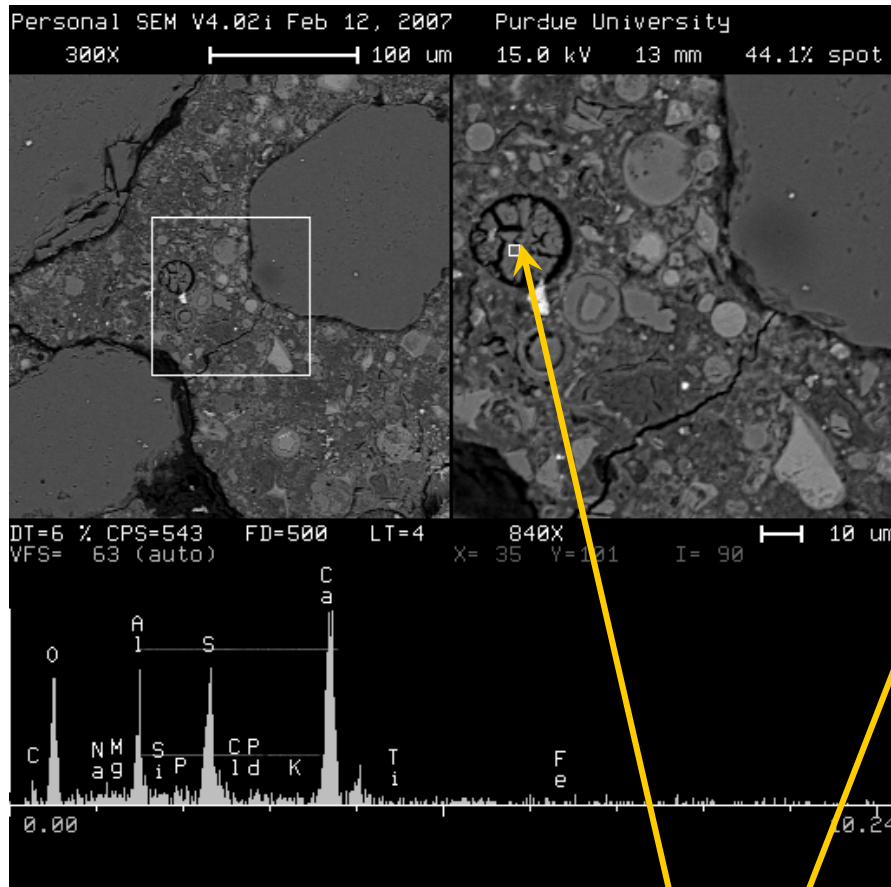
- **Voids frequently filled with Ettringite and/or Friedel's salt**

- Compared to laboratory specimens the field specimens exhibited larger degree of infilling of the air voids (A_{Ft}, Friedel's salt)
- Infilling increased with depth and was more extensive in areas located near the sealed joints
- In general, specimens obtained from mid-span of the slab exhibited better air void parameters, good FT resistance and relatively lower rates of absorption compared to cores from joints
