Tests of Decommissioned Box Beams Strengthened with CFRP Anchors and Laminates

ACI Fall 2023 Convention
Boston, MA
October 30th, 2023

Test Structure

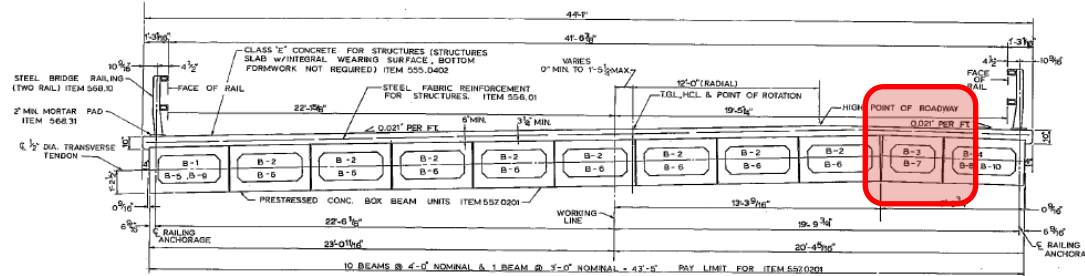
Deck Section

- Prestressed concrete box beams
- Deteriorated due to harsh winters
- Three 56-ft.-long beams extracted for retrofit with a FRP system

- Two 3-ft wide
- One 4-ft wide

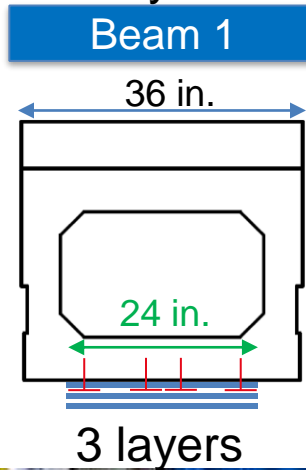
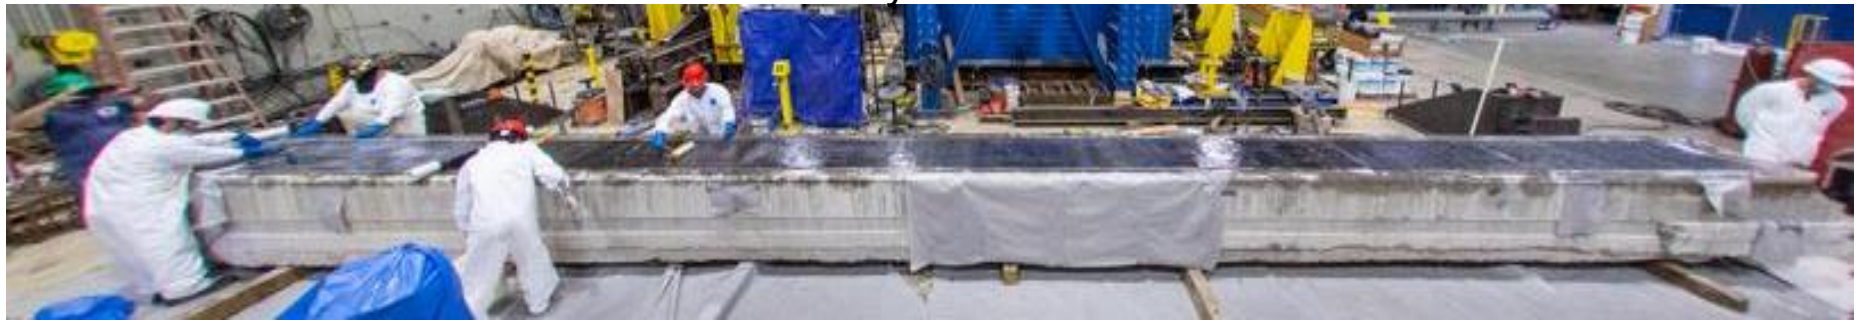
Beam 1

- The laminate thickness and anchor layout varied between the beams

Anchor/Laminate
Ratio
0.5

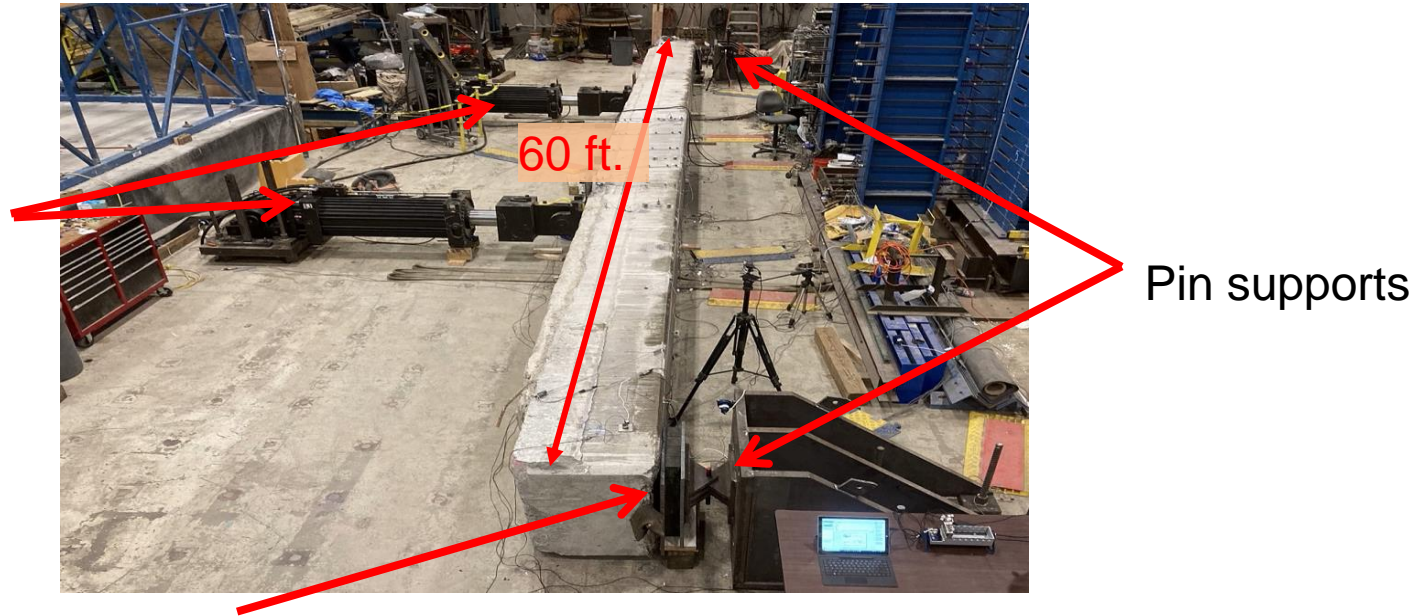
Test Setup

- Four-point-bending tests were conducted until failure

450 kip
actuators

Pin supports

Elastomeric pad
obtained from bridge

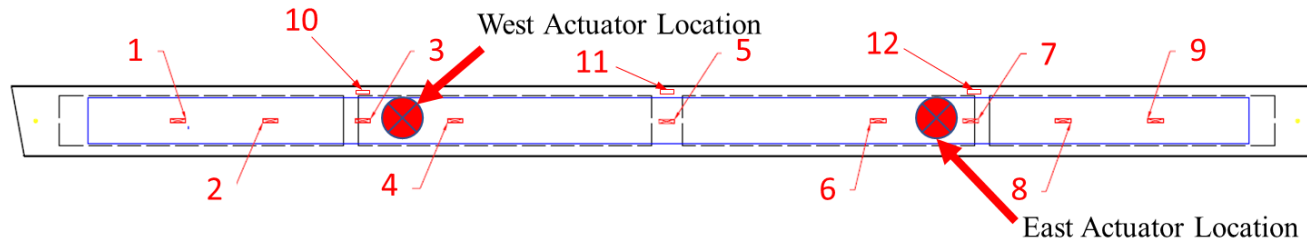
- Beam deformations and strains from the concrete and FRP laminate were measured

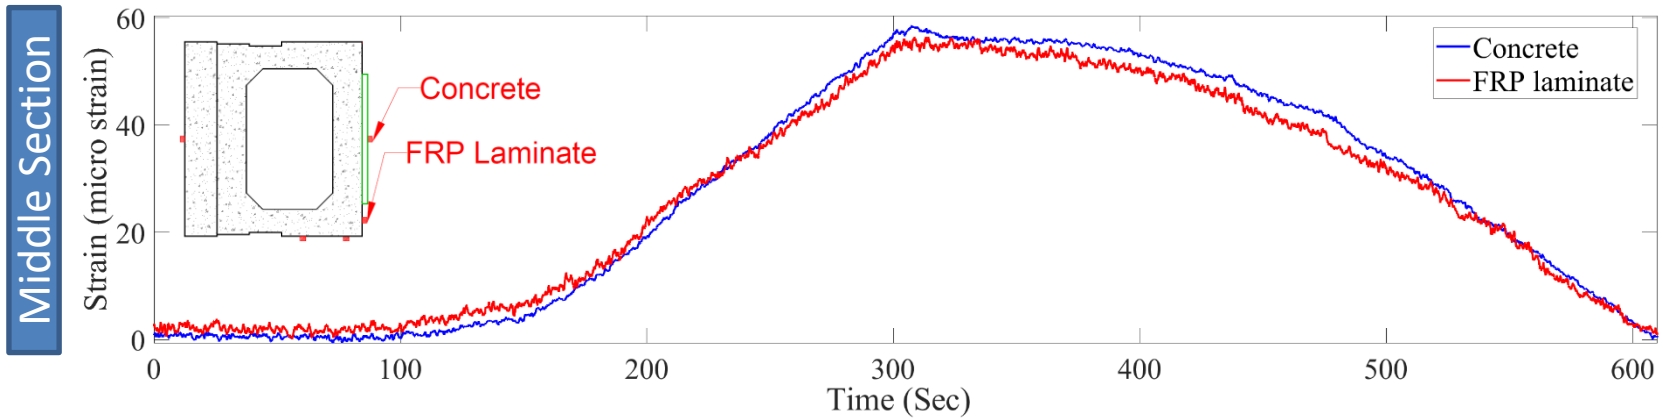
Service-Level Tests

- FRP-concrete strain compatibility was also investigated

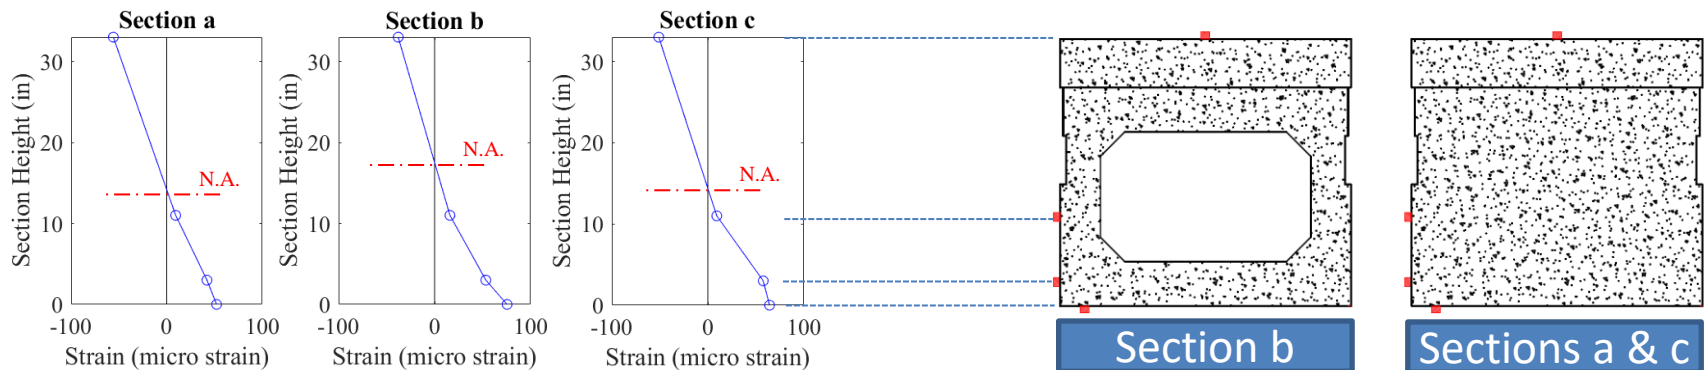
- Strain profiles were obtained at three sections at peak force

- ~linear
- N.A. varied between sections

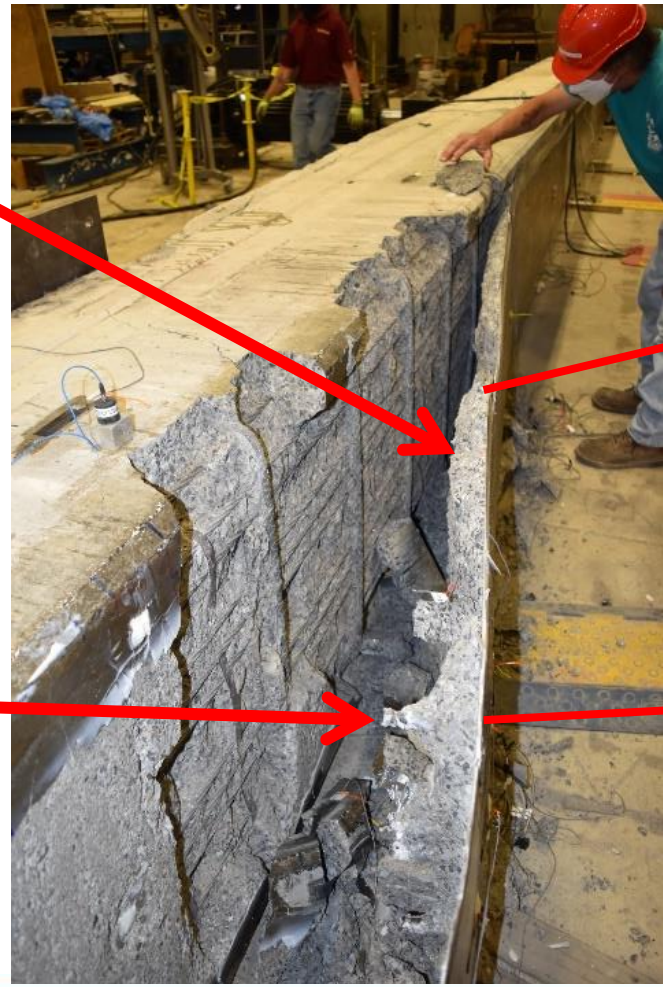
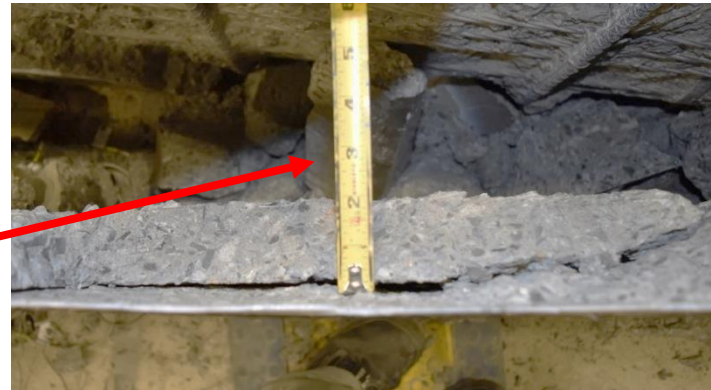
Concrete cover pulled by the FRP

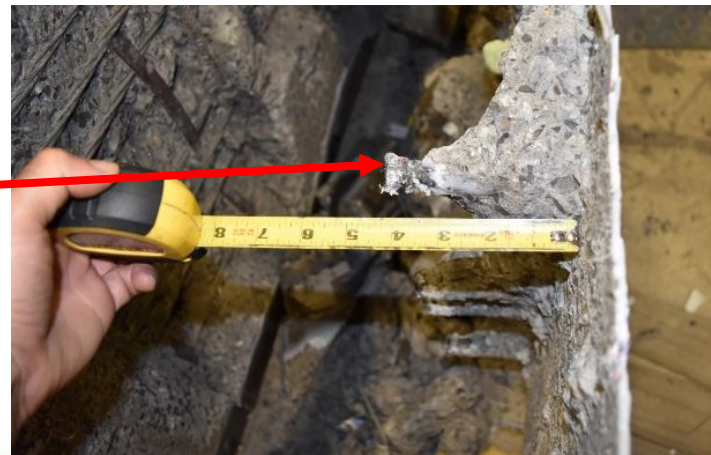
FRP anchors pulled concrete away

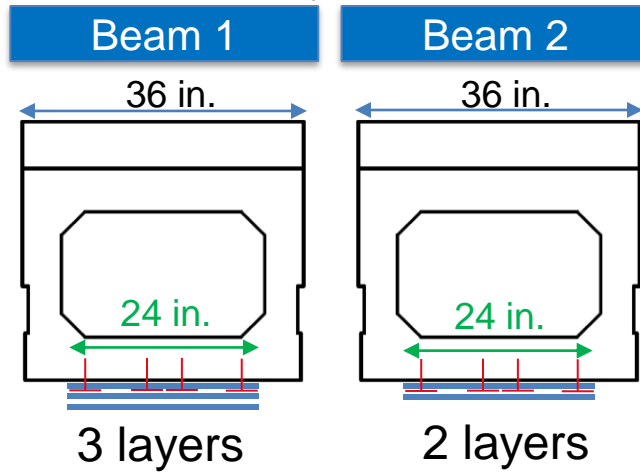
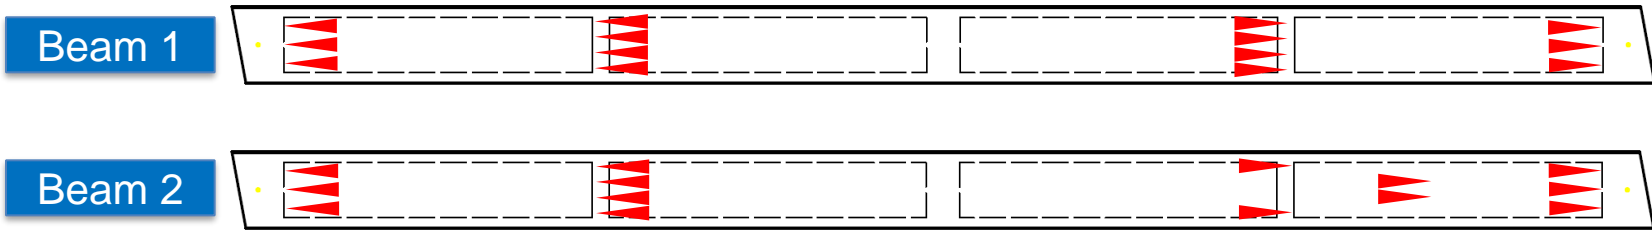
- The laminate thickness and anchor layout varied between the beams

Anchor/Laminate Ratio

0.5

0.8

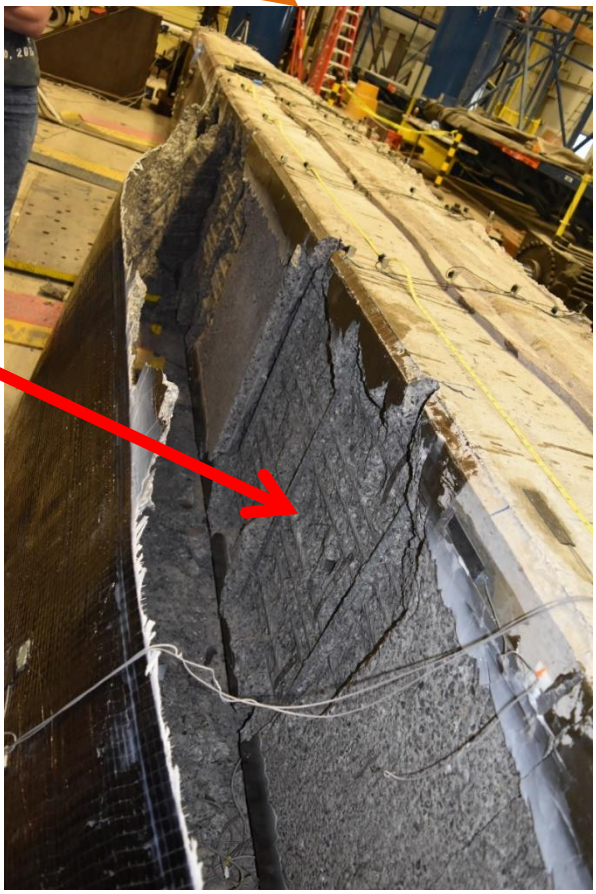
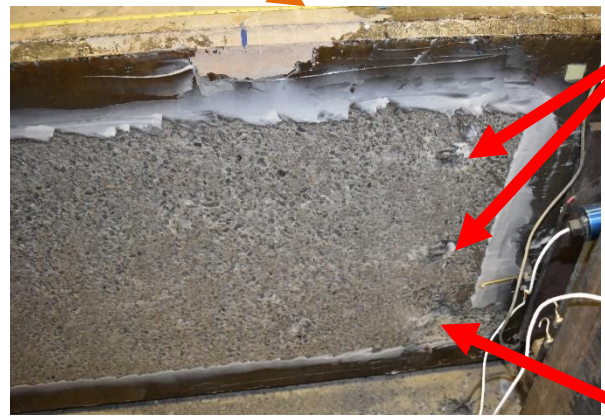
Concrete cover pulled by the FRP

Ruptured anchors

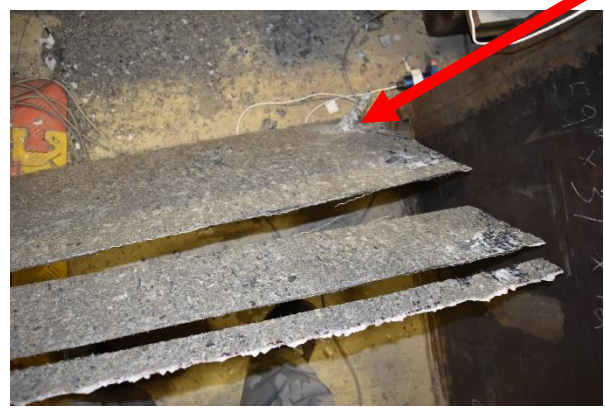
Pulled-out anchor

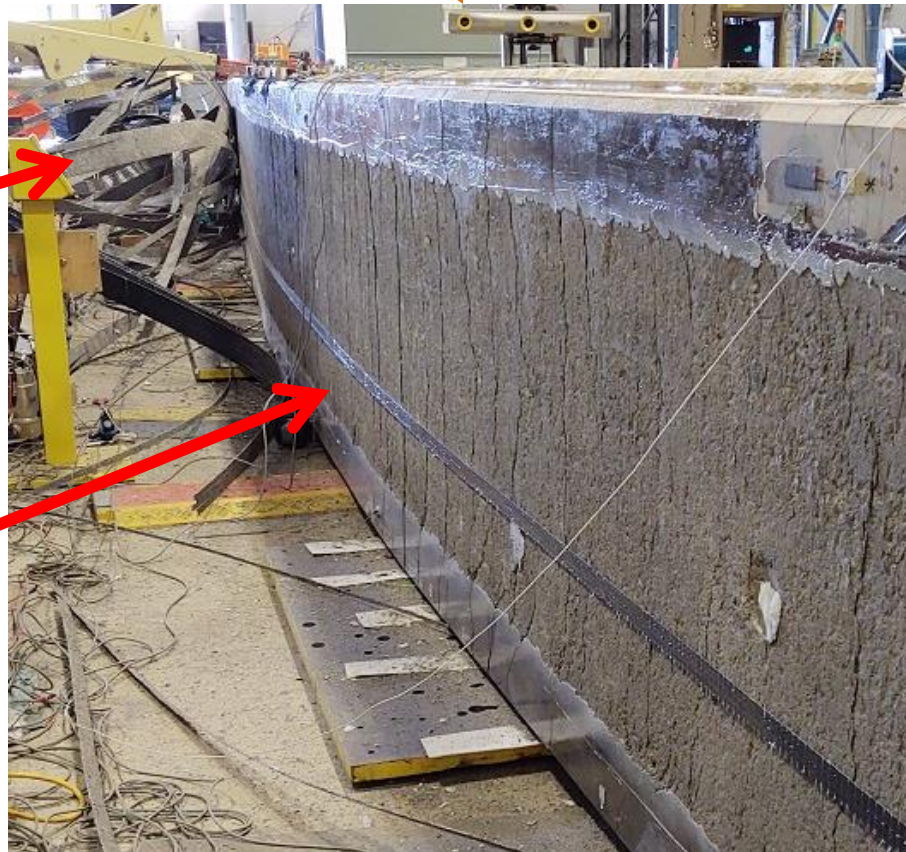
Beam 3: Failure Pattern

Ruptured laminates

Uniformly cracked concrete at mid span

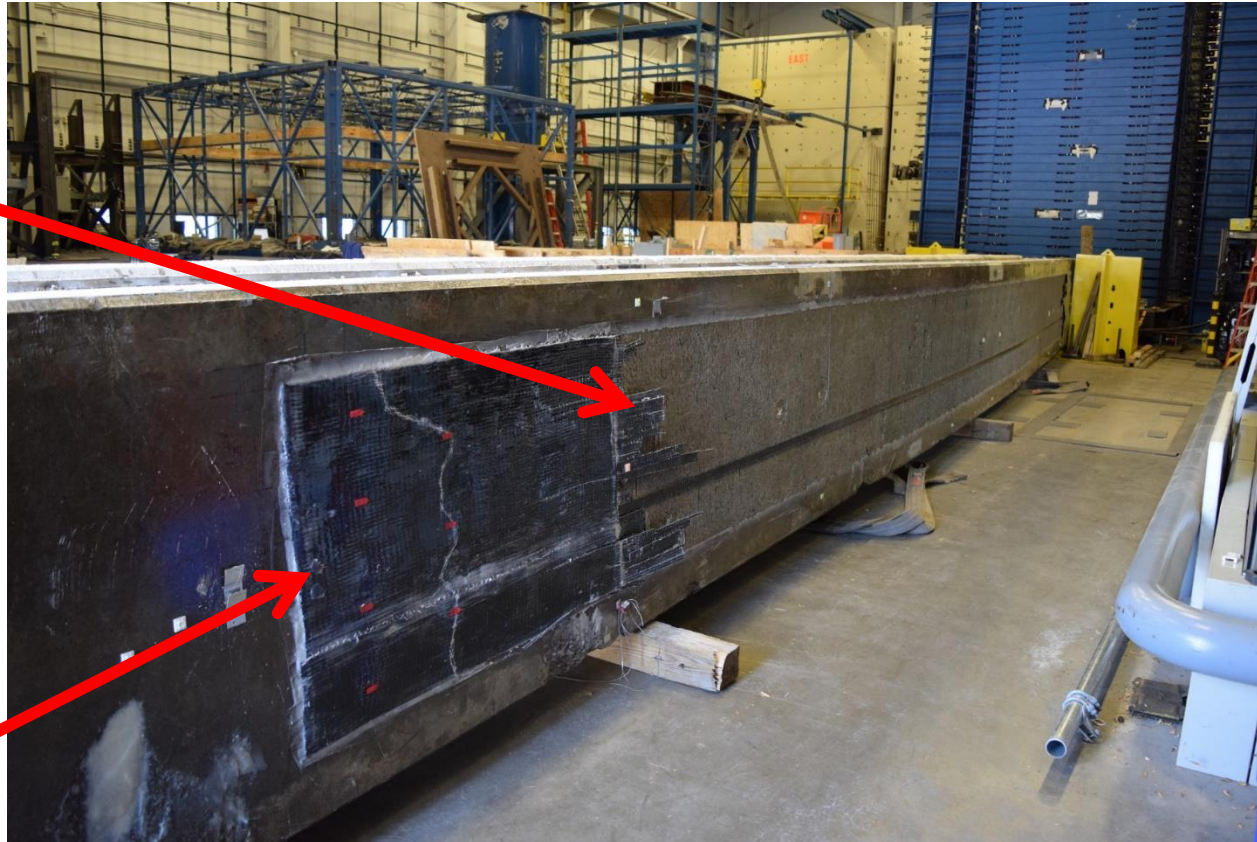
Beam 3: Failure Pattern

Ruptured
laminate
remains

Anchored
end zone

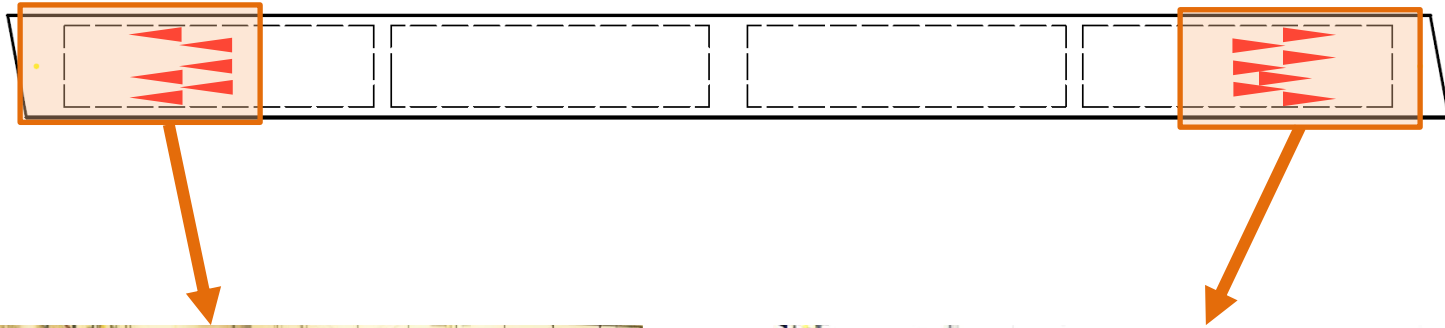
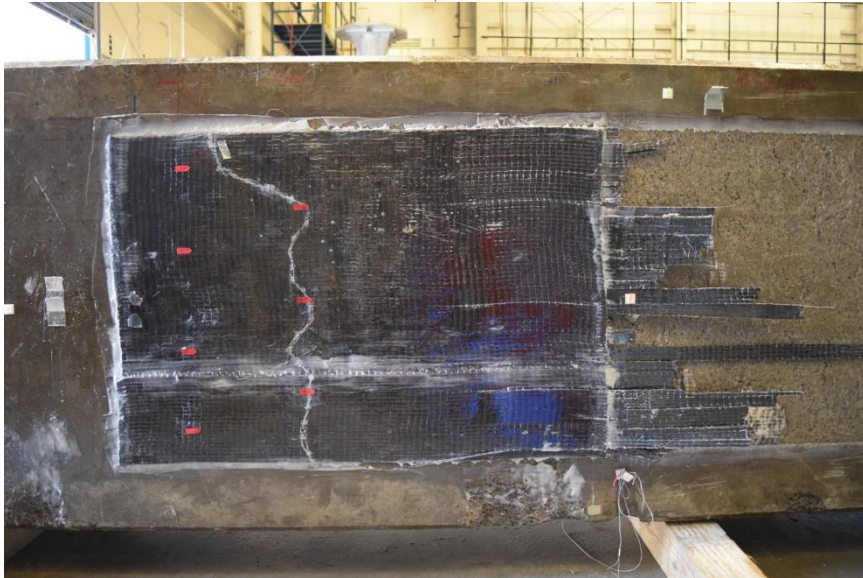
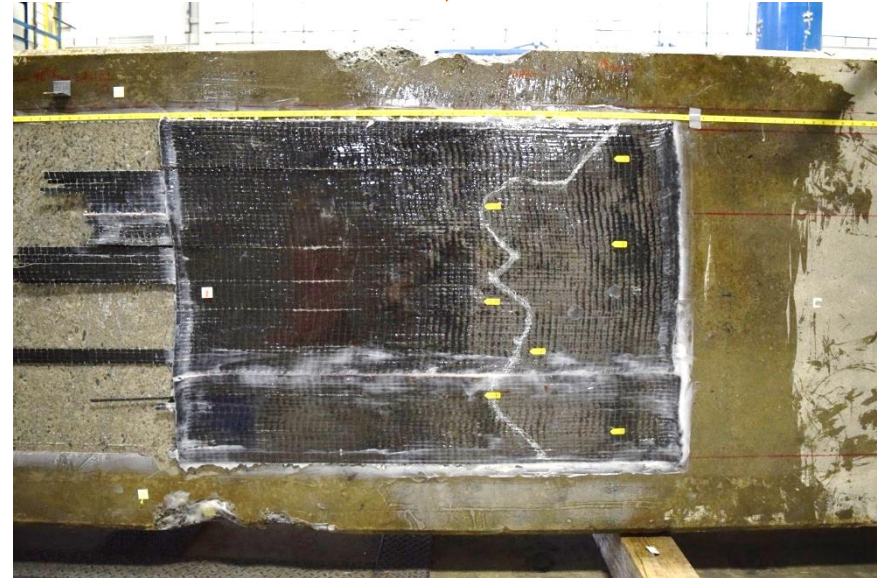
Beam 3: Failure Pattern

- Anchor locations are shown by **red** and **yellow** stickers
- White line defines the boundary between the debonded and undebonded laminate

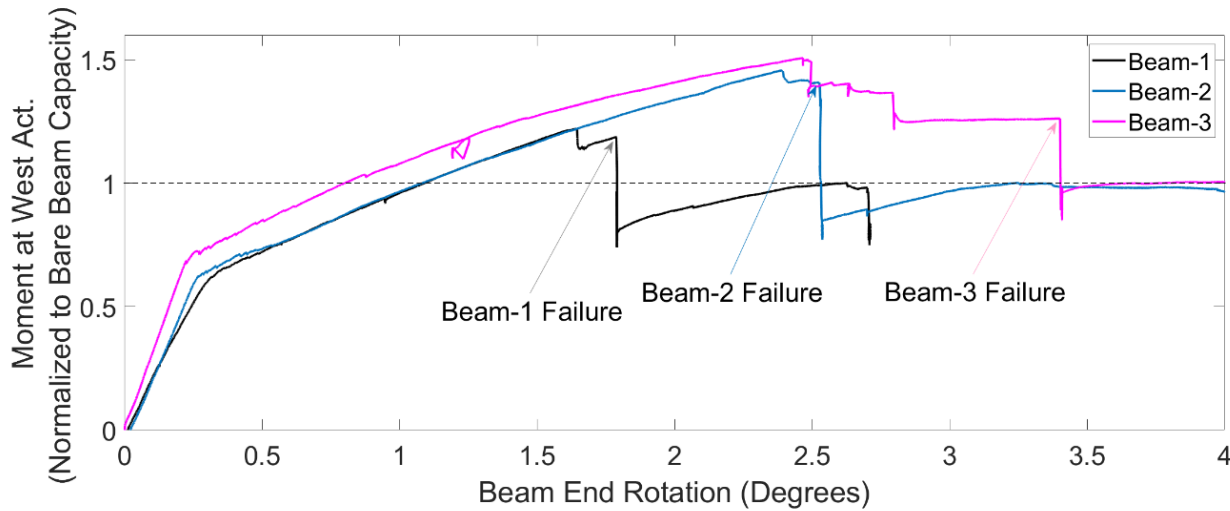
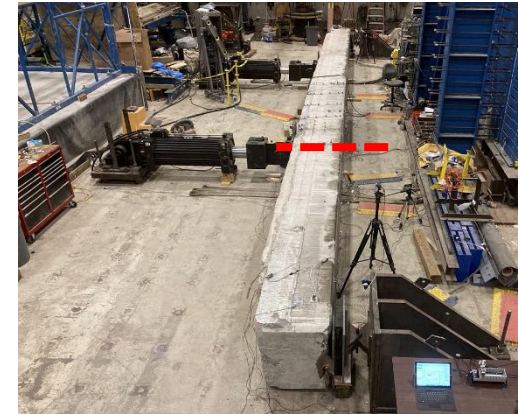
Comparison of Behavior

Specimen	Anchor to laminate ratio	Laminate area per beam width (sq. in/ft)	Capacity increase wrt. bare beam (at peak)	Capacity increase wrt. bare beam (at failure)
Beam 1	0.5	1.9	22%	19%
Beam 2	0.8	1.3	46%	41%
Beam 3	1.2	0.6	50%	26%

- Higher capacities achieved by using thinner FRP
- Ductility has almost doubled from Beam 1 to Beam 3

- Load capacity increased significantly in all configurations
- Anchors delayed the failure following debonding
- Increase in the laminate area increases the bond stress, facilitating the debonding
- FRP laminate rupture was achieved with the anchor/laminate ratio of 1.2
- Arrangement of anchors plays an important role in the performance of the retrofit
- Numerical modeling is ongoing

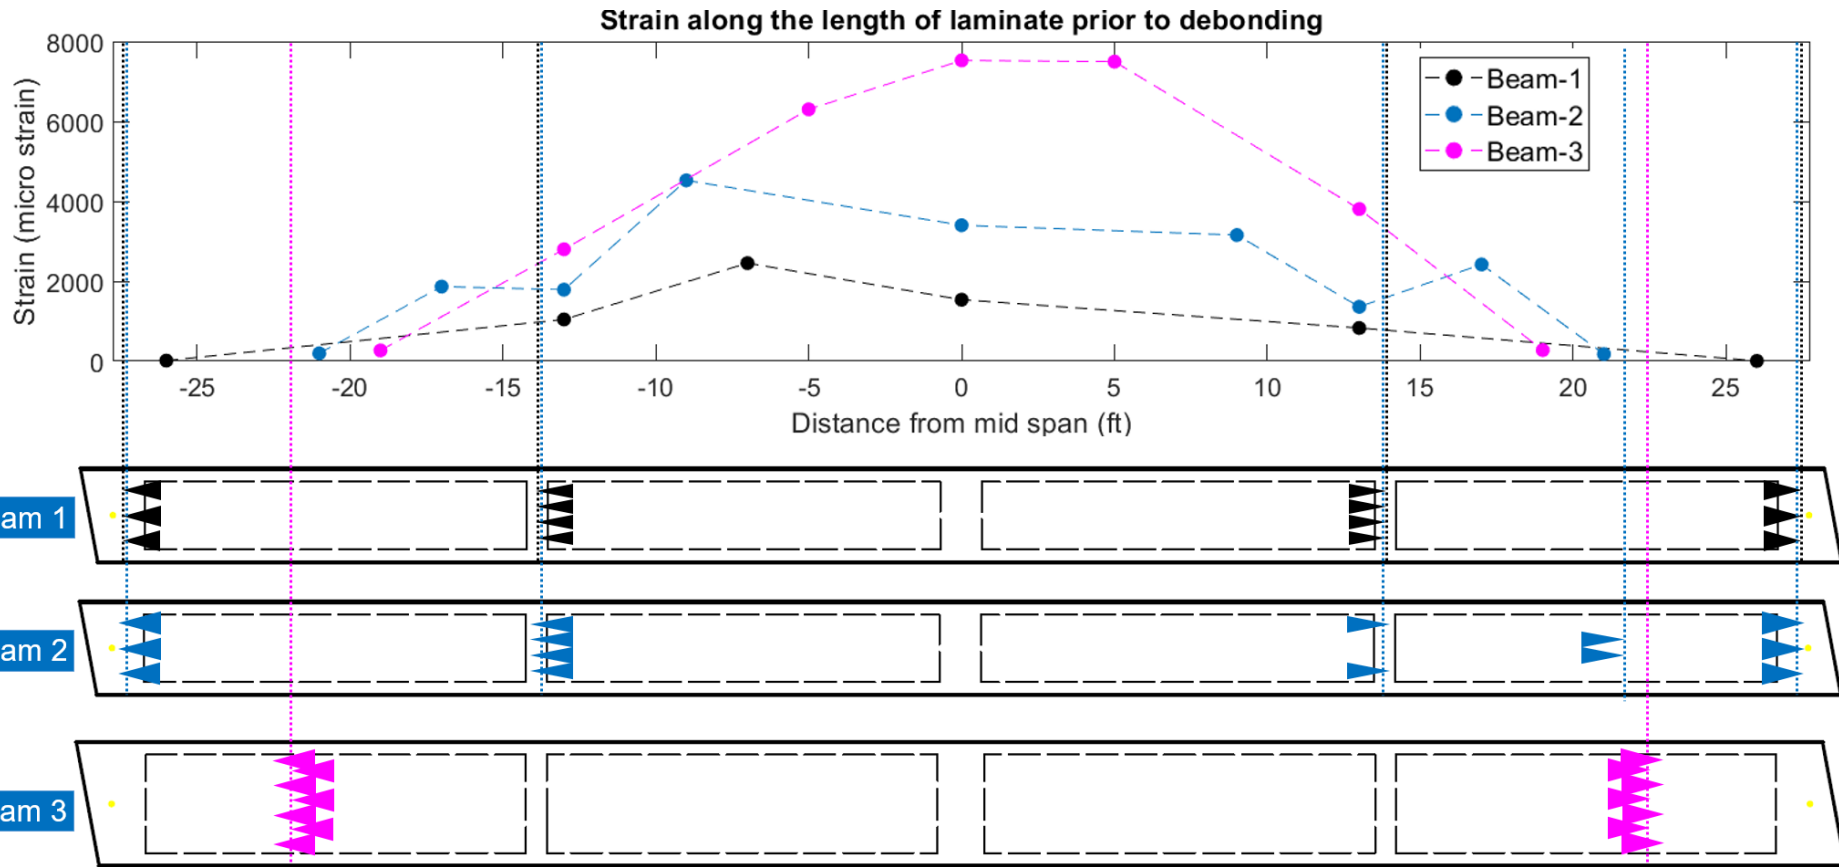
➤ Strain profiles along the length of the beams were obtained : [Pre-debonding](#)

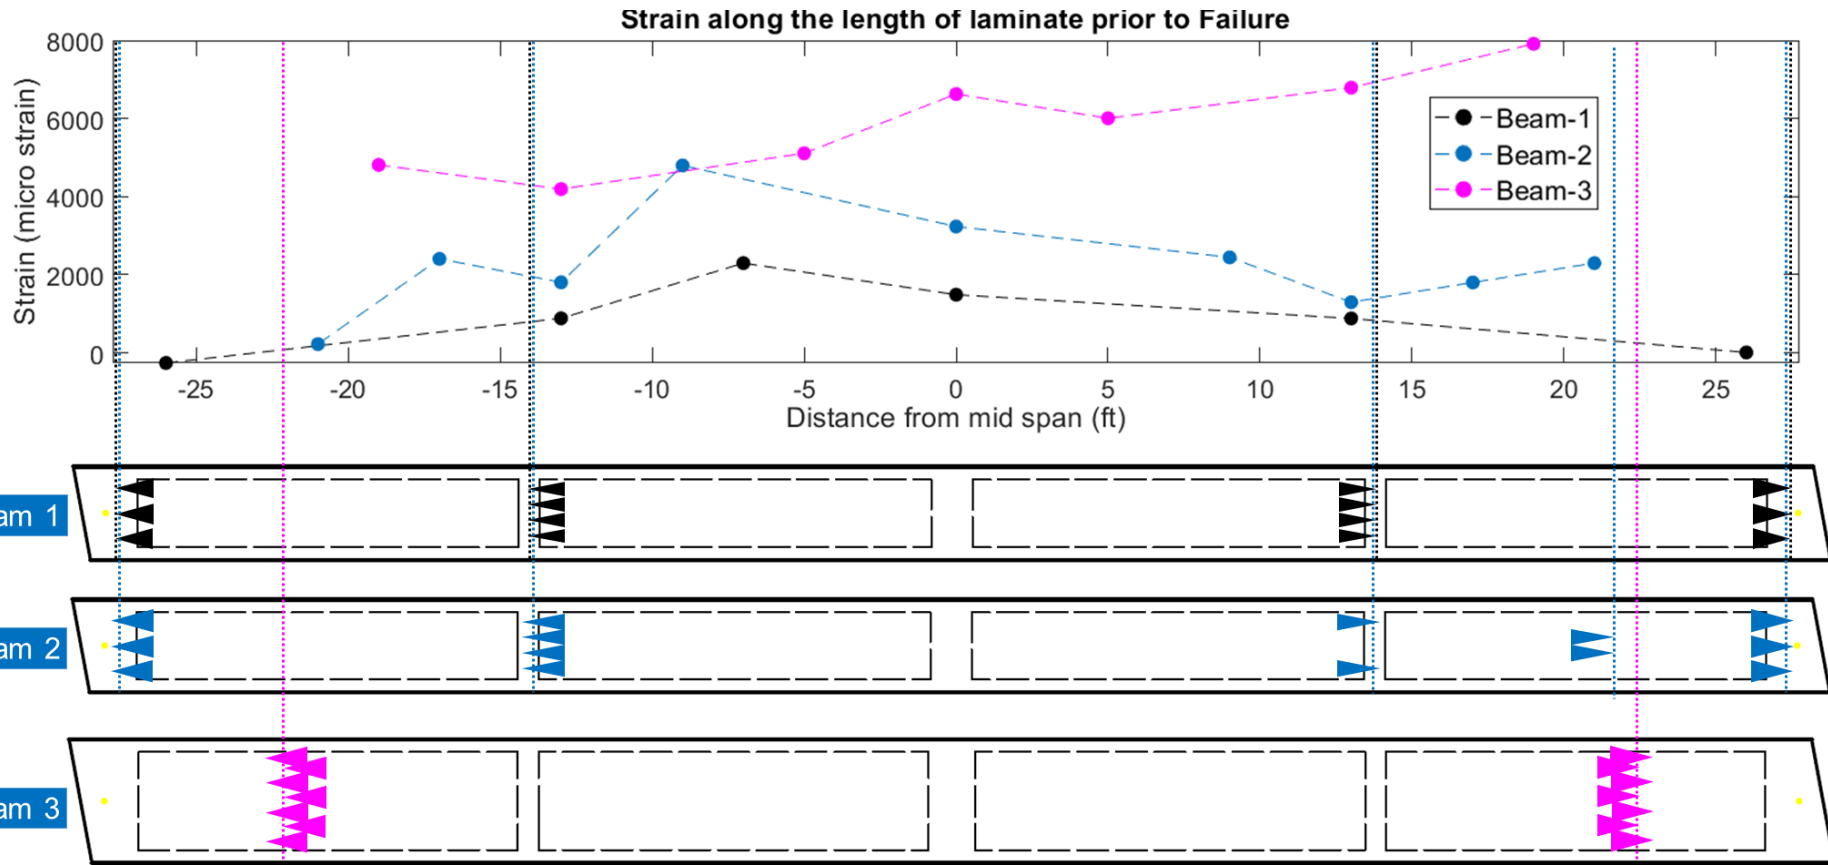
➤ Strain profiles along the length of the beams were obtained : **Pre-failure**

➤ FRP capacity is best used in Beam 3

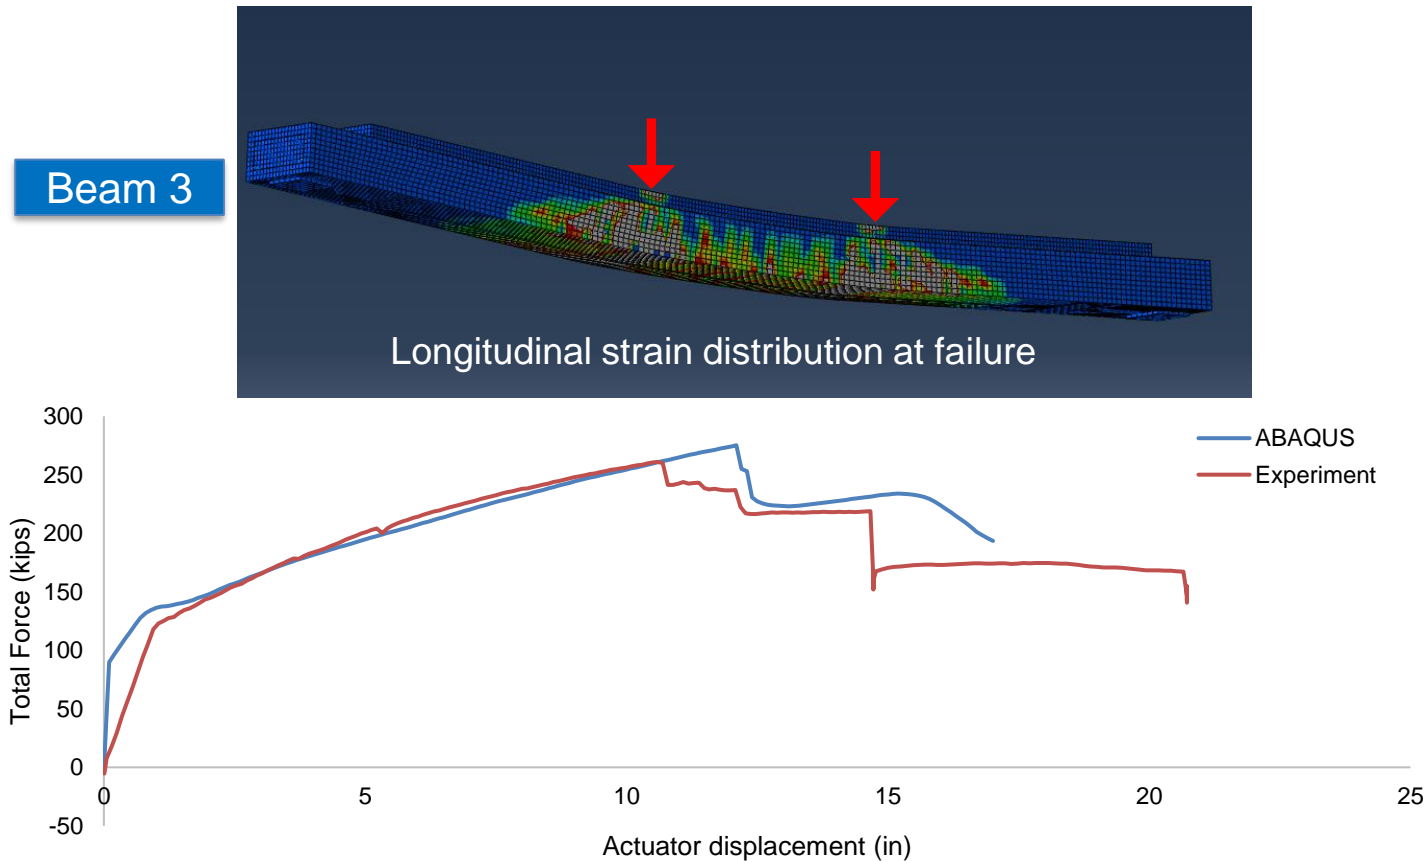
Numerical Modeling

- ABAQUS is used to develop finite element models of the beams
 - All details are included except for shear reinforcement
 - Concrete properties are based on those of extracted specimens

- Additional work needed to model the anchors
