Corrosion in CSA and Other ACM Reinforced Concrete

Neal S. Berke, Ph.D., FACI

Tourney Consulting Group, LLC
Kalamazoo, MI

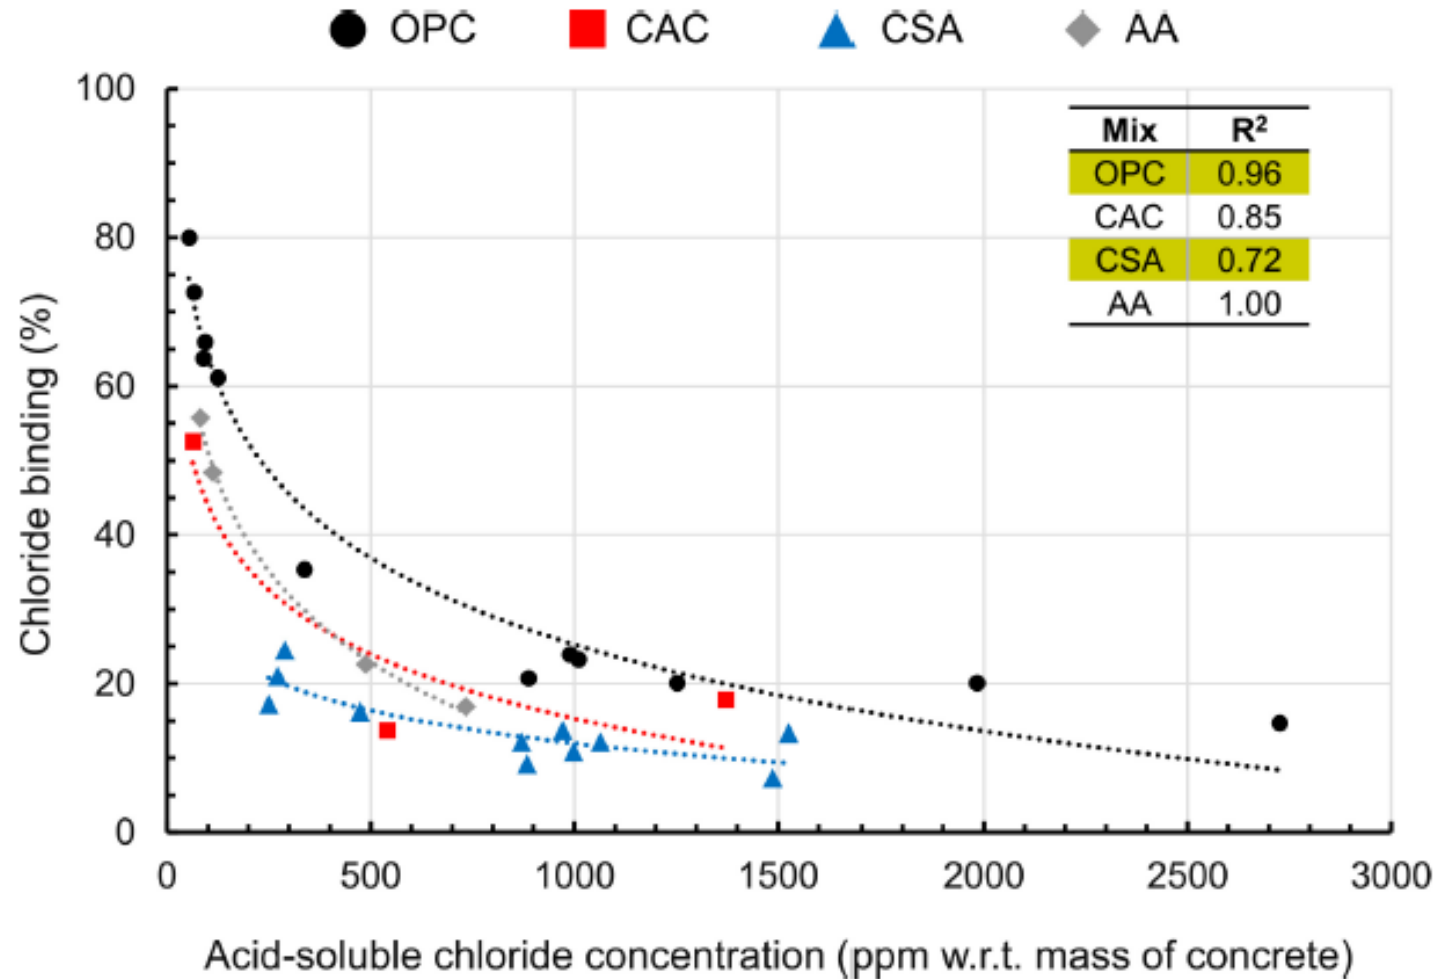
Bound Chloride as a Percentage of Total Acid Soluble Chloride

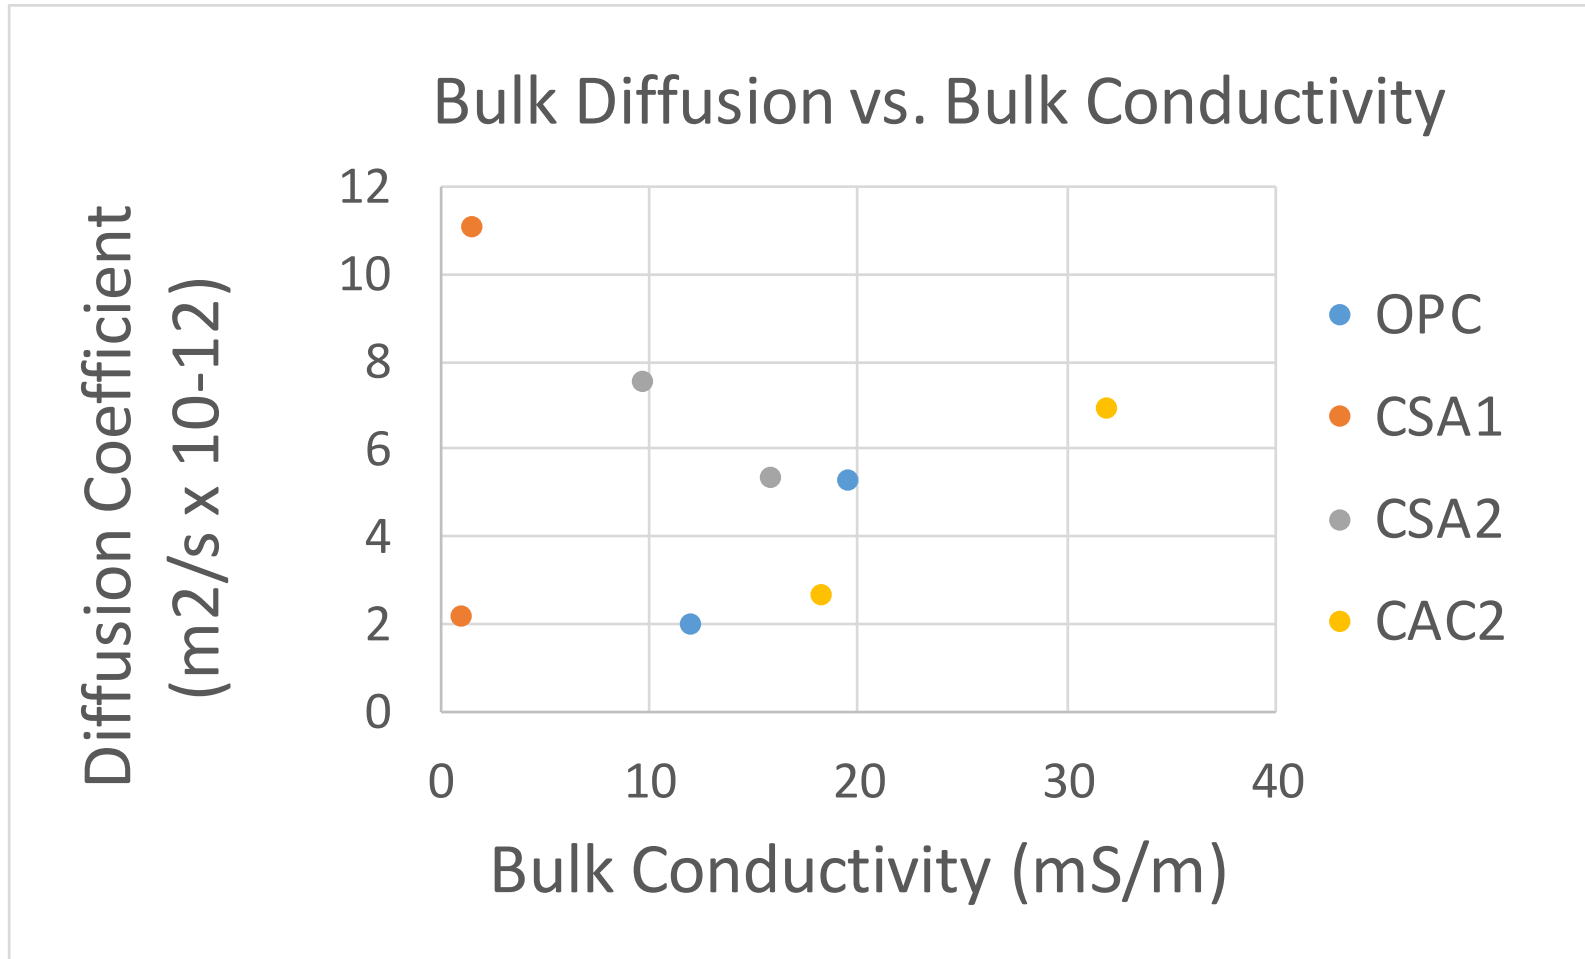
ASTM C1556 Bulk Diffusivity vs. ASTM C1760 Bulk Conductivity

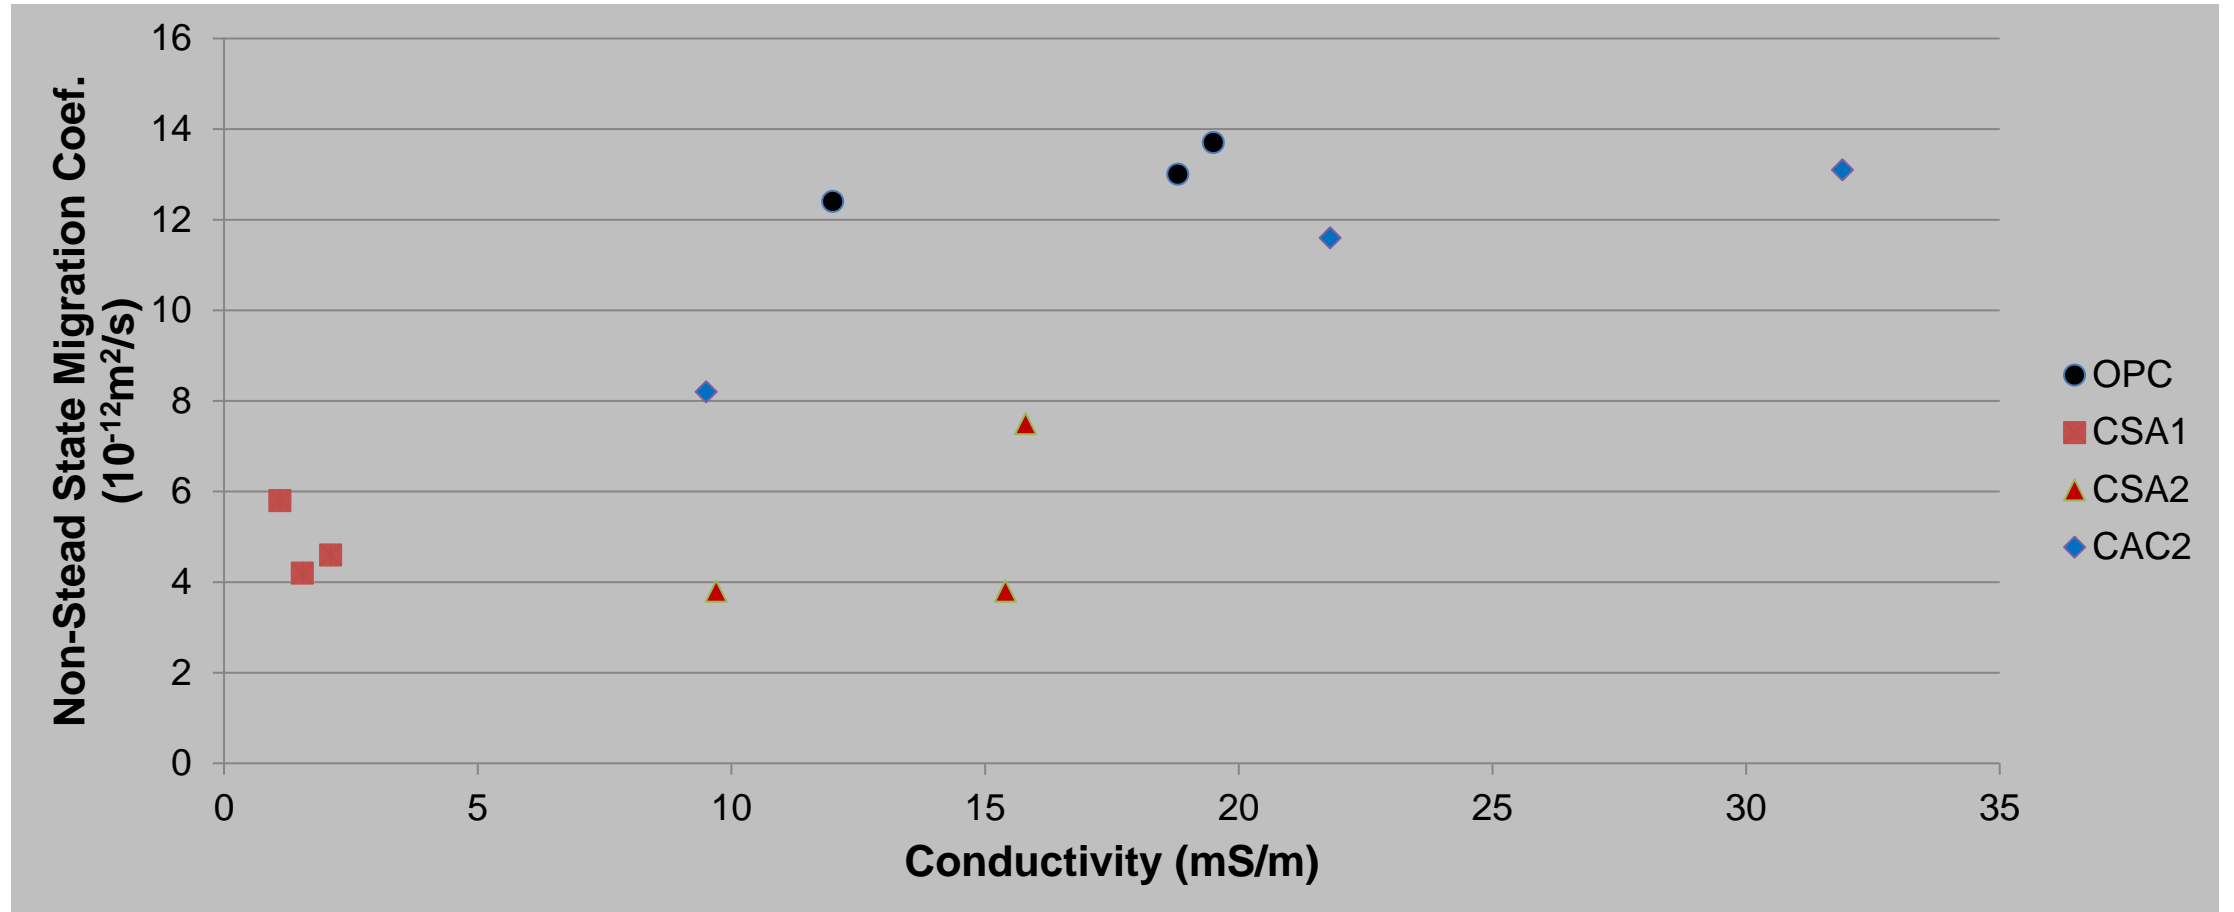
Comparisons of NT Build to Conductivity

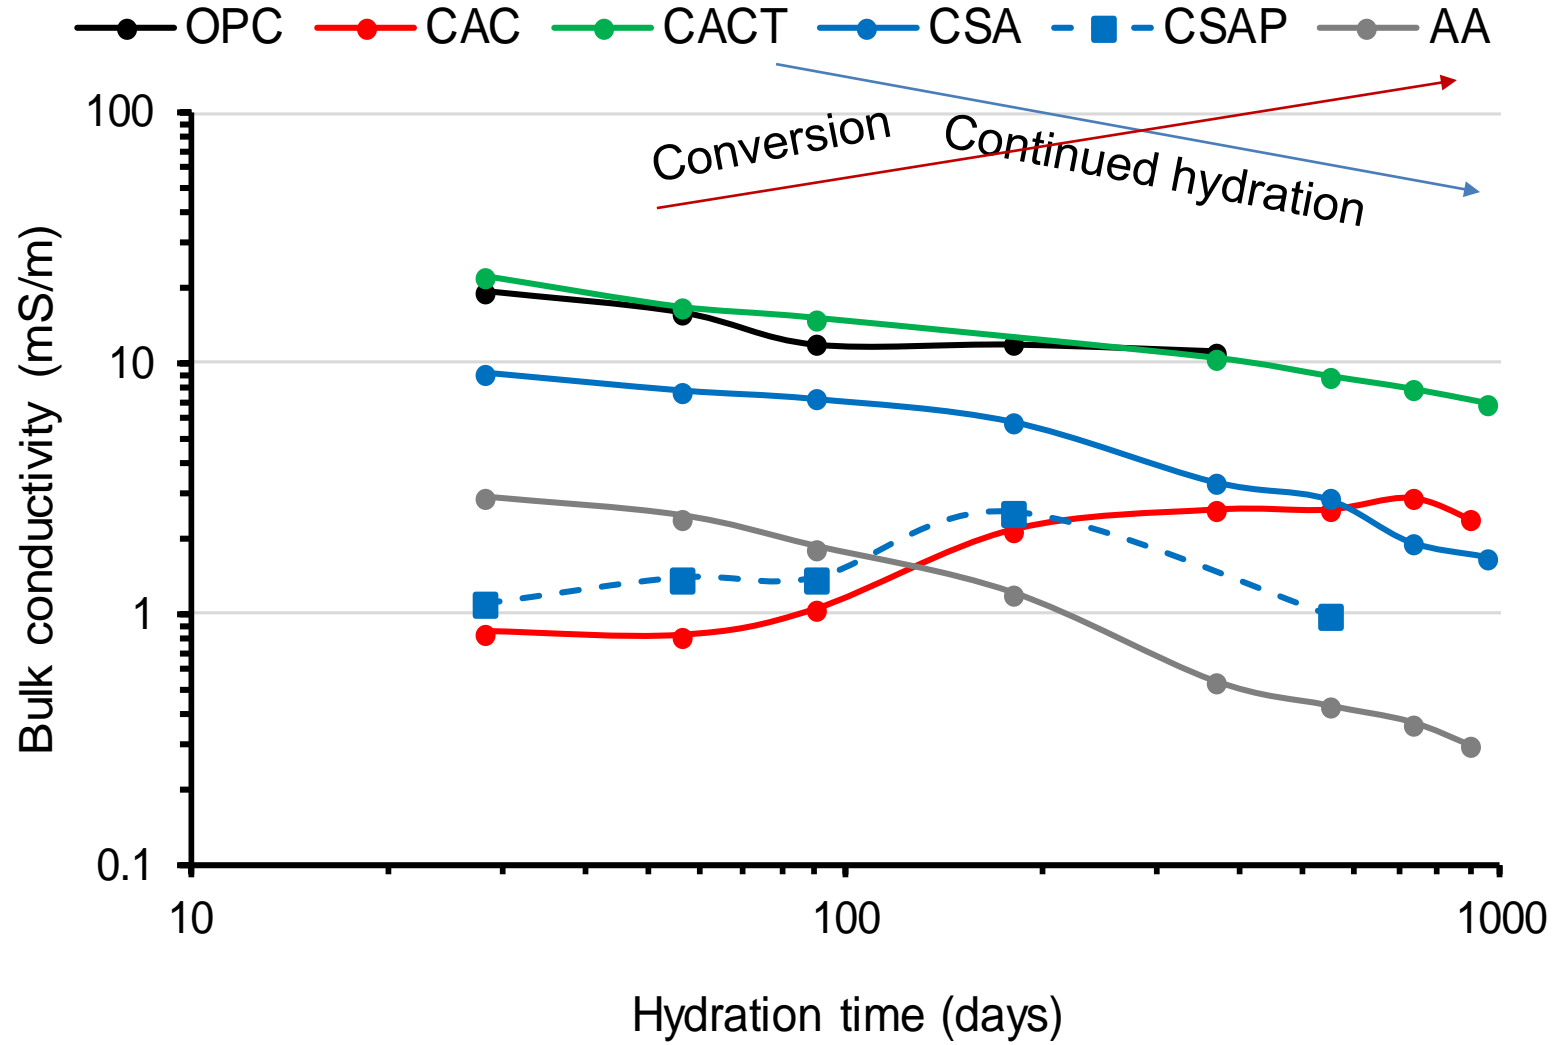
Bulk Conductivity vs. Time

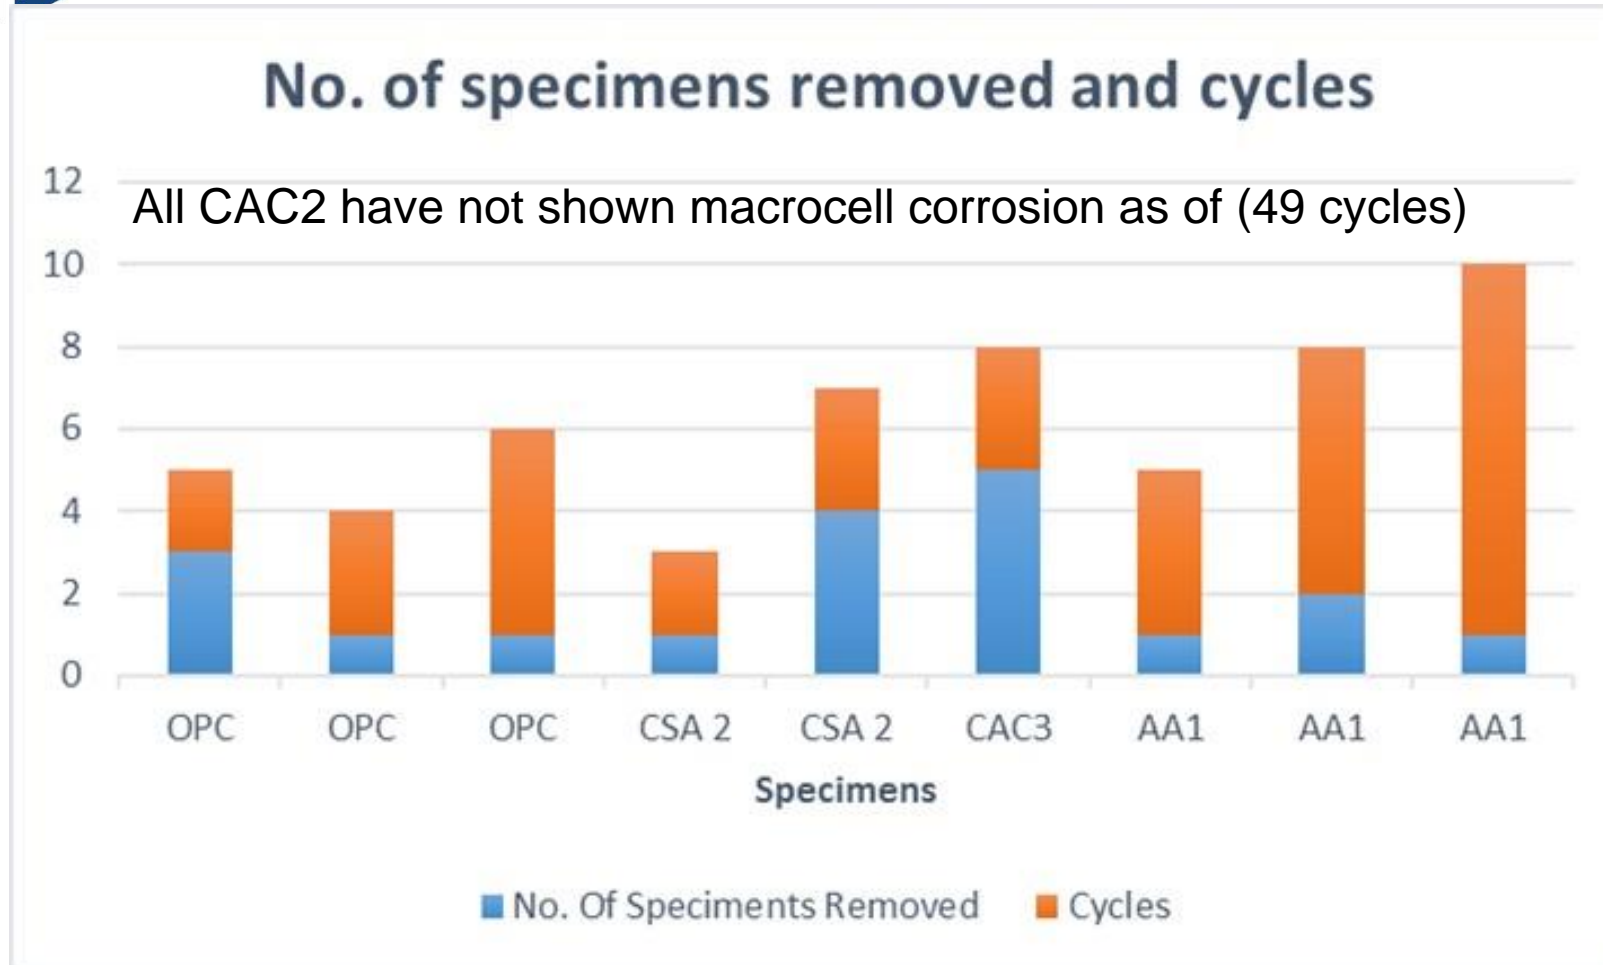
Status of Mortar Corrosion Specimens

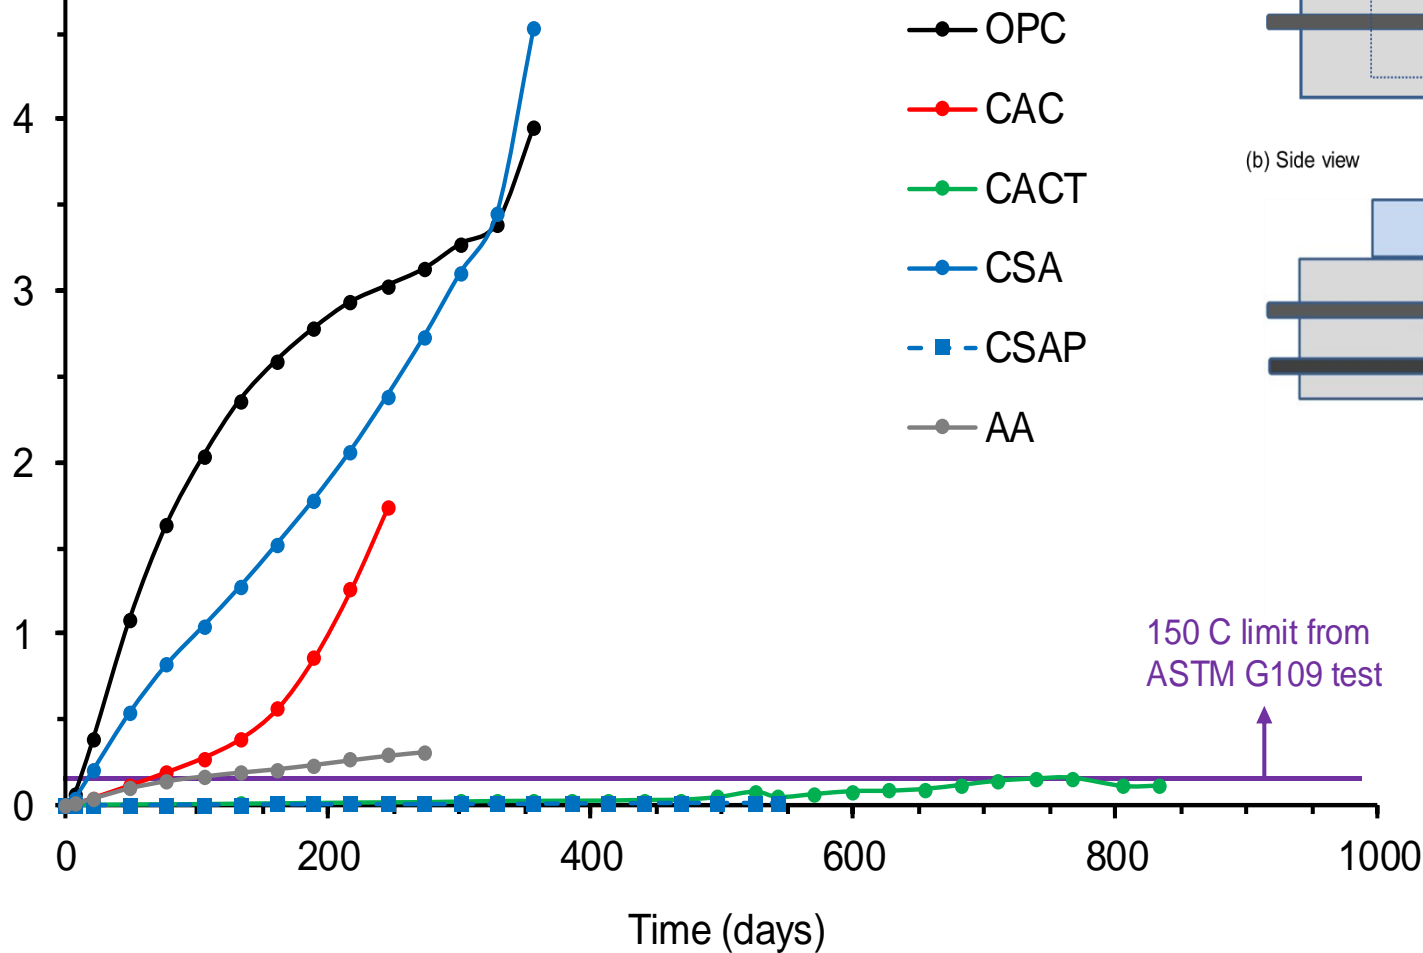
G109 Cracked Beam Macrocell Current – 3% NaCl

Integrated macrocell current (Kilocoulomb)

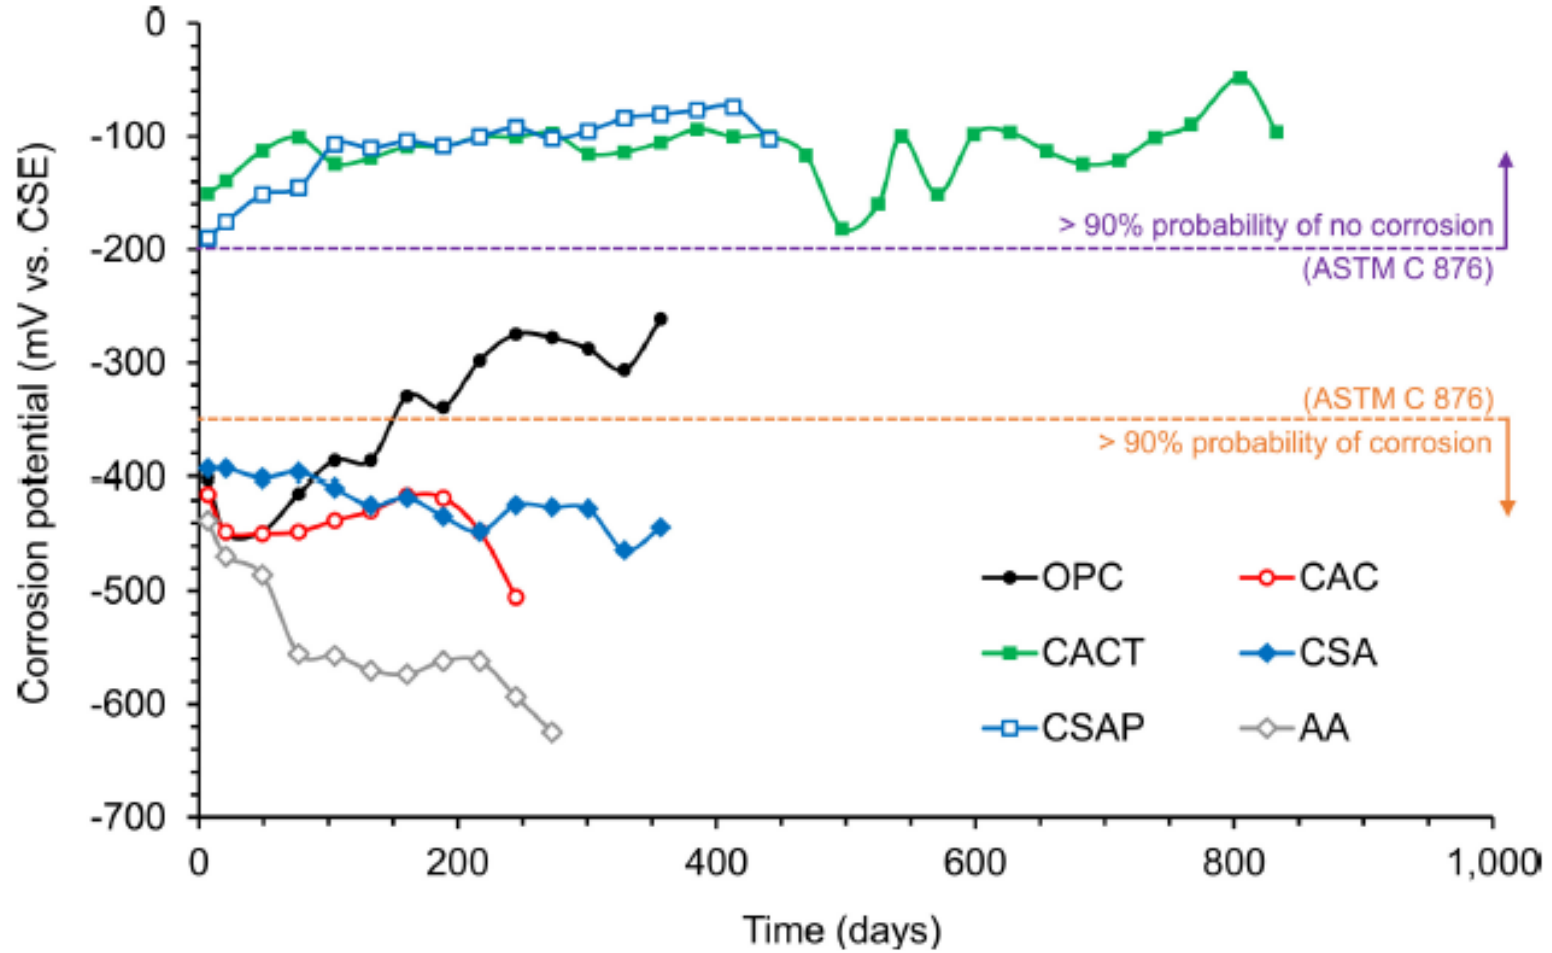
Corrosion Potentials vs. Time

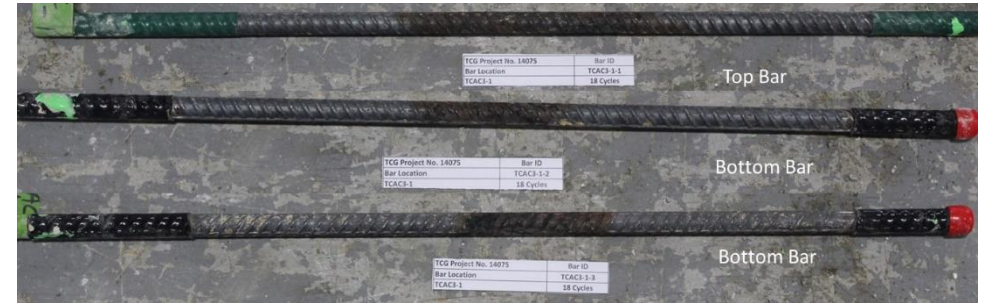
Typical CAC2 showing corrosion on top and bottom bars

- CACT showed best corrosion performance in macrocell currents and actual corrosion of the bars.
- CSA2P had good macrocell corrosion performance but still had some corrosion. Corrosion on bottom bars would offset some macrocell performance.
- OPC had corrosion on the top bar and high macrocell currents but none to very small corrosion on bottom bars.
- CSA1, CSA2, CAC2 had high macrocell currents somewhat reduced by a large amount of corrosion on bottom as well as top bars.
- AA1 had lower macrocell currents than OPC but more corrosion on the bottom bars.

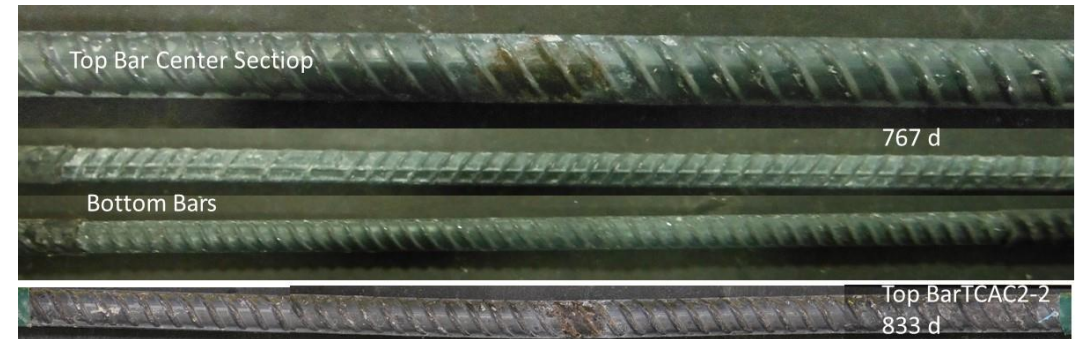
Typical CACT showing corrosion on top but not bottom bars

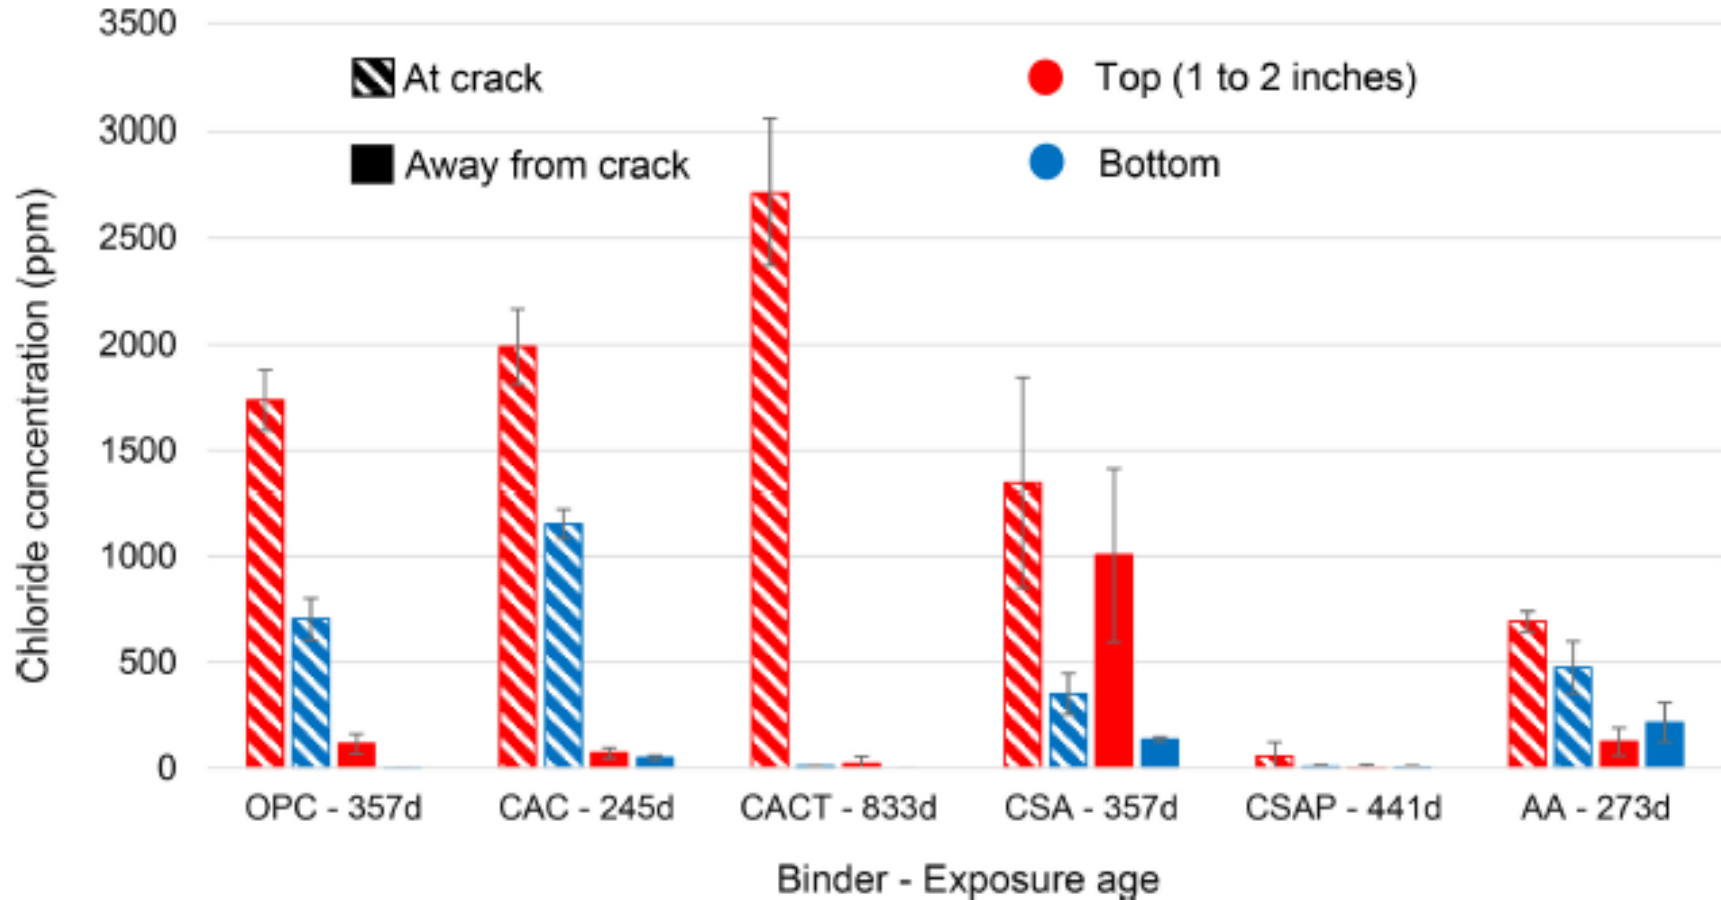
Chloride Distributions at and Away From Cracks

- Bulk pseudo diffusion coefficients compared to OPC
 - Higher for CSA1 and CSA2
 - Approximately the same for AA1 and CAC3
- However, total chloride at the surface and subsequently in the interior is less for the ACMs Could be due to reduced chloride bonding found for CSA and AA1 mixes.
- At cracks all of the ACMs (except CAC2 (CACT)) show no effect of depth on crack, whereas, there is a decrease in chloride with depth for the crack in OPC
- Equivalent corrosion rates at lower chloride levels (except CAC2)
