Errors in the Design and Construction of Concrete Structures

Why & What To Do? CRACKED P-T BEAMS & STEEPLY-CRACKED COLUMN

Two Case Studies in
Investigation and Repair

Errors in Design and Construction of Two-way Slab Systems

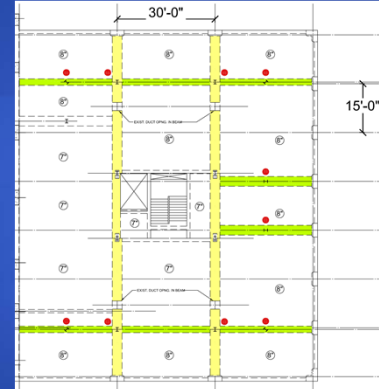
Partial plan of floor

- Initial plan called for a structure using primarily post-tensioned concrete beams and slabs and reinforced concrete columns
- Late in design phase, a steel-framed two-story structure (library and file storage) was added to building at what had been a set-back roof level
- Some of the new steel columns were supported at midspan of post-tensioned flexural members
- Beam spans were about 30'; girders spanned 45'

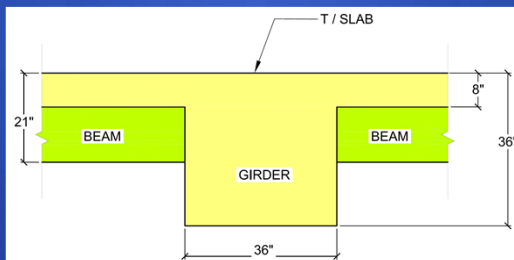
Section through girder

- Owner ultimately decided to have this part of building strengthened, rather than lower its allowable loading
- After study of options, CSD chose external post-tensioning (7-wire strands, 0.6" diam., 4 per tendon, 1 tendon each side of beam)
- A V-shaped profile provided an upward force to counteract the concentrated column-loads
- Space below affected part of floor had to be temporarily emptied for construction

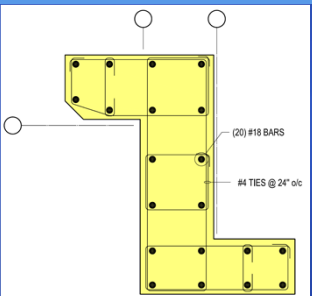
Column section (6.5' deep)

- Steep crack noticed on exposed side of a major column
- Z-shaped cross-section; 6.5' deep
- Reinforcing: (20) - #18 bars; #4 ties at 24"
- Concrete strength: $f_c' = 5.6$ ksi

(20) #18 BARS

#4 TIES @ 24" o/c

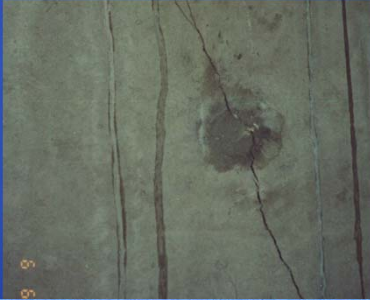
Close-up of crack

Initial observations

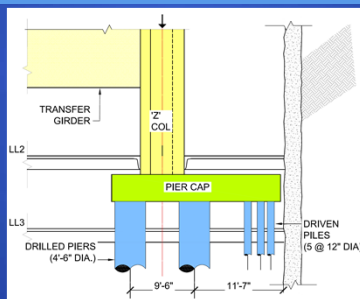
Overview

- Documents showed that piles were added, after original design using only drilled-piers
- Concern about bell strength, as constructed, led to adding 5 driven piles
- All piles located on one side of the drilled piers, apparently to avoid loss of parking space
- As a result, foundation's centroid did not match column's center

- This eccentricity caused a moment at the column's base, and a horizontal shear in the column
- The eccentricity was calculated and found to equal about 1.8', based on certain assumptions about behavior of drilled piers and driven piles

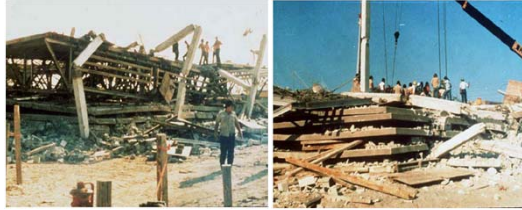
Harbour Cay Condominium Collapse

- Under construction, 5 story, roof slab
 - slab thickness low 8" vs 11"
 - top steel too low
- ↳ Combined effect
- Large deflections and severe cracking noted prior to collapse
- No punching shear calculations had been made
- Severe design errors

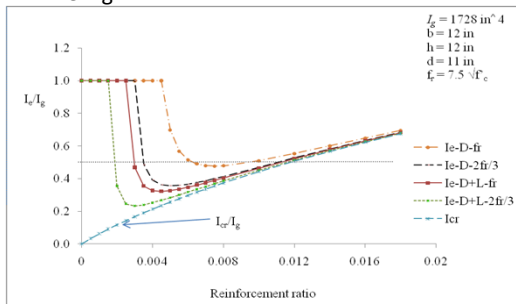
I_e/I_g vs Reinforcement Ratio

- Lightly loaded slabs sensitive to cracking
- Deflection underestimated if cracking ignored
- Slabs with low reinforcement ratio
-Substantial reduction in stiffness after cracking
