# Guide to the Code for Evaluation, Repair, and Rehabilitation of Concrete Buildings

A Companion to ACI 562-13

**First Edition**

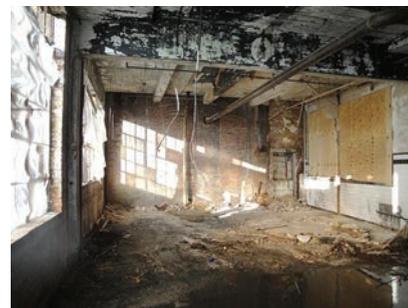
*Inside the factory before restoration*

A design and construction team was assembled to perform a condition assessment. Unoccupied and lacking maintenance for over a quarter of a century, the building was in extreme disrepair (see back cover). Due to the lack of concrete cover, lower-quality concrete, and advanced carbonation, corrosion had spread throughout the exterior reinforced elements and interior columns. Ceilings and spandrel beams were especially heavily damaged from accelerated corrosion. Testing revealed that the concrete compressive strength was 2000 psi (13.8 MPa), consistent with building codes of that era. The steel reinforcement was smooth and uncommonly placed diagonally to column alignment. The severe corrosion diminished the capacity of the reinforcement, making it necessary to use structural strengthening in addition to the repair and protection work.

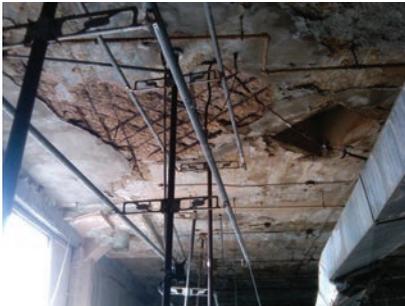
*Spalling ceiling*

3. Machine-applied repair mortar was used to repair some large ceiling sections. This method was selected to greatly improve production while providing a very dense material.

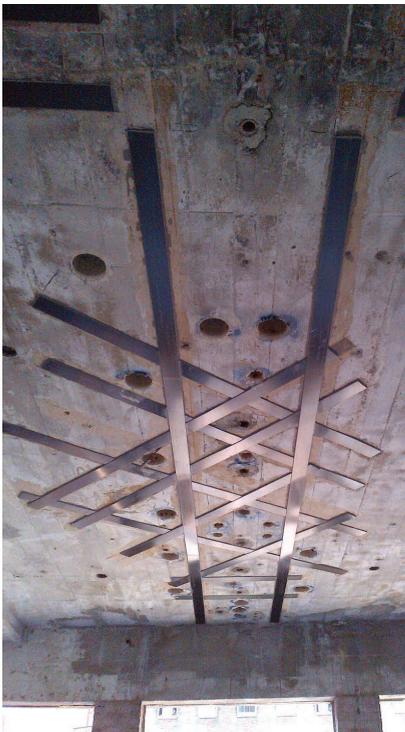
*Carbon-fiber plates*

Roof slabs of the building had extreme section loss requiring new reinforcement. Supplemental reinforcement was also used to bring slabs back to their safe load-bearing capacity. Carbon-fiber plates were installed for strengthening these areas along with strengthening locations of new cutouts for conduits, pipes, ducts, and vents and for the new HVAC system.

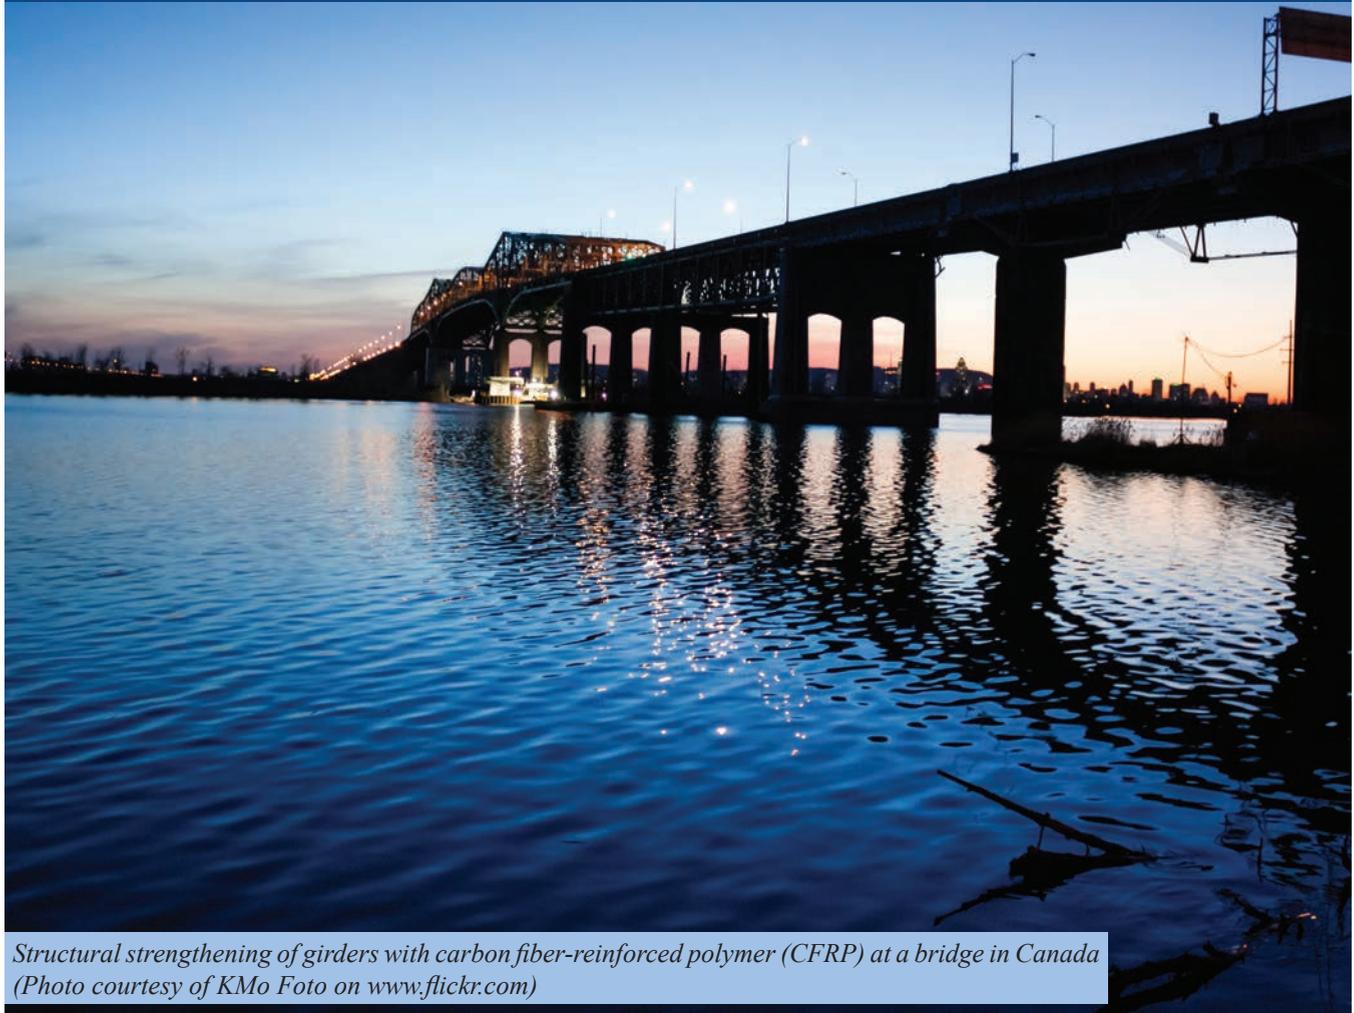
*Structural strengthening of girders with carbon fiber-reinforced polymer (CFRP) at a bridge in Canada  
(Photo courtesy of KMo Foto on www.flickr.com)*
