ACI Convention Minneapolis, Minnesota April 15, 2013

obert Quattrociocchi, EllisDon

- Construction began in 2004 for the Lakeridge Health Centre North Wing Expansion (Oshawa, Ontario)
- New cancer treatment facility housing 7 radiation therapy bunkers

# HD Concrete Repair Procedure:

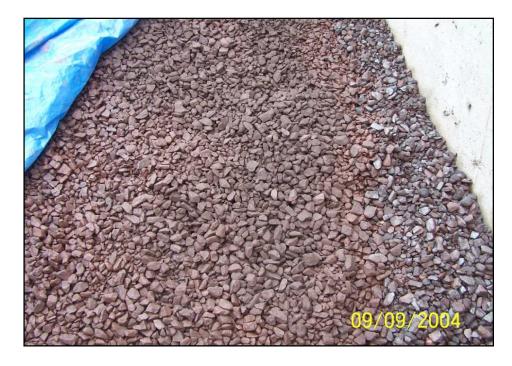
- Hematite aggregate from Brazil
- Specific Gravity = 5
- 20mm (3/4") nominal

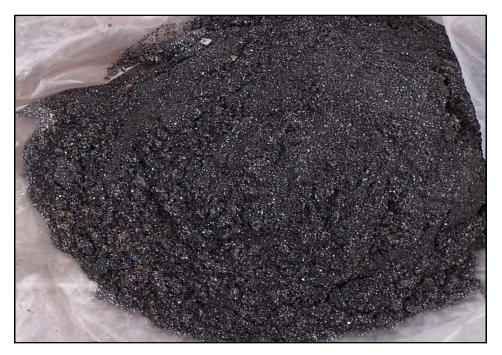
- Benificated Hematite sand from Quebec, Canada
- Specific Gravity = 4.9
- FM = 1.8

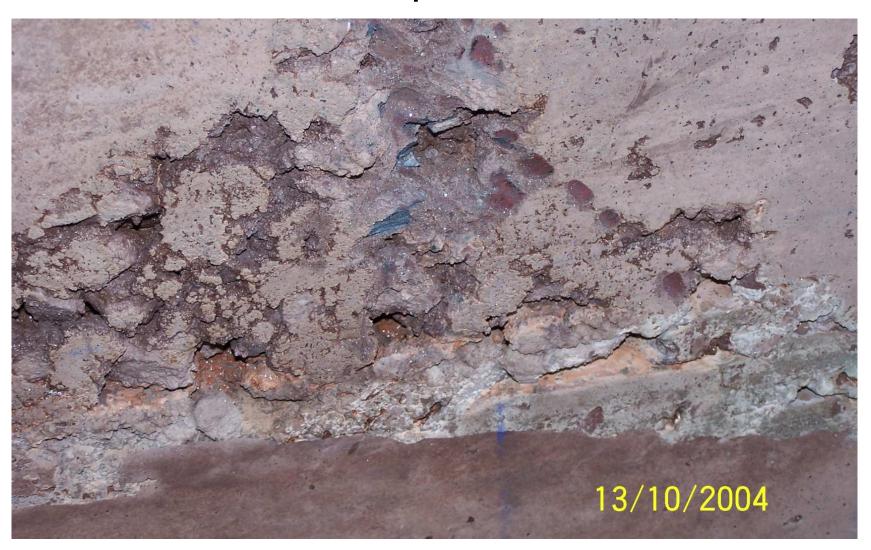
# What's with all the honeycombing?

Why all the honeycombing?

Low slump (well below target)
High slump (well above target)
3<sup>rd</sup> party testing took way too long
Improper consolidation
HD concrete poured in alternating 6" lifts with RD concrete (extended pour duration)
Issues integrating HD concrete with RD concrete
Yada yada yada ......

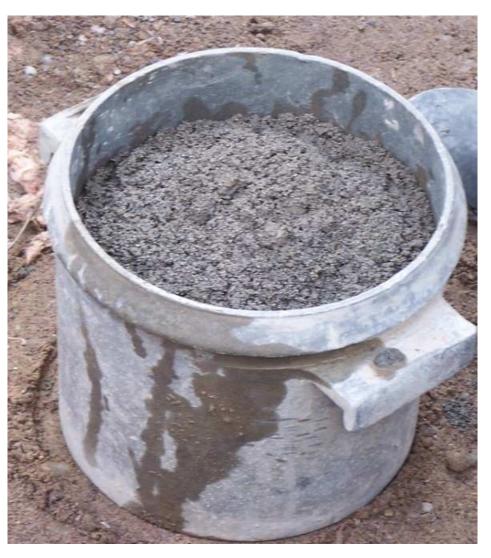
- High density grout to a "drypack" consistency
- Steel shot used as coarse aggregate (SG=7.8)
- Hematite sand used for fine aggregate (SG=4.9)
- Shrinkage Compensating Admixture
- Latex bonding agent
- Mixed in 30L mortar mixer

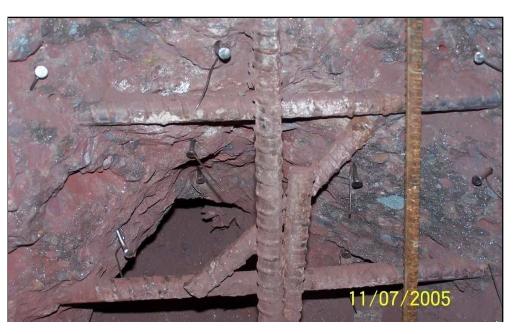
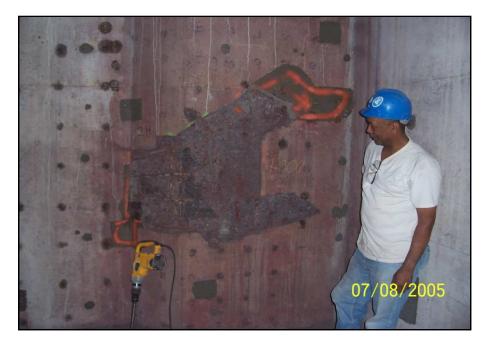
- Affected zones chipped out to sound material
- Perimeter areas benched to provide min <sup>1</sup>/<sub>2</sub>" ledge
- Exposed base substrate washed with high pressure sprayer

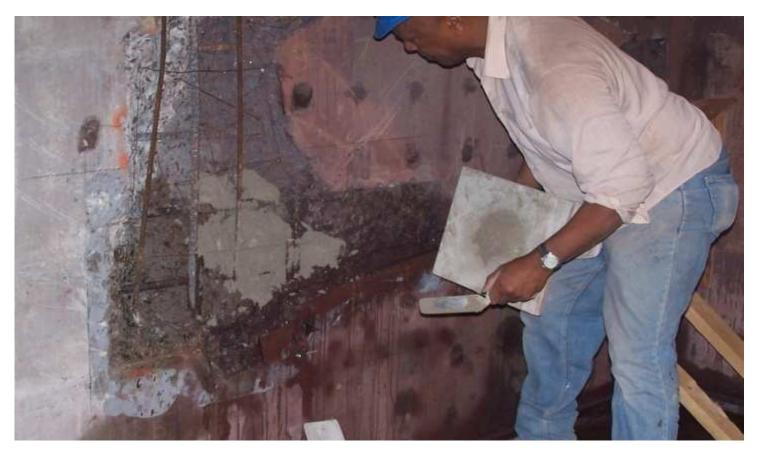
- Tapcons with tie-wire set into base substrate for transfer of shrinkage strains at bond line
- 10m rebar added for shrinkage restraint if depth of repair permitted

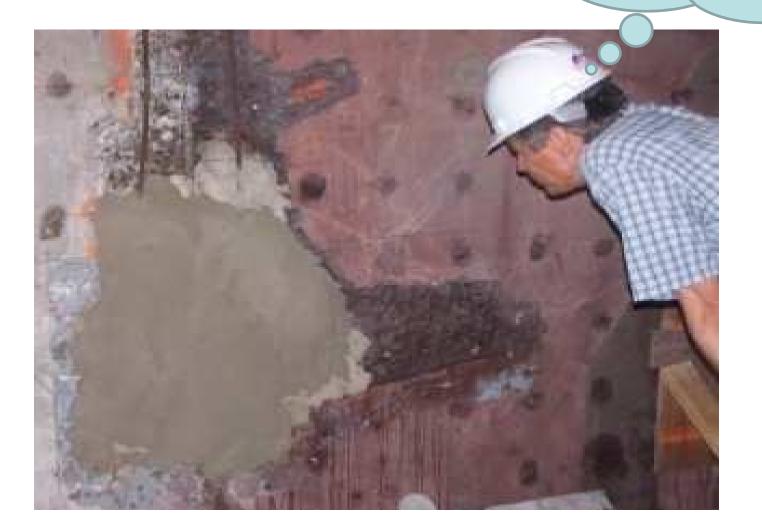
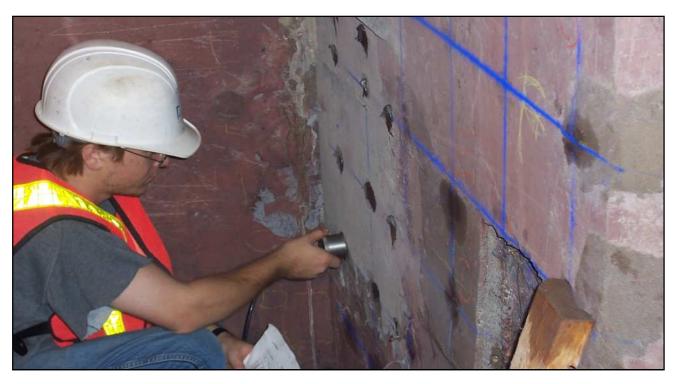
- Sounding or tapping process indicated potential for voids
- Ultrasonic Pulse Velocity (corelated to results from cores) used to verify integrity of patches
- Results indicated that several patches had delaminated / contained voids
- We needed another approach.....and fast!!!

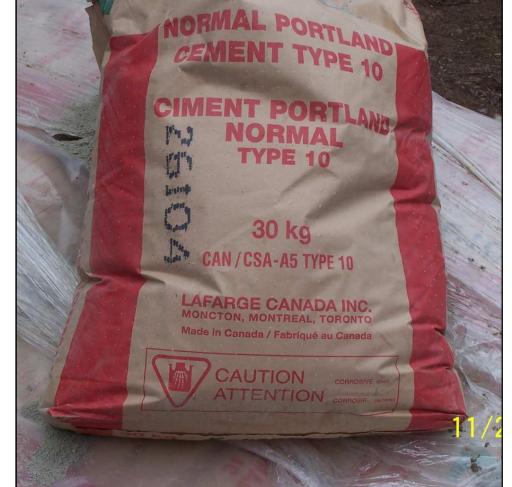
- High paste volume required:
  - due to shape and gradation of Hematite sand
  - due to void ratios of both the sand and steel shot
  - to act as carrier for high density aggregate
  - for filling around rebar
- 720 kg/m<sup>3</sup> of Type 10 used for flowable mix

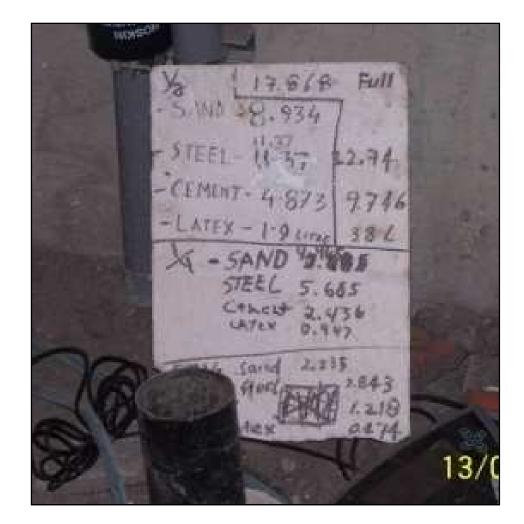
- Preliminary trials performed in the field
- Initially targeted 650mm
   (26") slump flow
- We were achieving the flow we needed, but mix was unstable
- Experienced segregation issues at this slump flow level

To increase stability while maintaining our spread we:

- Reduced water content
- Increased HRWR
- Increased VMA
- Trial & Error process
- The results.....

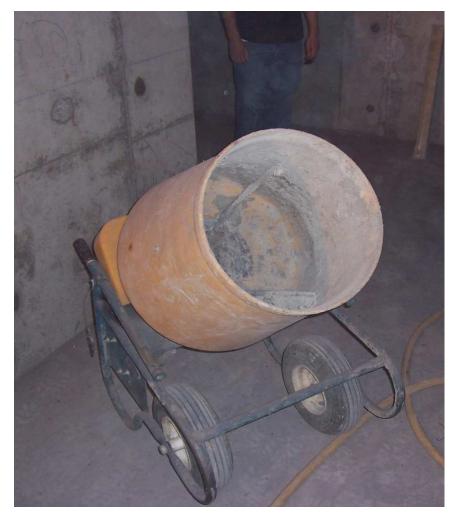
- 5 liter batch
- Butter mixer with blend of steel shot, sand, cement and water
- Add steel shot
- Add cement and blend
- Add sand to mixture
- Add 90% of water & SRA
- Add HRWR and 5% of water
- Add VMA and remainder of water
- Mix until consistency achieved
- Check slump flow (if not min. 560mm, temper with HRWR)

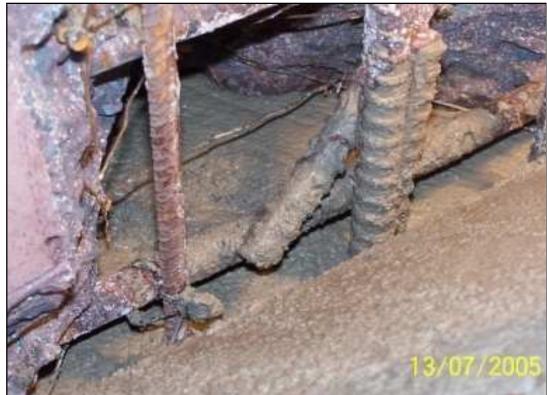
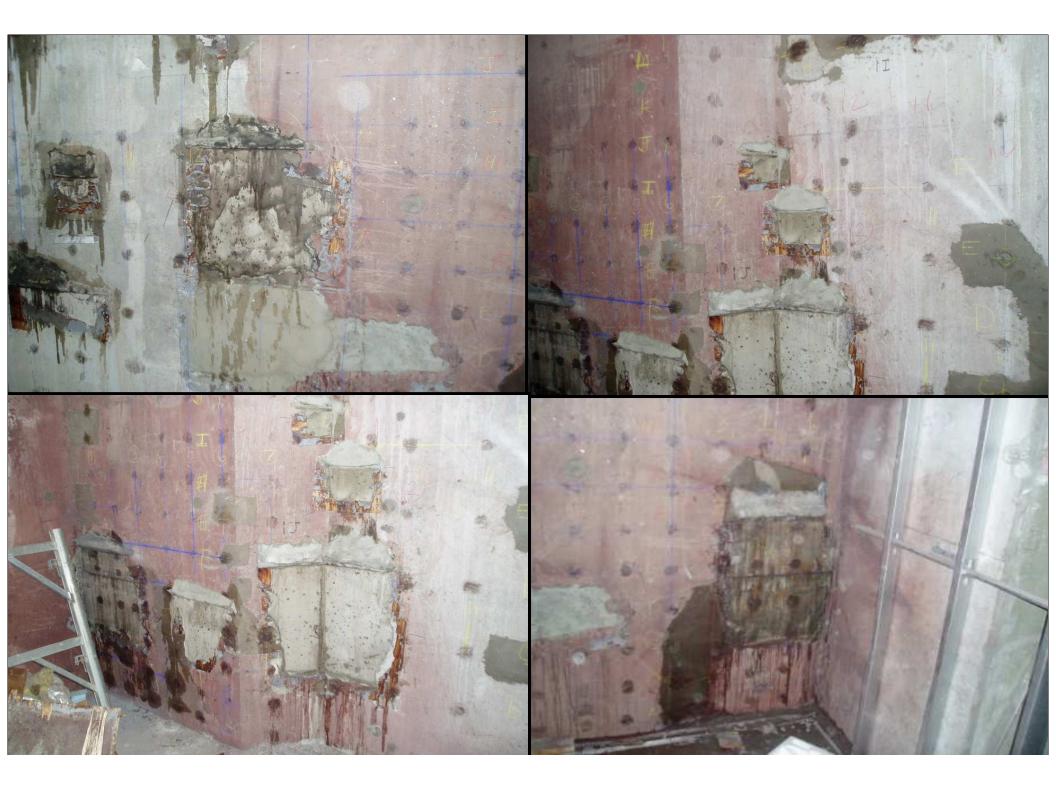
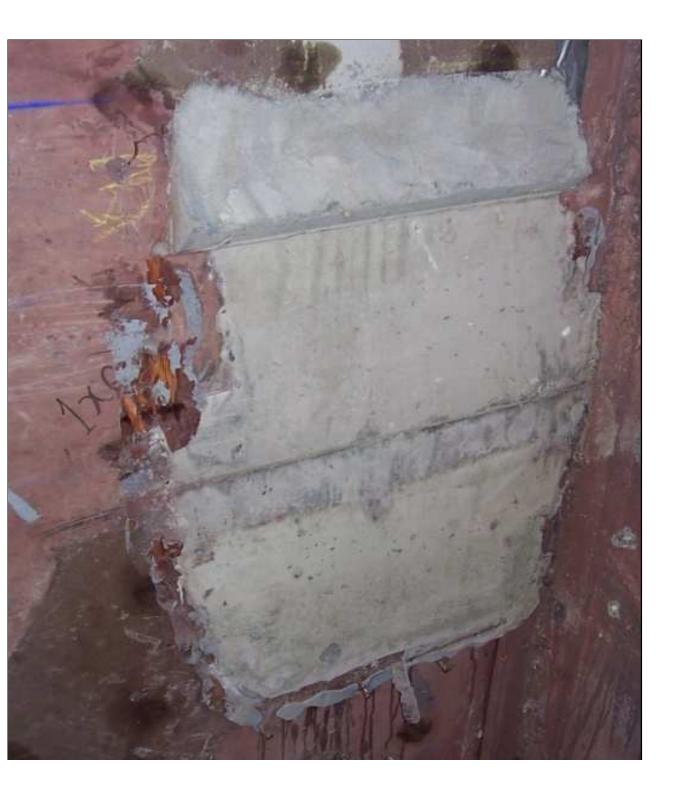
Forms installed with a beak extending 75mm (3") above patch

Perimeter of forms and joints sealed with caulking

Drainage hole with plug installed at bottom of form to check for water tightness and for preconditioning

- SCC poured in 3 uniform lifts to reduce drop
- Formwork tapped after each lift to remove air bubbles
- Filled to min. 75mm (3") above patch
- Larger patches formed in segments
- After first lift was placed, another panel was installed above

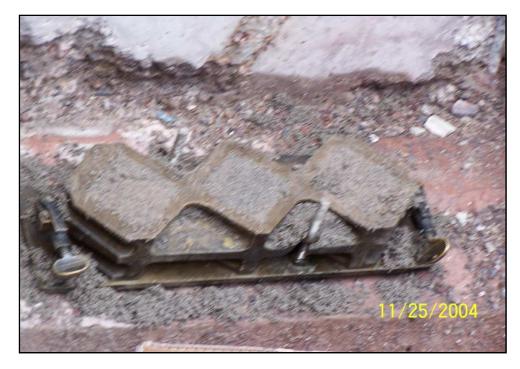
- Grout cubes taken at the beginning and end of each day to monitor strength
- Surfaces tapped with rebar to determine if hollow sounds present
- Ultrasonic Pulse Velocity testing performed once more after 7 days

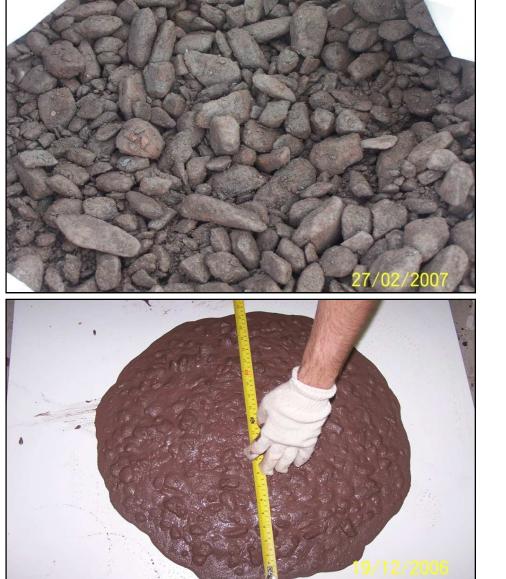
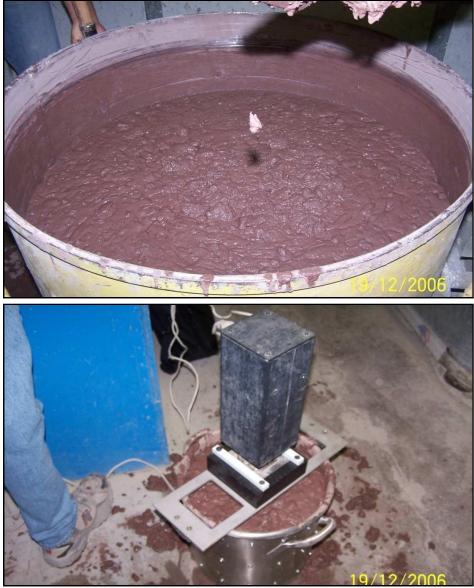
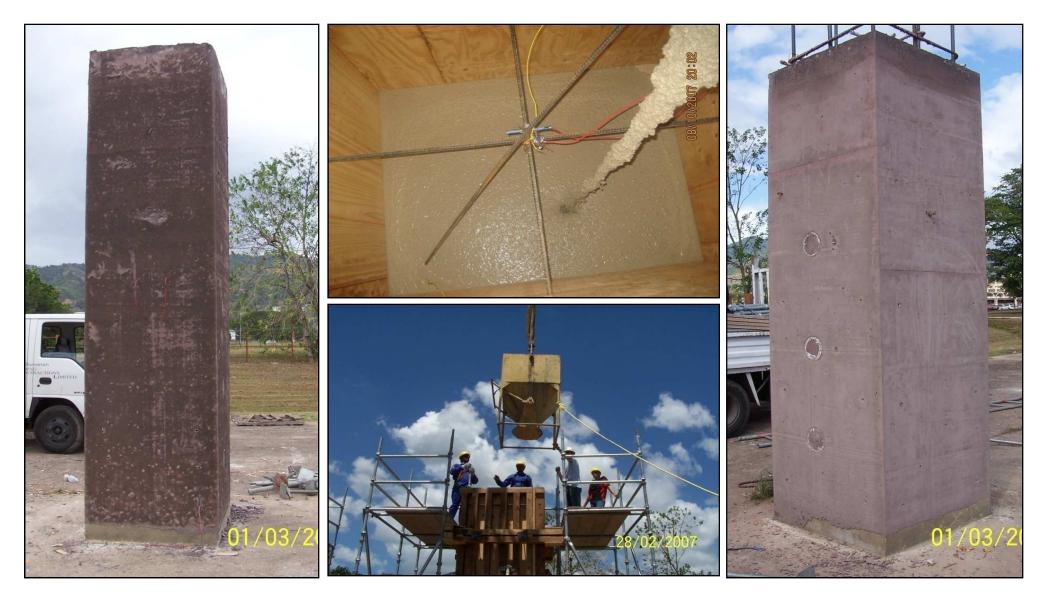
#### National Oncology Centre Mount Hope, Trinidad & Tobago

- From October 2006 July 2007
- 4000 kg/m3 high density SCC concrete for radiation therapy bunkers
- SCC required to provide full consolidation between rebar and to flow beneath block-outs cast-in for mechanical ductwork sleeving
- Technology transfer to local readymix producers in the Caribbean
- Concrete trials performed in lab (Toronto) and in field to prove the viability of the mix
- Series of mock-ups cast on site to verify performance and constructability
