**Virginia Experience with  
Post-tensioned Tendon Grouts  
ACI Washington DC  
Monday October 27, 2014**

Michael Sprinkel, P.E.  
Associate Director, VCTIR

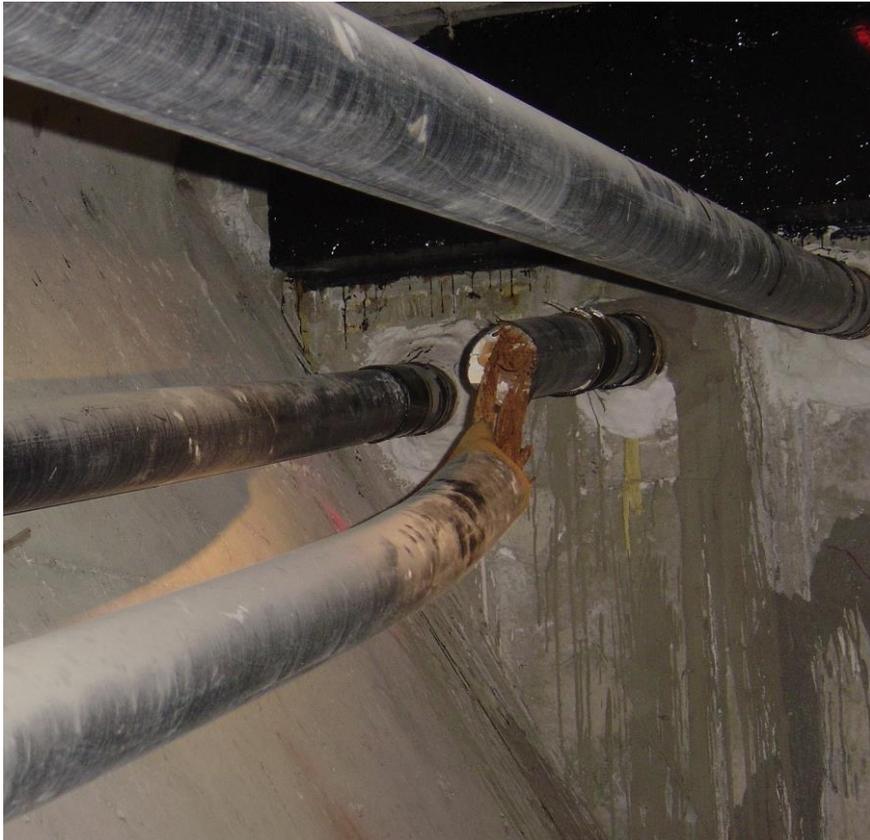
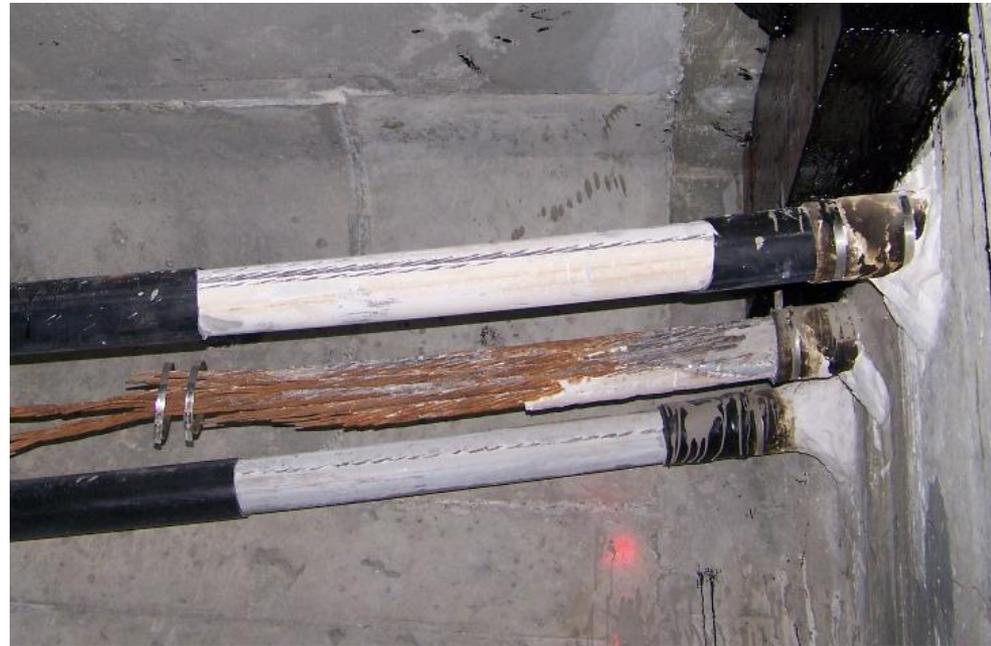
- Tendon fails in Varina Enon Bridge after 17 years. Two tendons replaced. 20 tendon sites in VE bridge inspected by removing 2-ft of duct.

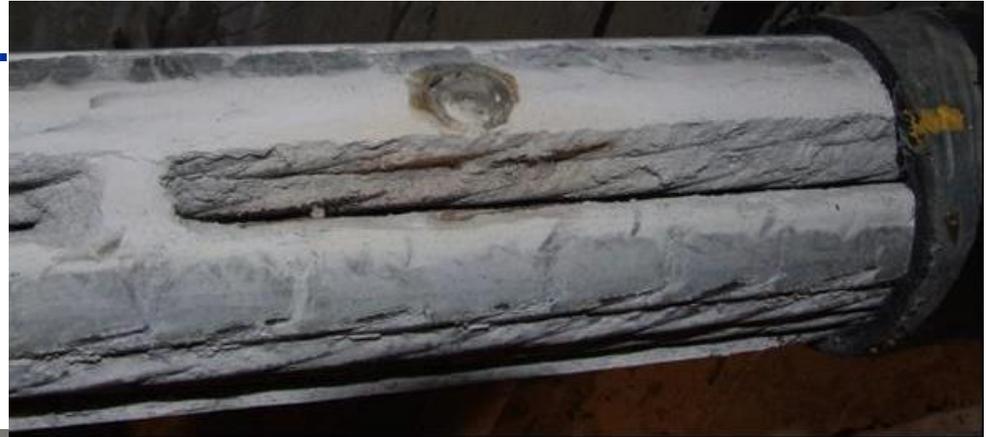
Incomplete  
vacuum grout,  
NP3T16

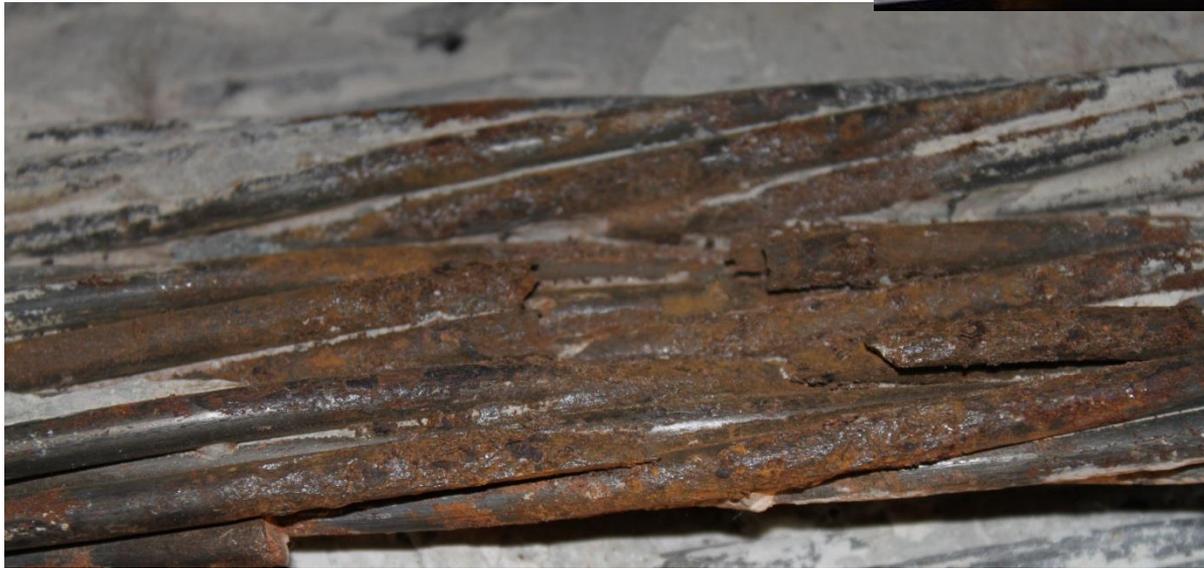
8 Broken Wires, NP13T10

Tendon	Broken wires 2007	Broken wires 2013	*Avg. broken wires /yr	Section loss 2007	Section loss 2013	*Avg. section loss/yr
NP13 T10	2	4	0.33	7 wires 5.3 %	10 wires 2.9%	0.5 wires 0%
SP12 T9	1	1	0	4.8 wires 3.6 %	15 wires 4.4%	1.7 wires 0.13%
Avg.	1.5	2.5	0.17	5.9 wires 4.4%	12.5 wires 3.7%	1.1 wires 0.065%

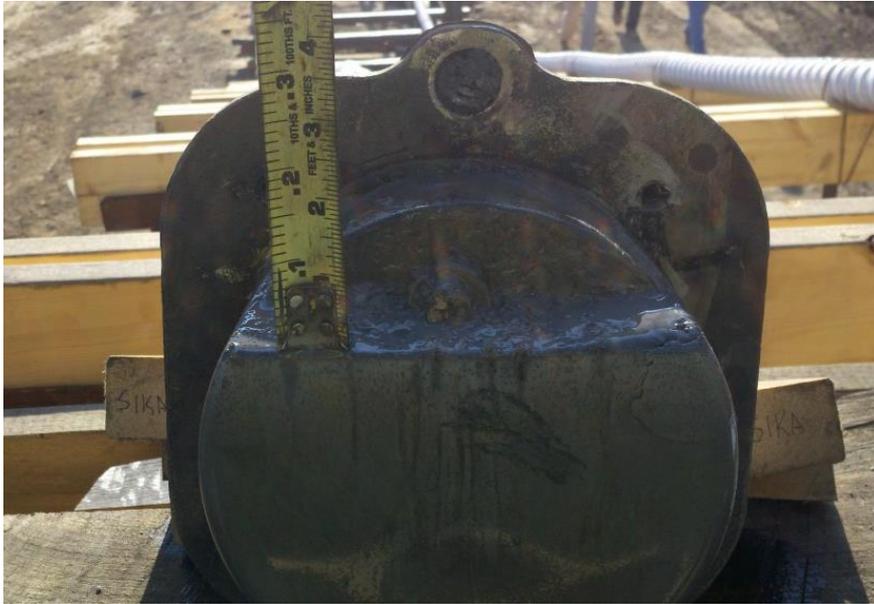
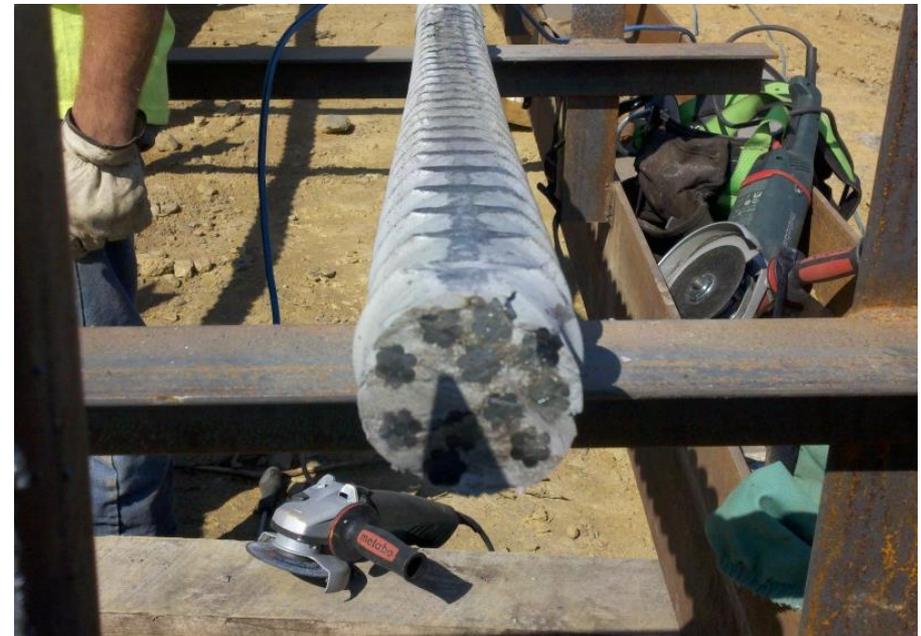
- **Mockup for US 460** segmental bridge identifies voids, segregation and soft grout in tendon grouted with an approved Grout 2.

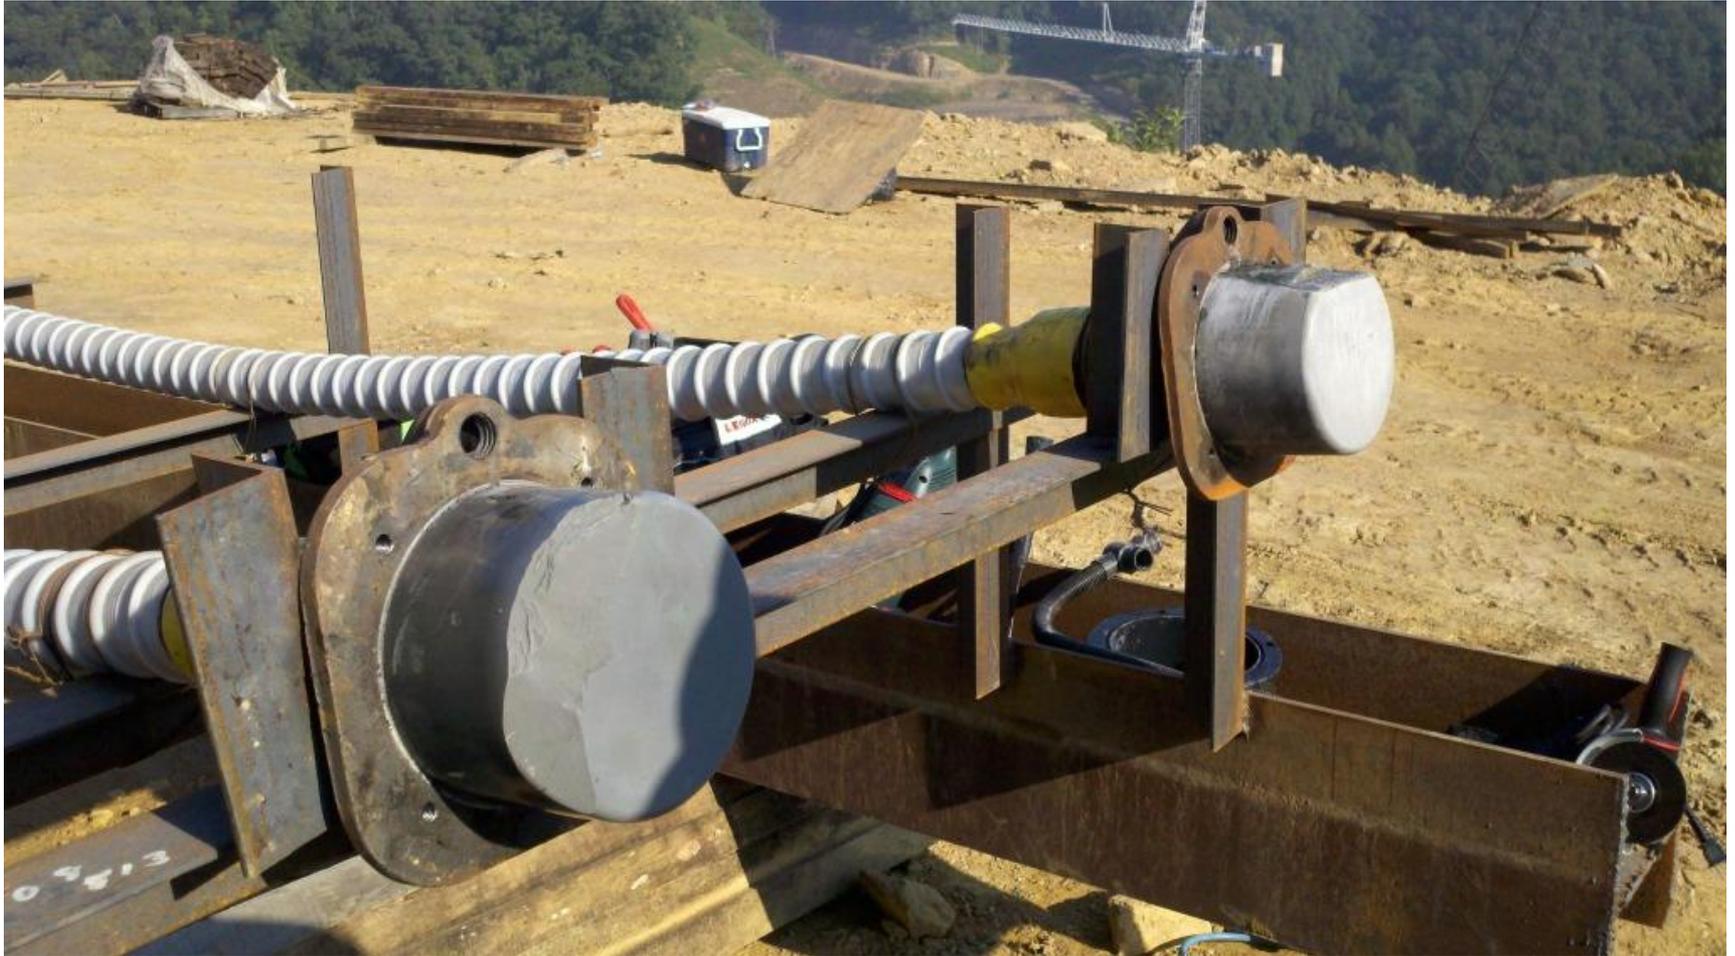
# US 460 Tendon Mock up inlet end caps

grout 3 no void or soft grout, grout 2 void and soft grout

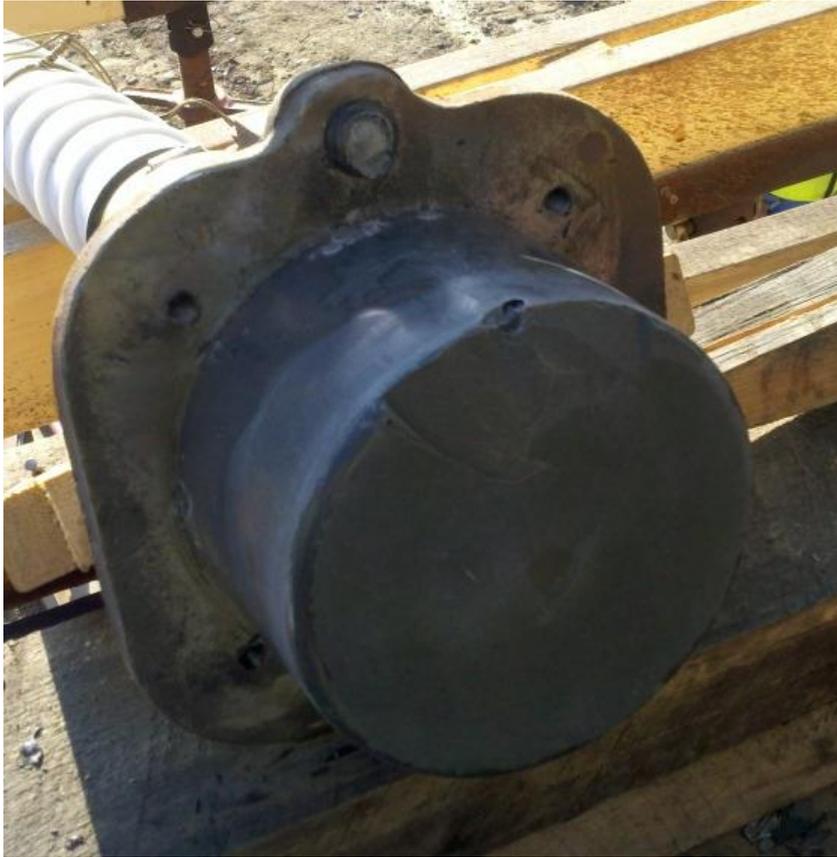
# US 460 Tendon Mock up outlet end caps

Grout 3 no void or soft grout

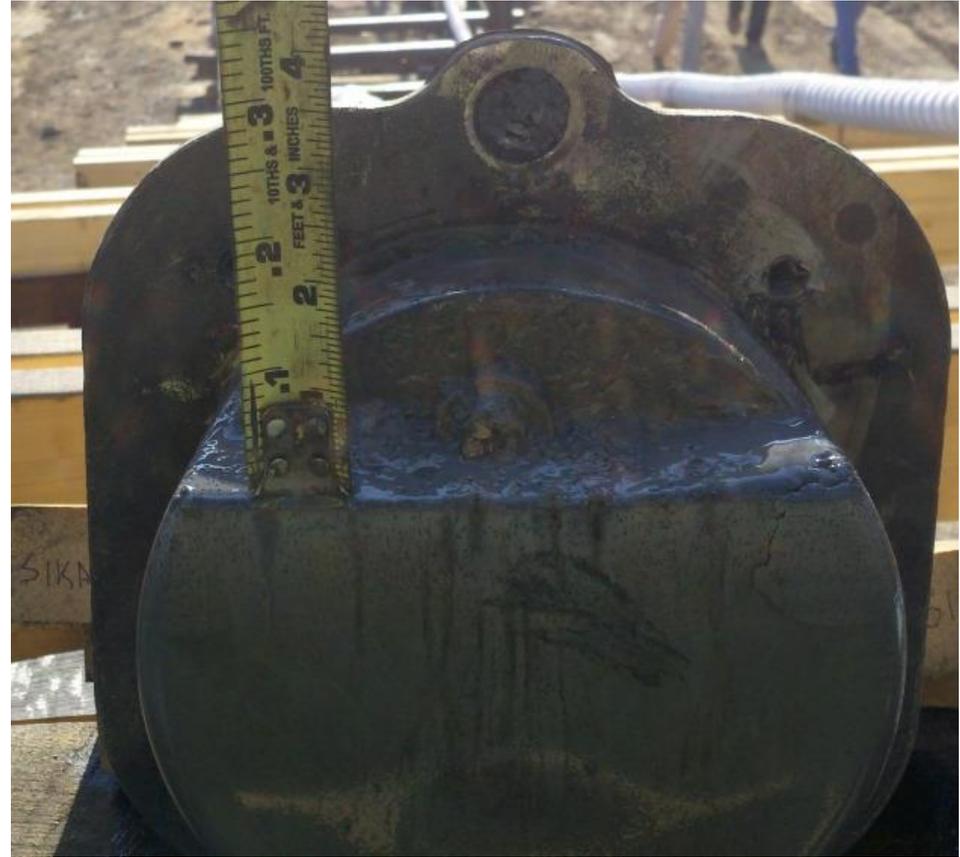
Grout 2 void and soft grout

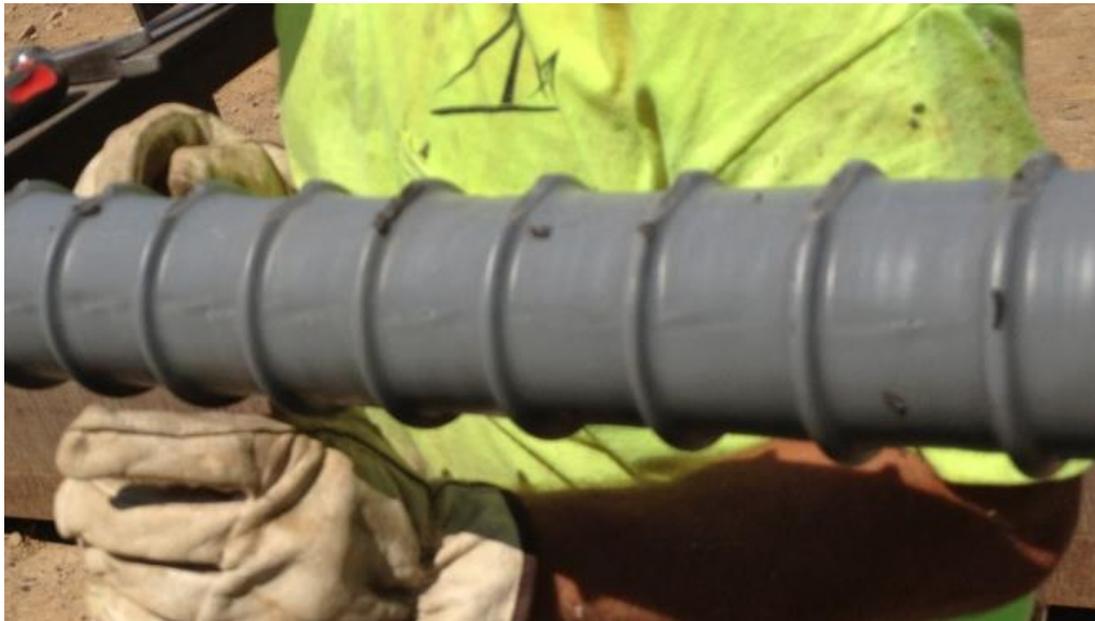
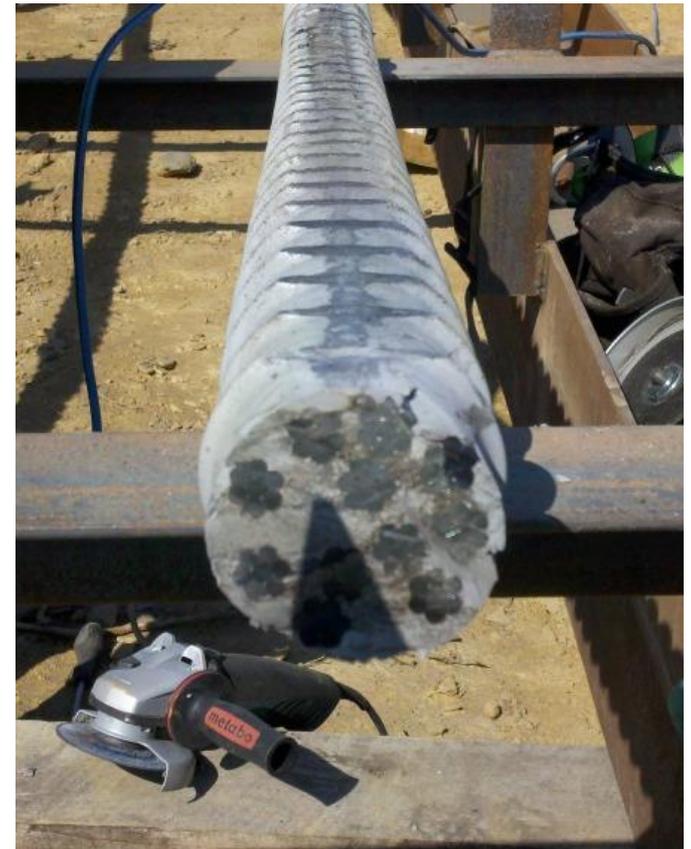
# US 460 Tendon Mock up

grout 3 provides filled tendon  
grout 2 leaves void on top

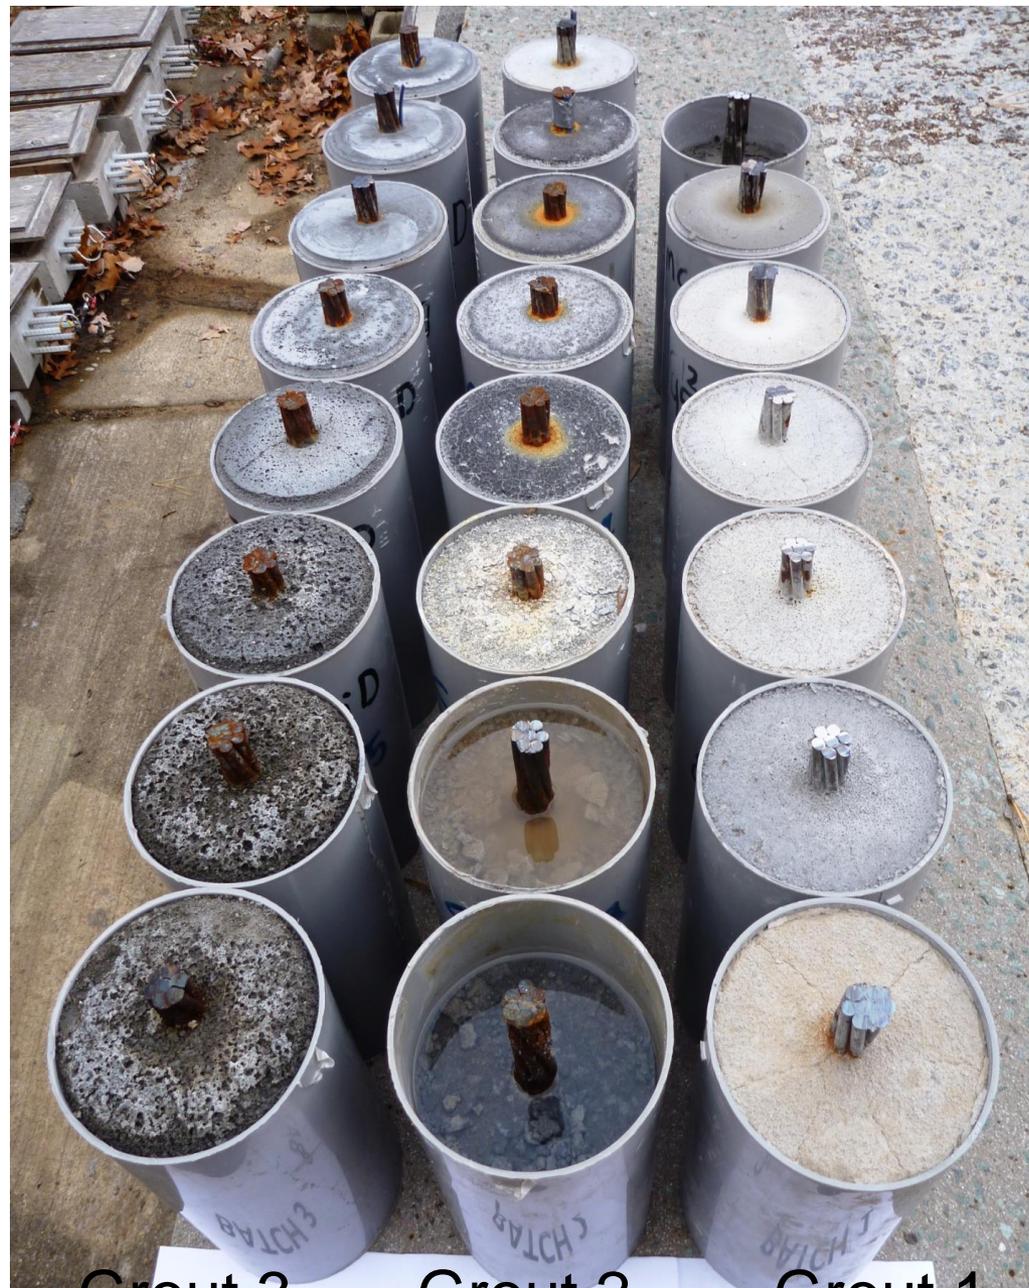
Prepackaged  
grouts with  
different W/B

Grout 1:  
diminished  
properties

Grout 2:  
bleed,  
segregation,  
soft grout

Grout 3: foam

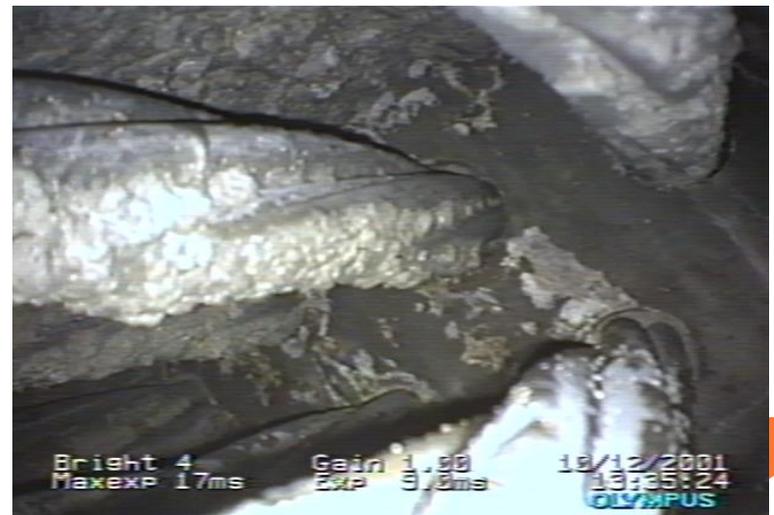
- Bleeding was approximately 4 percent in a properly batched grout ( $w/c \leq 0.42$ ) prior to 1995.
- In a typical 150 ft long tendon 6 ft of void at the high points adjacent to the anchor plates in draped tendons is expected.

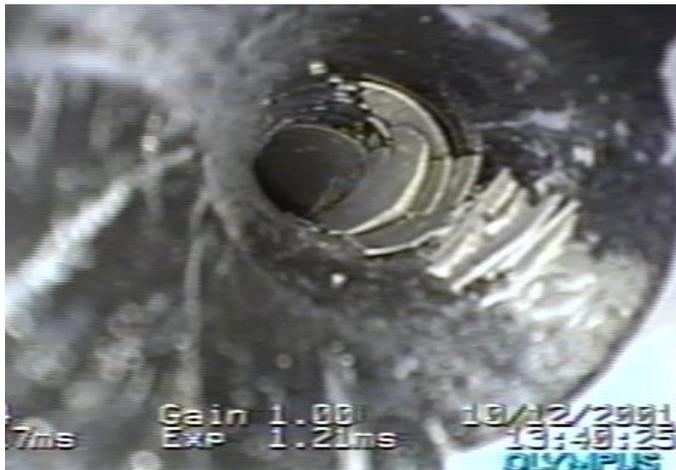
Inside vent tube

- Tendons not sealed because metal straps used to connect duct at diaphragms and bulk heads.
- Vent tubes were not sealed.
- Holes were often drilled in the plastic ducts to check for voids and grout.

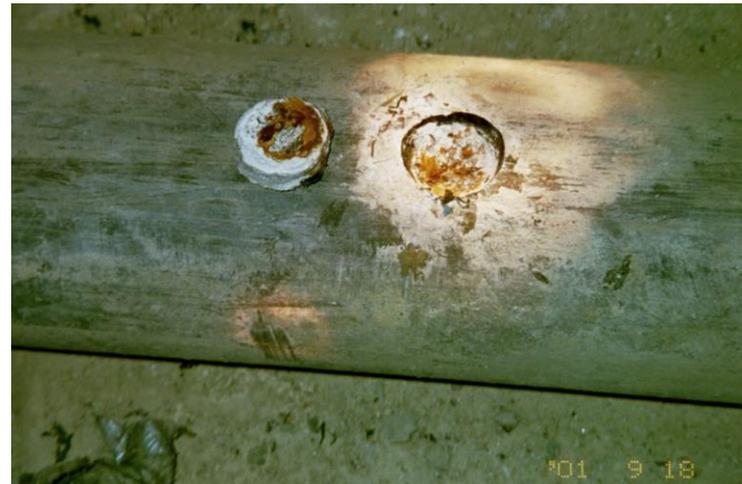
Hole in duct
