# Finishing the Sidewalk Scaling Situation

An investigation of widespread damage caused by extreme weather

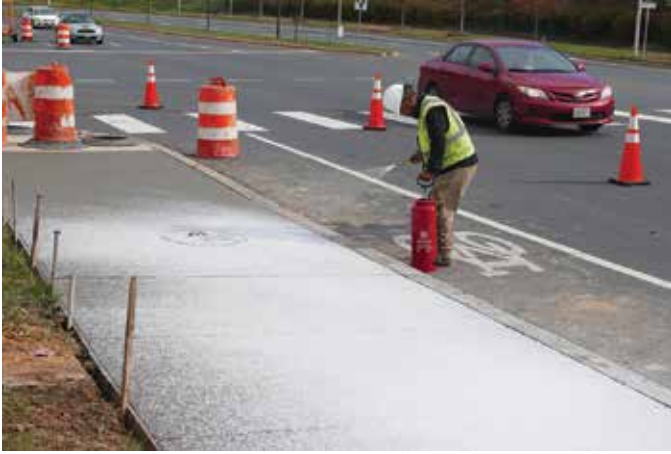
**Curing**

On the part of the contractor, understanding the basic finishing procedures and ensuring proper curing will go a long way to alleviate our current cycle of troubleshooting scaling problems every spring in cold climate regions. There is not much we can do with the choice of deicing chemicals, but good quality concrete and proper finishing and curing practices, as evidenced in our demonstration project, can deliver required service life of sidewalks and associated concrete flatwork.

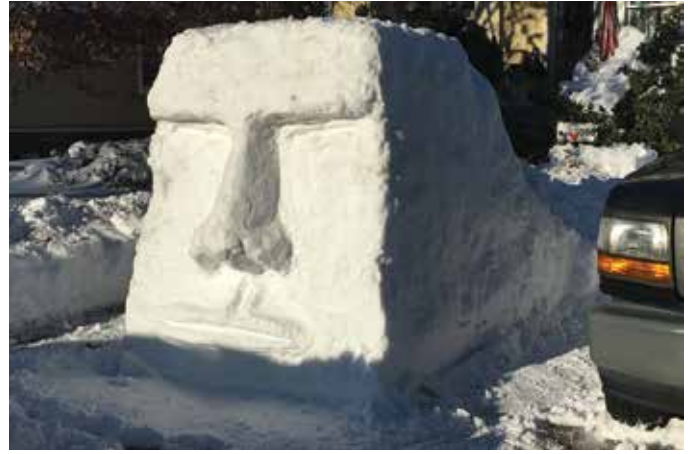
**Proof of record snow in Maryland the first year in service**

the sidewalk was covered with nearly 30 in. (762 mm) of snow in a record-breaking blizzard. The sidewalk lines a road that is a feeder to Interstate 270, a major thoroughfare leading into Washington, DC, and as such, is heavily treated with deicing chemicals during snow and ice events. While there are no signs of scaling or deterioration on the demonstration sidewalk after 3 years of service, the sidewalk sections that were placed on either side of the demonstration section have scaled.

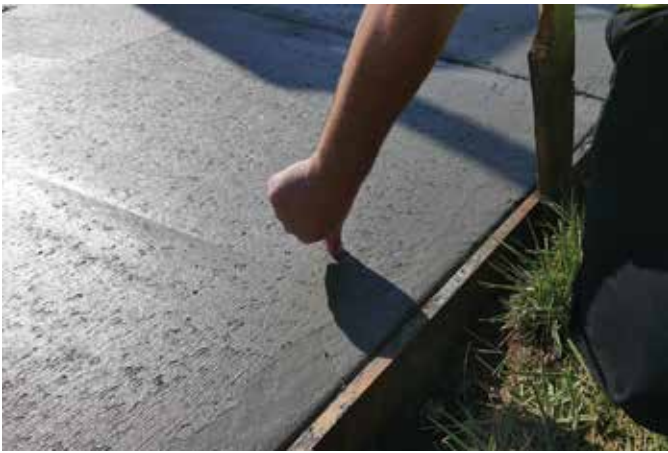
**Testing for set**

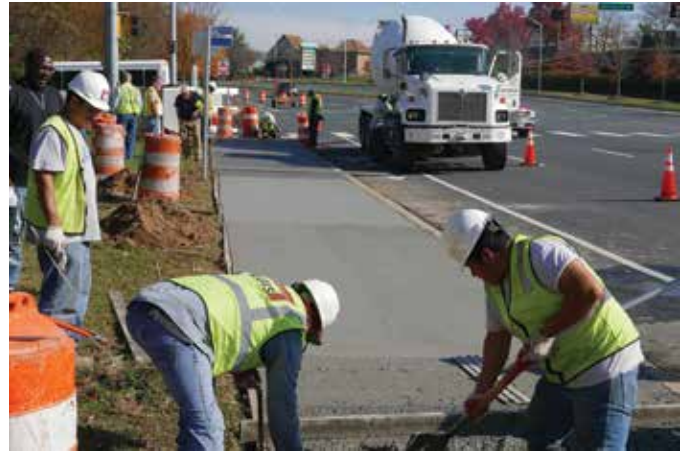
**Concrete placement in Montgomery County, MD, trial of various SCM mixtures**

A demonstration evaluation was also commissioned. A sidewalk, with various materials and conditions, was placed for the Montgomery County Department of Transportation in Maryland to study the effects of slag cement and fly ash on scaling of concrete flatwork. The field study included concrete mixtures that met minimum industry standards, and the concrete was tested, placed, finished, and cured properly. The sidewalk, which was placed in November of 2015, included concrete mixtures with straight portland cement; 15% and 25% cement replacement with Class F fly ash; and 25%, 35%, and 50% portland cement replacement with slag cement. These six mixtures had a total of 615 lb/yd<sup>3</sup> (365 kg/m<sup>3</sup>) cementitious material and a design  $w/cm$  of 0.45. An additional mixture, containing 580 lb/yd<sup>3</sup> (344 kg/m<sup>3</sup>) of cement with a design  $w/cm$  of 0.50, was also used.

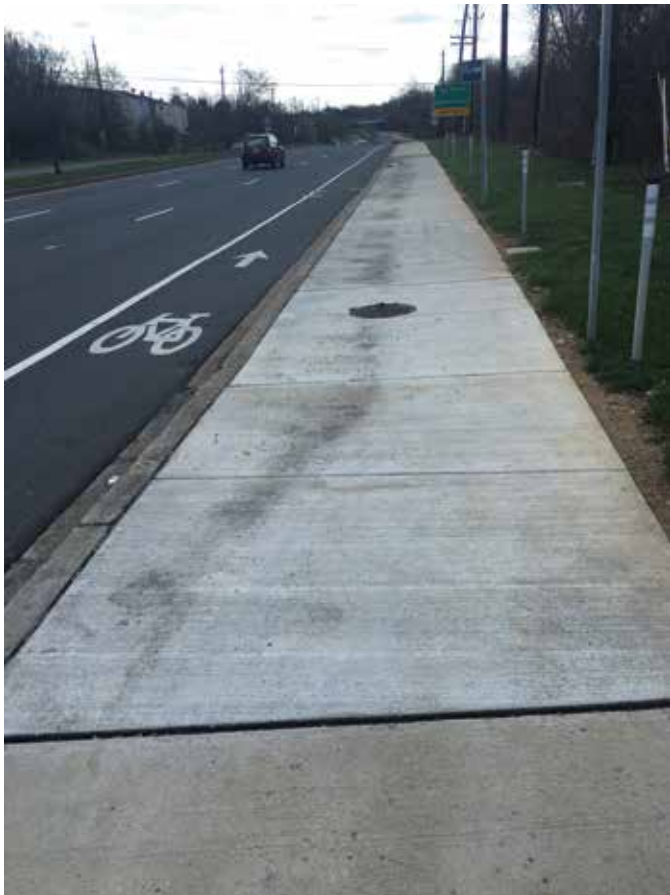
**Slag cement sidewalks after a winter in service. Dark marks are temporary due to melting snow and ice**

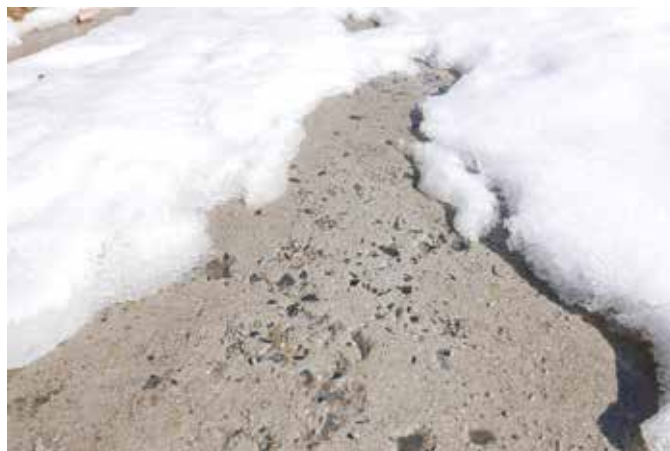
**Typical scaling problems that were happening in the Northeast United States due to harsh winters**

- Addition of water to the concrete to increase flowability, without regard to slump or  $w/cm$  requirements;
- “Blessing” (sprinkling water on the surface) the concrete at every point of the finishing process;
- Performing final finishing operations before initial setting and while bleed water was still coming to the surface;
- Using steel trowels during finishing operations;
- Over-finishing;
- Brooming water into the surface; and
- Poor to nonexistent curing practices.
