Means and Methods of Evaluating Reinforced Concrete Structures

ACI Fall 2012 Convention
 October 21 – 24, Toronto, ON

CONDITION ASSESSMENT AND CONCRETE REPAIR STRATEGIES AT WATER TREATMENT STRUCTURES

STEPHEN FOSTER
 WISS, JANNEY, ELSTNER ASSOCIATES, INC.

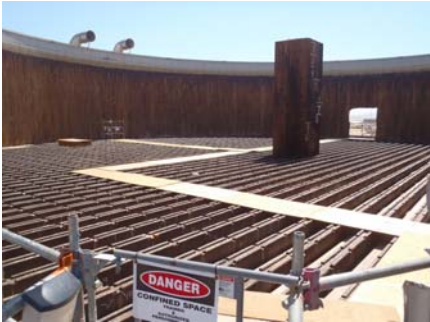
Task:

- Comprehensive condition assessment

Goals:

- 30 years of additional service life
- Develop scope for repair documents

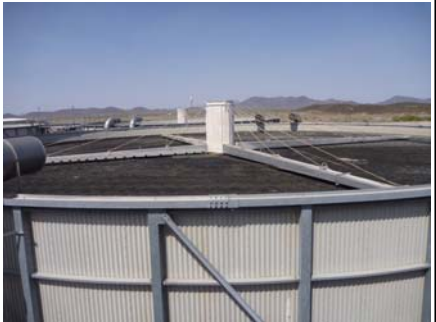
Structure:

- In service since 1986
- 128 ft [39 m] diameter
- 5,000 psi [34.4 MPa]
- 10 years of noted distress
- Moderate amount of chlorides in H₂O

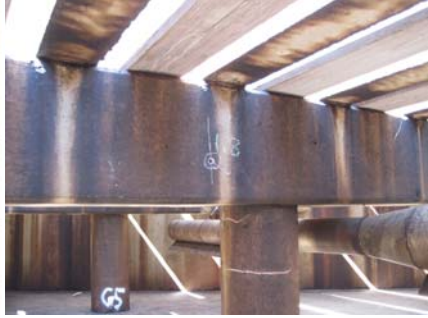
TYPICAL GIRDER

Girders:

- 106 girders
- 18 in square [457 mm]
- 16 ft long [4.9 m]

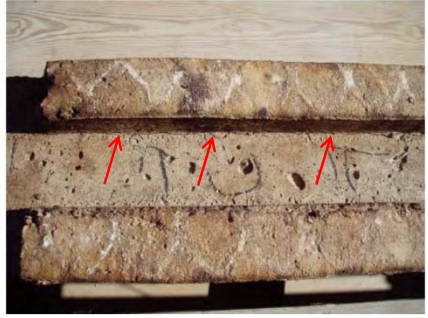
PREVIOUS REPAIRS ON TF2

- Cracked beam "ears"
- Cracking of slab
- Missing hairpin reinforcement at beams
- Beam end spalls
- Sealant joint at wall

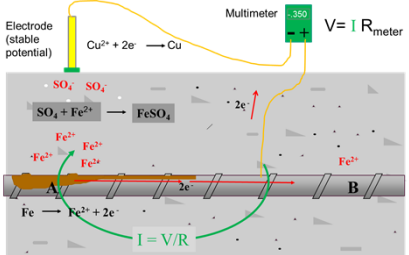
ASTM C876: Corrosion Potentials of Uncoated Reinforcing Steel in Concrete

- > -200mV = 90% probability of no corrosion
- < -350 mV 90% probability of corrosion

- Indication of corrosion risk for reinforcement
- Factors: moisture, continuity, carbonation, delaminations, adjacent soil

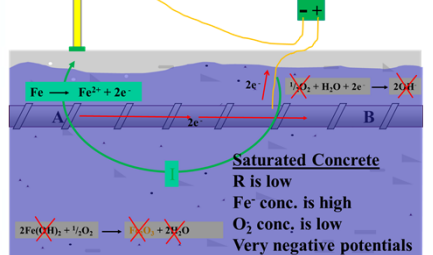
- Dry in AZ!
- Moisture increases from beams → girders → piers → slab
- Look for "hot" spots

- Saturated concrete = more negative potentials (less resistance)

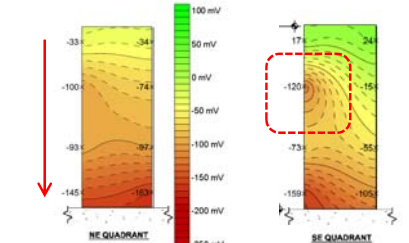
- Dry in AZ!
- More moisture from beams → girders → piers → slab
- Look for "hot" spots

- General potential gradient = more negative at bottom of Trickingling Filter
- Look for "hot" spots

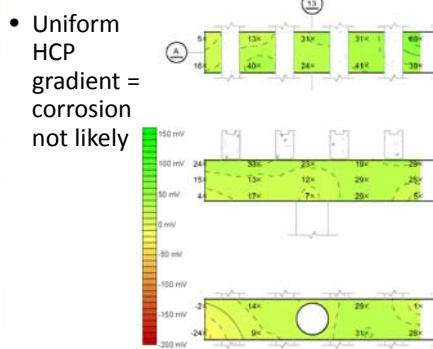
- Dry in AZ!
- Moisture increases from beams → girders → piers → slab
- Look for "hot" spots

- Uniform HCP gradient = corrosion not likely

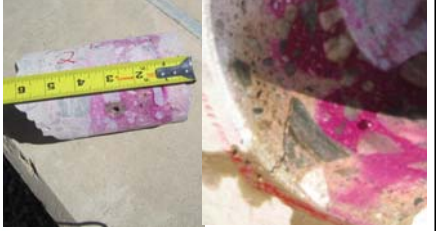
Typical concrete: pH 12-14
 Passive layer of steel may deteriorate: pH 9.5-11
 Phenolphthalein: pink = pH>9
 25 yrs = ~1 in. [25 mm] typical concrete

- Carbonation progresses ~0.04 in [1 mm]/year in typical concrete
- Moisture + oxygen + low pH = corrosion

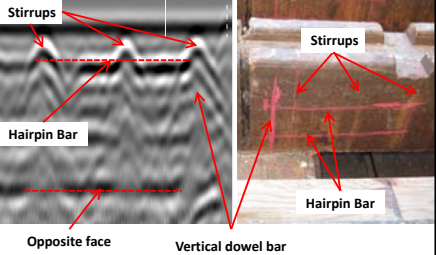
Results:
 GPR on 74 of 196 beams with hairpins, randomly selected

Vertical and horizontal scans
 All scans showed hairpins in place

- Non-destructive technique to verify presence of steel hairpins at the ends of beams

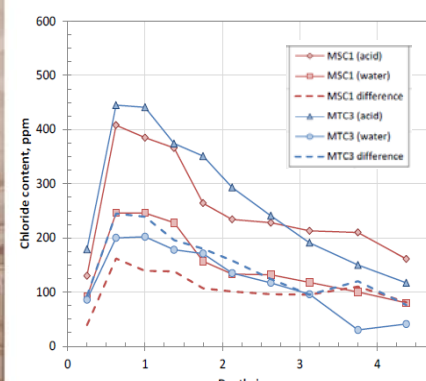
Background chloride content = 70 ppm

Revised Chloride Threshold → 420ppm

"Hump" due to transport method: Water flow → Absorption → Diffusion

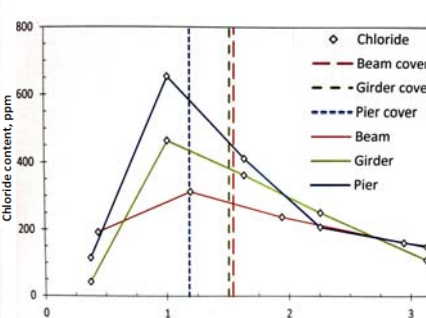
Piers:
>500 ppm at reinforcement

Beams/Girders:
<400 ppm at reinforcement

Top of Wall:
500-800 ppm at reinforcement

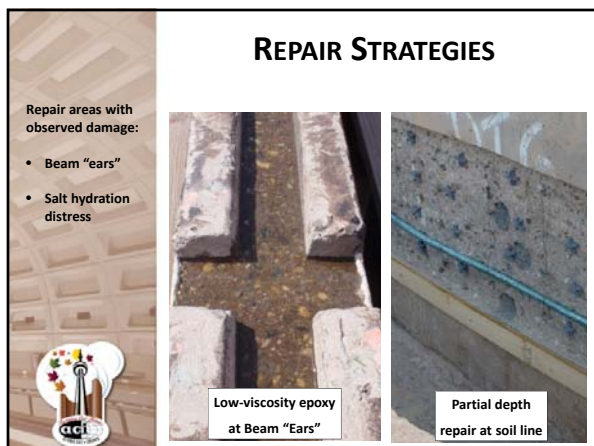
- ### REPAIR STRATEGIES
- Goal: 30 years of additional service life
 - Repair all observed damage
 - Focus long-term maintenance strategies at critical areas
 - Piers
 - Shortest remaining service life
 - Top of Wall
 - High chlorides
 - 50% delamination
