# Use of SCC for the Repair of Bridge Substructures

H. Celik Ozyildirim, Ph.D., P.E.  
Principal Research Scientist

ACI Spring Convention: April 15, 2013

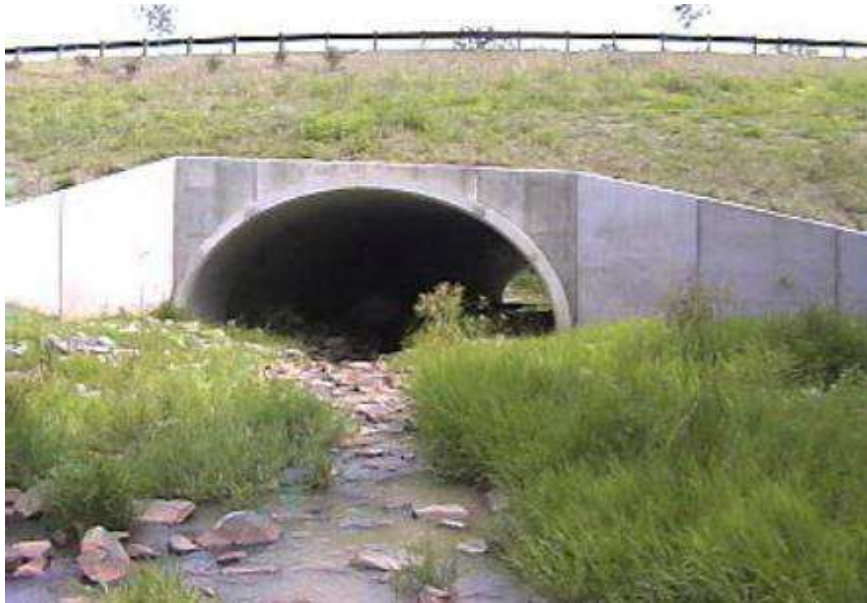
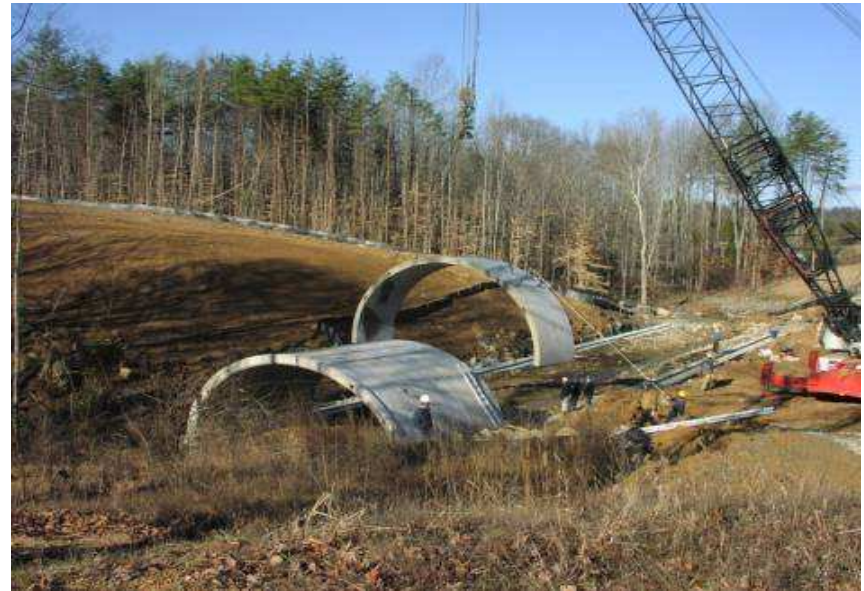
# SCC Arch Bridge in Fredericksburg, VA 2001

- 5,000 psi
- Low permeability

- Arch length of 45 ft

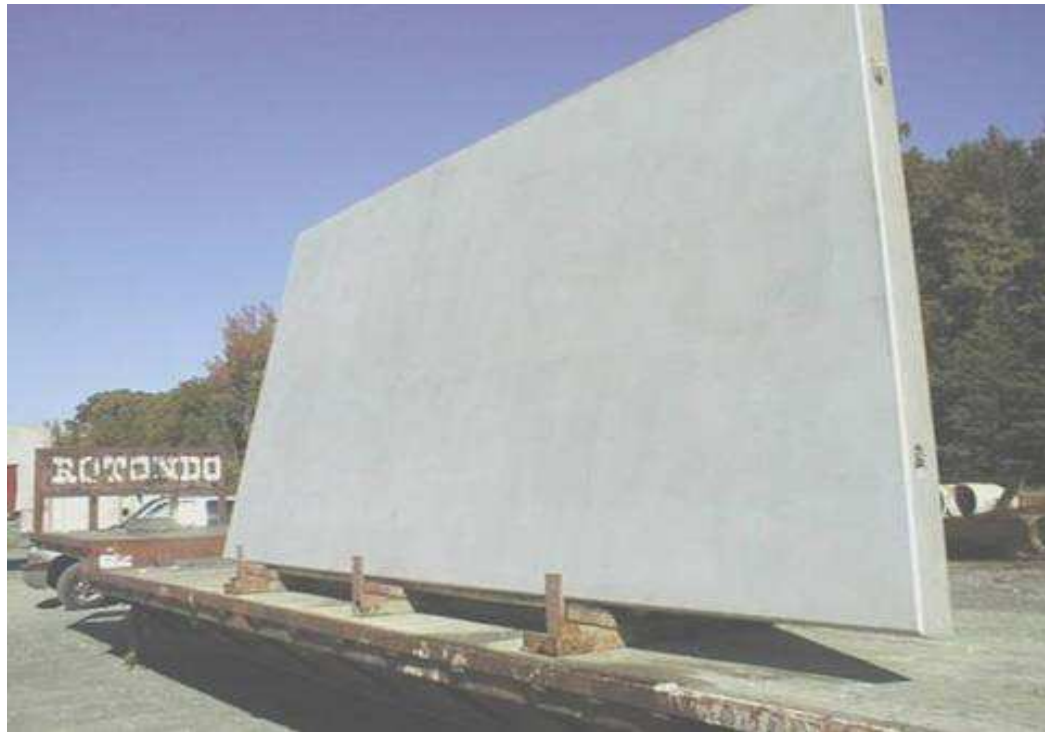
## Smooth surface finish

Wing wall from the arch bridge

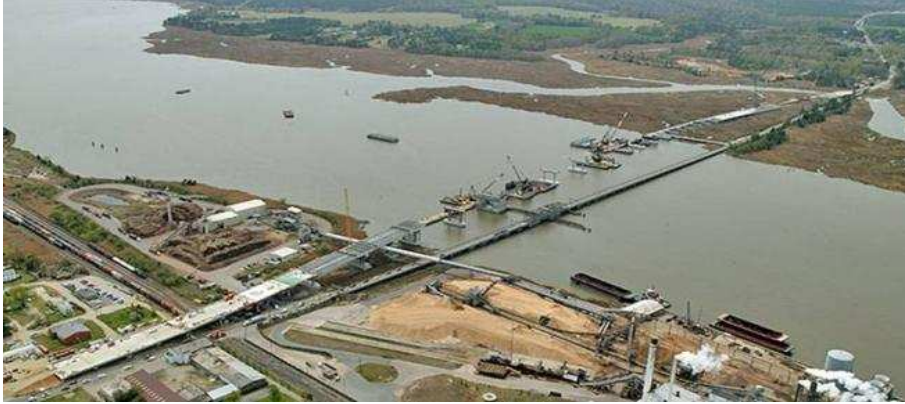
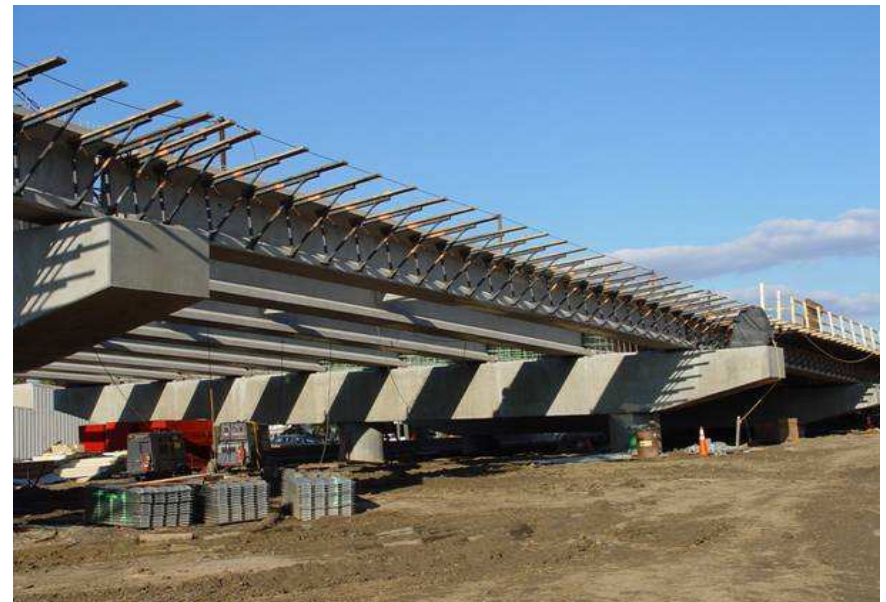
# SCC Beams – Rte 33 (2005)

Over Pamunkey River

- 8,000 psi
- Low permeability

Project planned 8 SCC beams; however, producer used SCC in 32 more beams

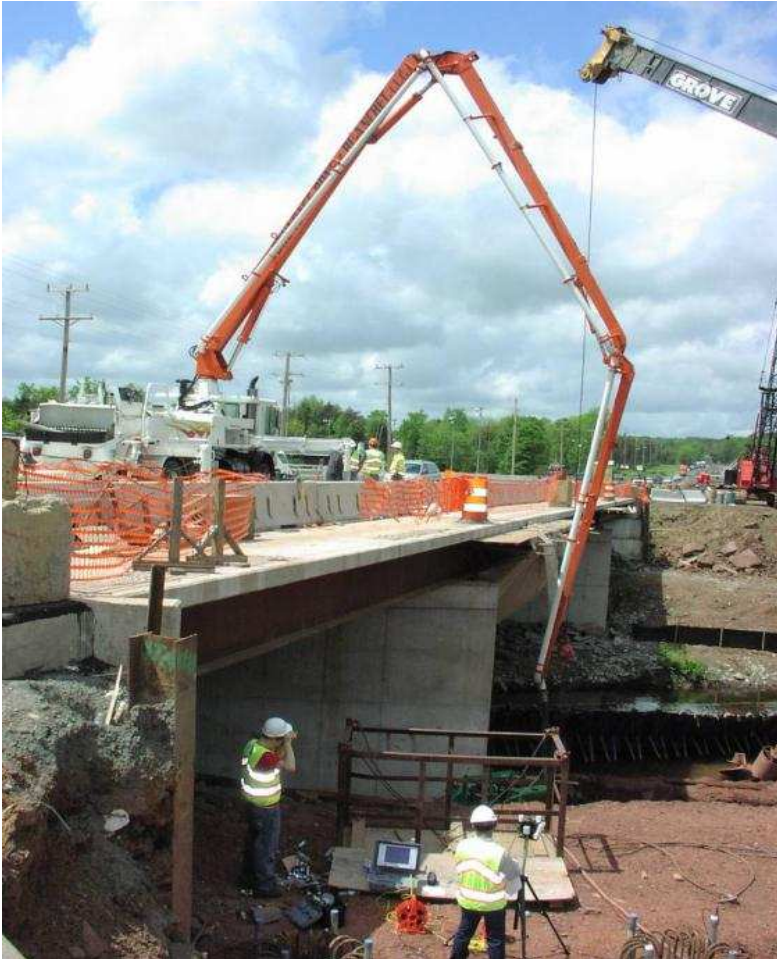
# Drilled Shaft – Route 28 (2007)

Placement of concrete and removal of casing were easy.

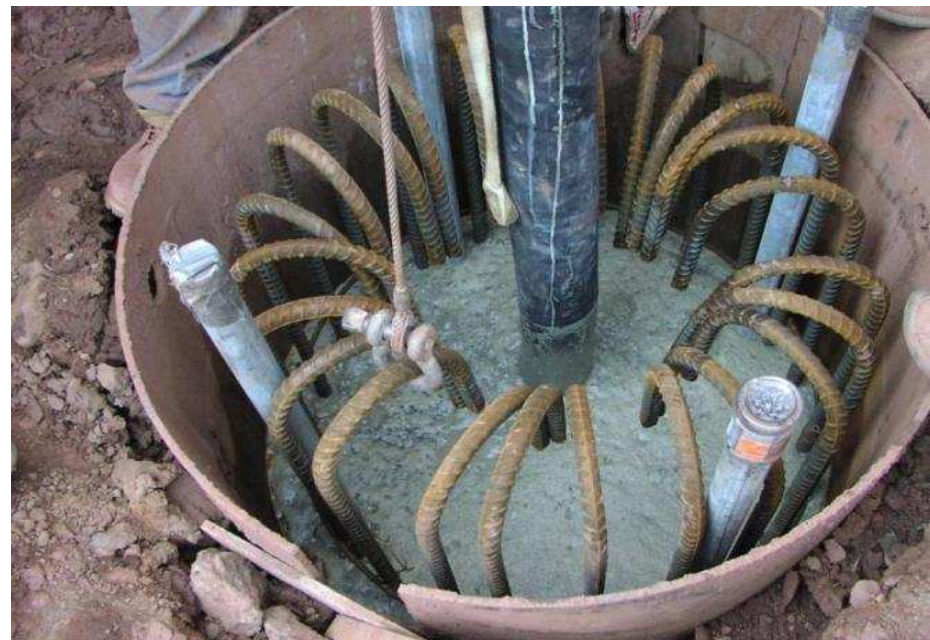
Lack of consolidation is a problem with conventional concrete.

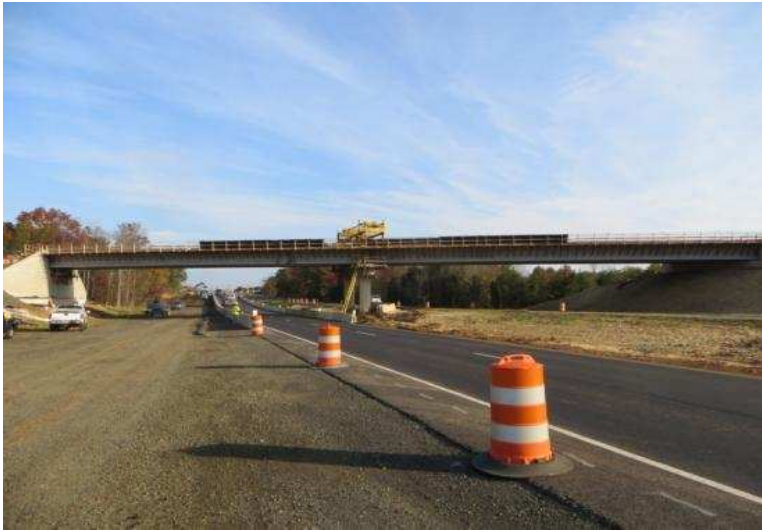
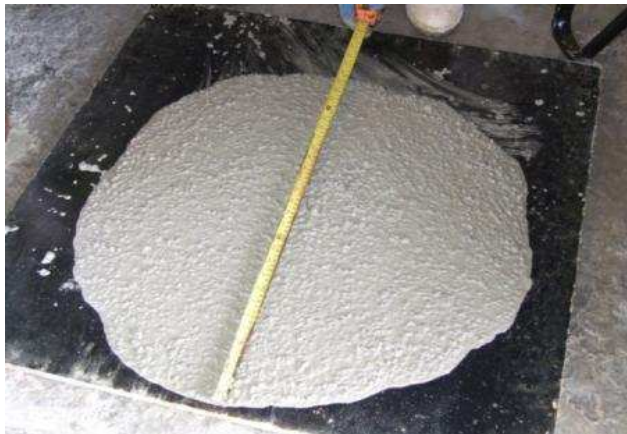
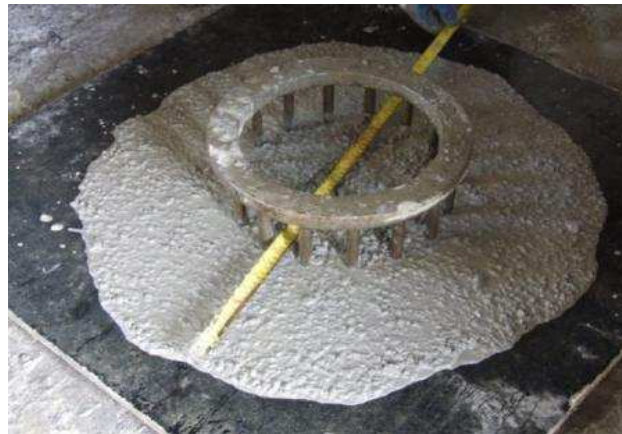
# Lightweight SCC - 2012

- Two 128 ft spans
- 4 beams per span, one test for each beam (8 tests)
- Average compressive strength: 10,724 psi, 5 out of 8 batches had over 11,000 psi.
- Low permeability (< 1,000 coulombs)

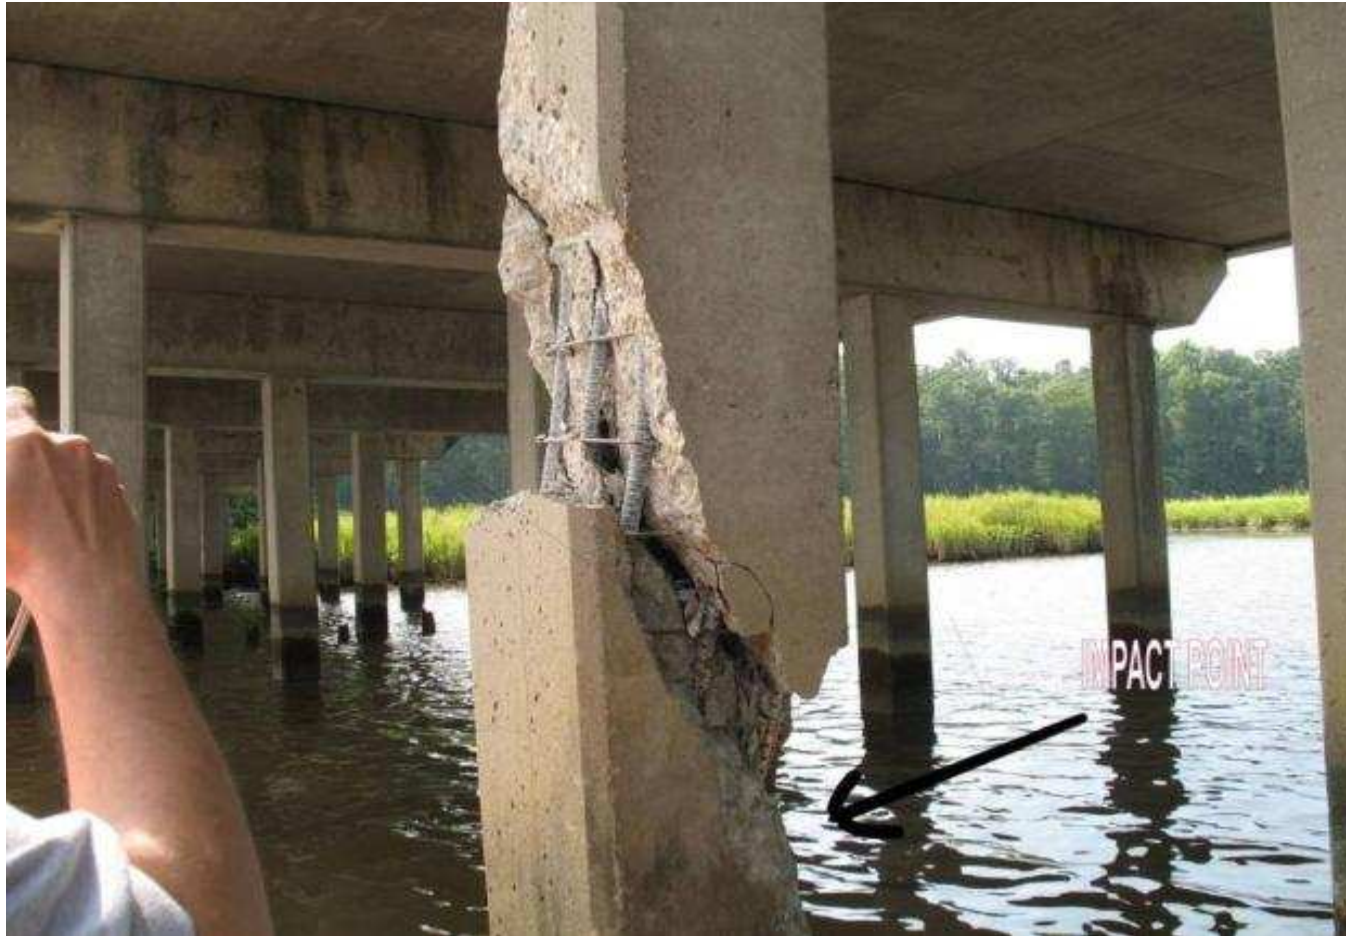
# FHWA Pile Repair - 2009

At Colonial Parkway a pile was hit by a barge.

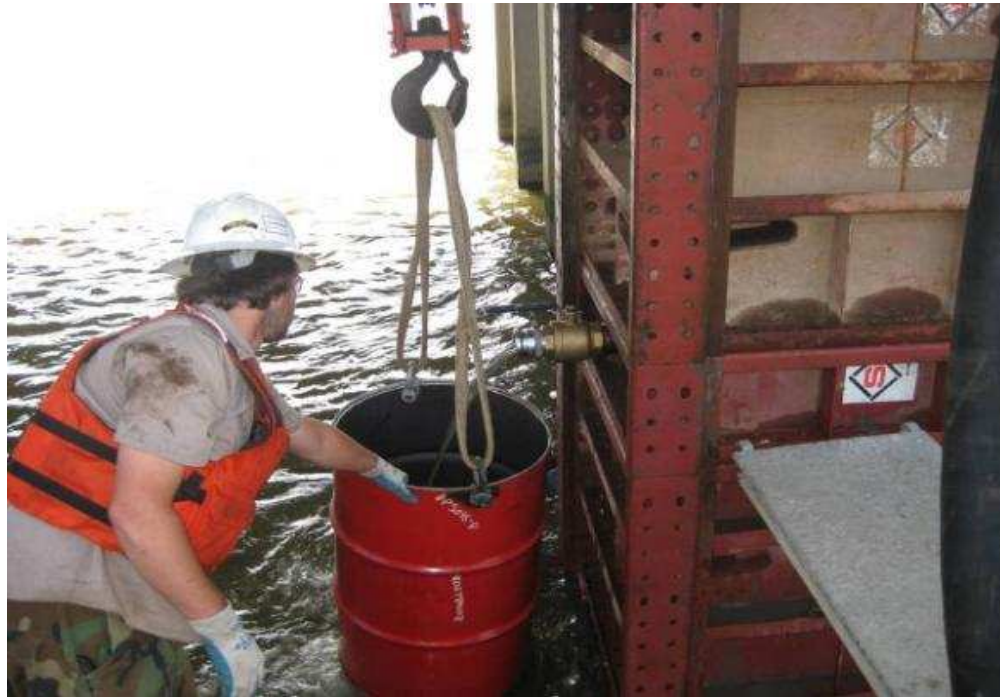
Concrete pumped from bottom up.  
Drum to catch the overflow.

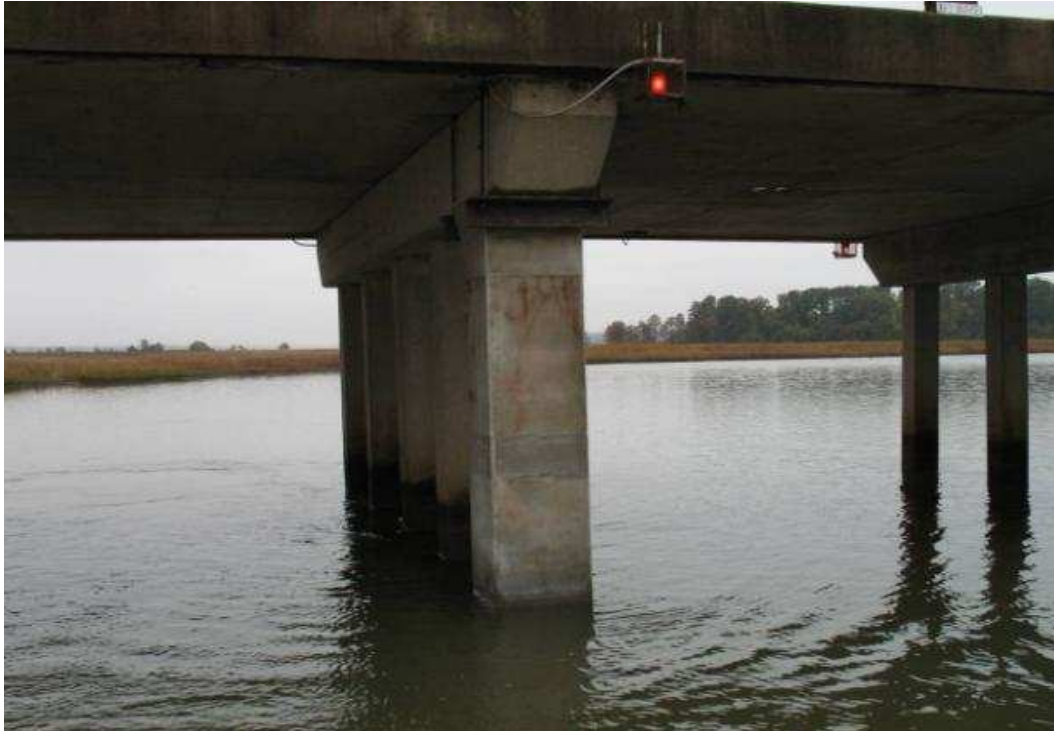
Repaired pile

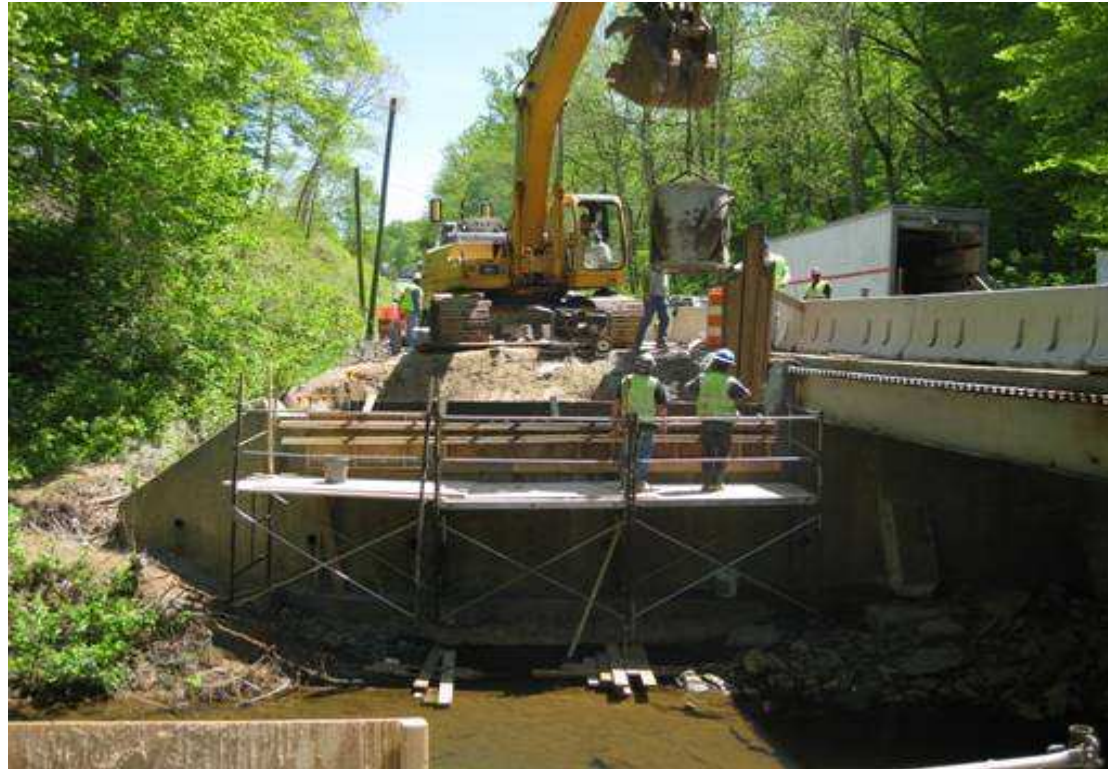
# Route 699 - Backwall

Bucket is used to place SCC in the backwall.

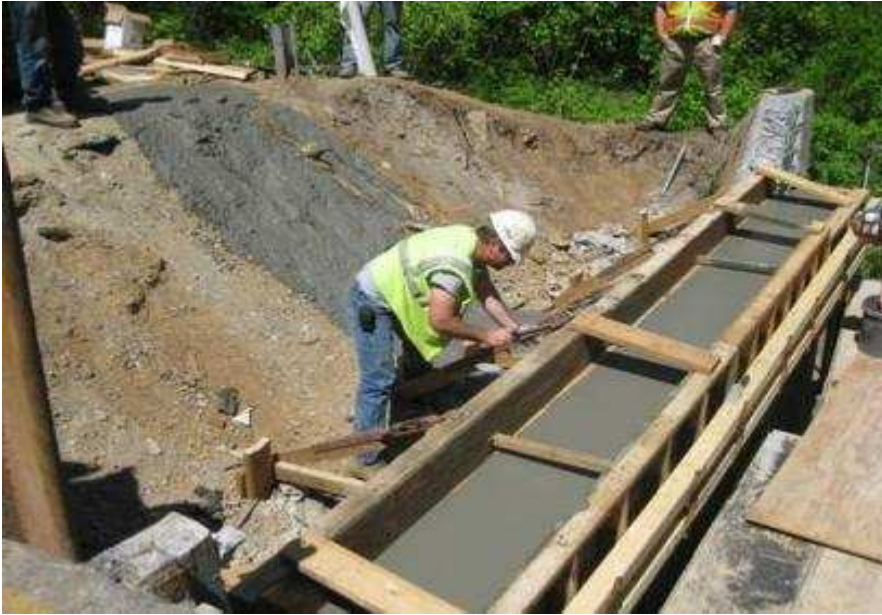
Backwall construction

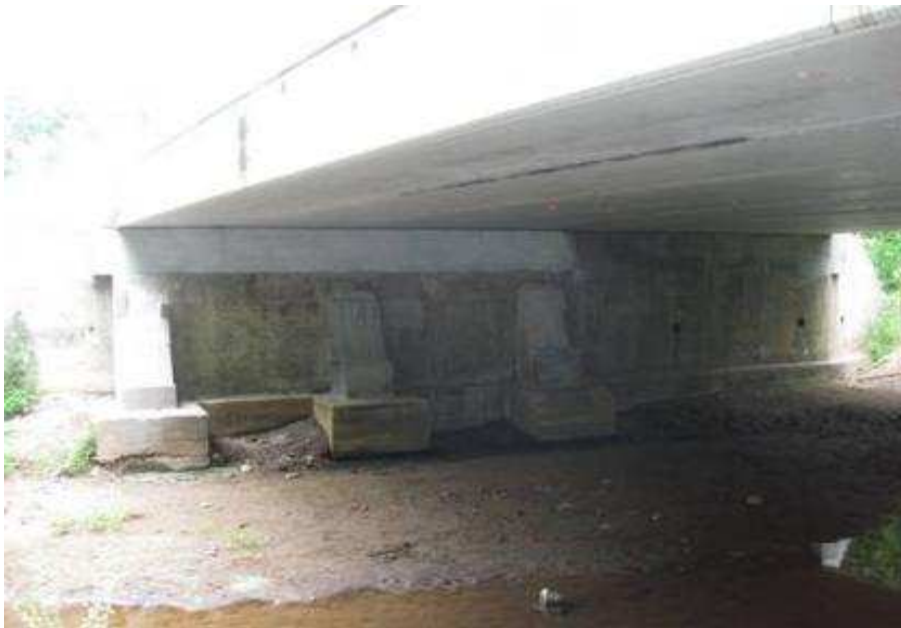
Smooth SCC finish on the  
support buttress

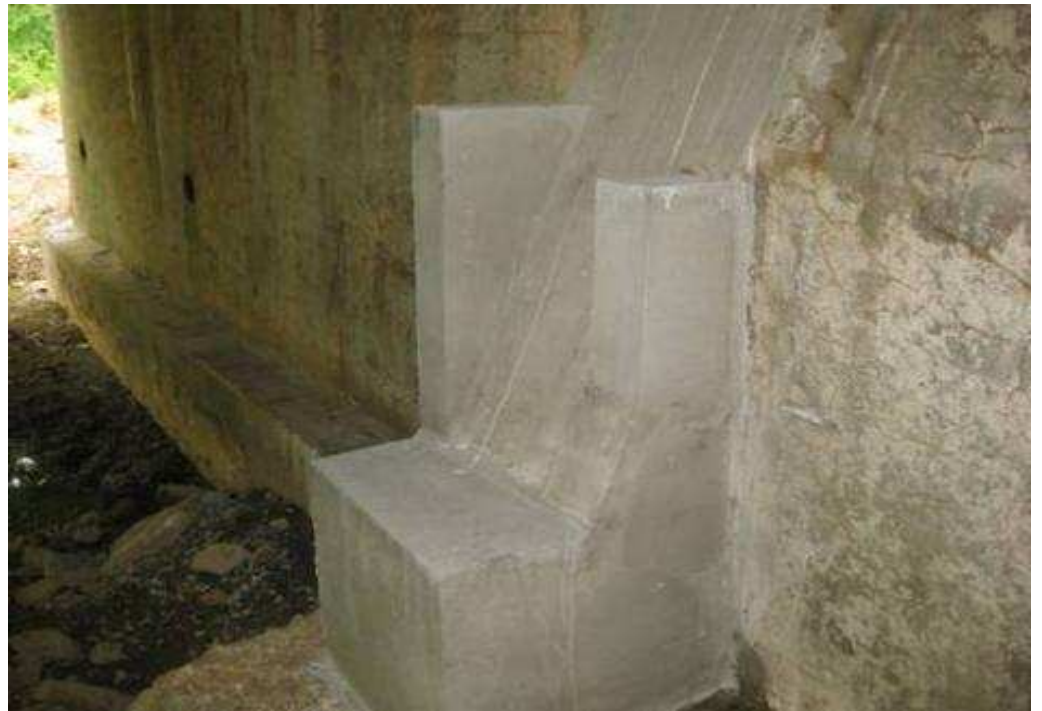
Finished backwall

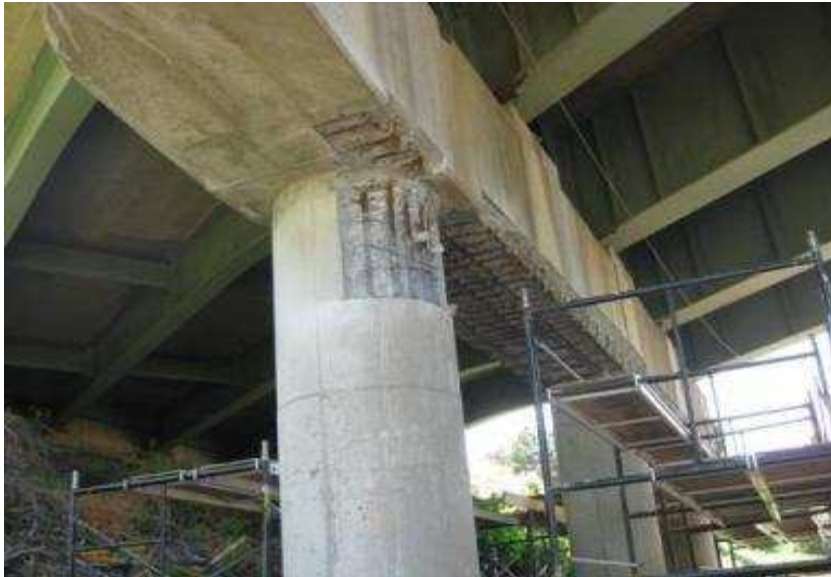
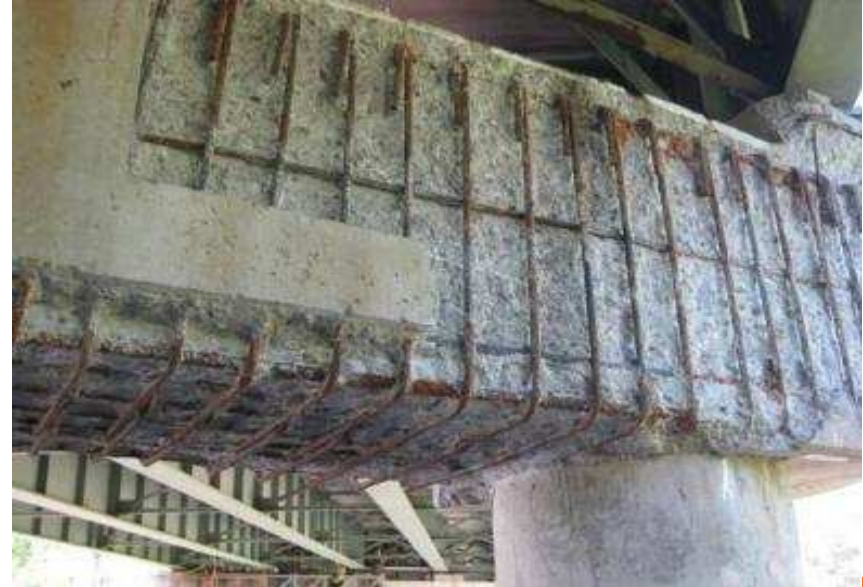
# Route 712 – Column and Pier Cap

Removal of deteriorated concrete

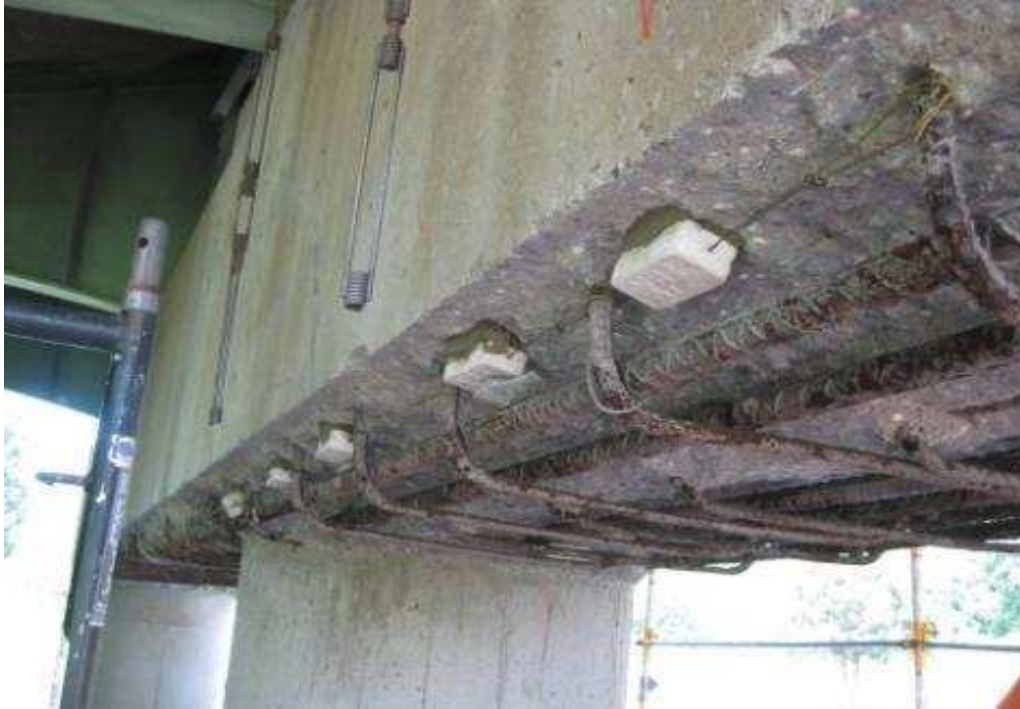
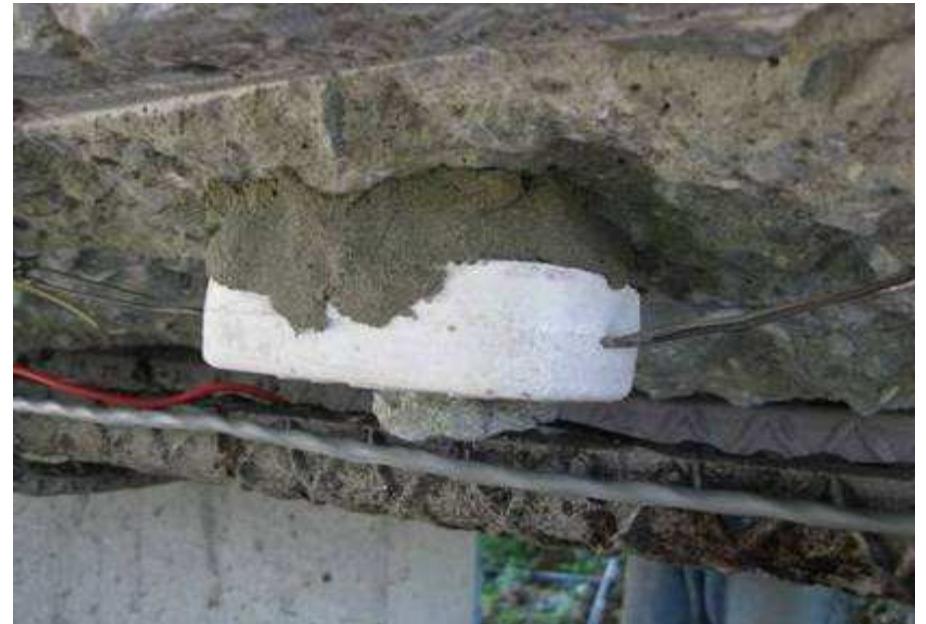
Evaluating anodes: sections  
had anodes with and without  
embedment mortar

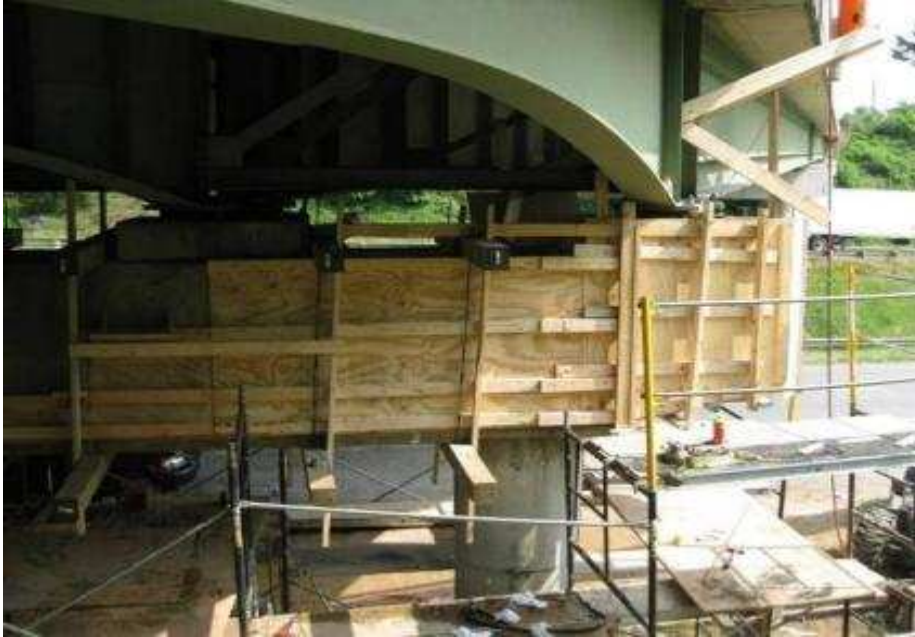
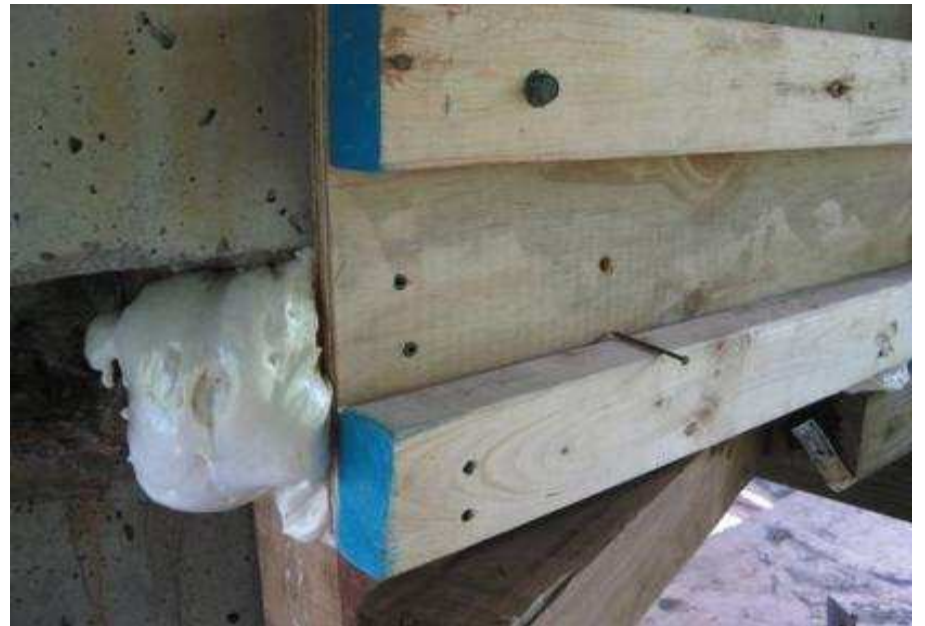
Formwork

Foam to close gaps

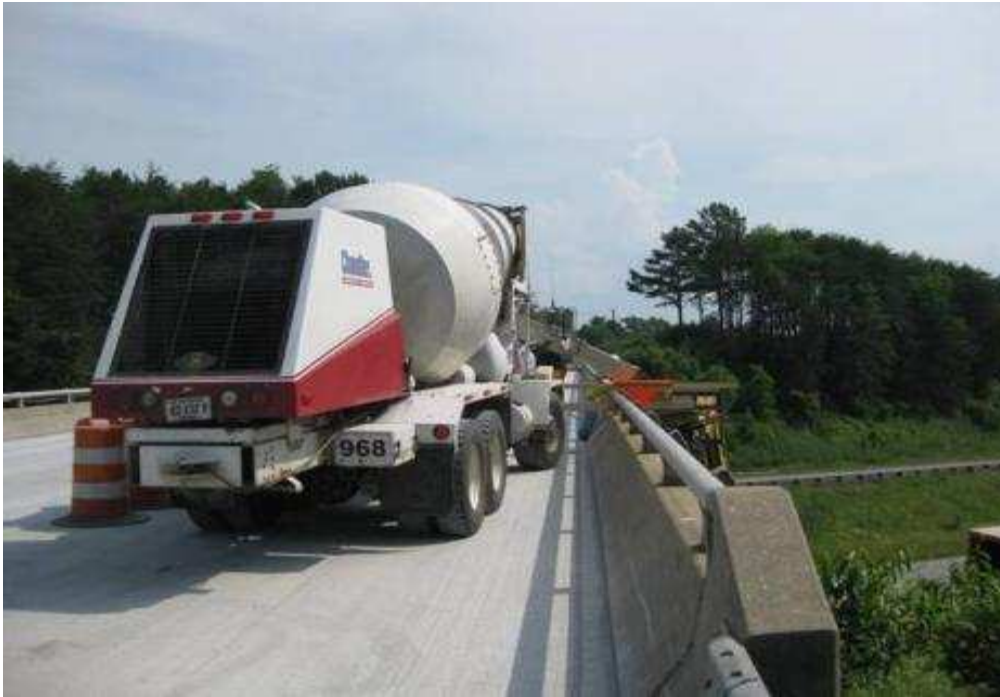
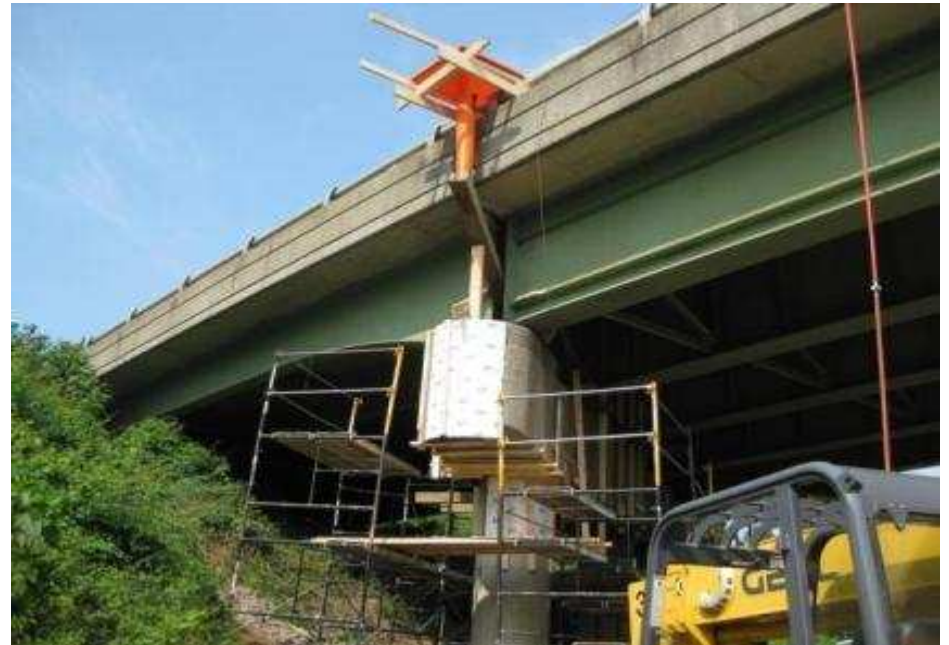
SCC delivery through funnel and flexible tube

Strength 4,880 psi,  
Permeability 1,347 coulombs

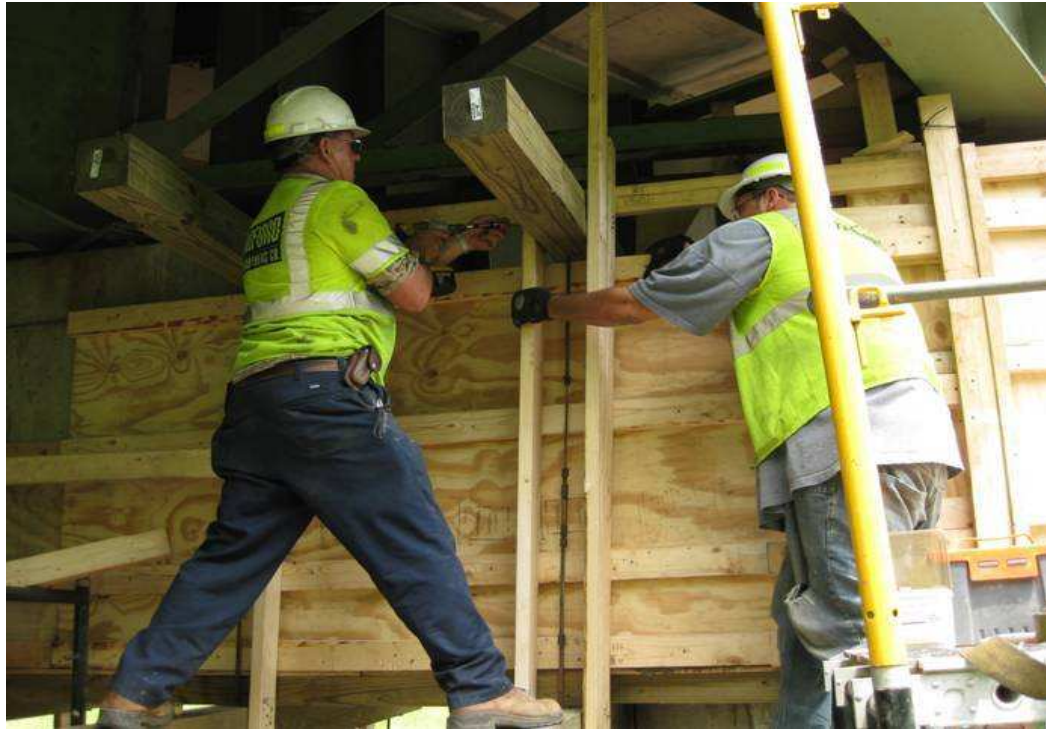
Shoring up the bulged formwork

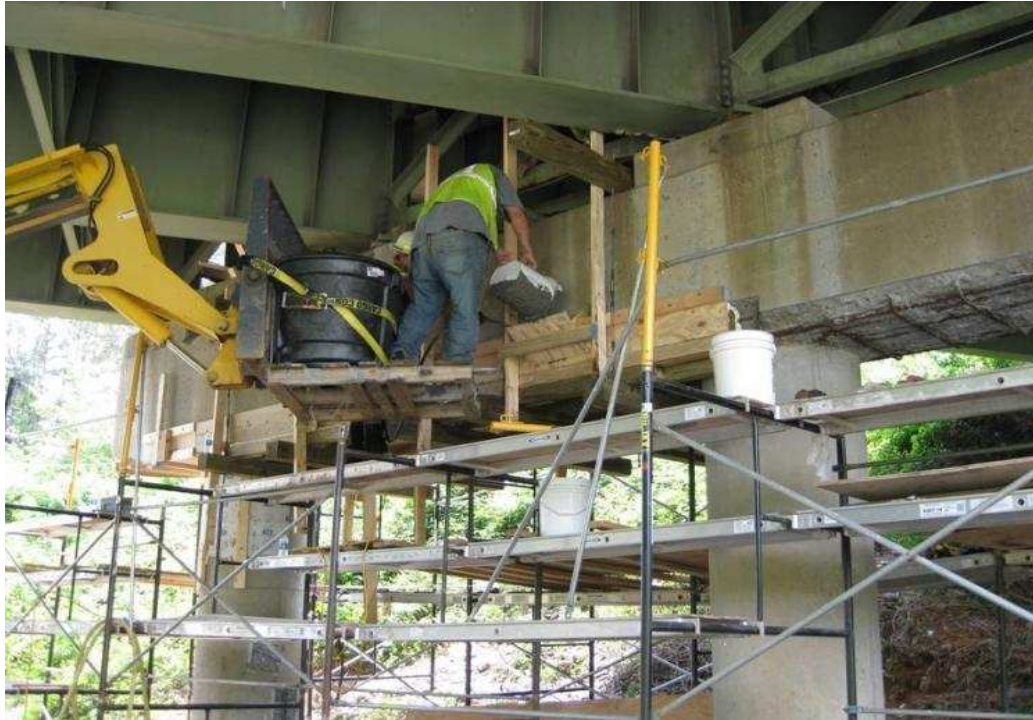
Using buckets to place SCC is not a good method!

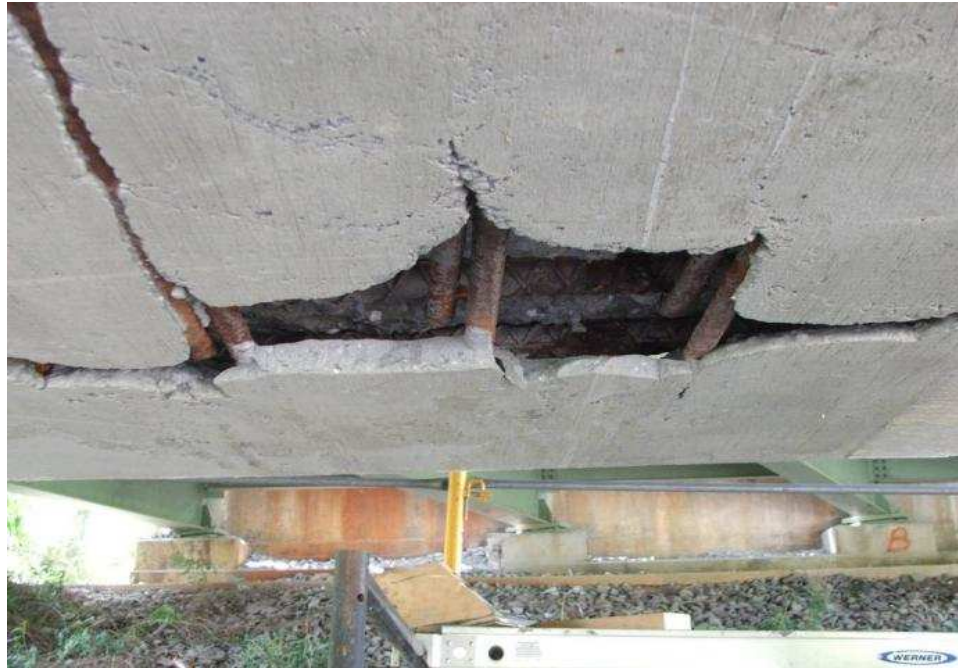
Void at the bottom due to stiffening mixture, shy cover, and congested reinforcement

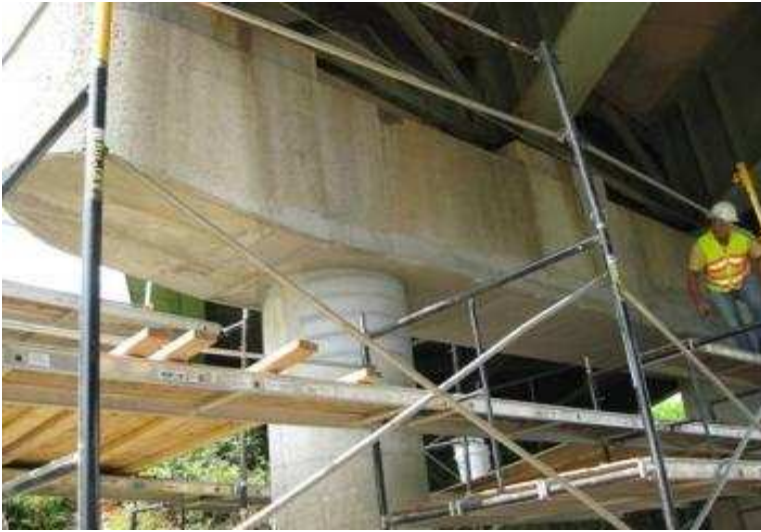
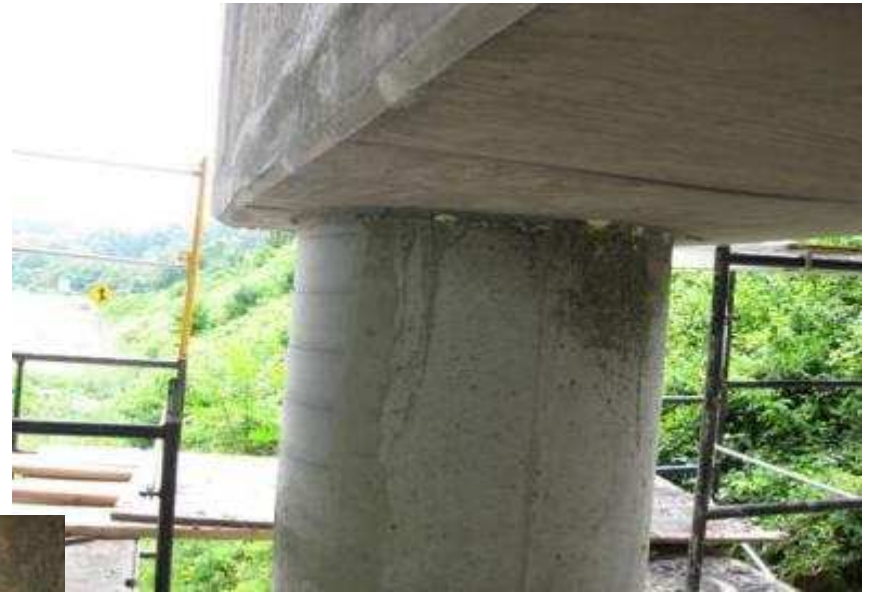
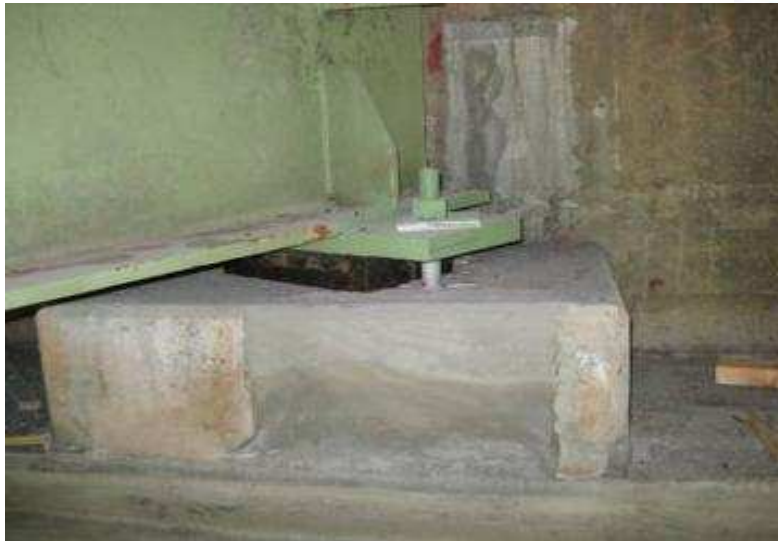
Completed SCC repair.

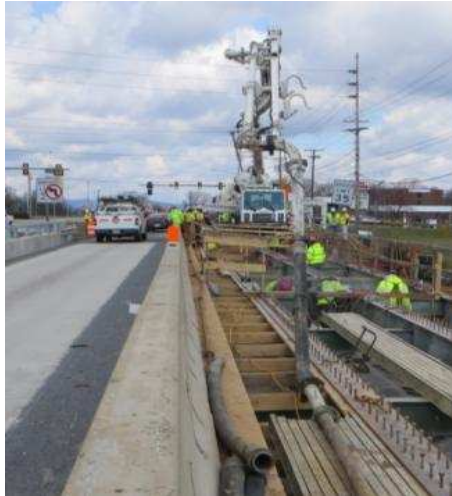
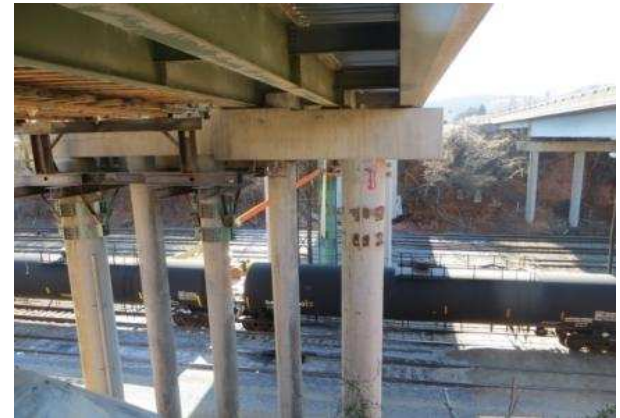
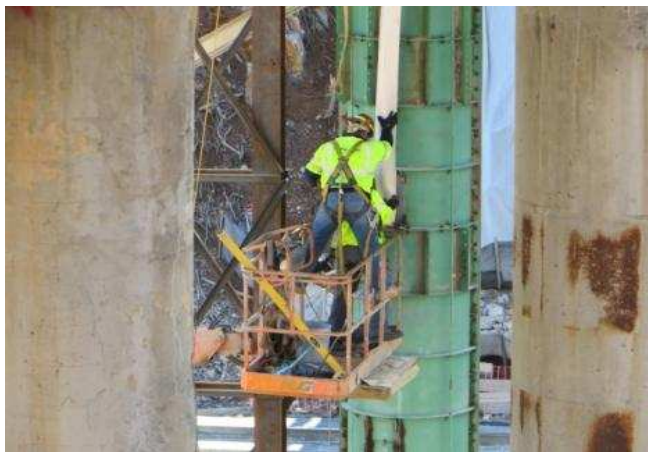
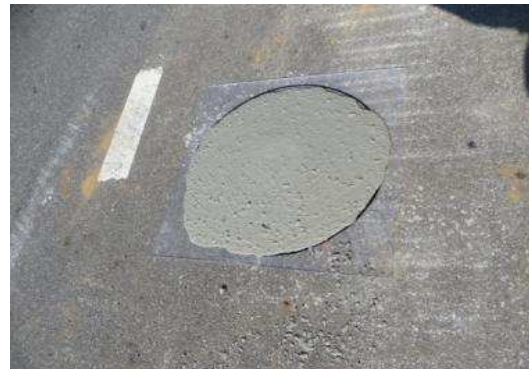
# Lynchburg, 2013

## Encasing columns

Column 2 ft 8 in  
increased to  
3 ft 8 in

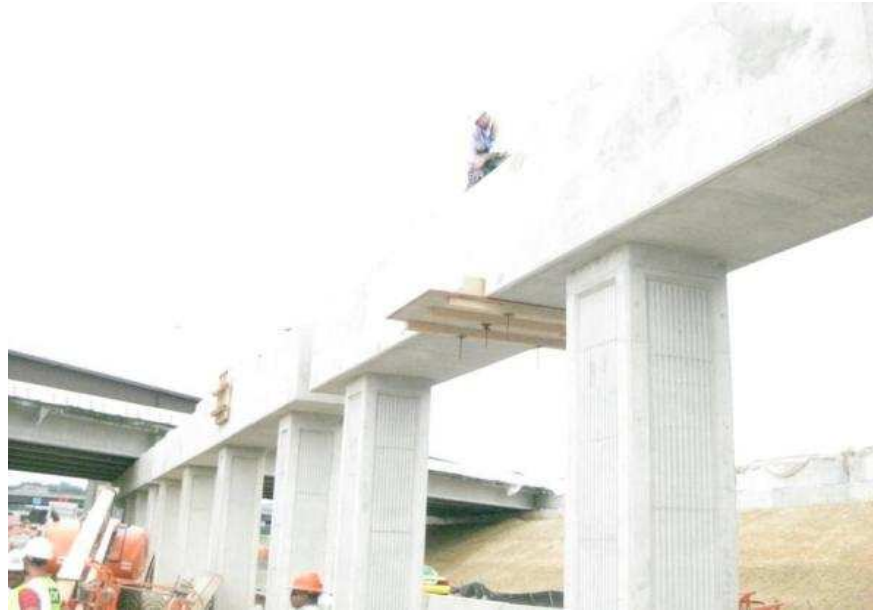
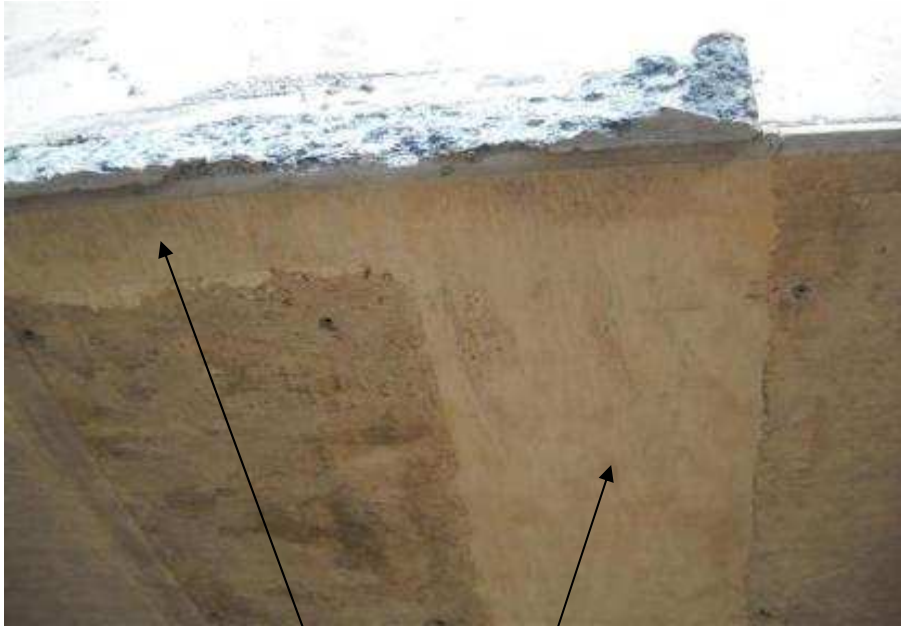
# NOVA Bridge - 2011

Repair of a new pier cap that had consolidation problem

Pier Cap  
Soffit  
Repaired  
with SCC

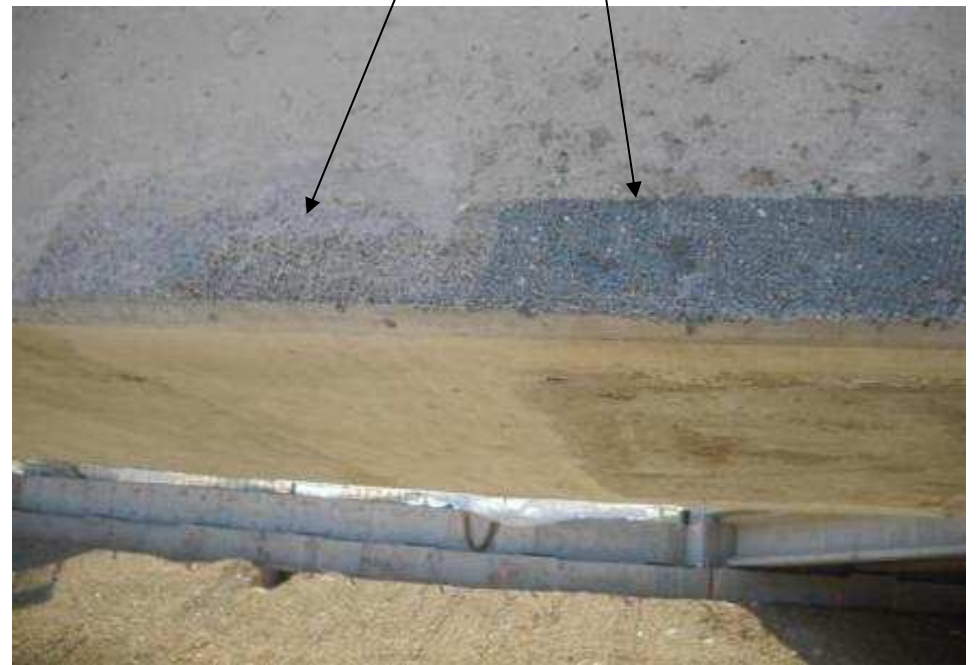
interface  
between  
SCC and  
existing  
concrete

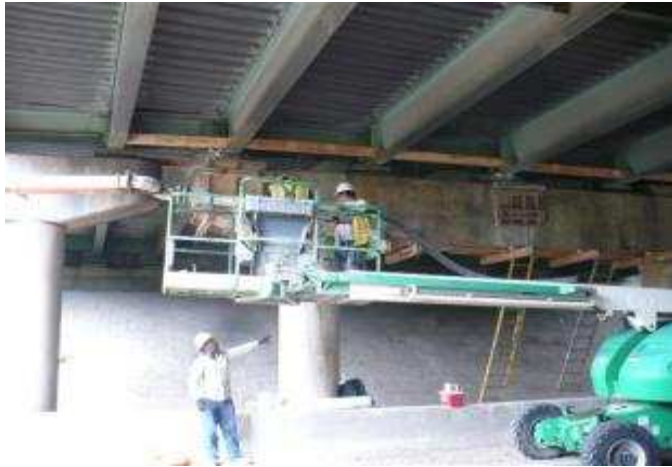
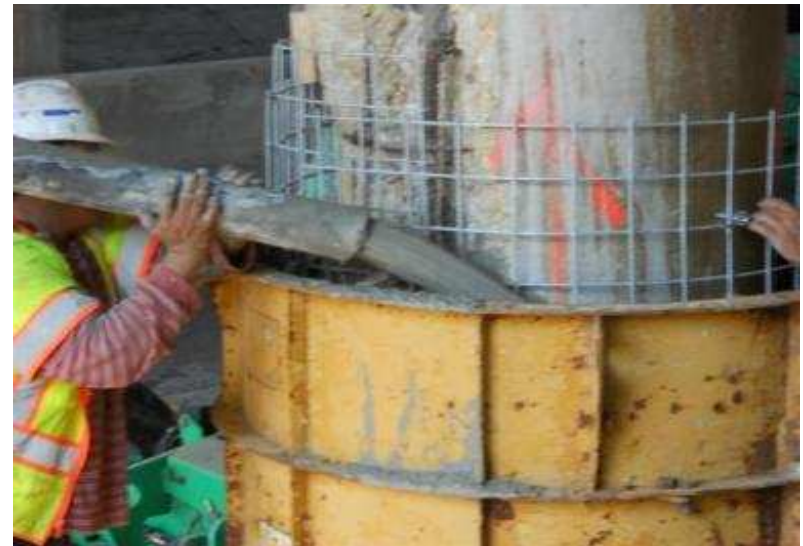
SCC pumped

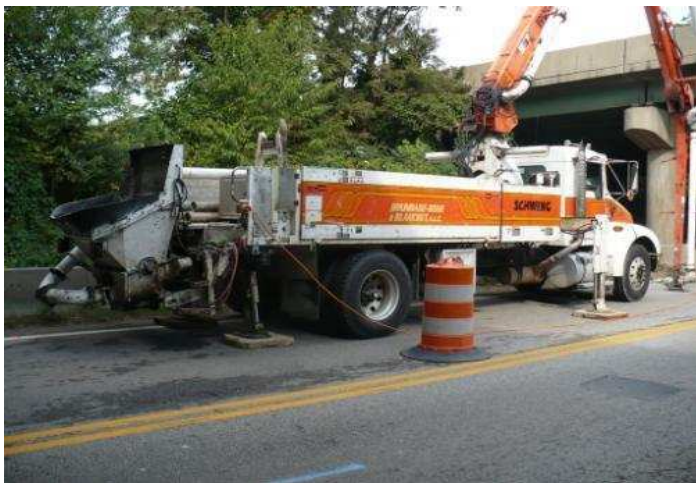
Increase in size of an existing column
