# Use of SCC for the Repair of Bridge Substructures

H. Celik Ozyildirim, Ph.D., P.E.  
Principal Research Scientist

ACI Spring Convention: April 15, 2013

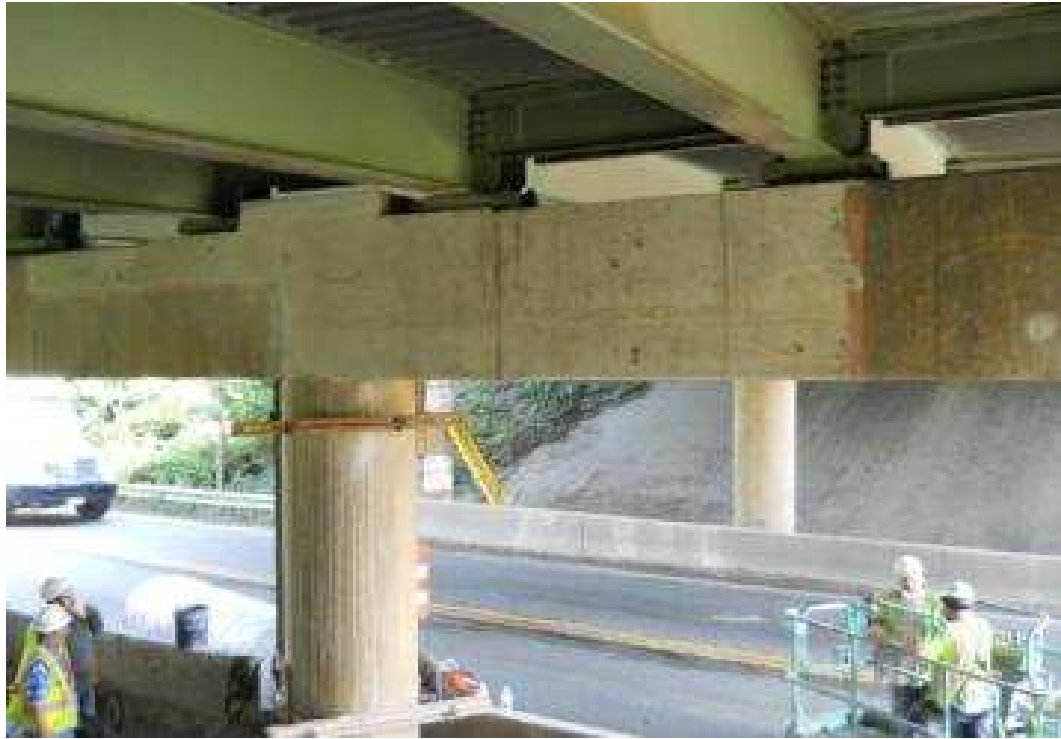
Completed pier cap

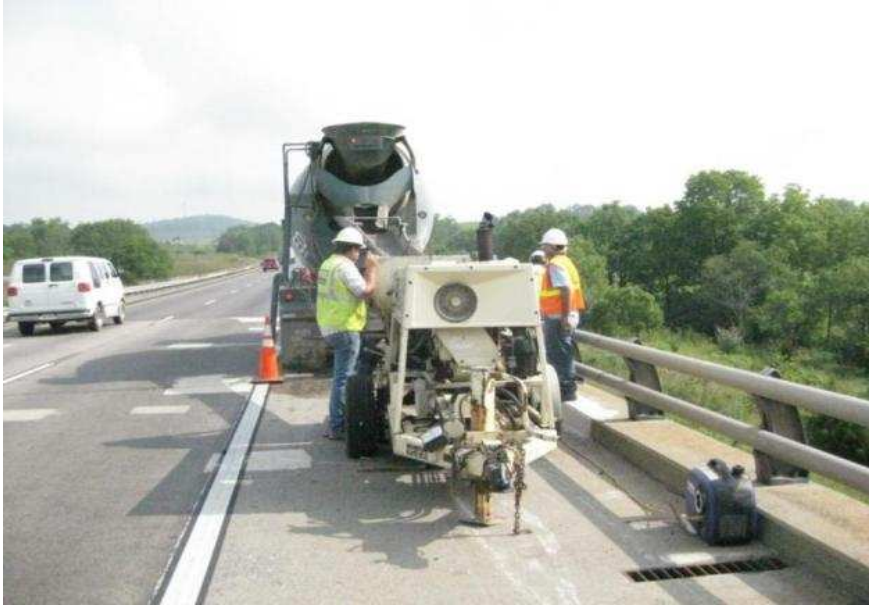
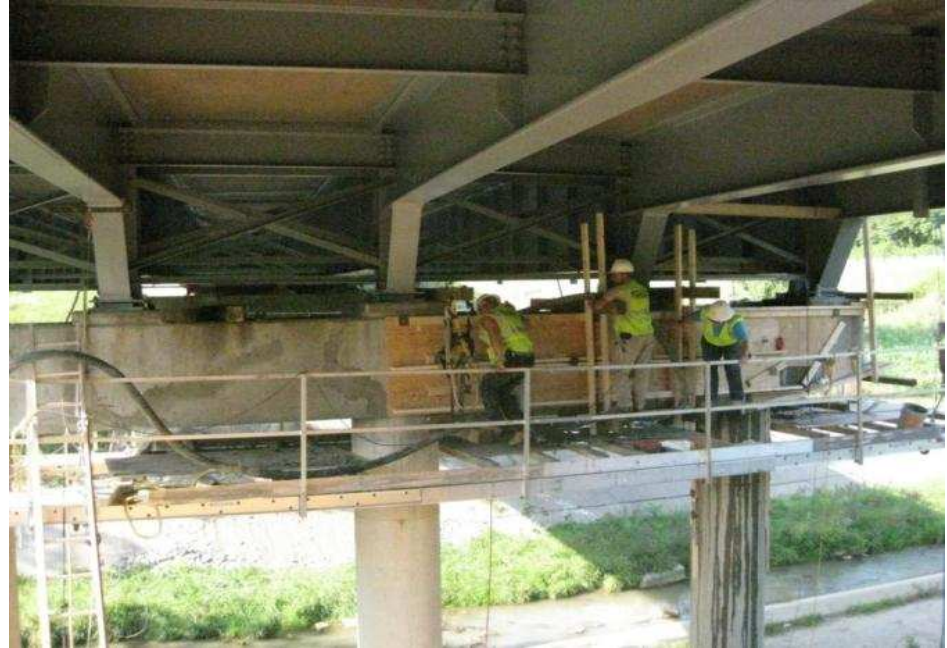
# Staunton, I-81 (2011)

SCC pumped

Strength 5,310 psi,  
Permeability 1,503 coulombs

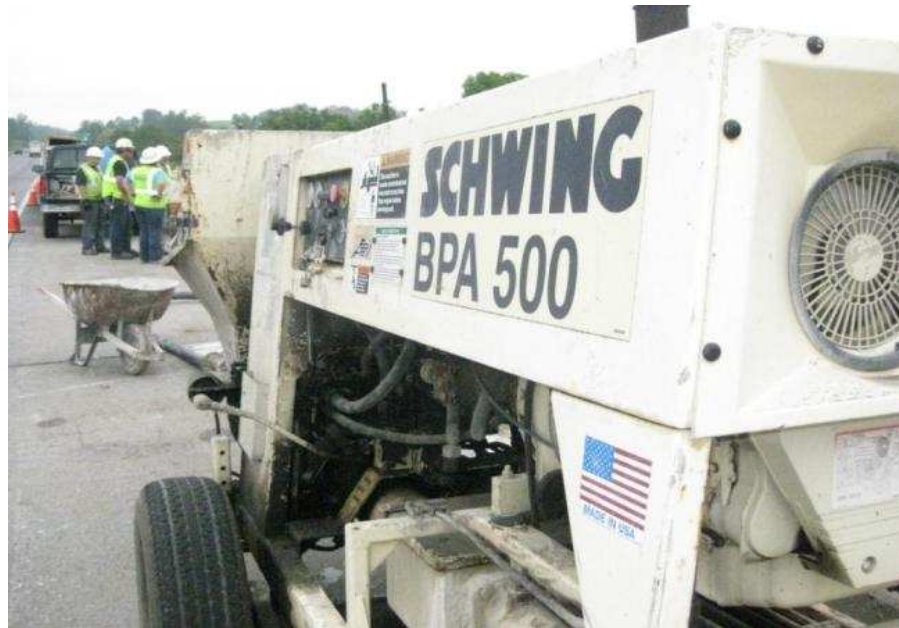
Small pump is sufficient for SCC repairs

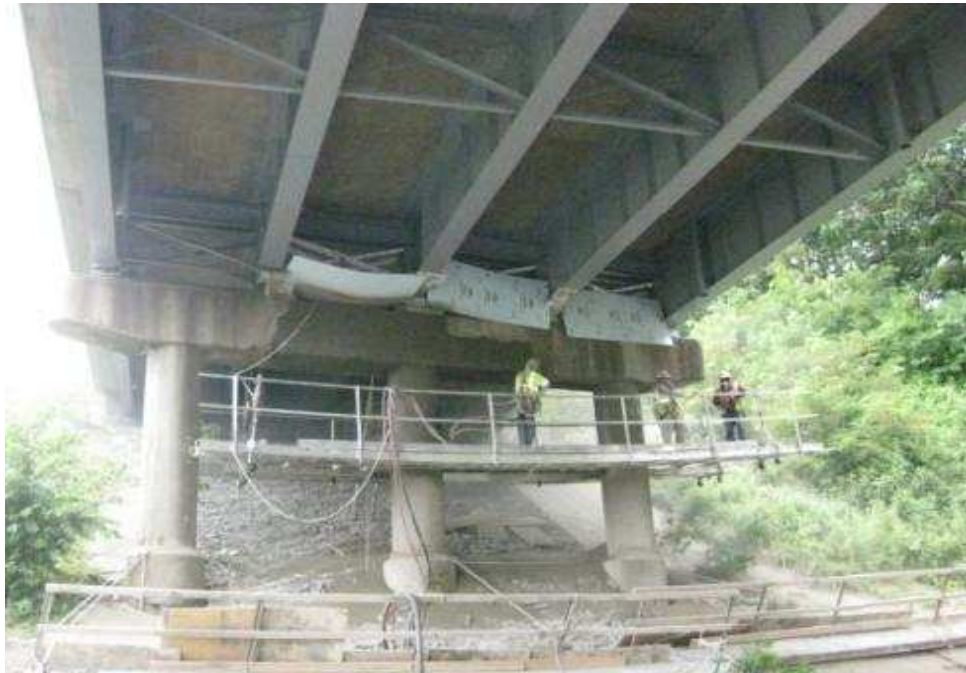
Adjacent pier caps repaired by shotcrete

Shotcrete - concrete pneumatically projected at high velocity onto a surface.

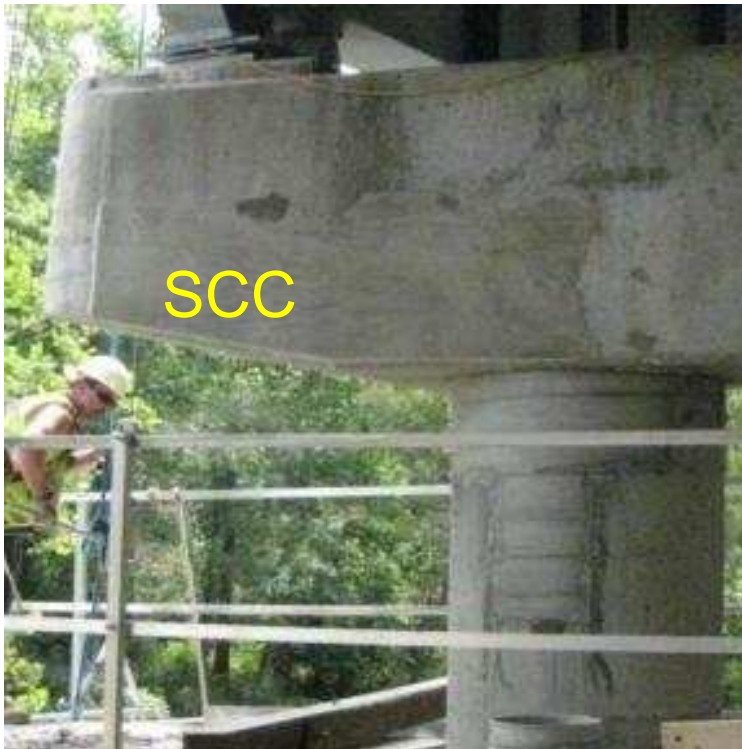
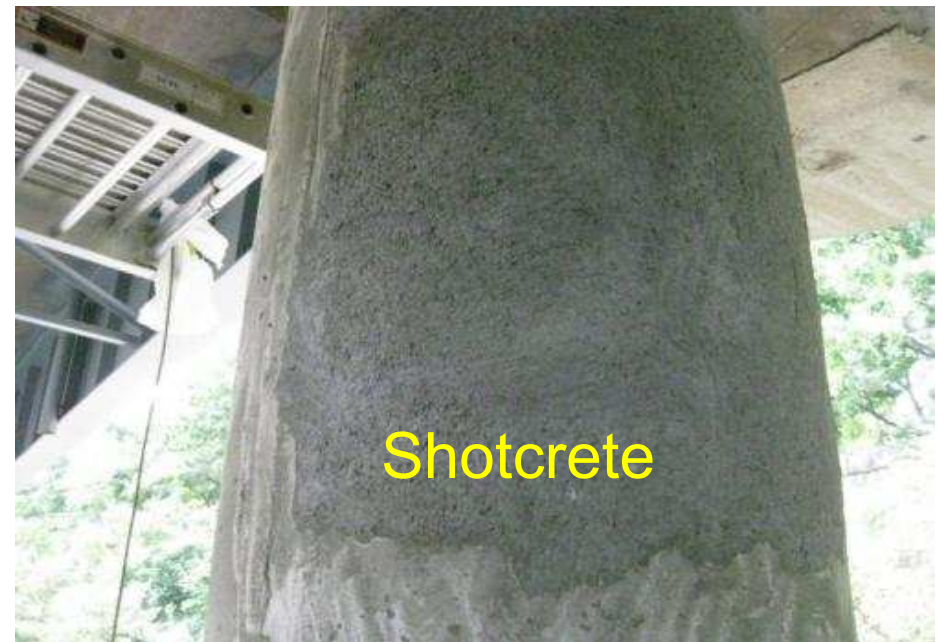
Smooth surface

Rough surface

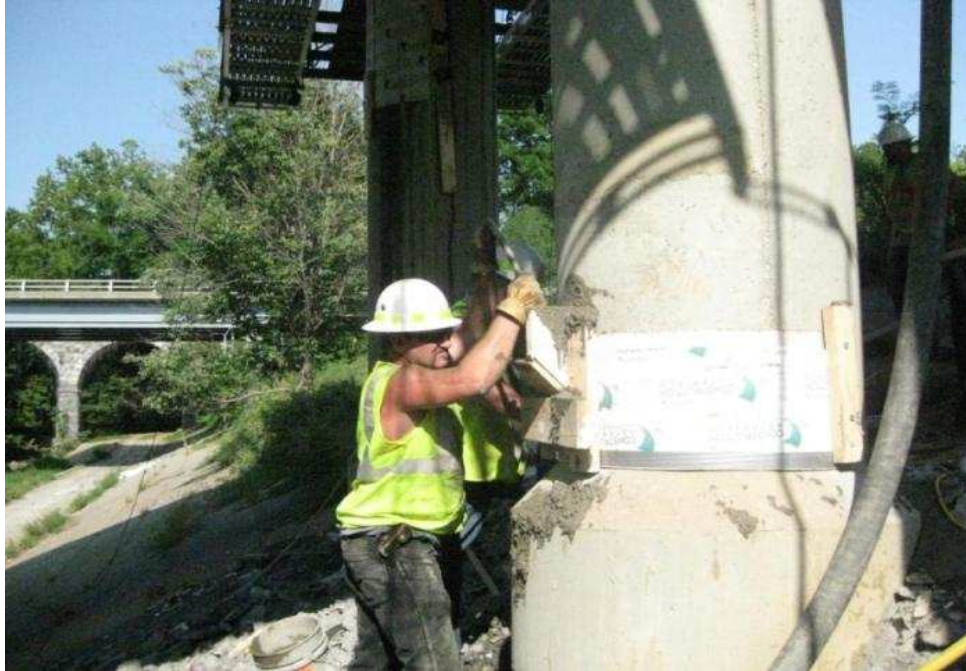
Loss of workability necessitated internal vibration
