Chapter 9—Construction

Chapter 10—Quality Assurance

Jay H. Paul, SE, FACI
Klein and Hoffman-Chicago, IL

Construction/Quality Assurance

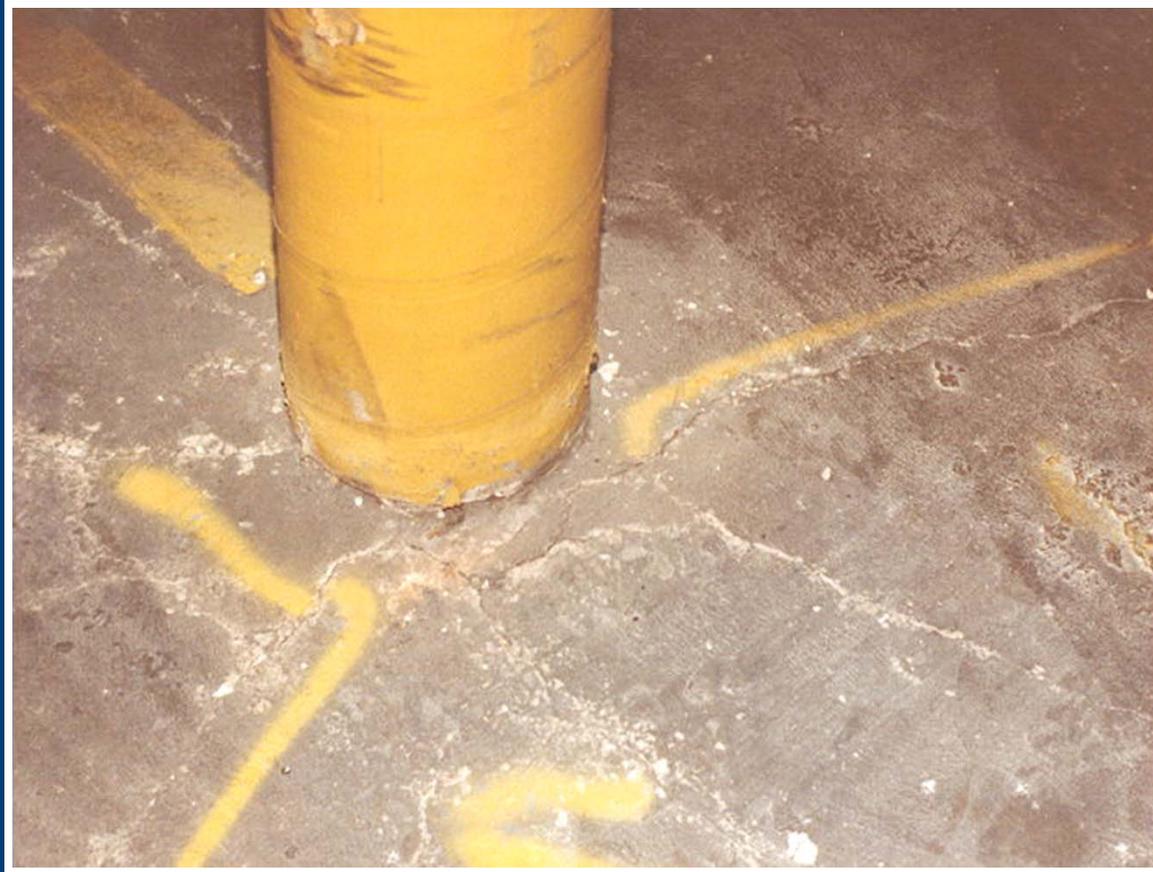
Punching shear concerns discovered during initial evaluation

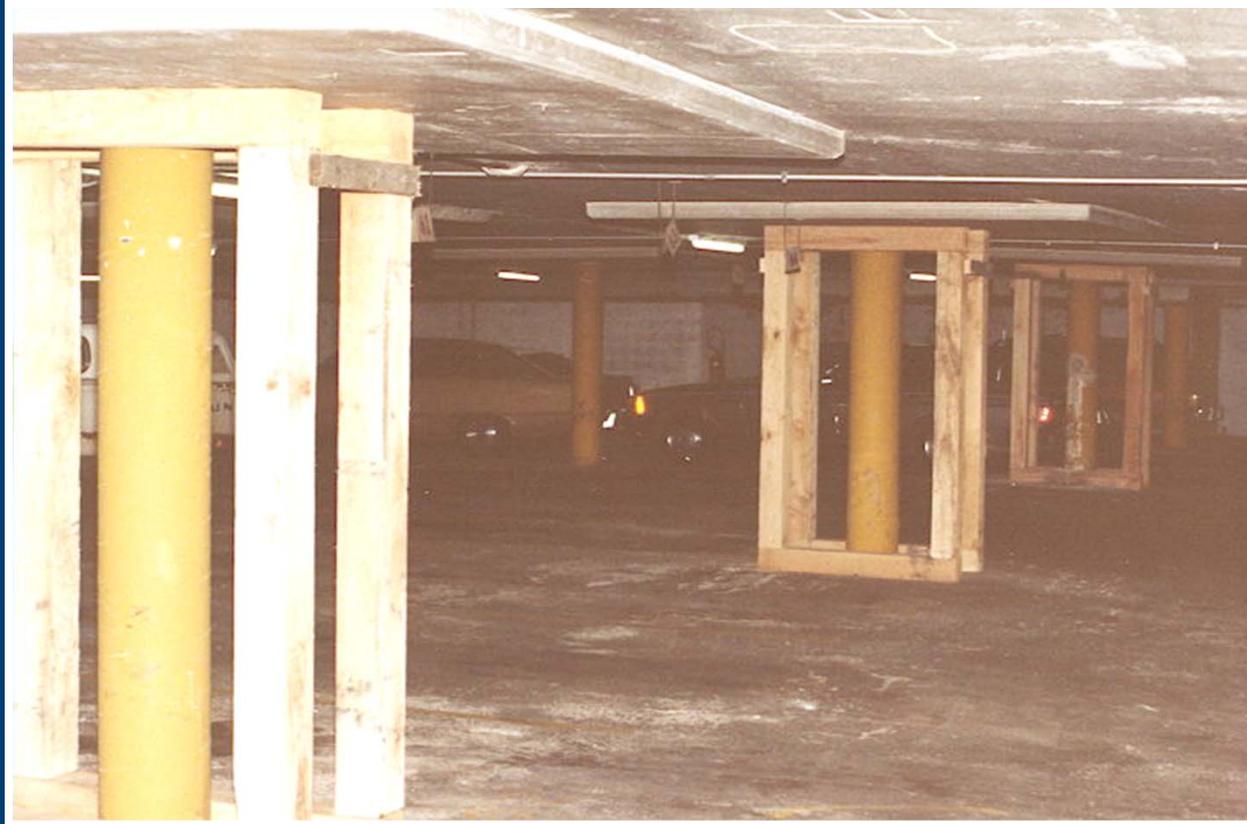
Temporary shoring was immediately installed by the contractor assisting with the evaluation

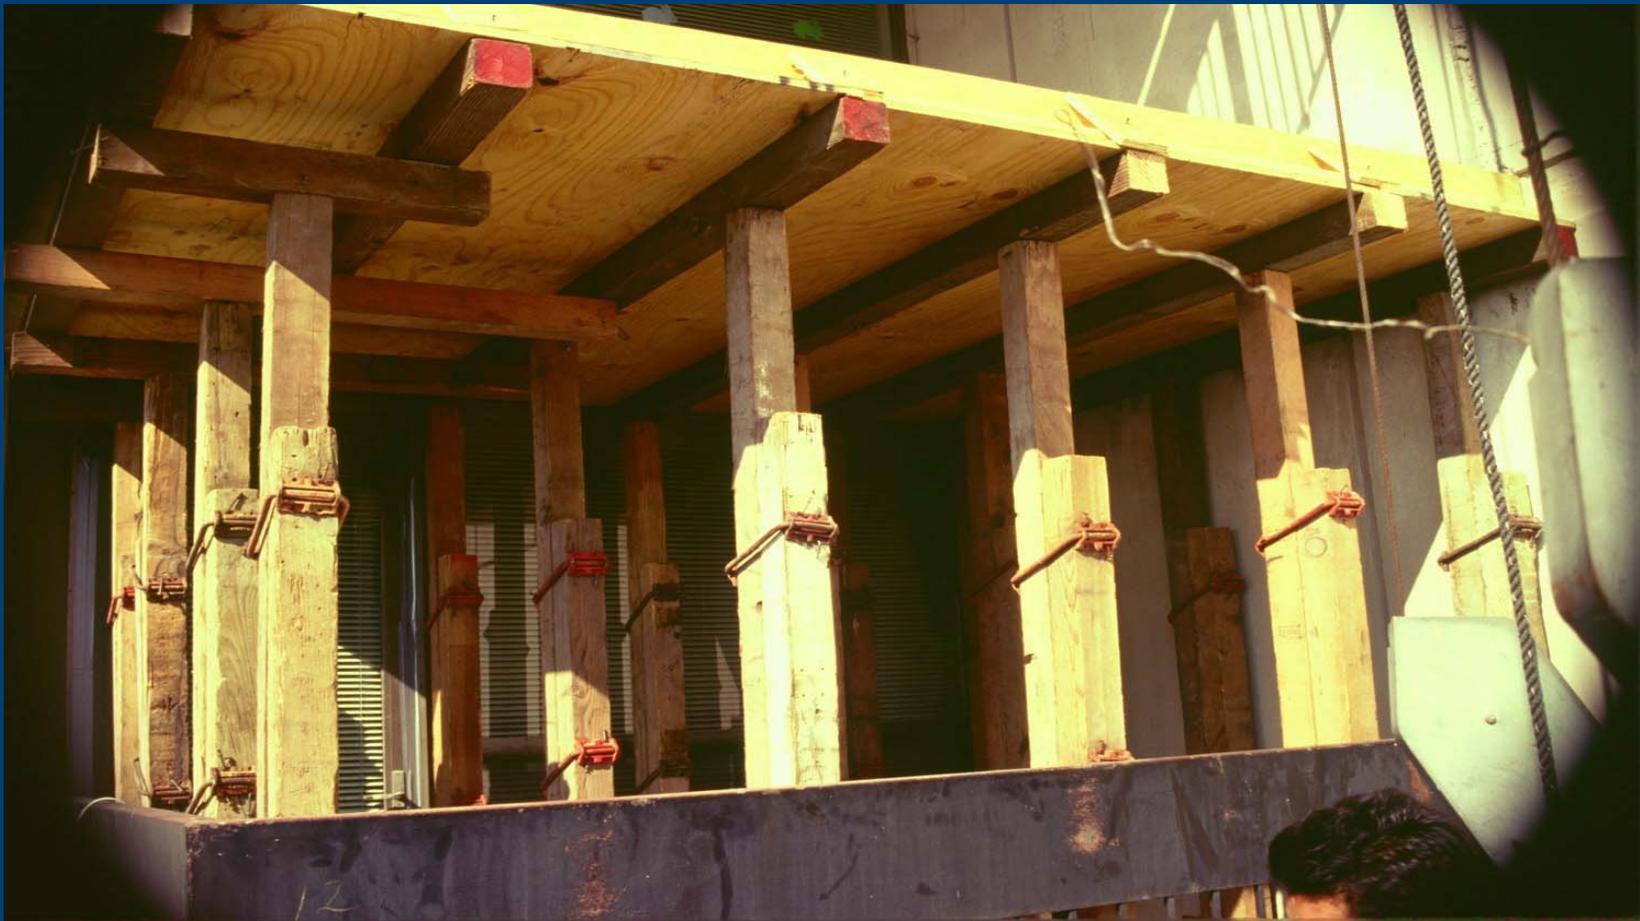
LDP must check capacity of framing to support shoring

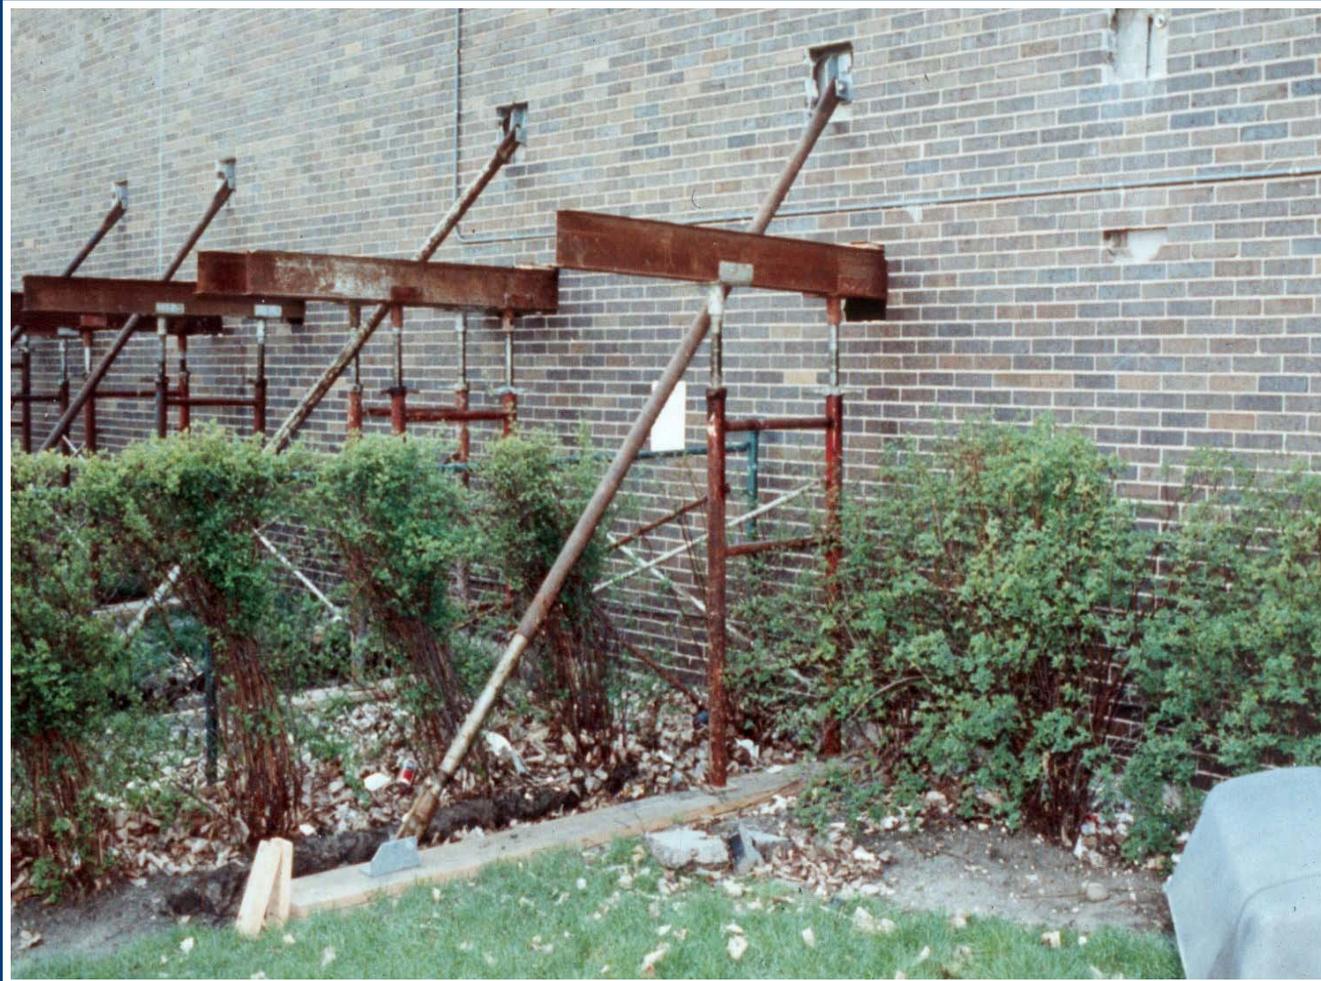
Global Stability

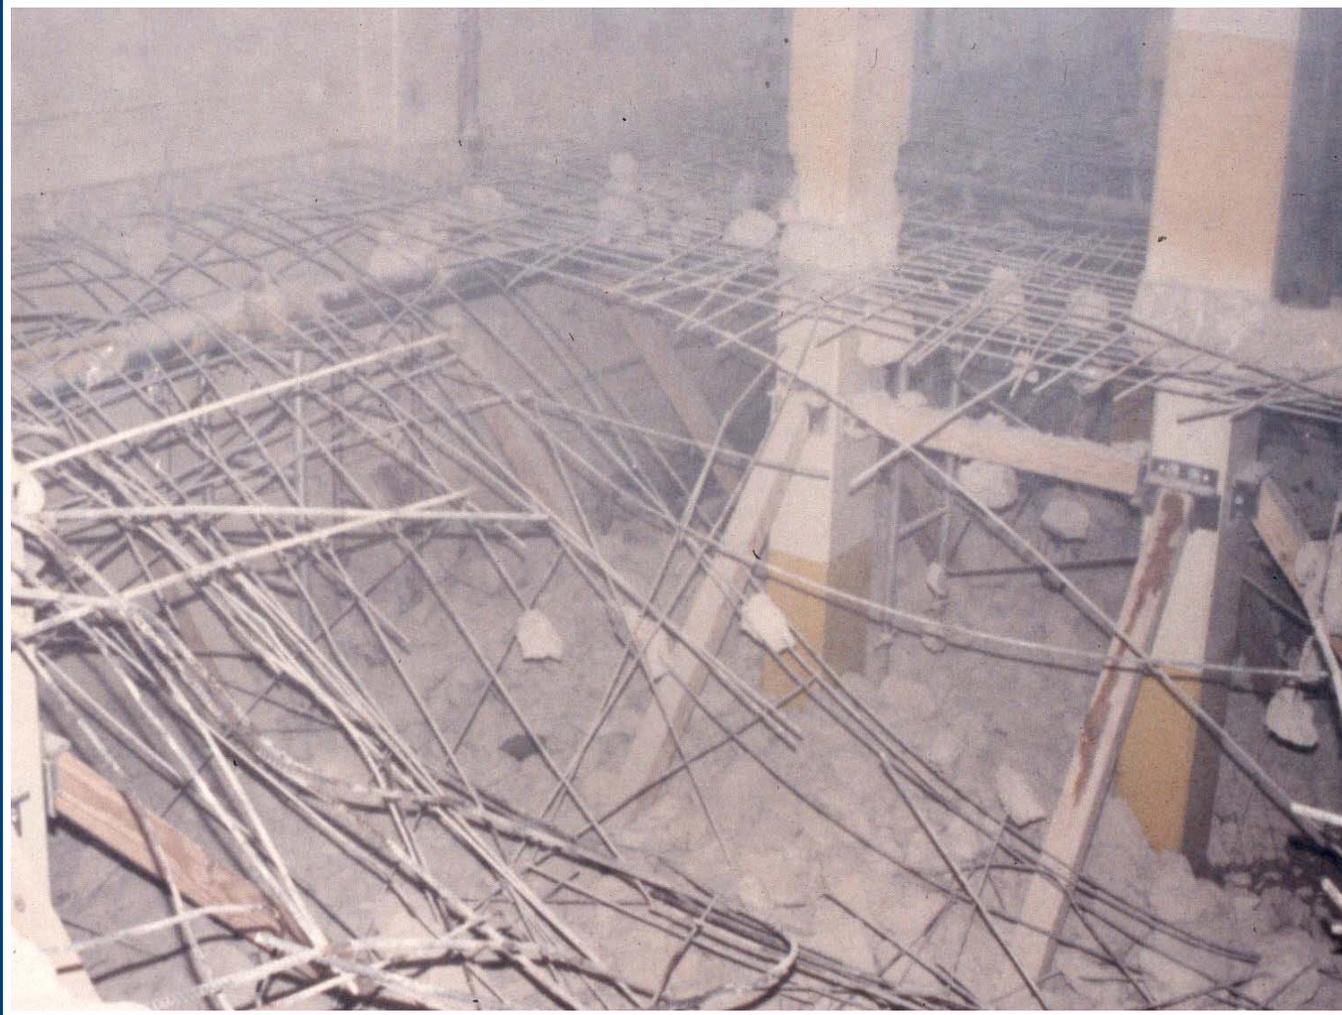
Temporary bracing of columns

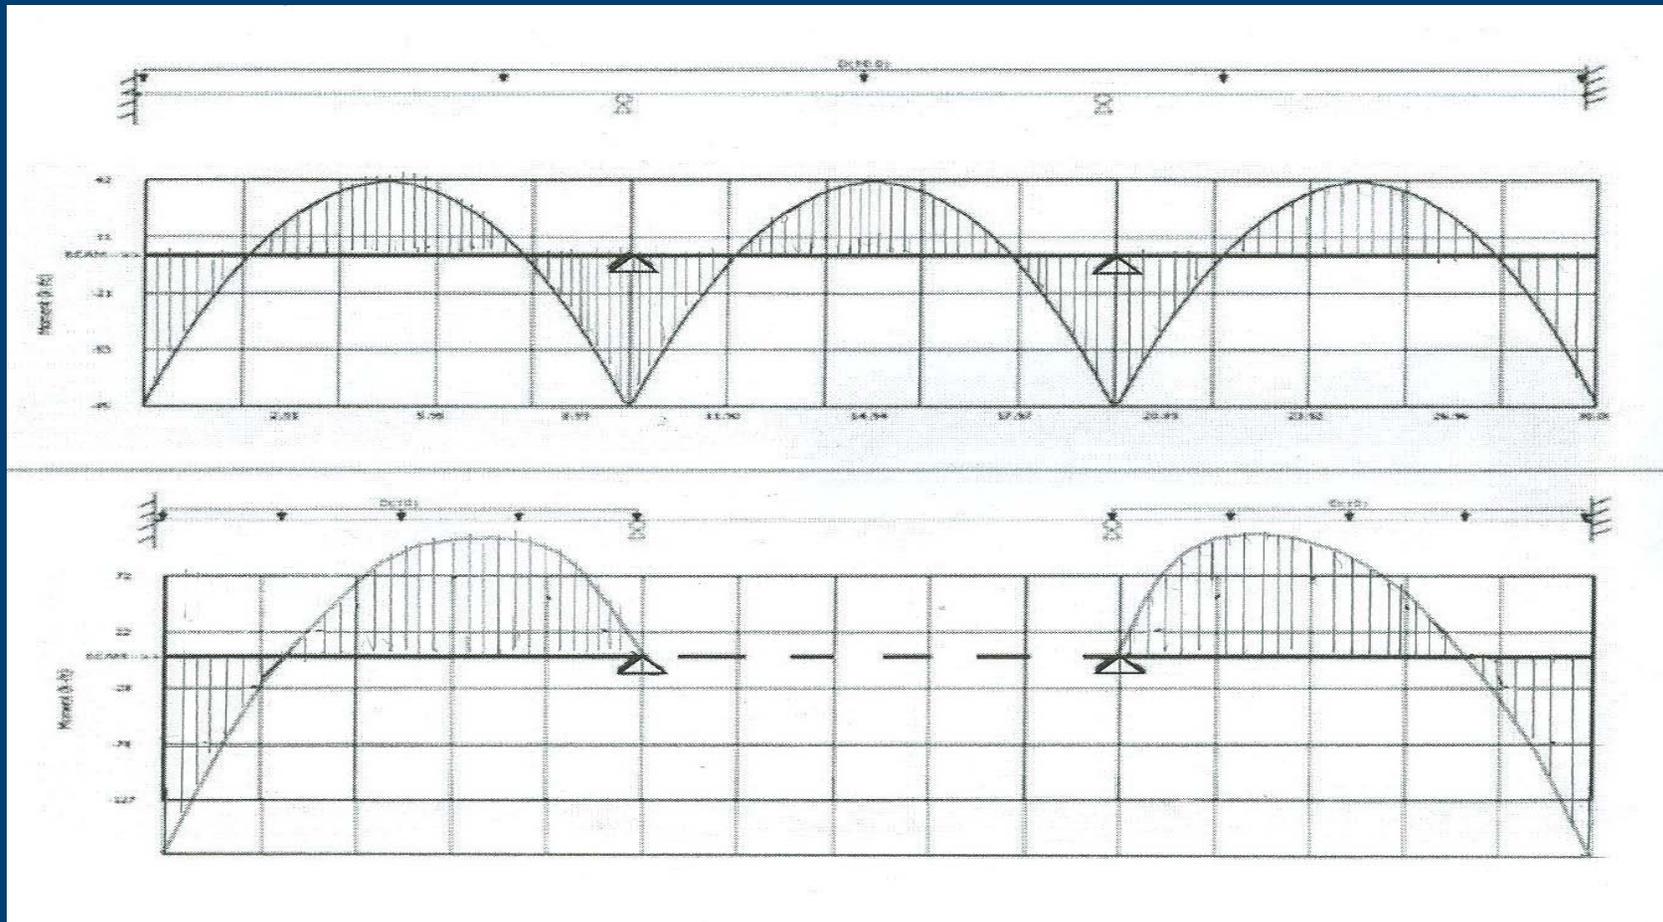
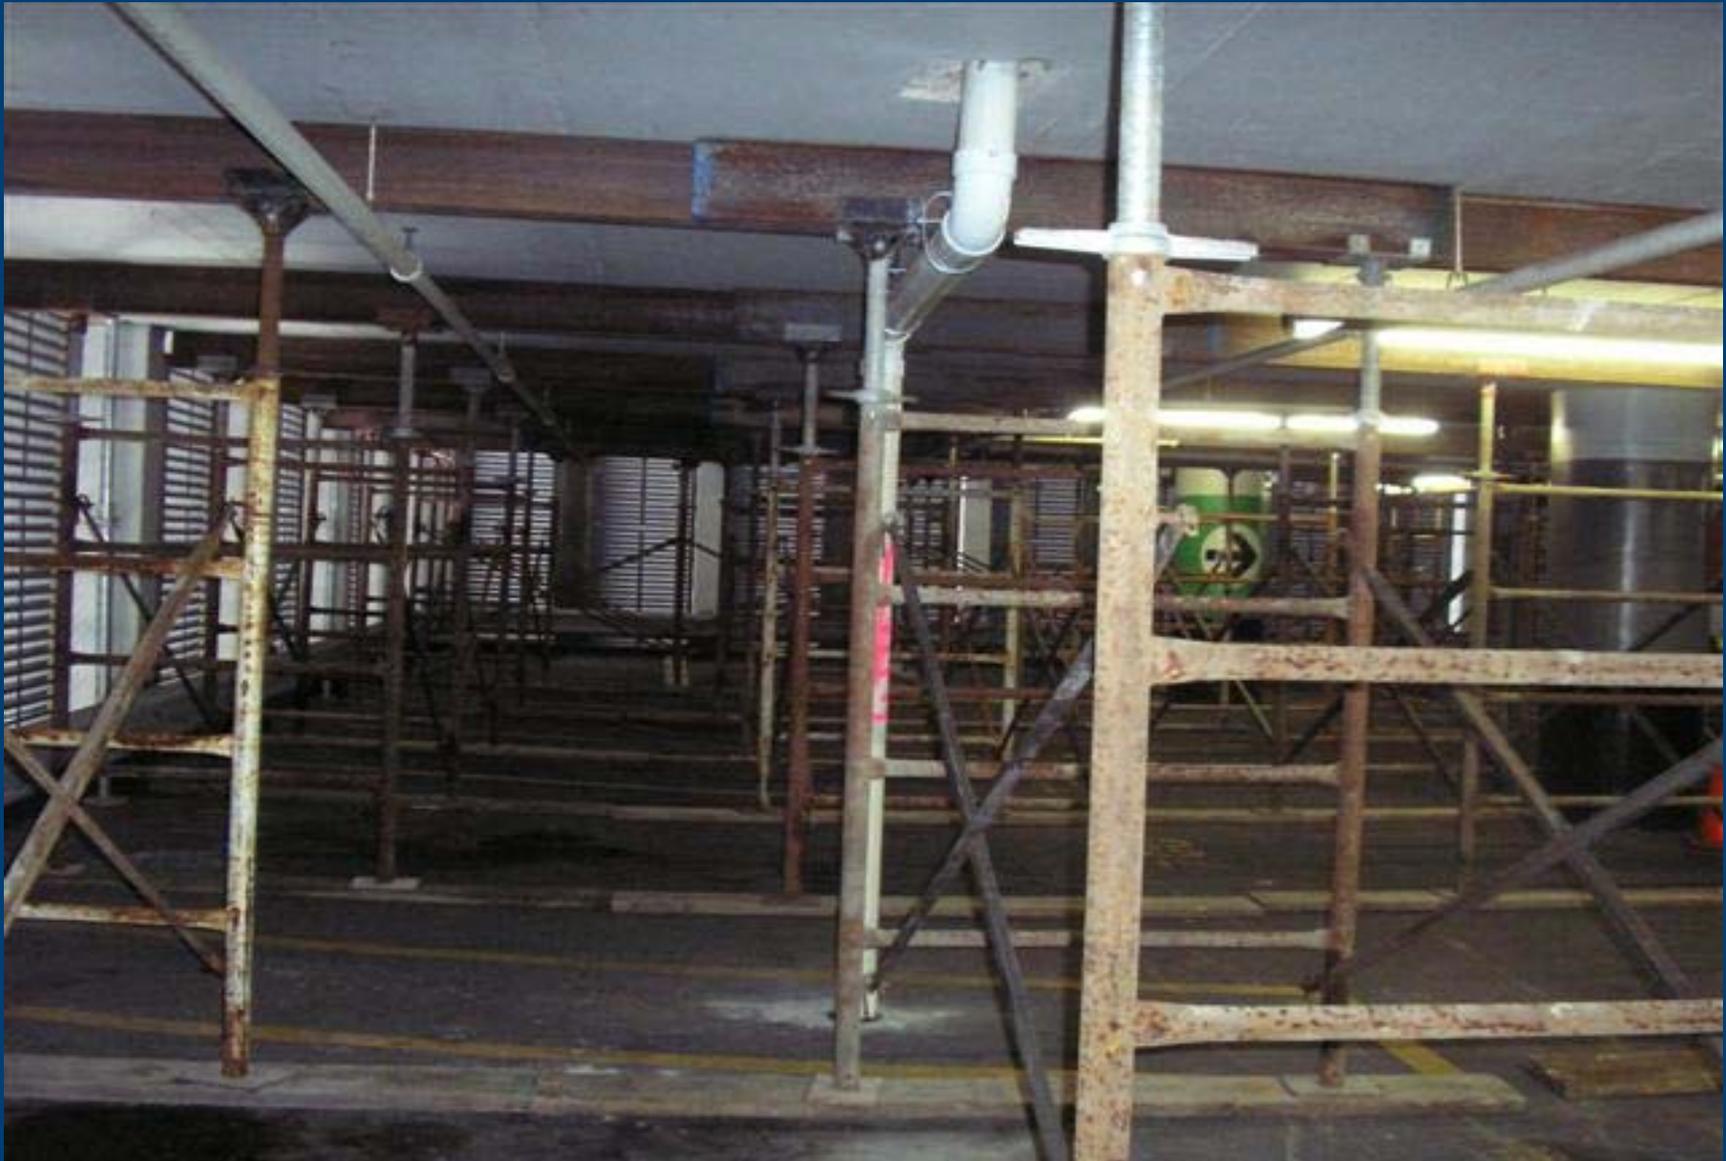
9.1.4 Design of shoring and bracing—redistribution of loads due to removal of member

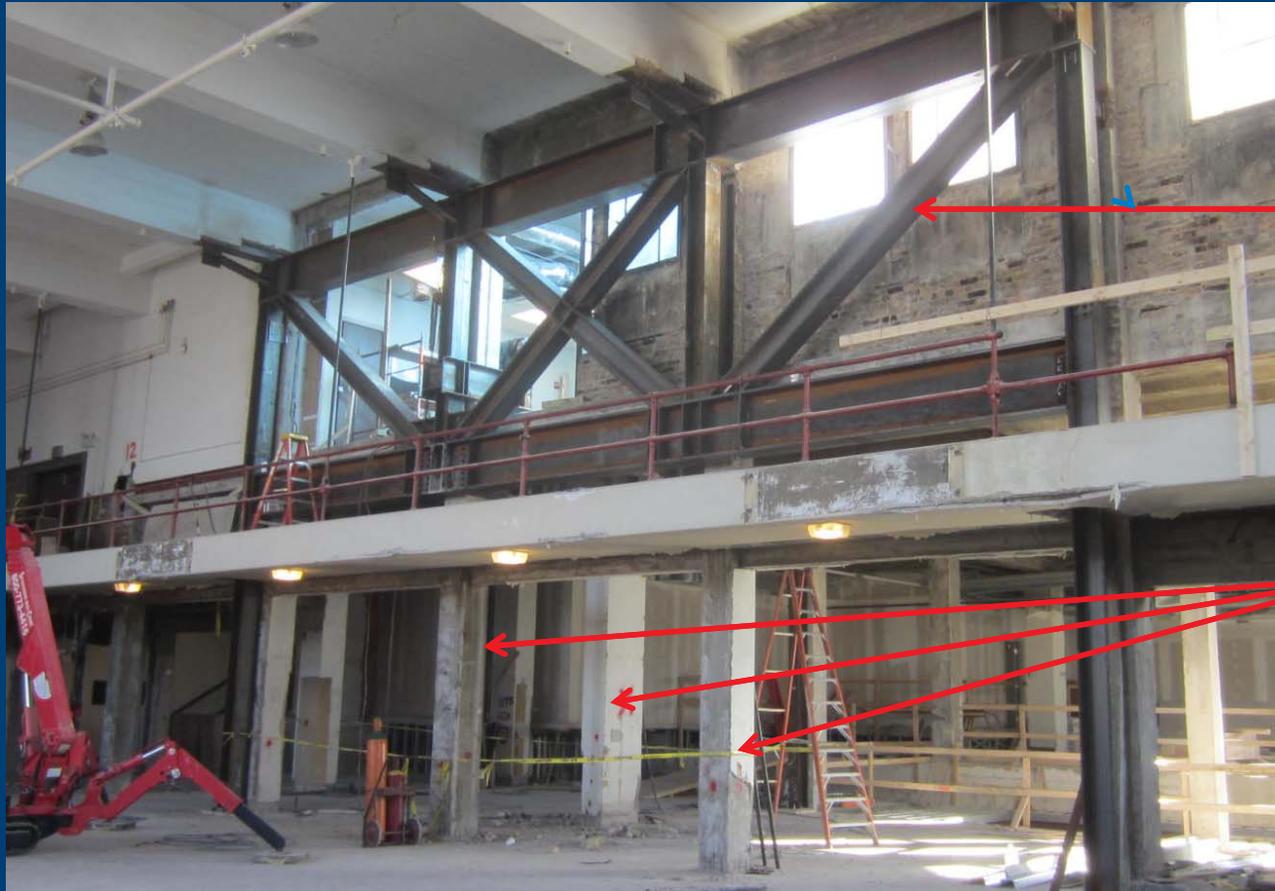
New 13 ft deep,
42 ft long transfer
truss

Columns to be
removed

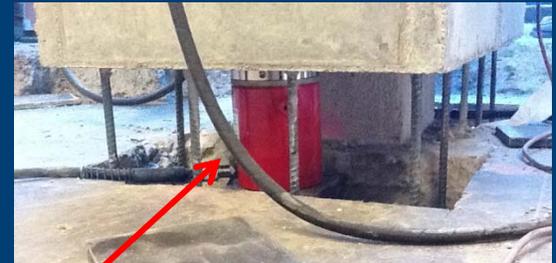
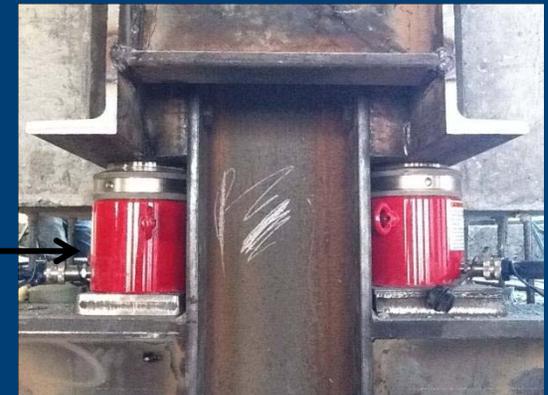
Concrete Jackets @
Column Transfers

Hydraulic Jacks to
Pre-Load Truss/Dbf
Beams (300 kips)

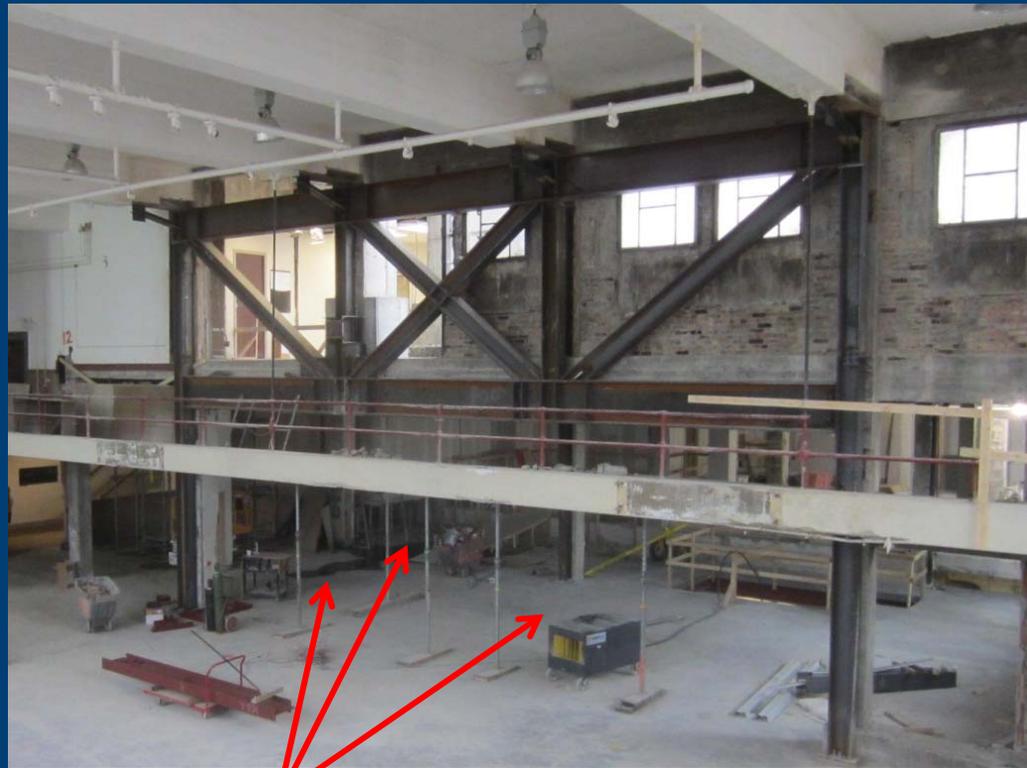
Columns Removed

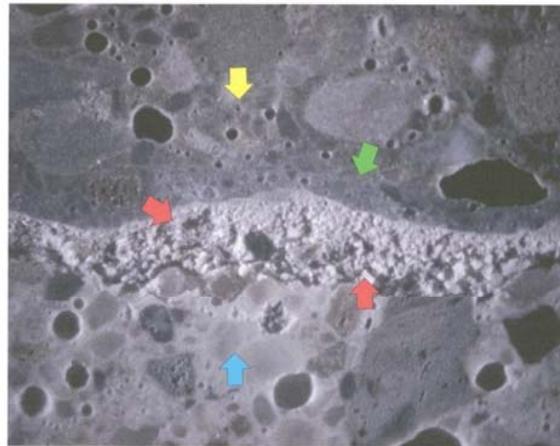
Figure 1 - Photomicrograph taken at the interface between the overlay and existing concrete in Core BT-3, which indicated a relatively low (32 psi) bond strength. This cross section shows a high porosity (loose) material between the bonding agent layer (green arrow) and the original concrete (blue arrow). Note the layer of loosely compacted material on top of the existing concrete (red arrows). This material is soft and friable, and represents a zone of weakness that ultimately becomes the failure plane.

- Actions taken to improve bond strength:
 - Contractor improved methods to clean surface of substrate and to remove all residue resulting from hydro demolition
 - K&H inspectors more closely examined surface of substrate for suitability to receive bonded overlay
