Behavior of Concrete Beams with Corroded Reinforcement Retrofitted with CFRP

Needa Lingga, MSCE, ACI Member

Franz N. Rad, PhD, PE, SE, FASCE, FACI

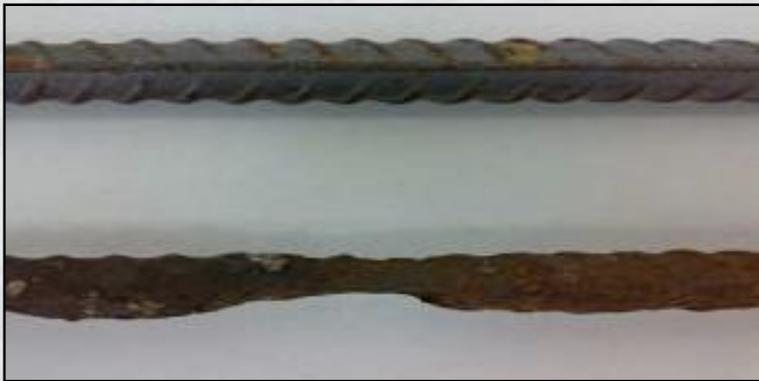
Steel Reinforcement Cross Section

- Formation of rust \rightarrow corrosion \rightarrow reduce the cross sectional area of steel \rightarrow reduce the flexural and shear strength capacity of RC \rightarrow loss the bond between concrete and reinforcement

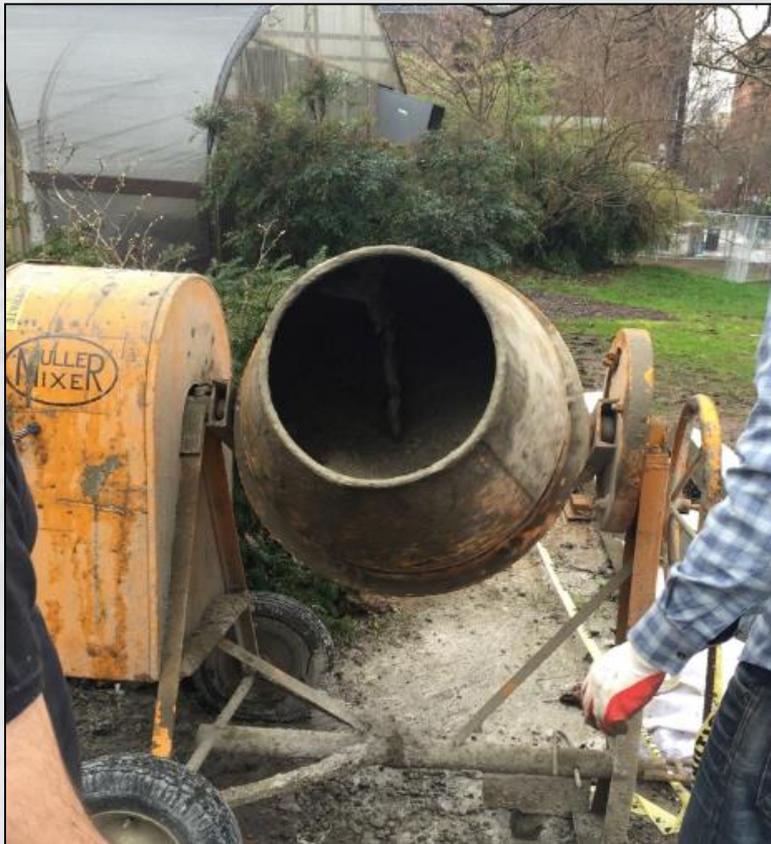
Concrete Mix

Target compressive strength = 3000 psi

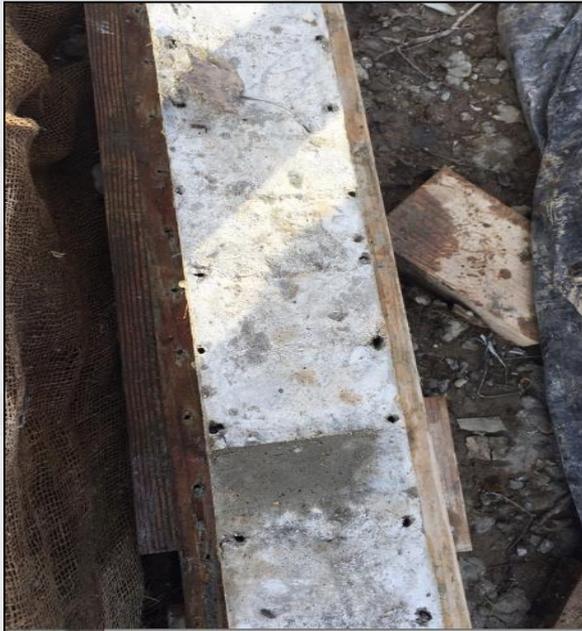
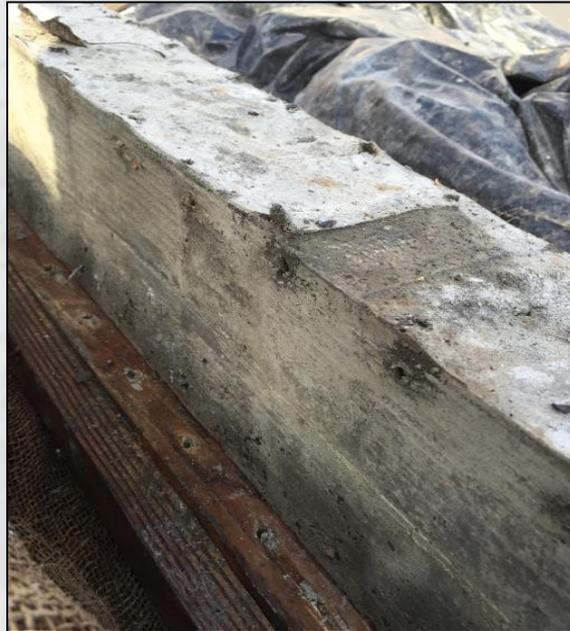
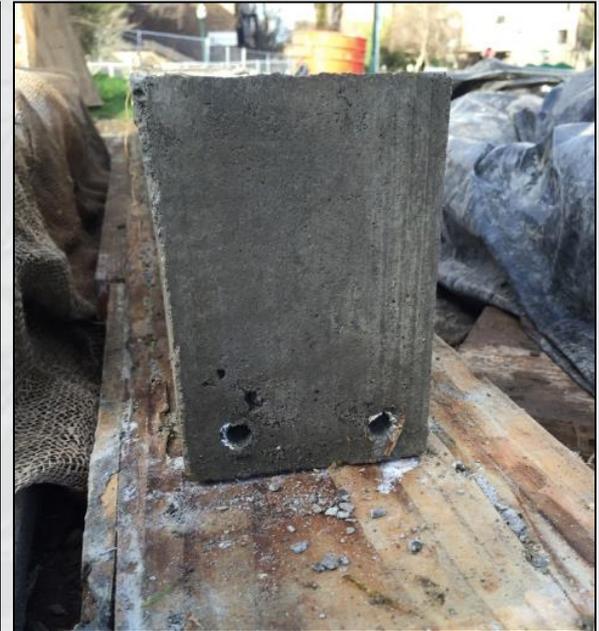
Deteriorated RC Beam (Fully corroded steel)

- A worst case scenario of corrosion was considered.
- Definition :
 - 100% corrosion
 - A complete loss in the bond between concrete and reinforcement
 - A complete loss in rebar cross sectional area and strength
 - Steel reinforcement is considered non-active
 - Steel reinforcement is eliminated in the experiment

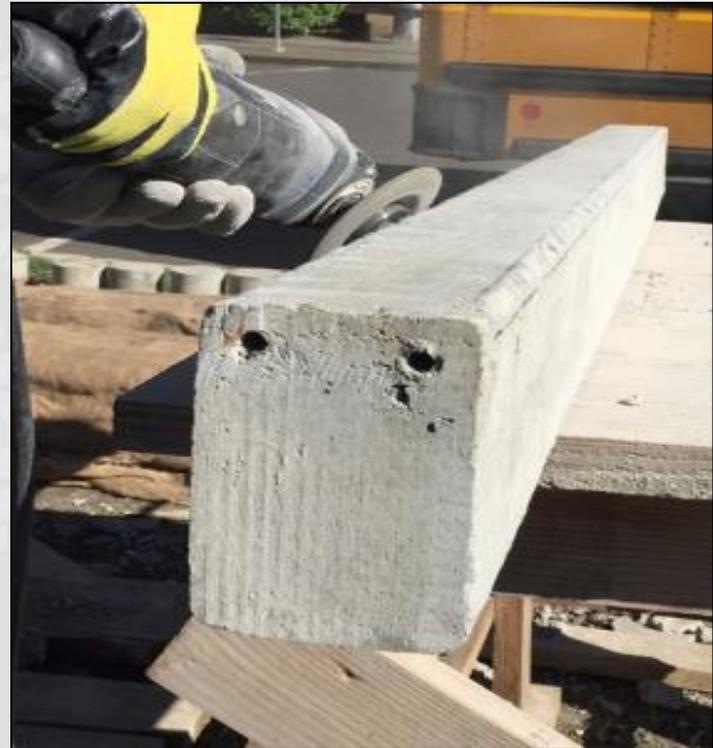
- ✓ Surfaces was grinded
- ✓ Edges were rounded
- ✓ Big cavities were grouted using cement mortar

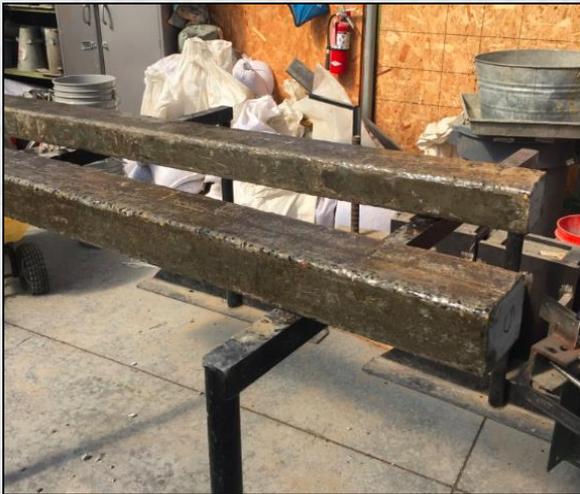
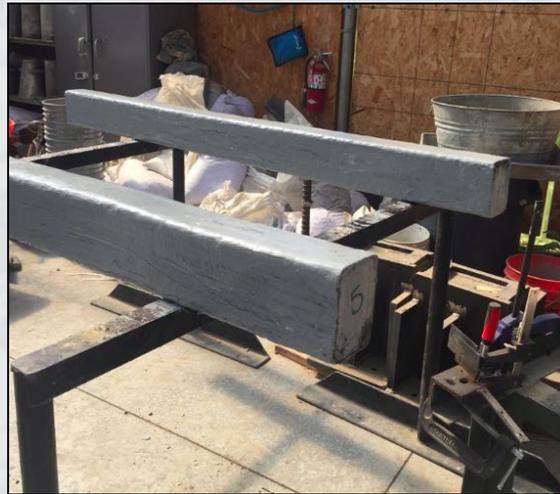
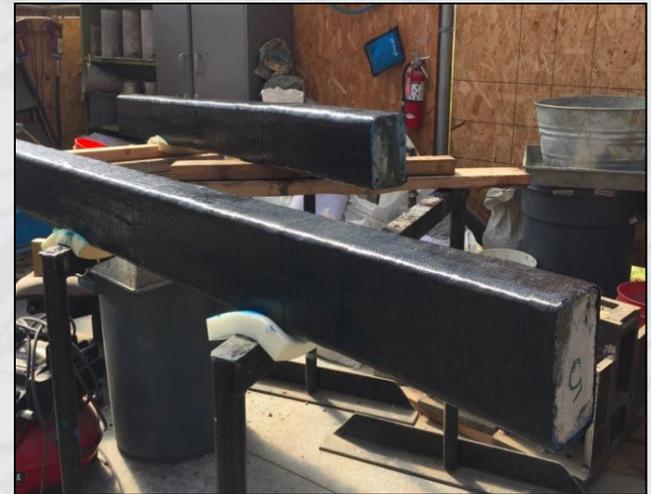
- ✓ Each epoxy sets for 24 hours.
- ✓ Minimum one week for curing

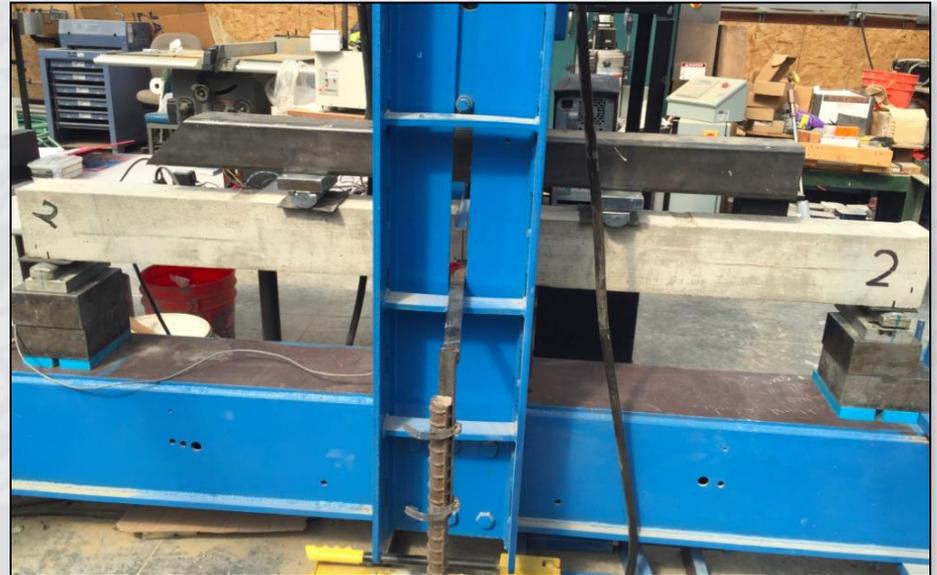
Testing Setup and Data Collection

- All beams were tested to failure under third-point loading.
- Two channels of data were collected during the tests
 - Applied load
 - Middle deflection

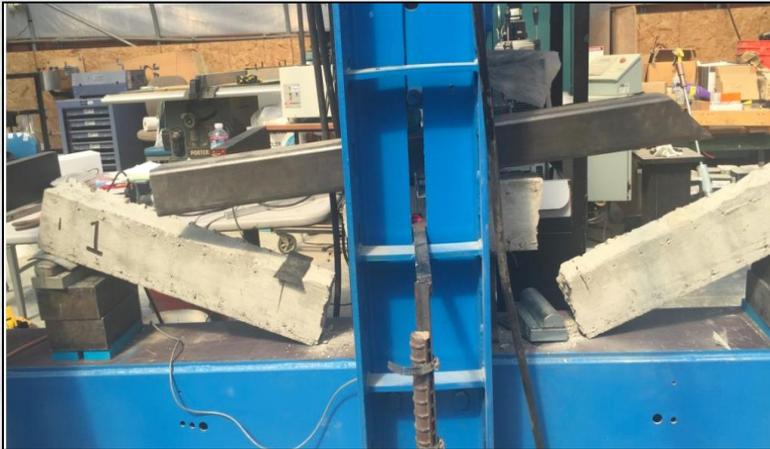
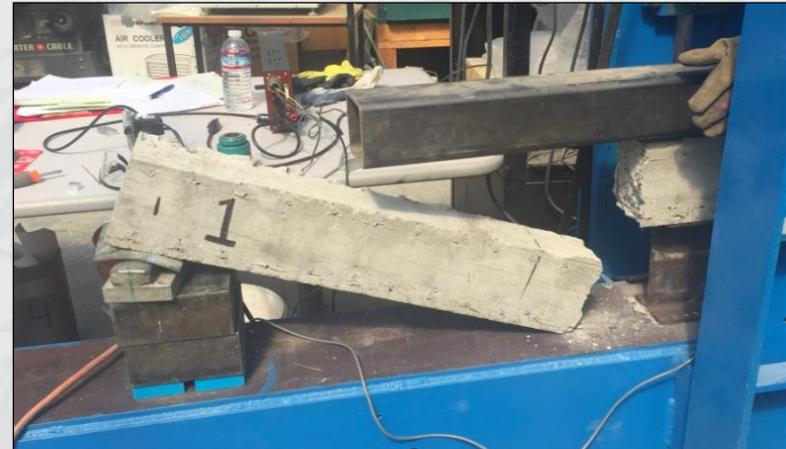
Test Result Beam #1

Deteriorated Beam
Classic brittle failure

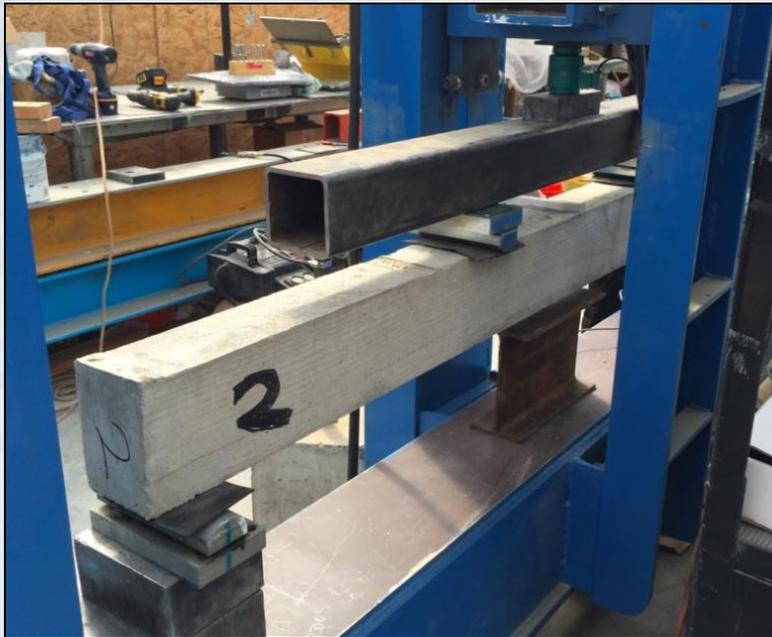
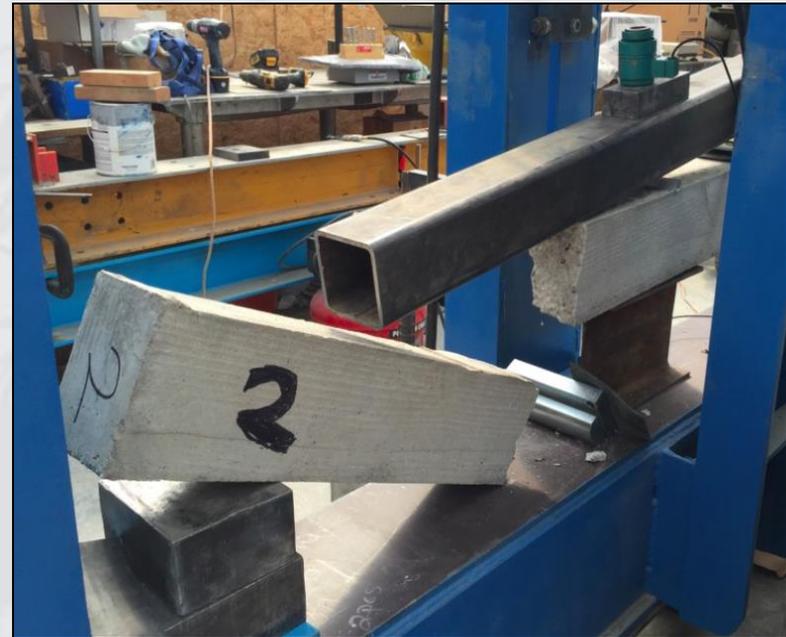
Test Result Beam #2

Plain Concrete Beam
Classic brittle failure

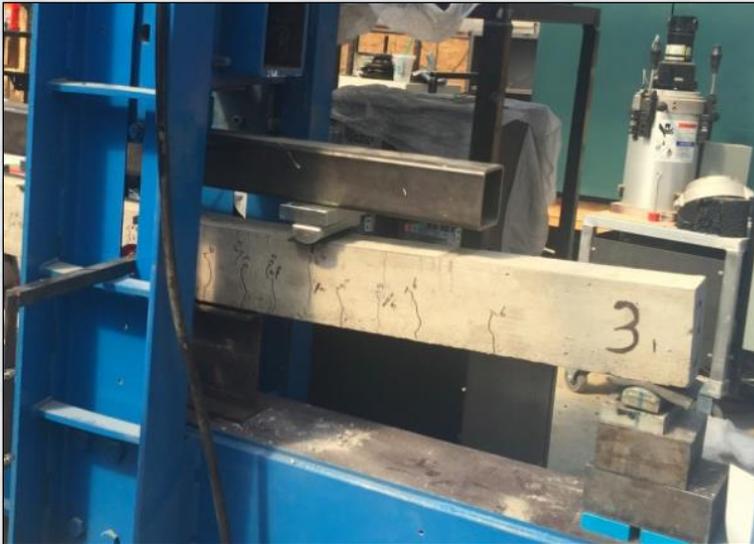
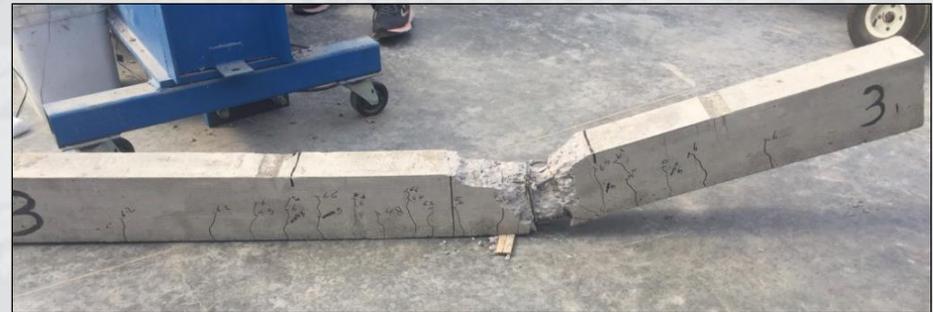
Test Result Beam #3

Reinforced Concrete Beam

Classic ductile failure, gradual and controlled

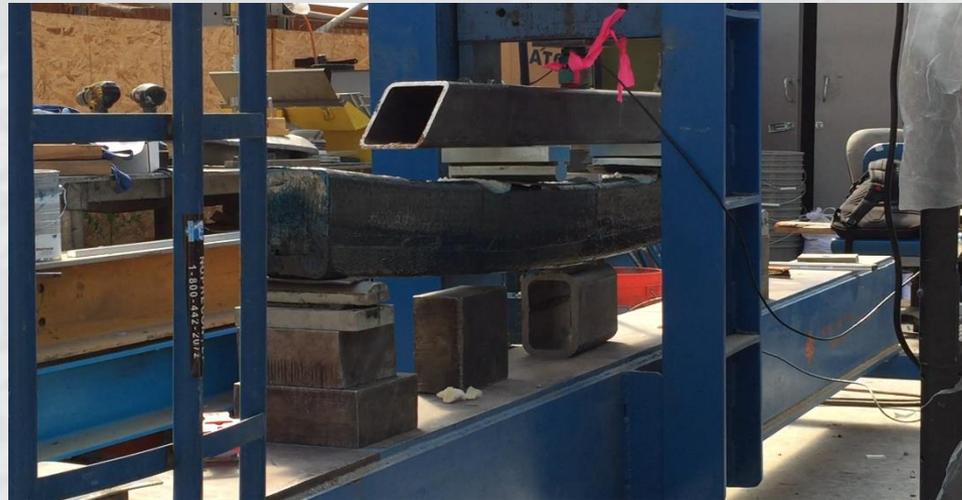
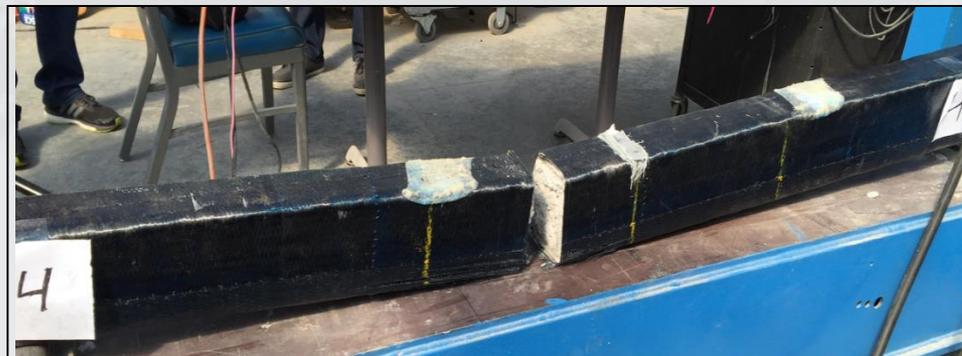
Test Result Beam #4

Deteriorated beam with one layer of CFRP

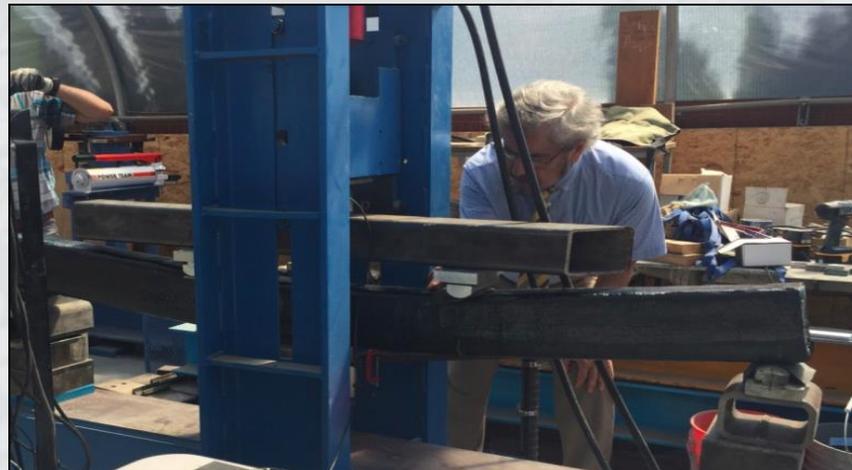
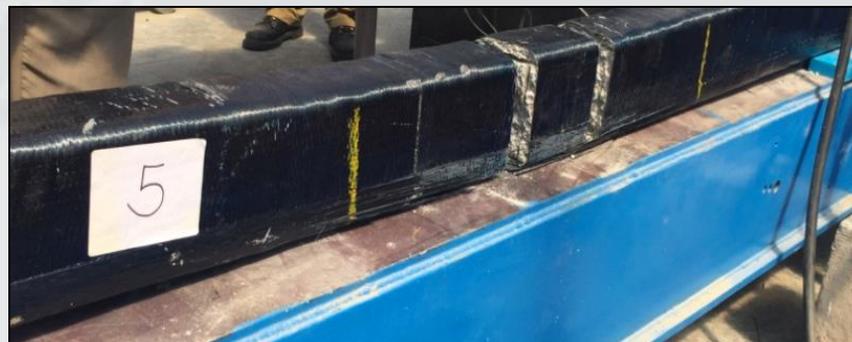
Test Result Beam #5

Deteriorated beam with two layers of CFRP
