Performance Evaluation of Silane in Concrete Bridge Decks Using Transmission X-ray Microscopy

Amir Behravan, Syed Muhammad Aqib , Norbert J. Delatte , M. Tyler Ley, Anna Rywelski

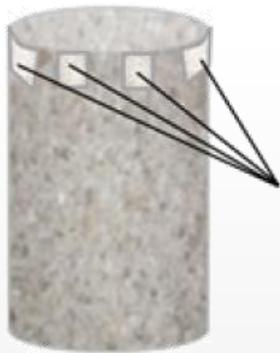
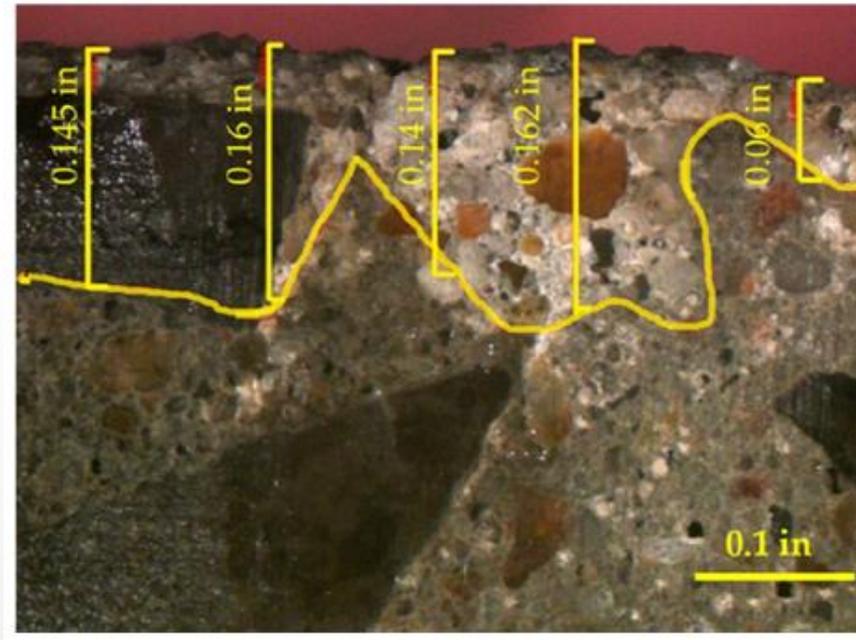
Silane Penetration Depth

d = 100 mm

9 polished spots around the sample near the surface

45 Measurements / Core

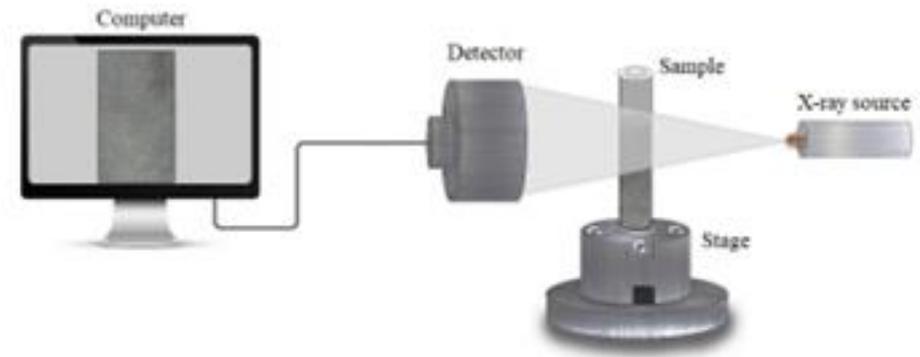
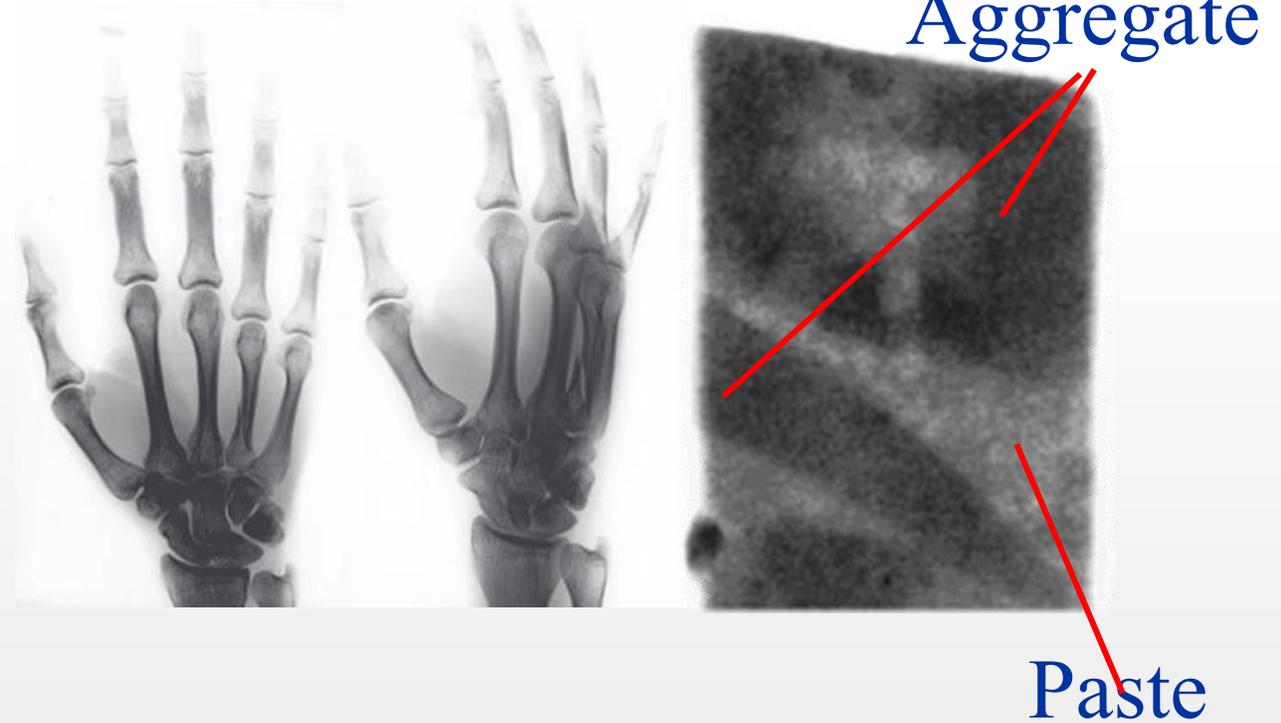
TXM Method

Put the sample between X-ray Source and detector to get a radiograph image;

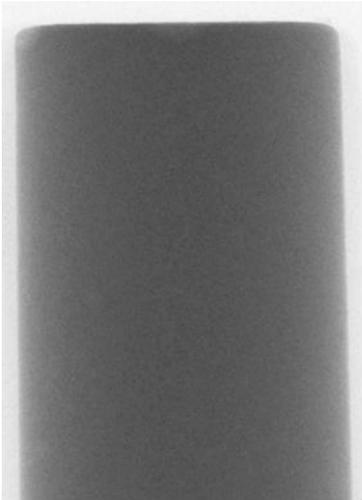
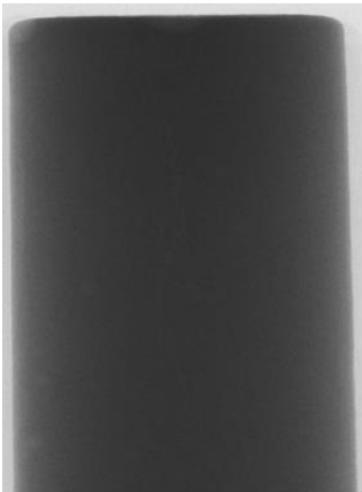
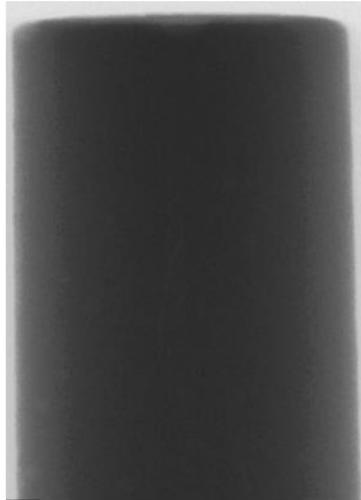
Ponding period

Initial

1 days

28 days

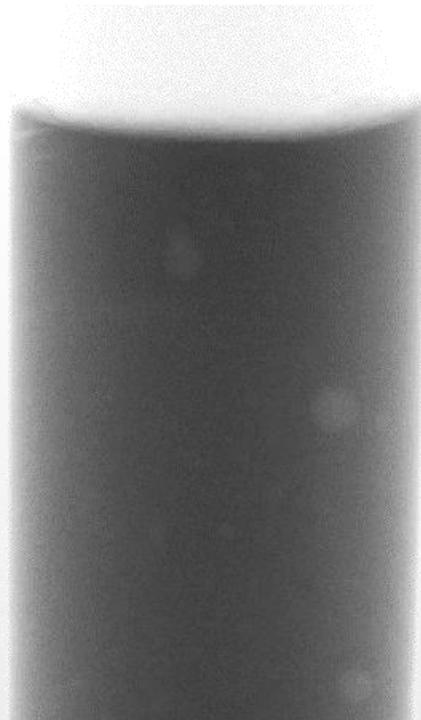
Materials with low electron density(e.g. Beryllium, Water, NaCl) cannot be detected in this method

Water on top

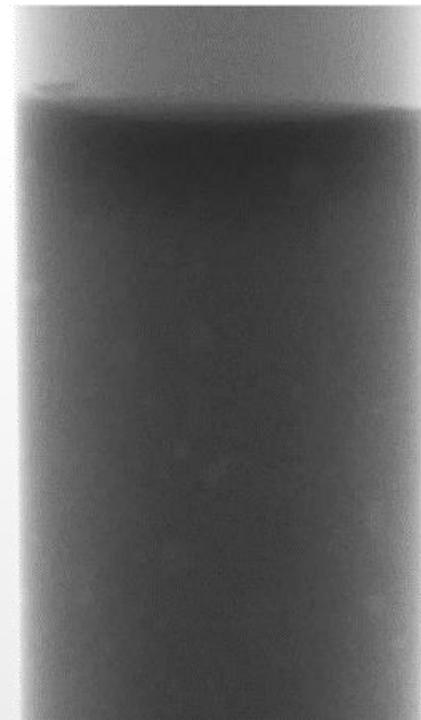
KI solution on top (0.6 Mol/L)

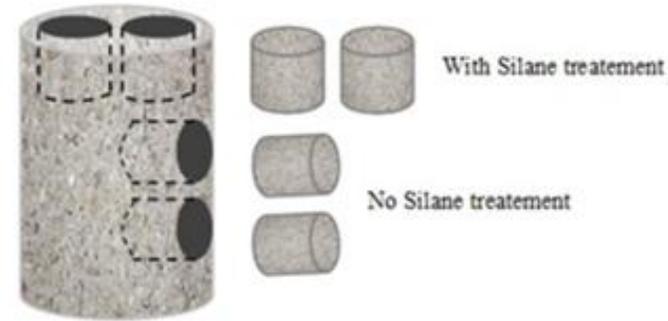
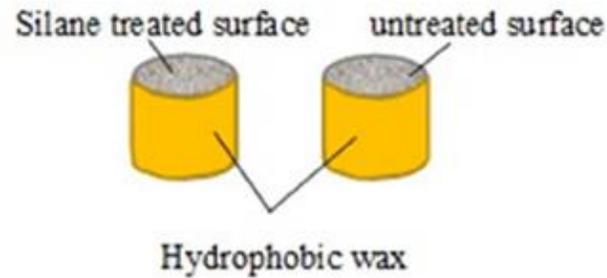
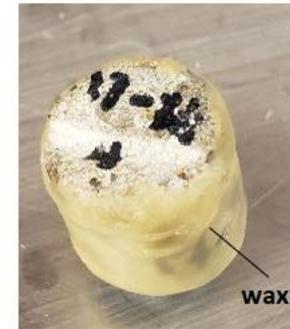
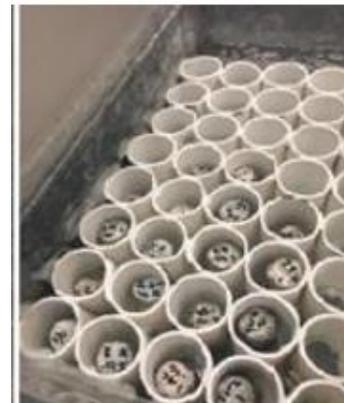
External ion penetration

- 4 miniature cores;
- Sealing the sides of the samples;
- Obtaining reference/consequent radiographs;
- Compared the ion concentration profile, penetration depth, and ion diffusion coefficient between silane-treated and untreated samples.

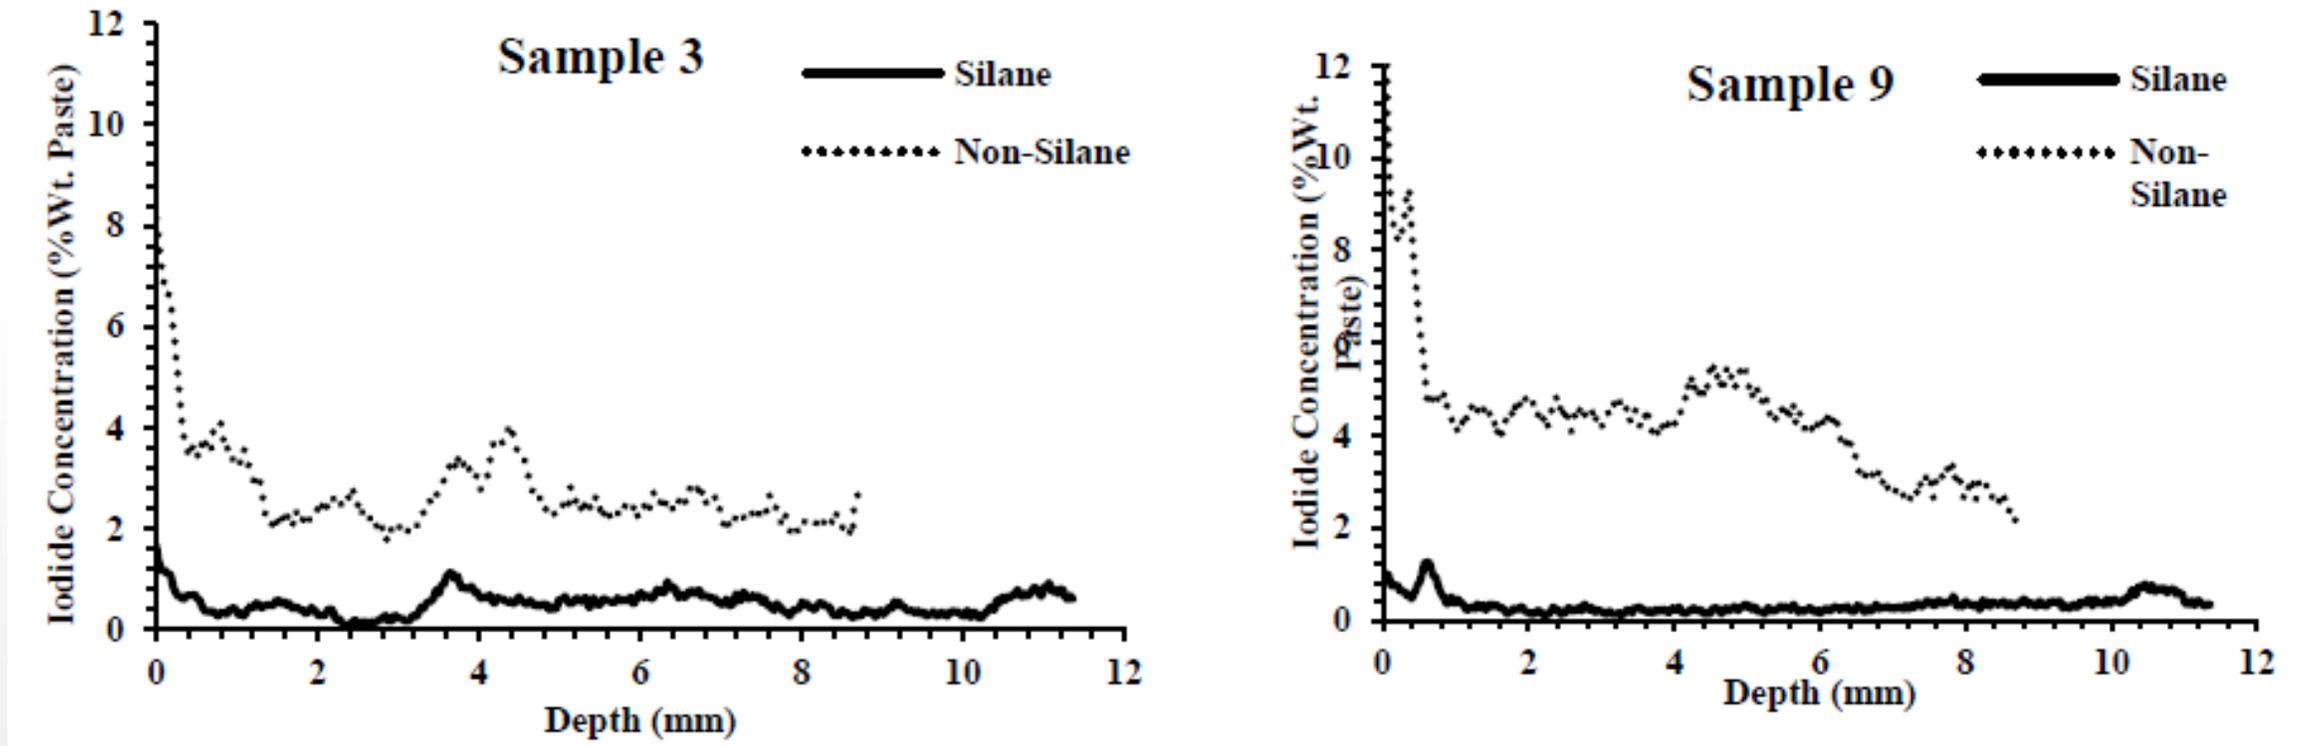
Typical Concentration Profiles for Samples with & without Silane

- **Silane penetration was below specification limits.**
- **Despite this, treated samples showed ~9x less chemical ingress than untreated ones.**
- **Surface cracks allowed chemicals to bypass the coating, indicating crack vulnerability.**

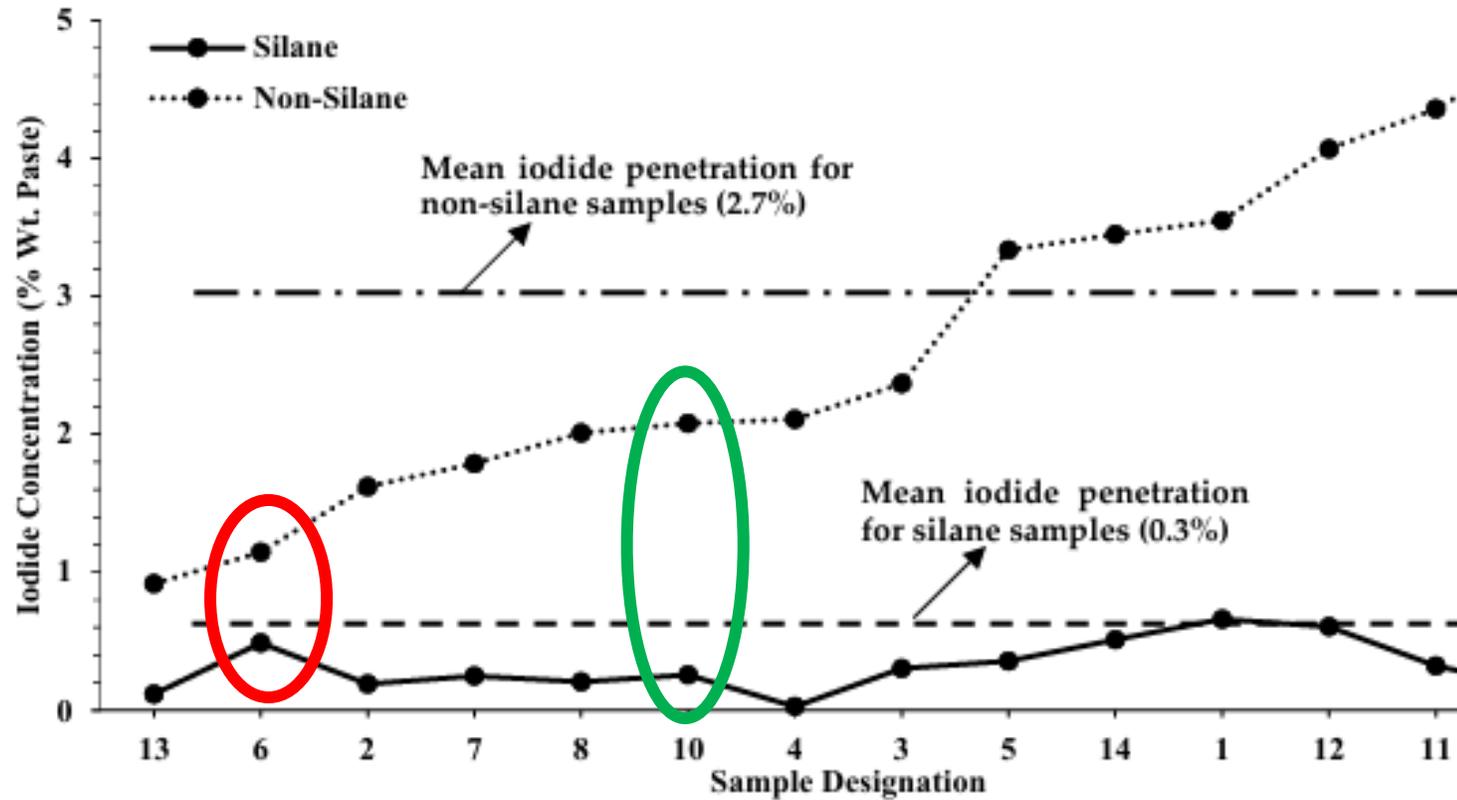
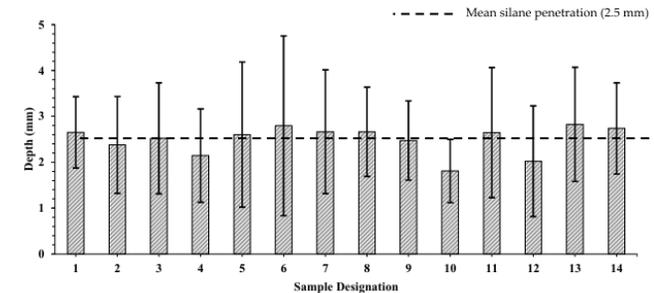
Comparison of Silane-Treated vs. Untreated Samples at 2 mm Depth

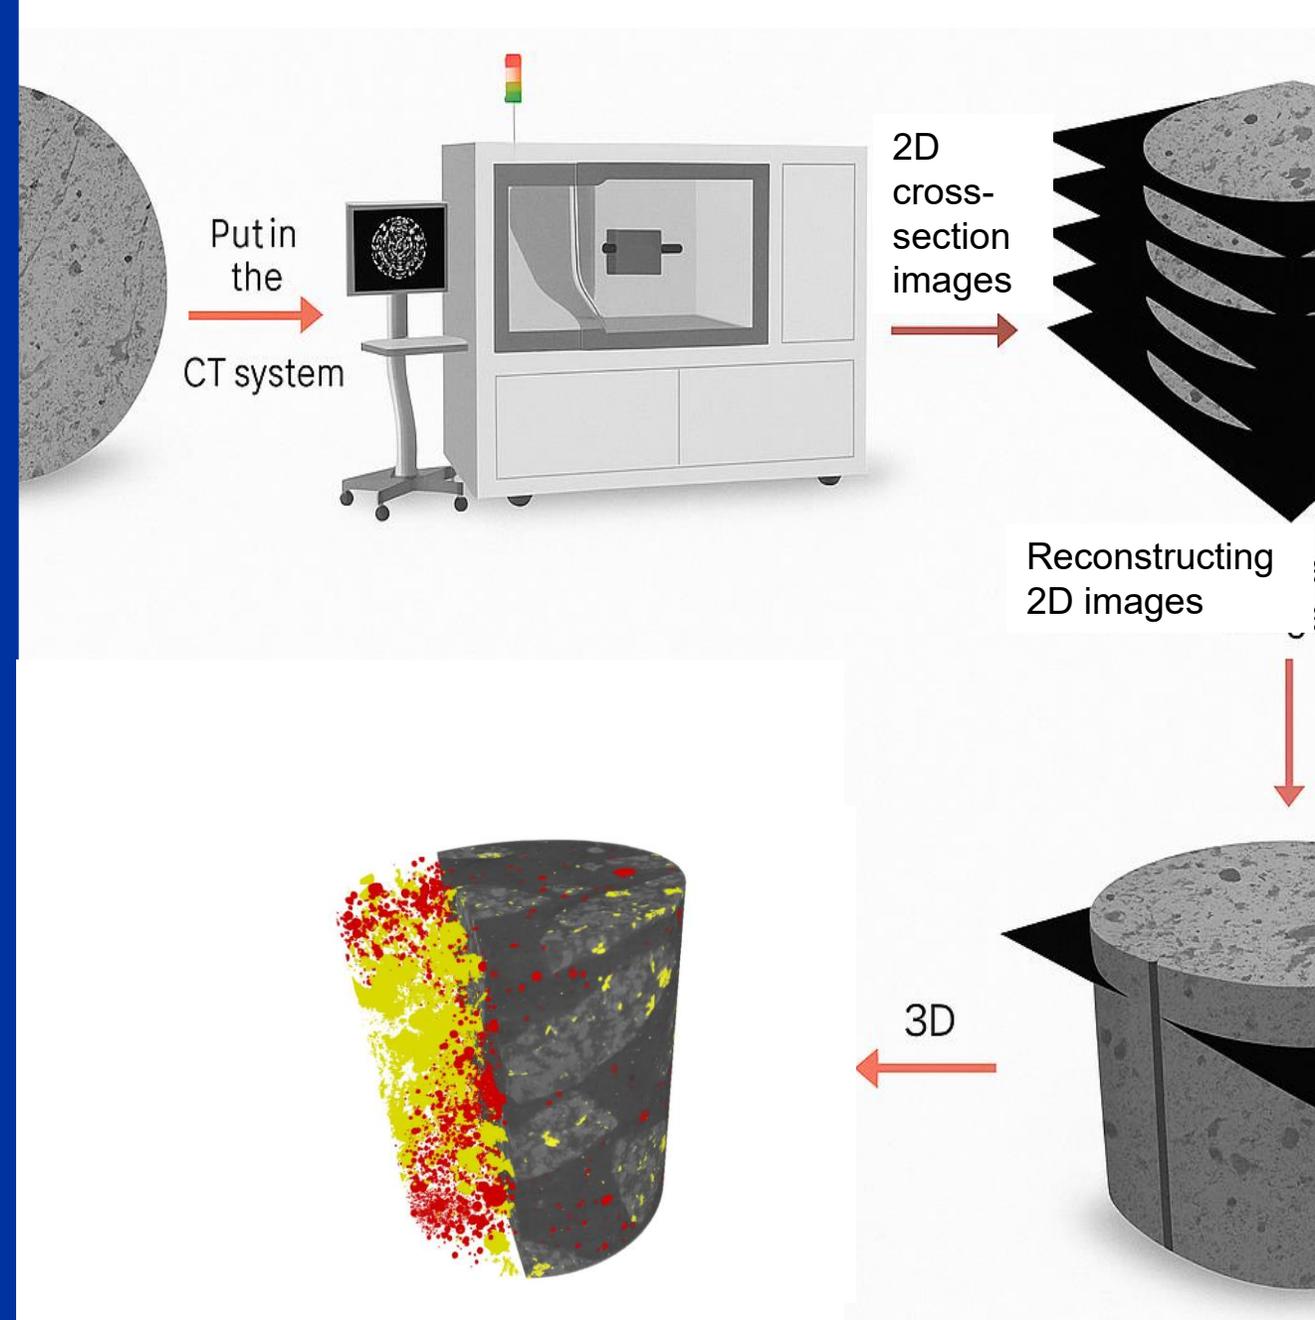
X-Ray Computed Tomography (XCT)

- Resolution ($\mu\text{m}/\text{pixel}$): 15.29
- Number of projections: 1014
- Images are captured at many different viewing angles;
- These images are used to make a 3D image called a tomograph;
- Like the gray values in the TXM radiographs, the voxel values in the tomograph represent materials with different chemical consistency and density.

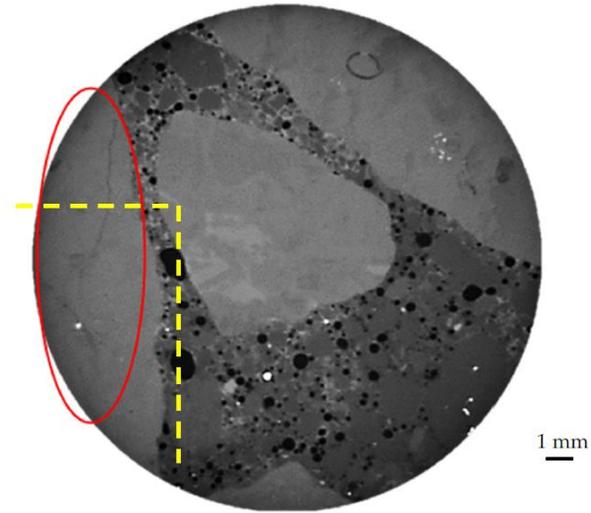
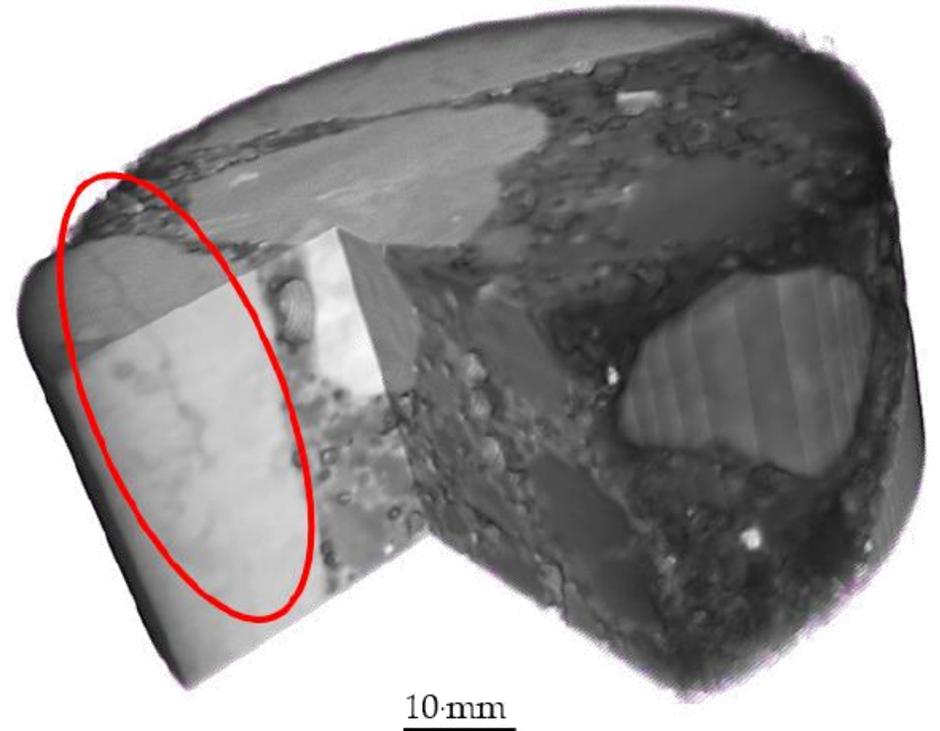
X-Ray Computed Tomography (XCT)

- Resolution ($\mu\text{m}/\text{pixel}$): 15.29
- Number of projections: 1014
- Images are captured at many different viewing angles;
- These images are used to make a 3D image called a tomograph;
- Like the gray values in the TXM radiographs, the voxel values in the tomograph represent materials with different chemical consistency and density.
