Effect of Cracking on Reinforced Concrete Corrosion

Brian Pailles, Ph.D., PE, NACE
CP-3

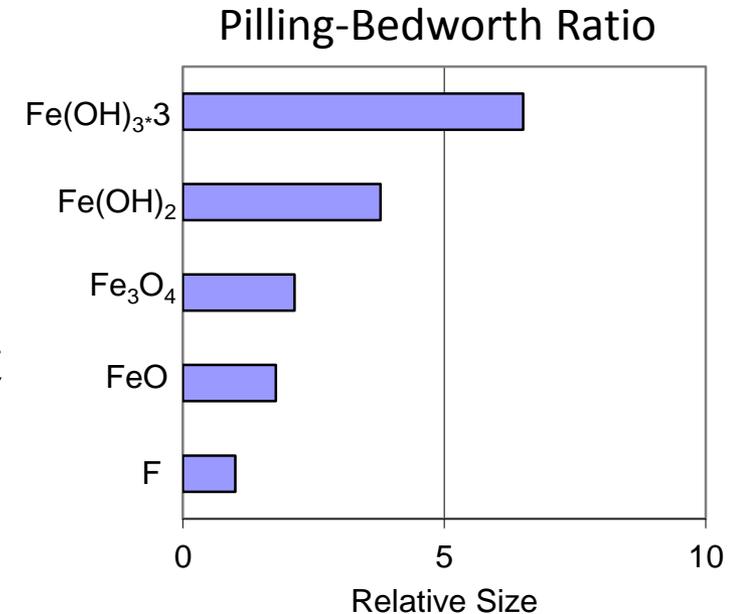
Cracks and Corrosion

- Corrosion leads to cracking
 - Iron oxide is expansive
 - Note, some forms of corrosion in low oxygen environments are not expansive, i.e. black rust
- **Cracking leads to corrosion**
 - **Direct path**

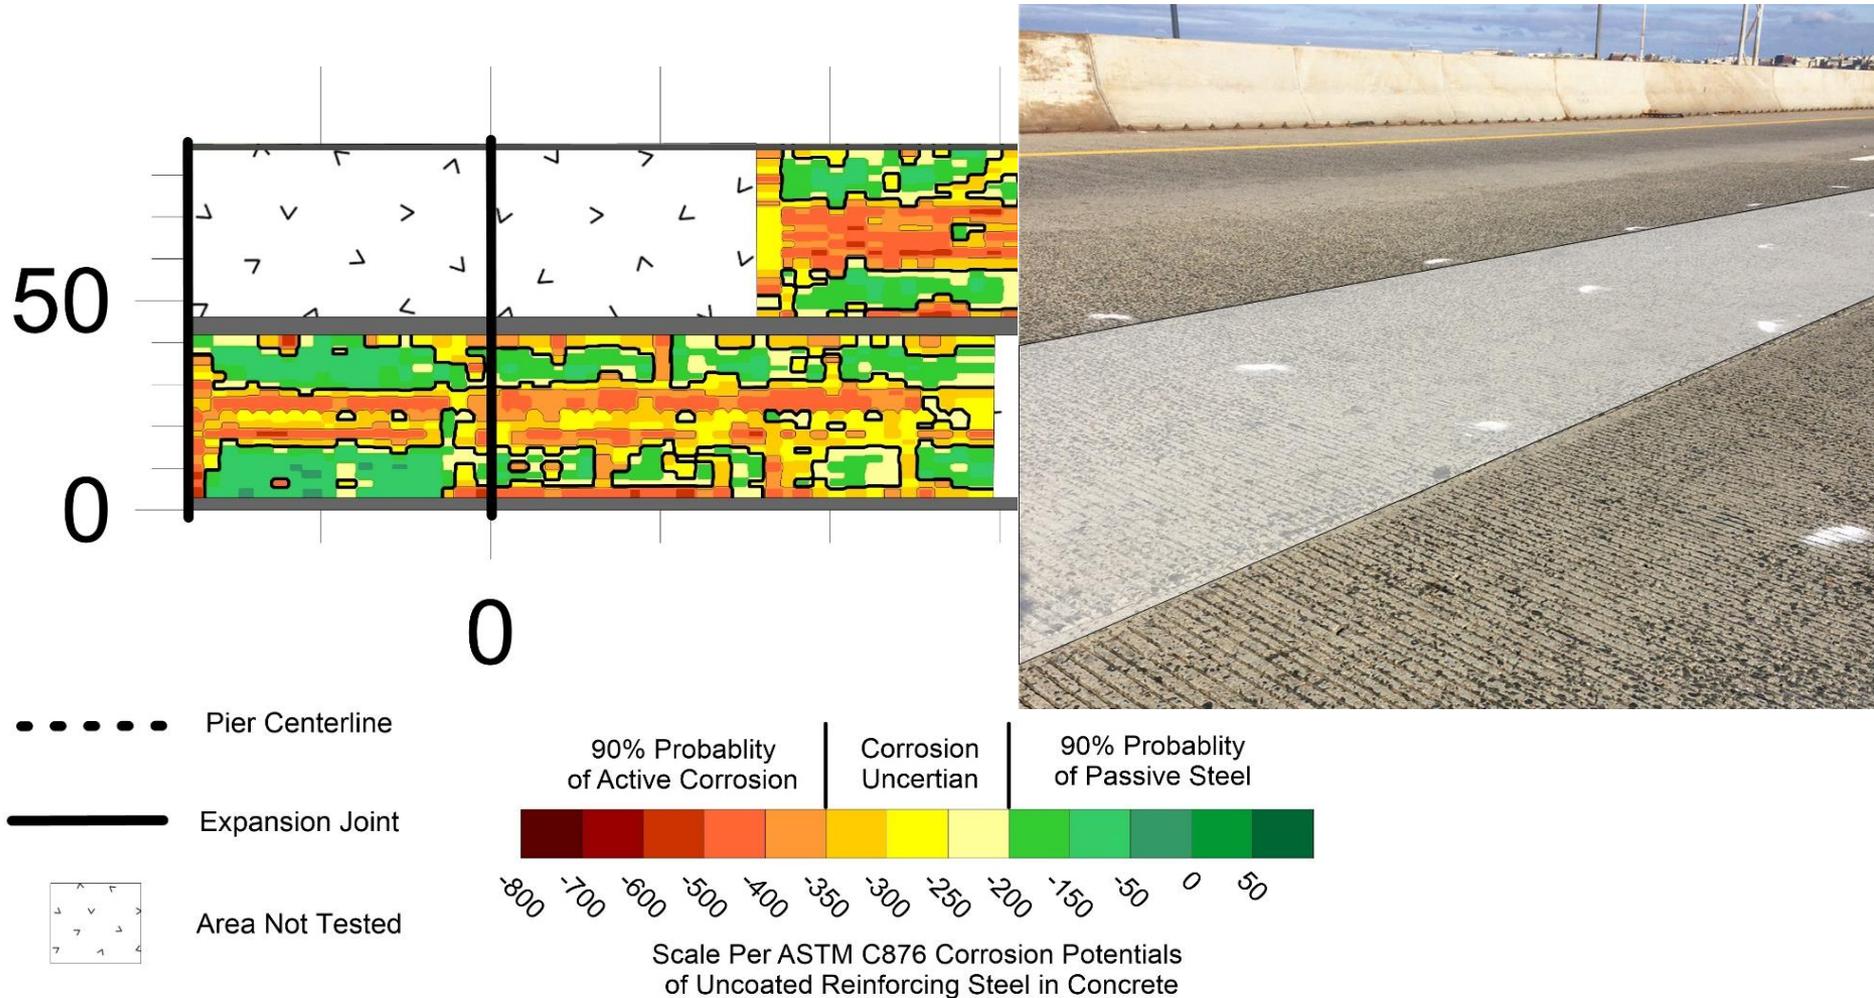
Deck – Corrosion Potentials

- Deck
 - Original concrete deck was overlaid
 - Shrinkage cracking in the overlay has exposed the deck to high concentrations of chlorides
 - Center lane closure pour construction joint has provided a pathway for moisture and chlorides
- Substructure
 - Chloride exposure only at expansion joints

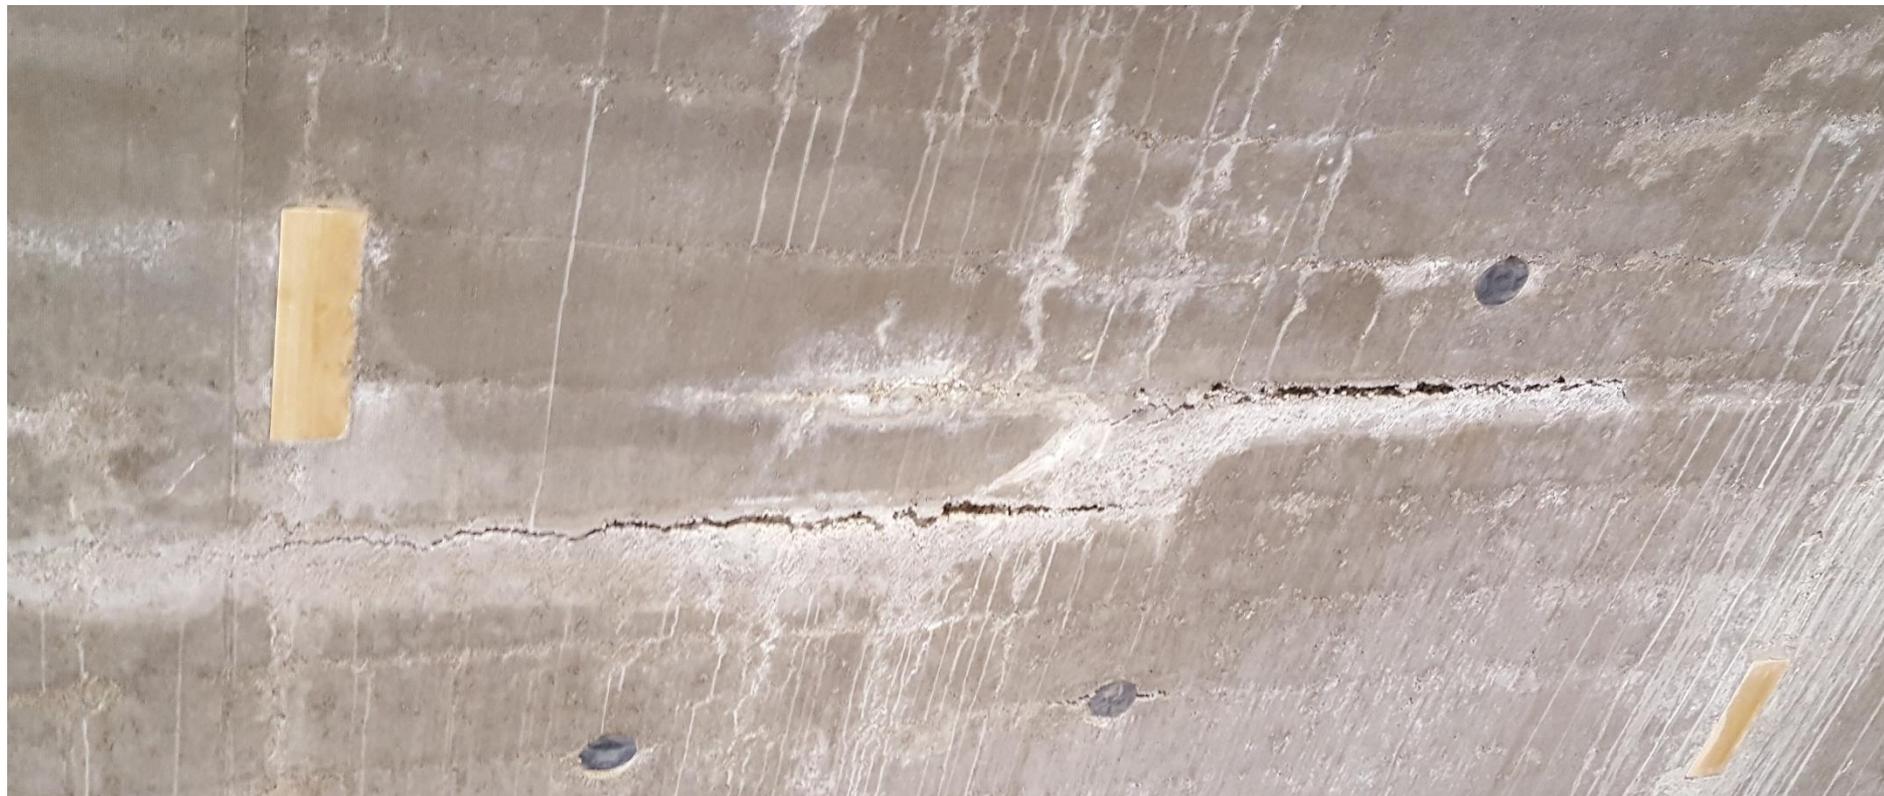
Poor Shotcrete Application

- Shadowing of welded wire fabric reinforcement

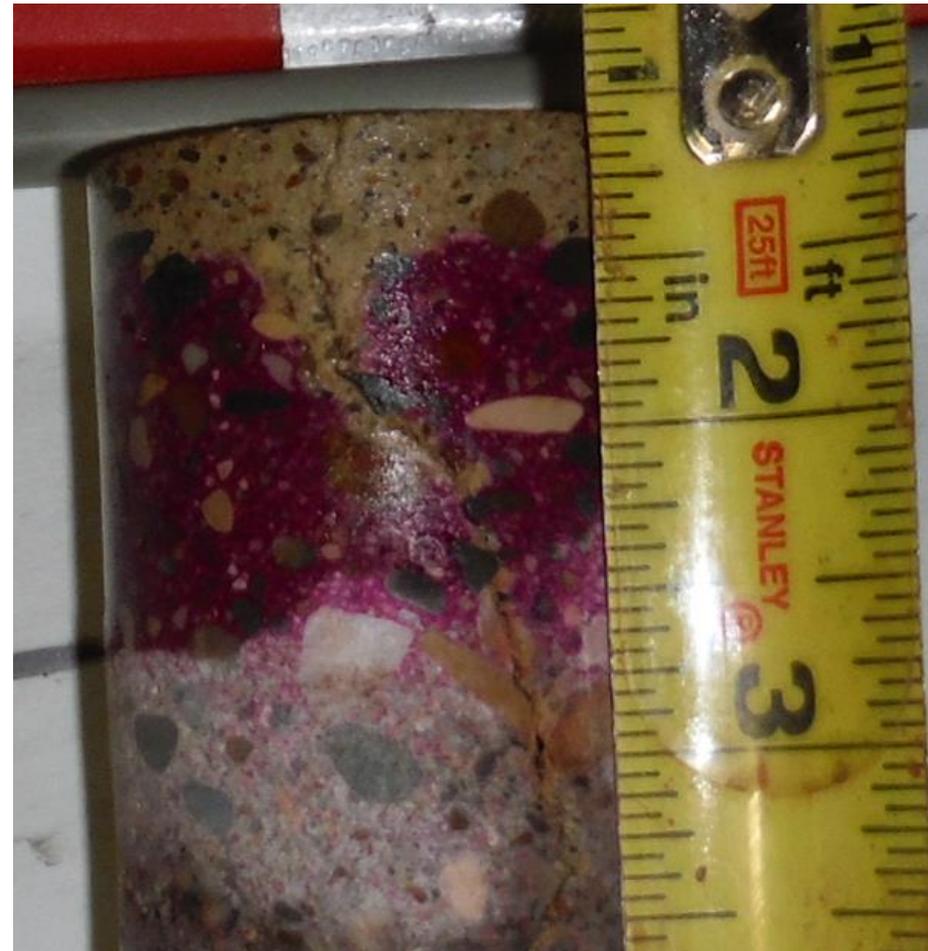
Carbonation Depth

- Sound concrete has a maximum of 0.5 inches of carbonation
- Crack allowed reduction of pH past 3 inches

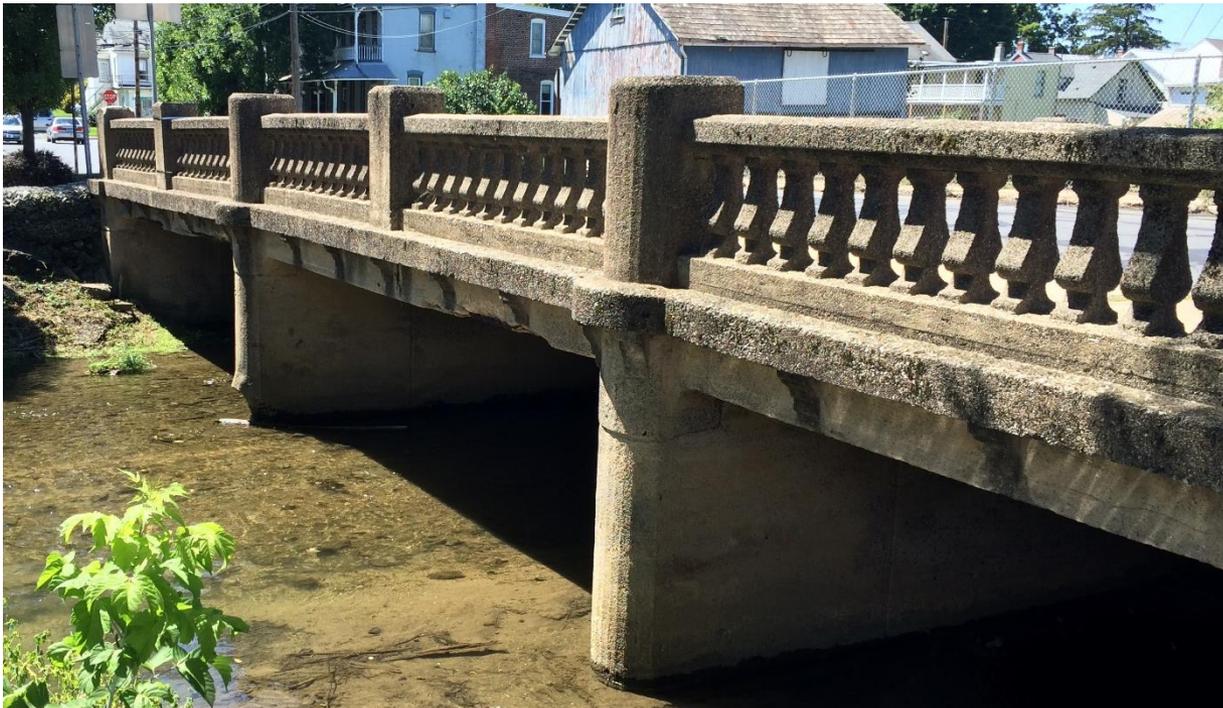
Peach Street Bridge

- 3-span bridge in Kutztown PA
- Freeze thaw damage leading to corrosion deterioration
