**Repair of Concrete Session in Memory
of Tony Murray**

**Post Tensioning Repairs and
Modifications**

Contech Services, Inc.

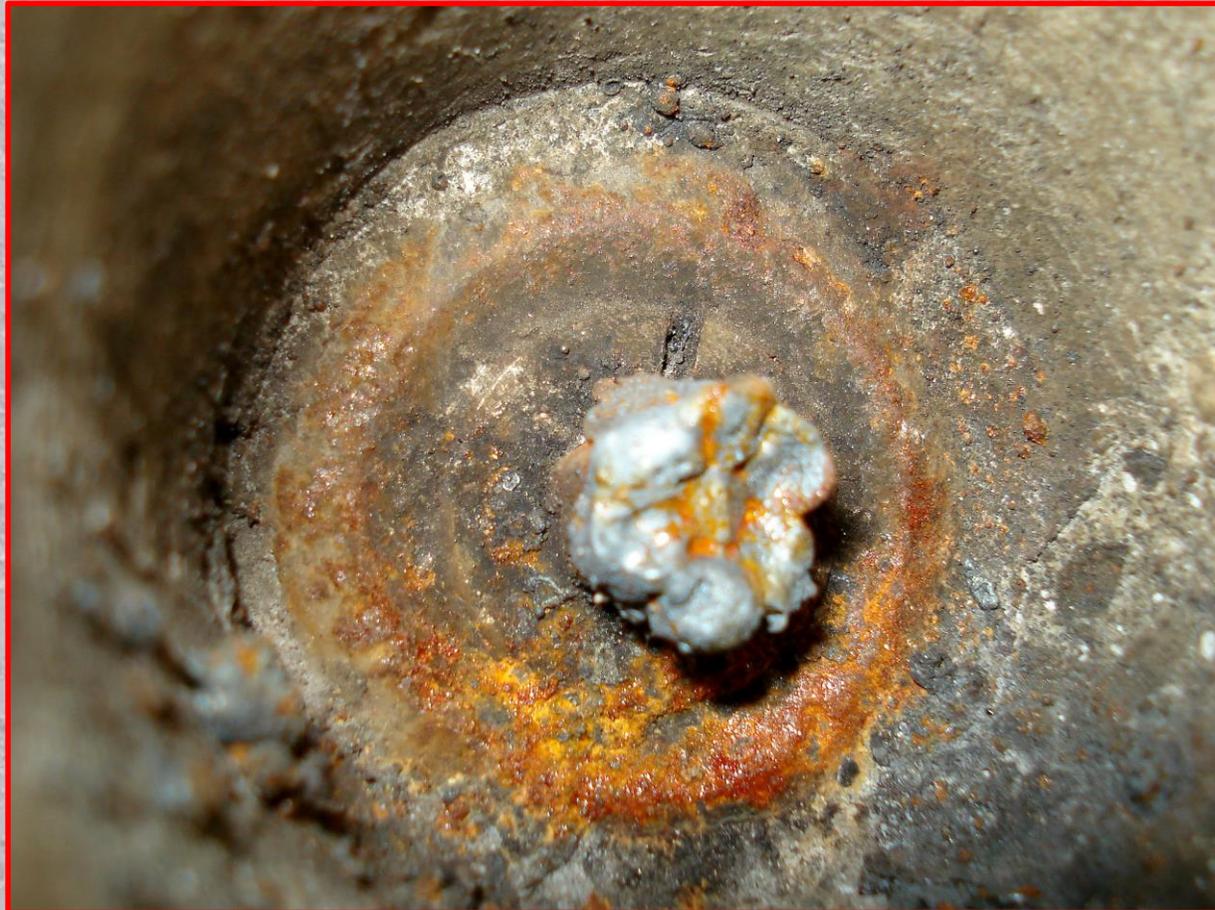
Chloride Accelerators in Grout

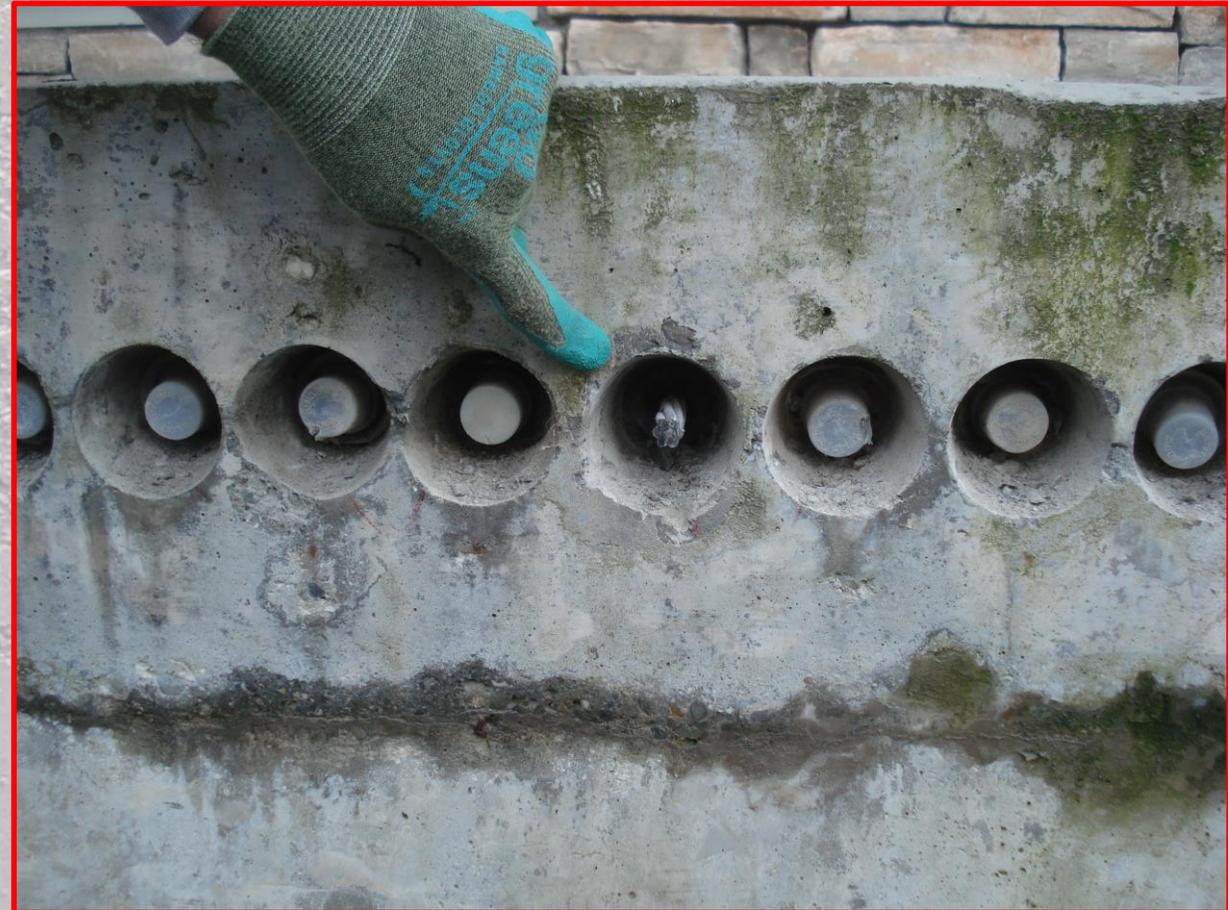
Missing Grease Caps

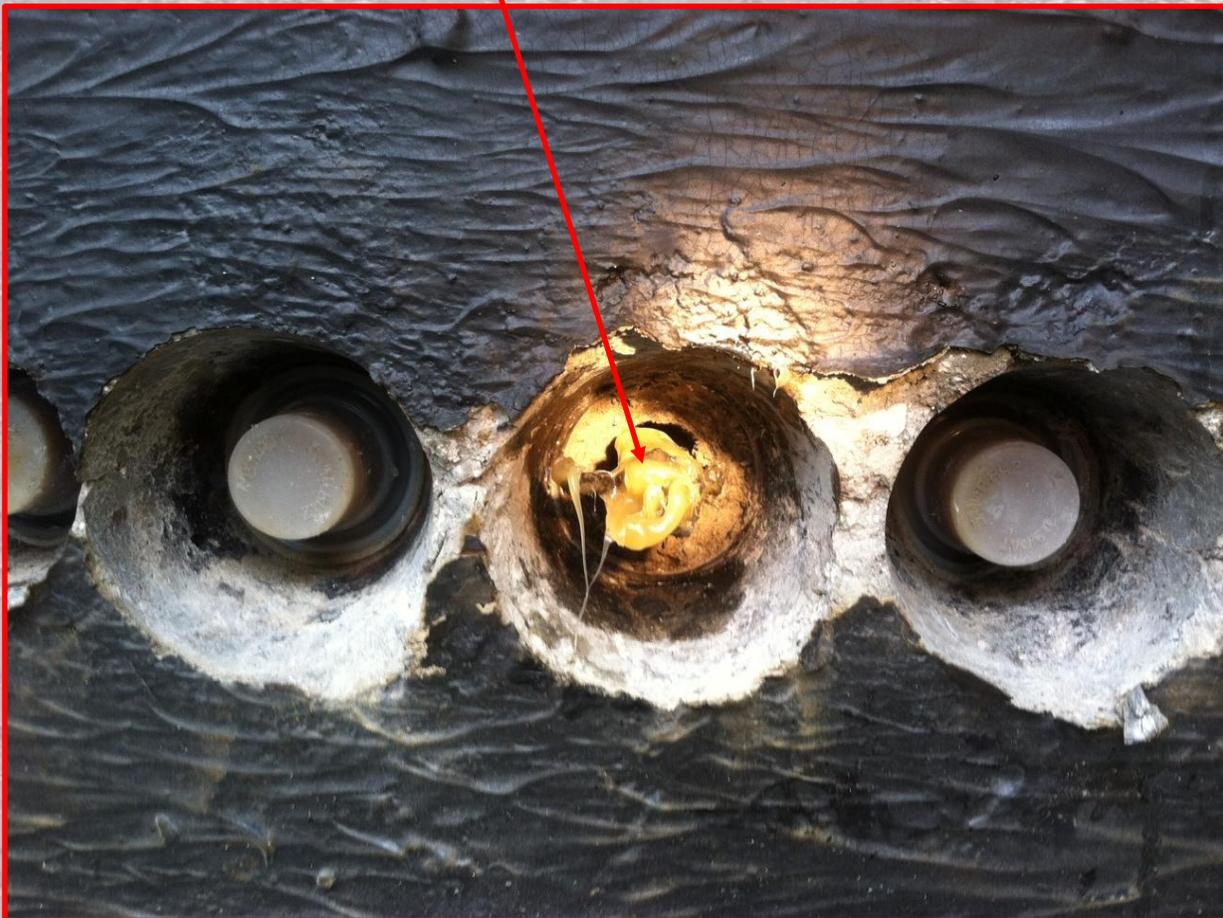
Poorly Protected or Unprotected Anchors

Grease Only—No Grease Cap

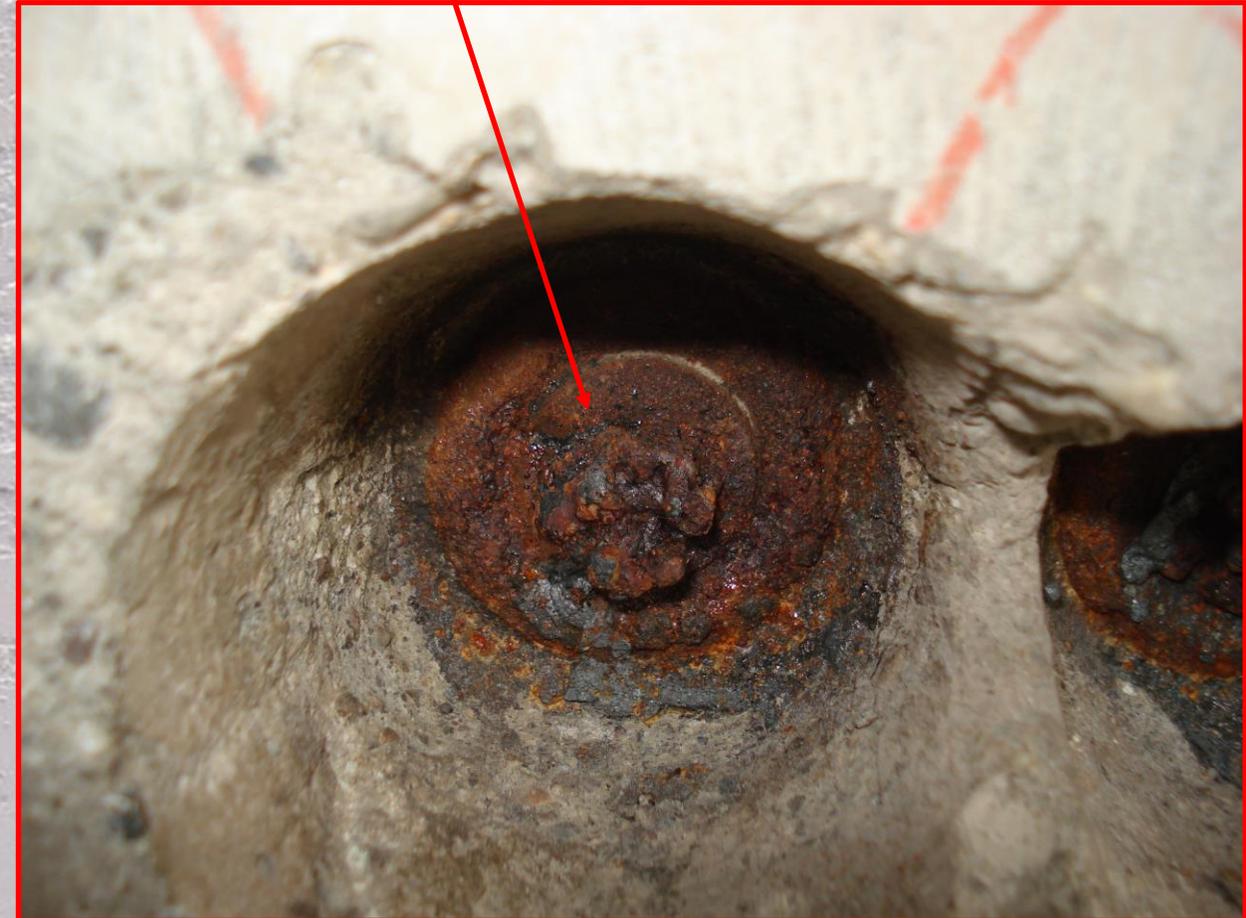
Severe Corrosion of Wedges and Anchor

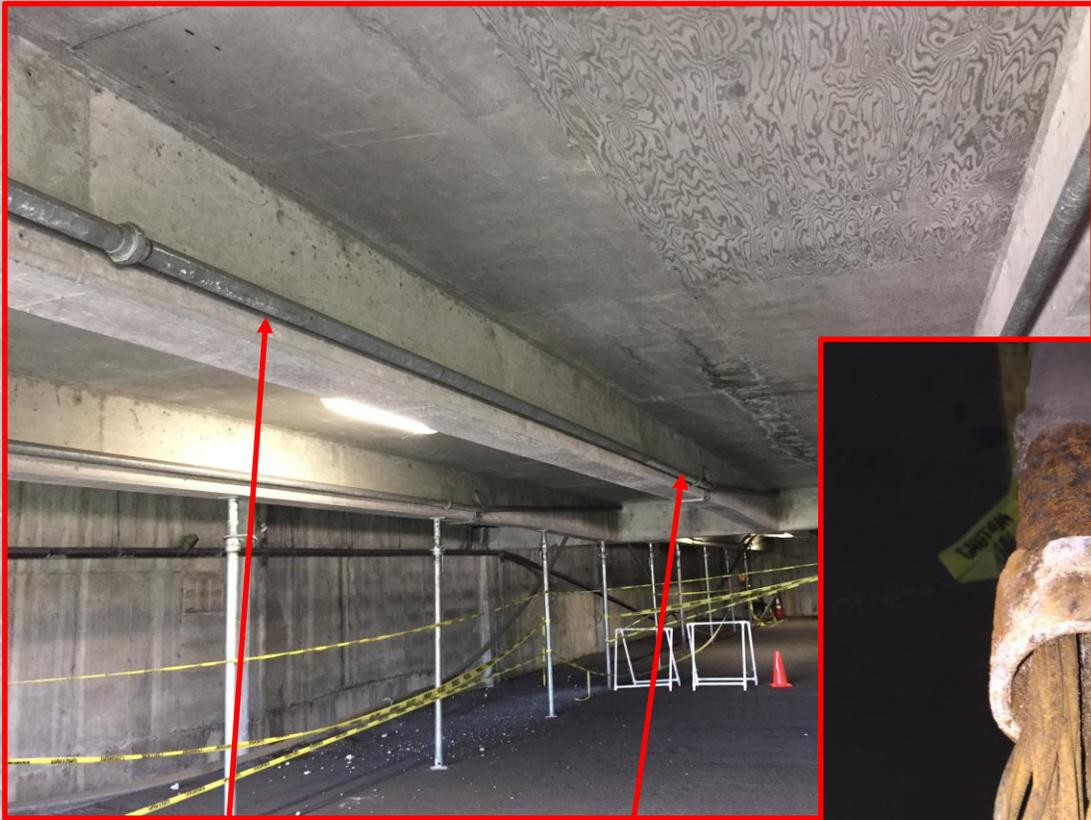
Failed Post Tensioning Due to Anchorage Corrosion

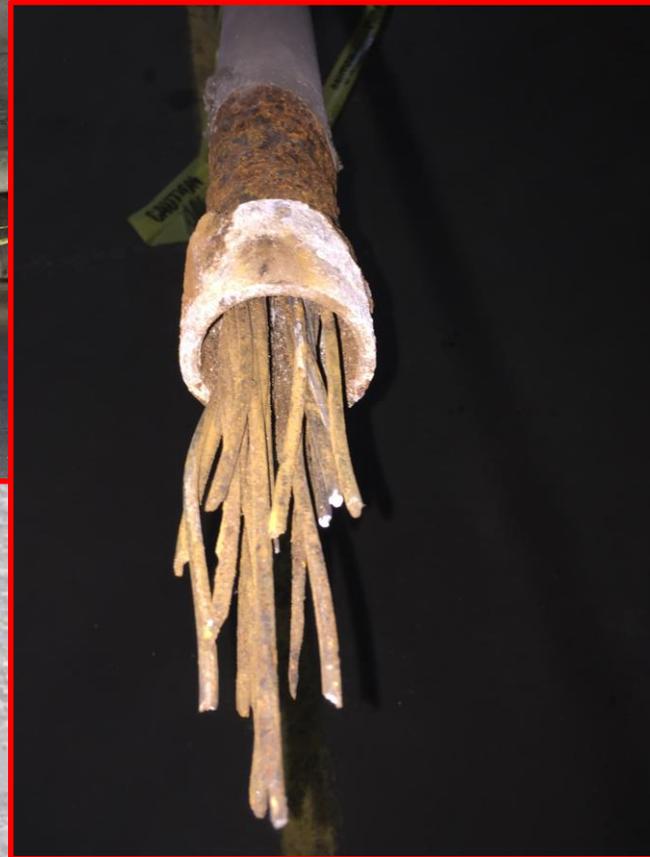
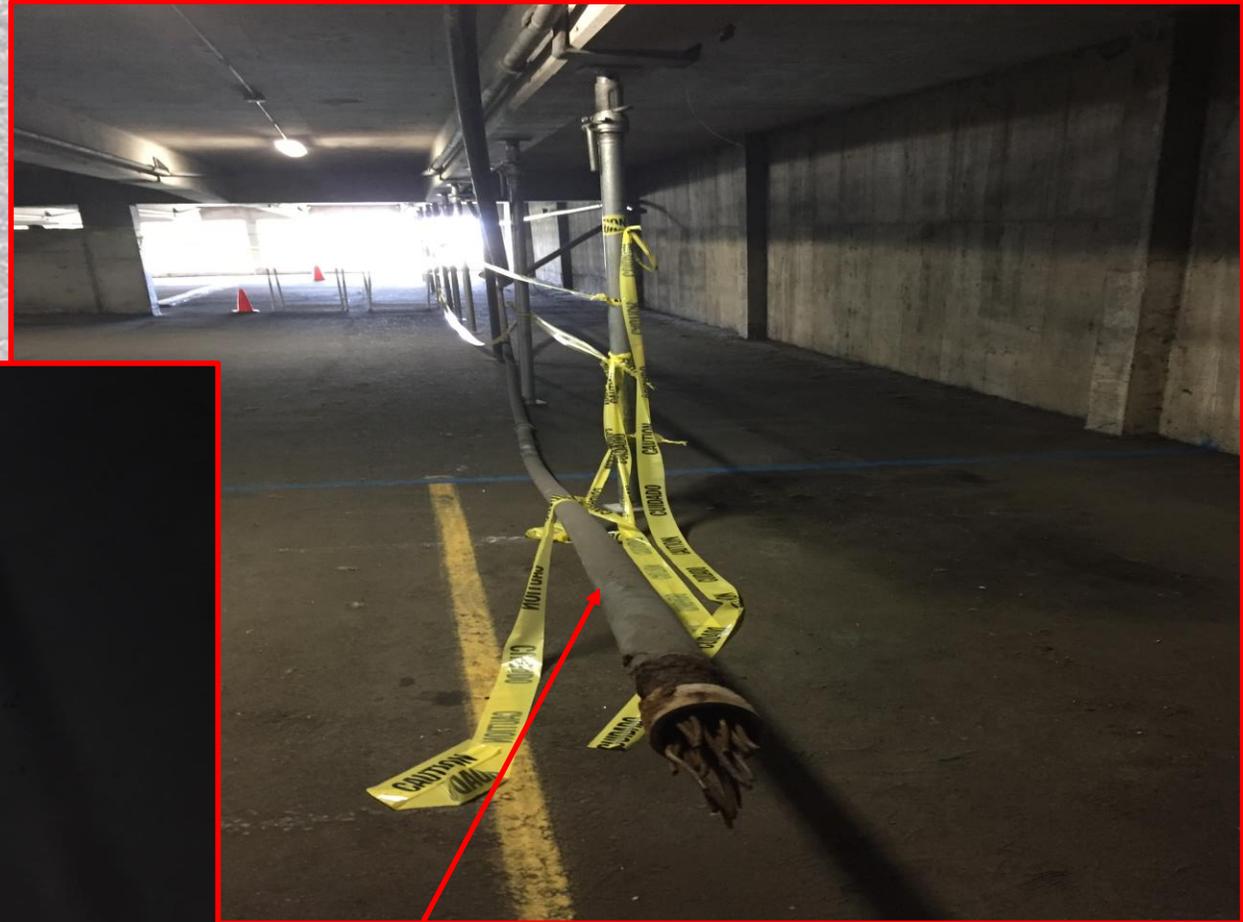
External Post Tensioning

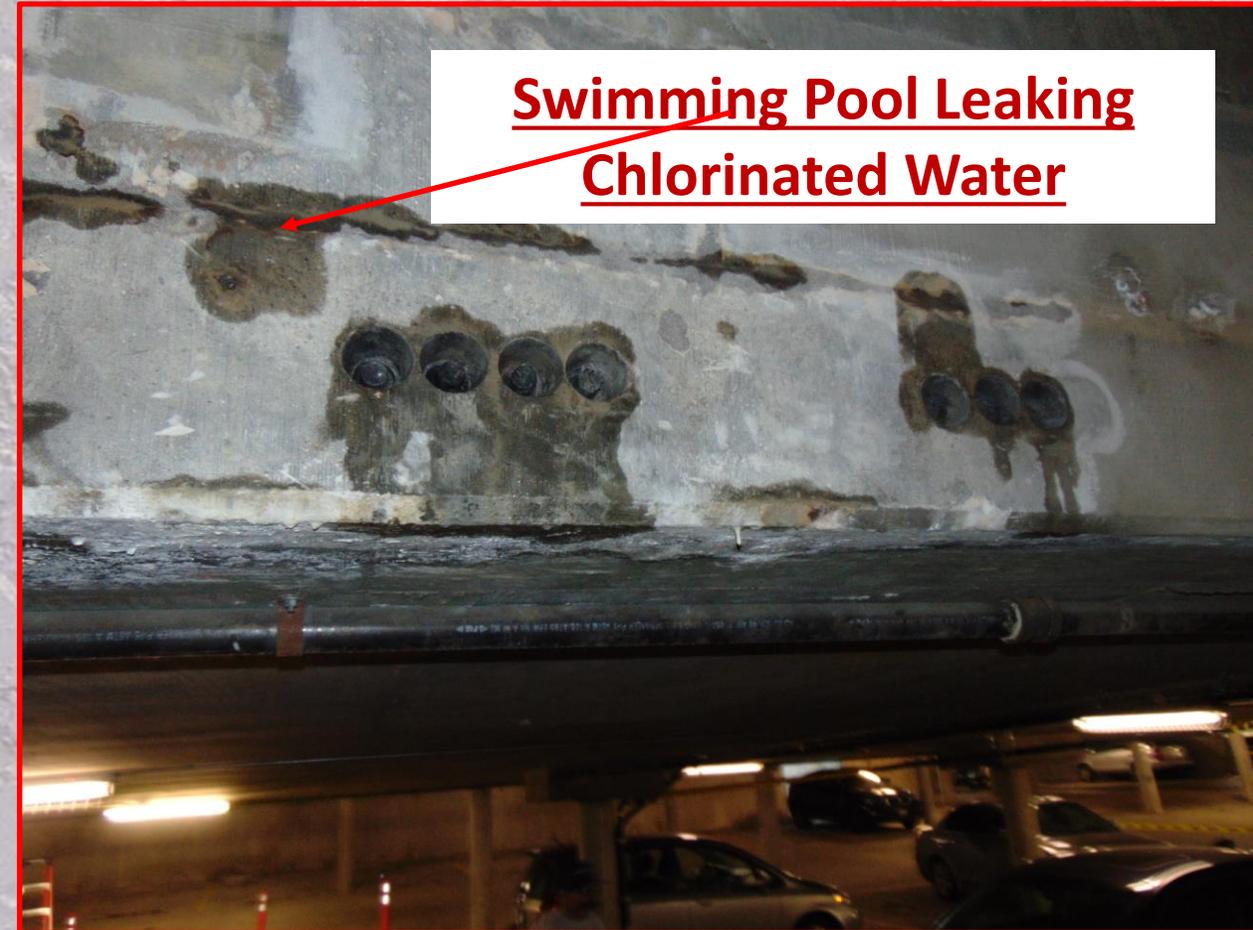
Swimming Pool Leaking
Chlorinated Water

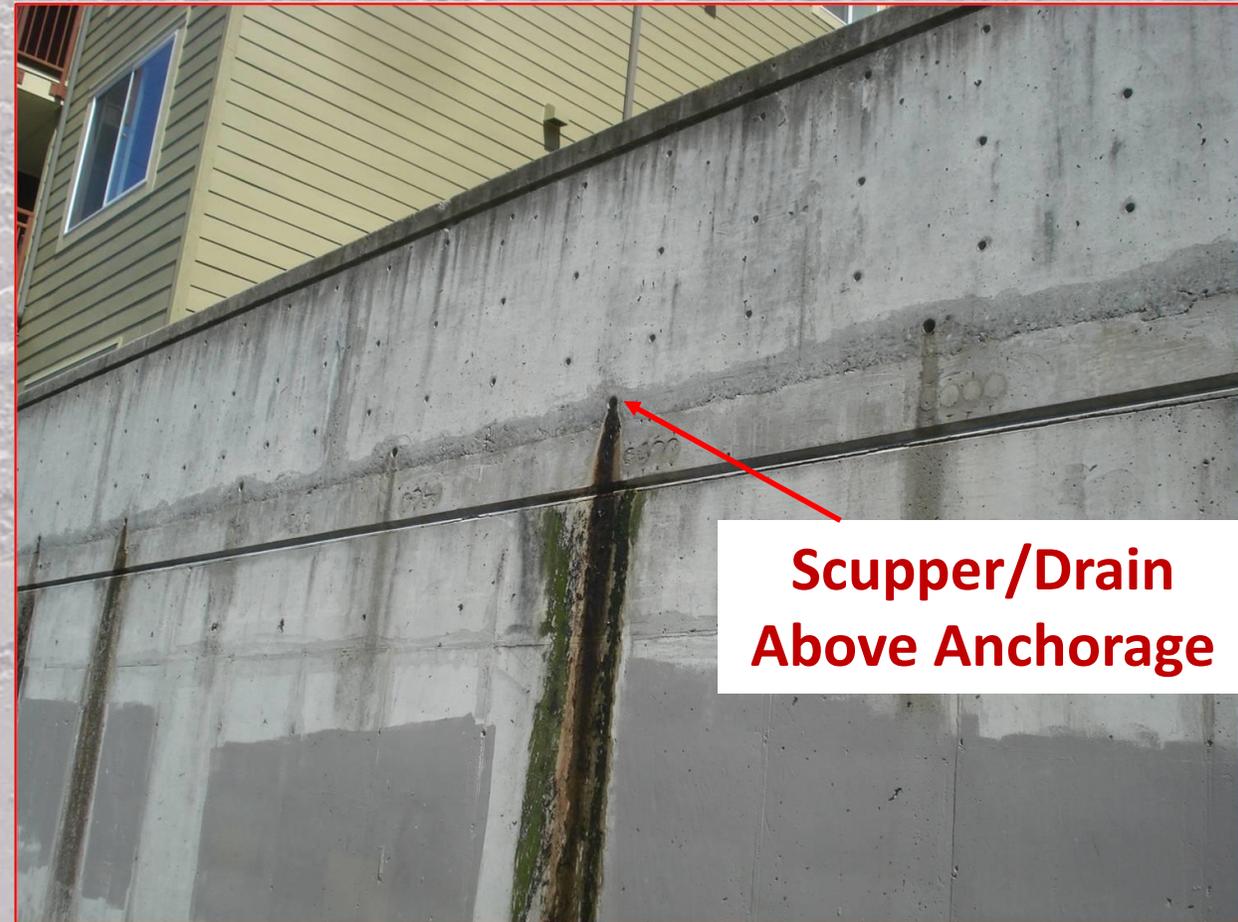
Scupper/Drain
Above Anchorage

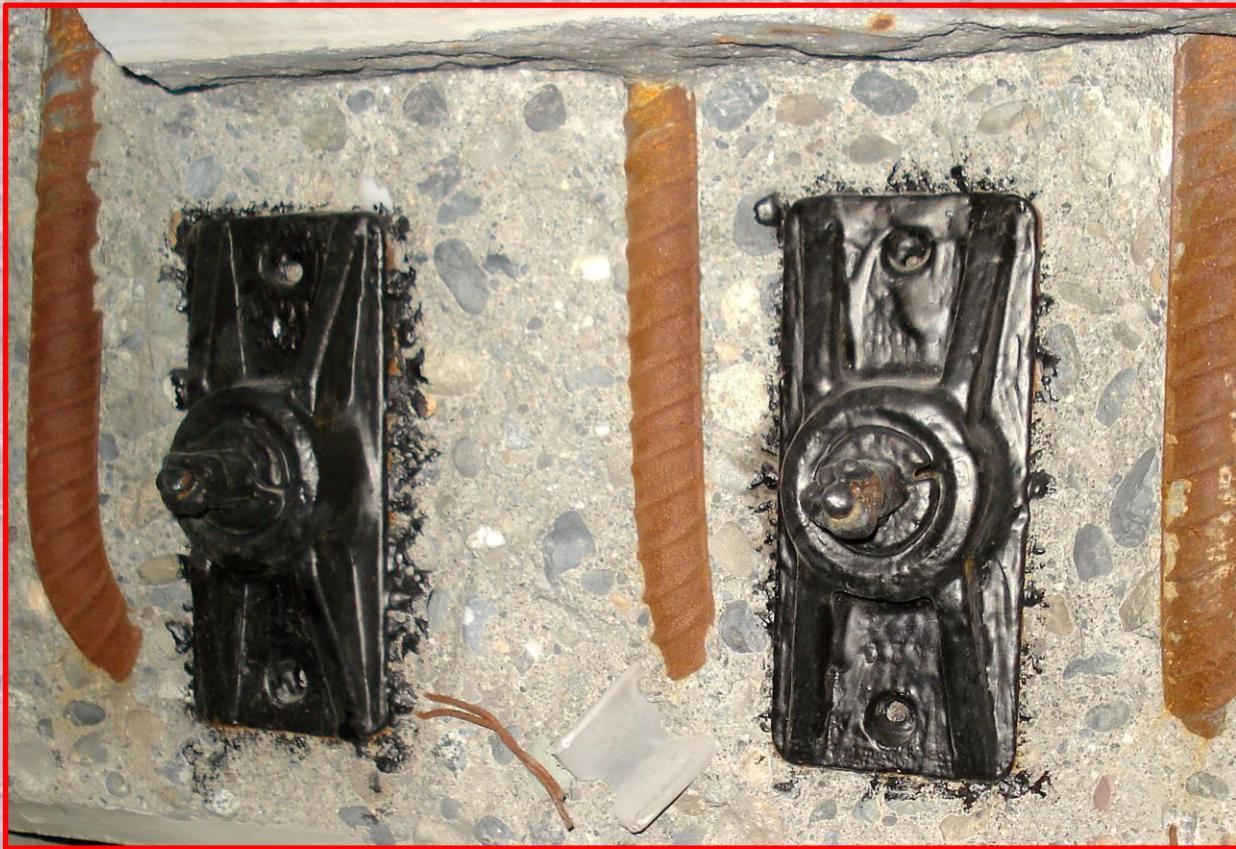
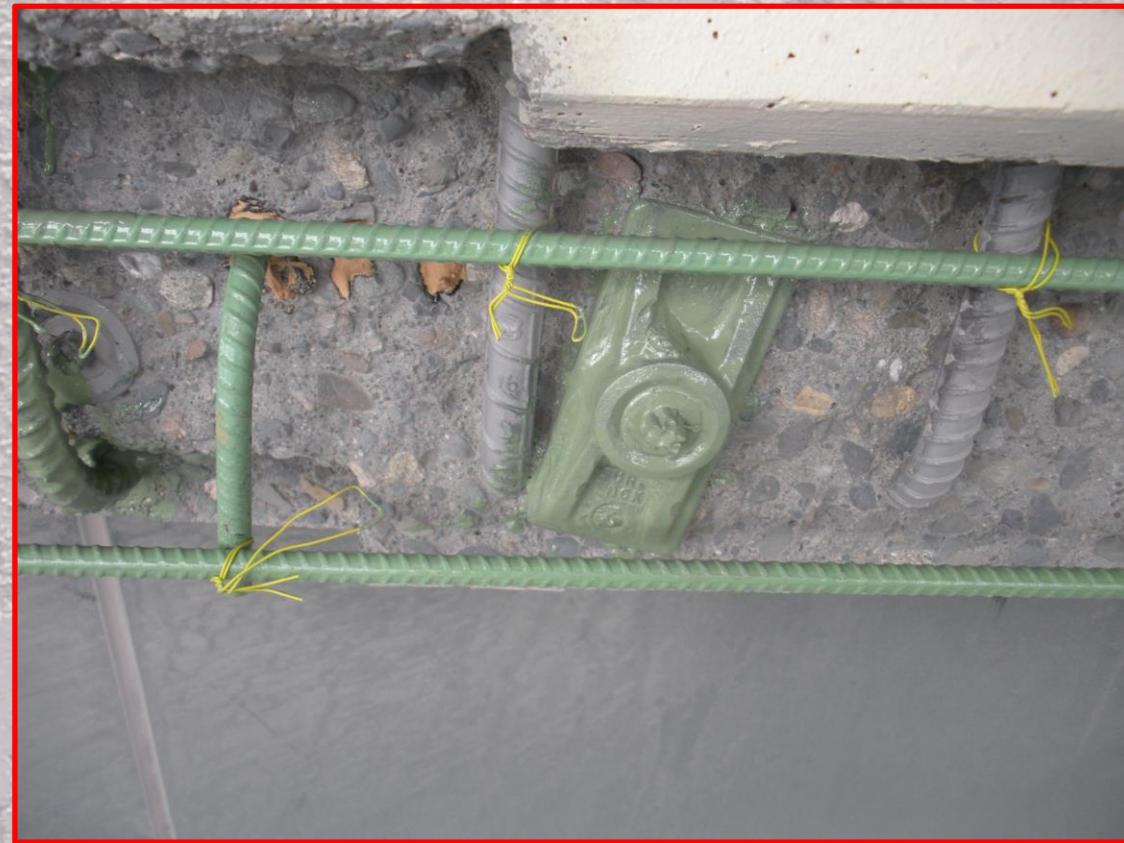
Previously Unprotected Anchors

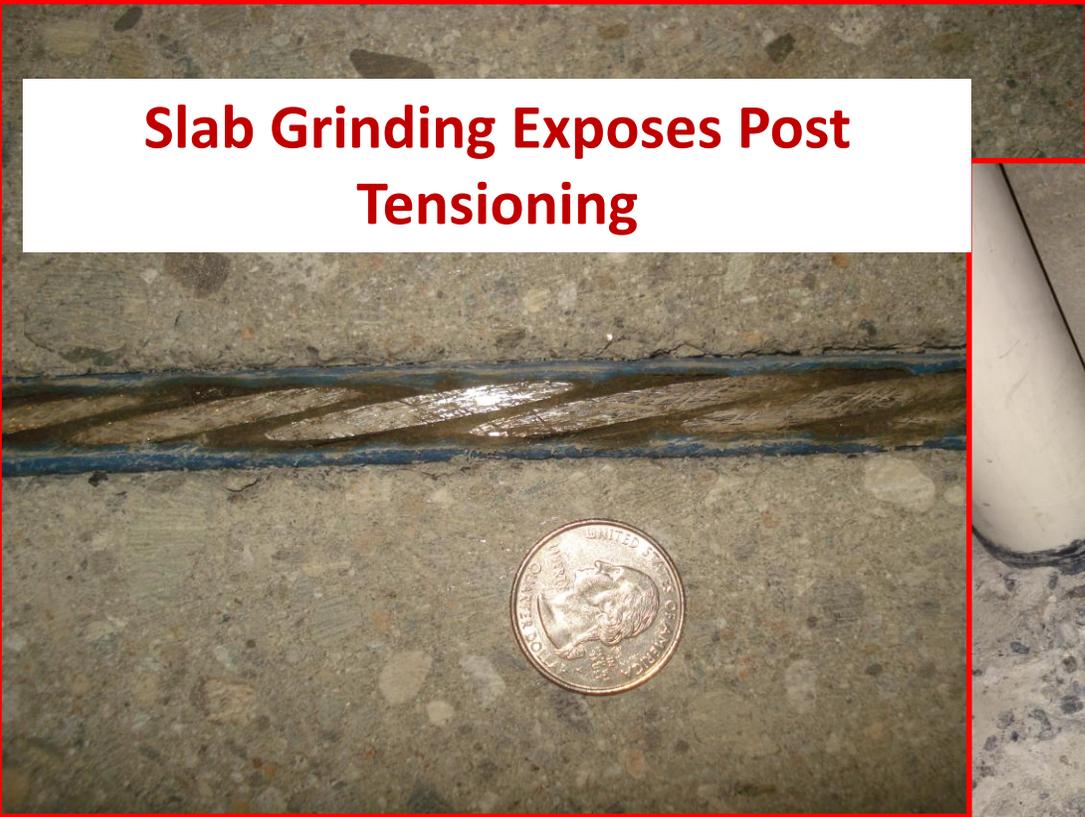
Slab Grinding Exposes Post Tensioning

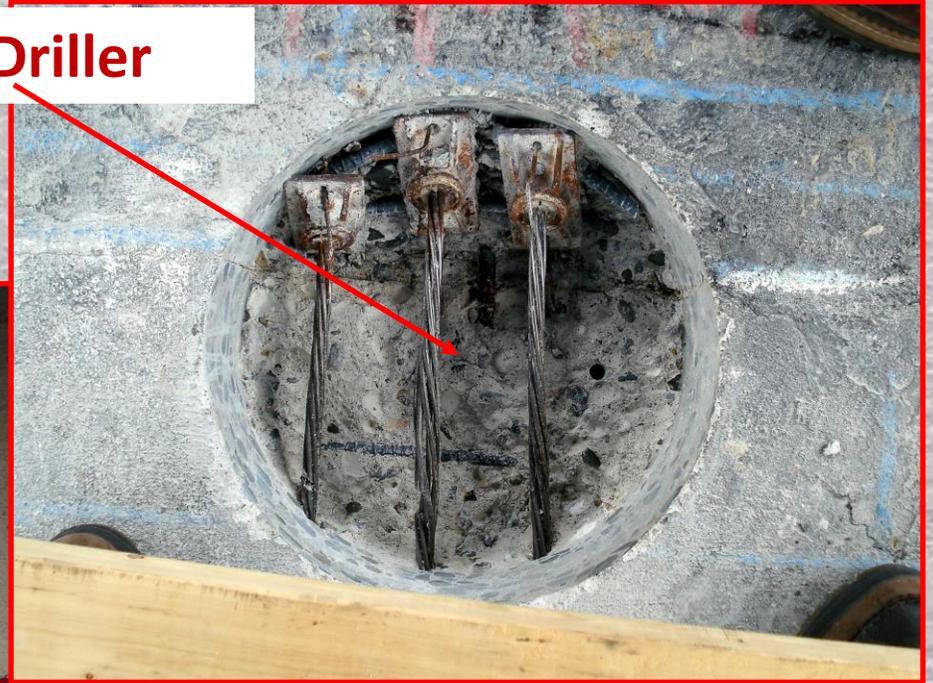
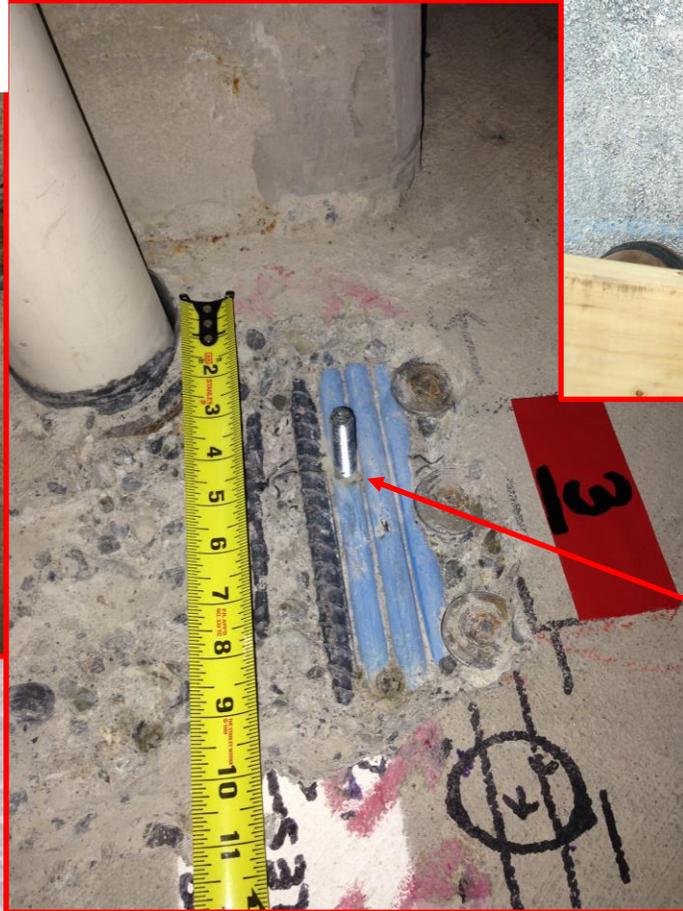
Errant Core Driller

Direct Hit Post Installed
Fence Anchor

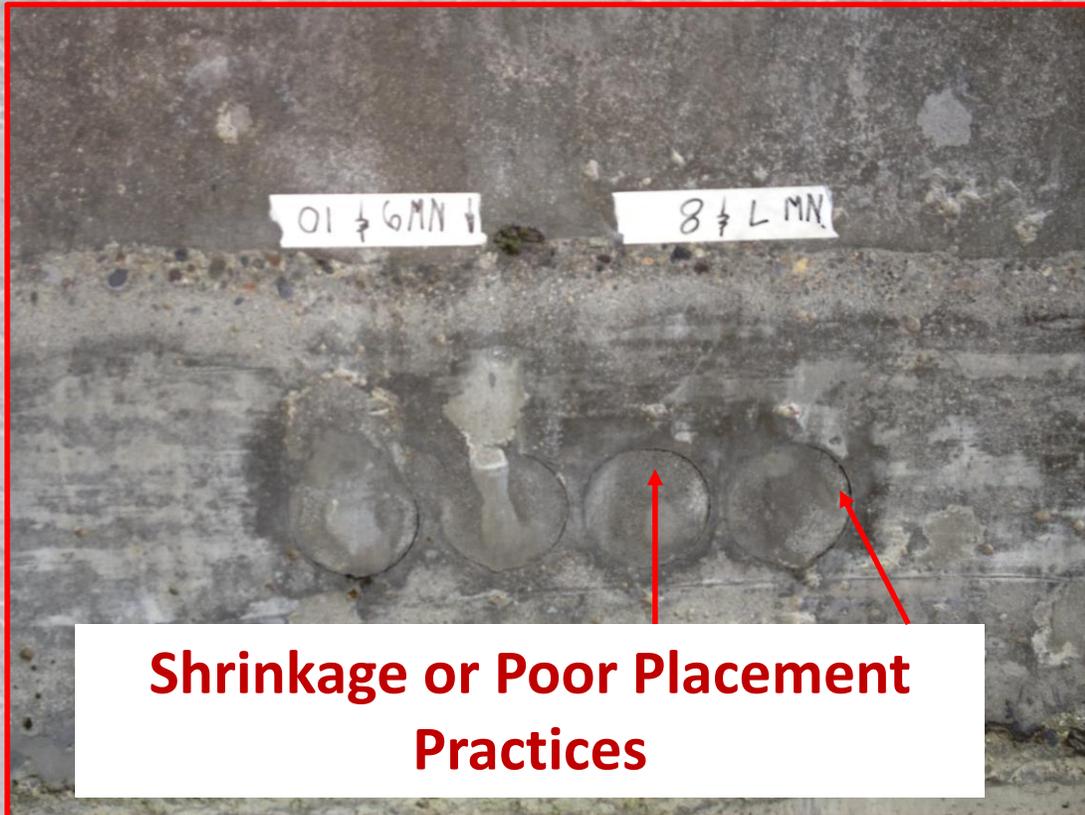
Grout Issues

- Shrinkage
- Tempering
- Poor Consolidation
- Addition of Chlorides

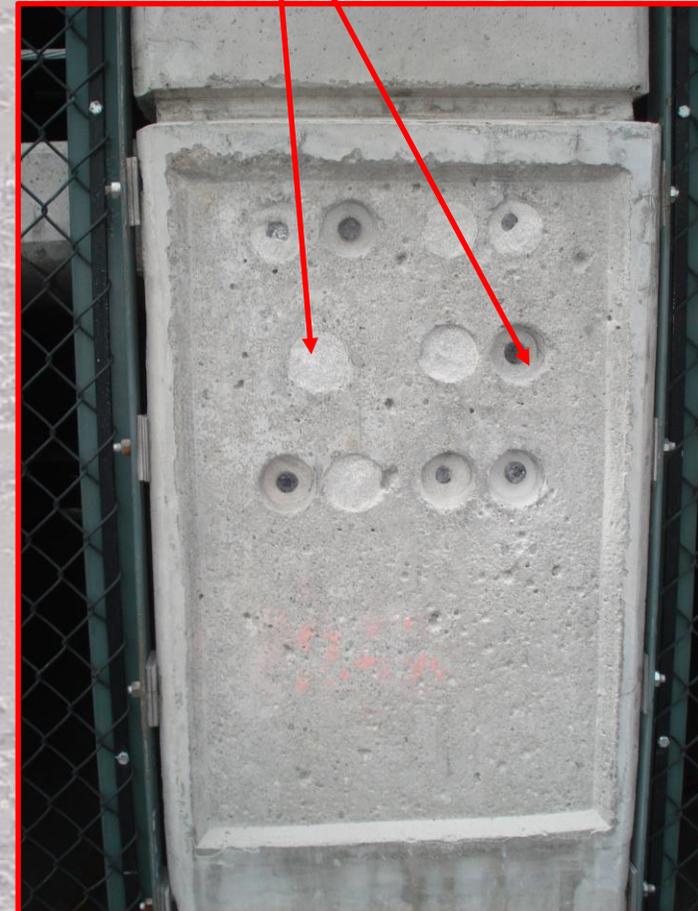
Varying Qualities of Grout

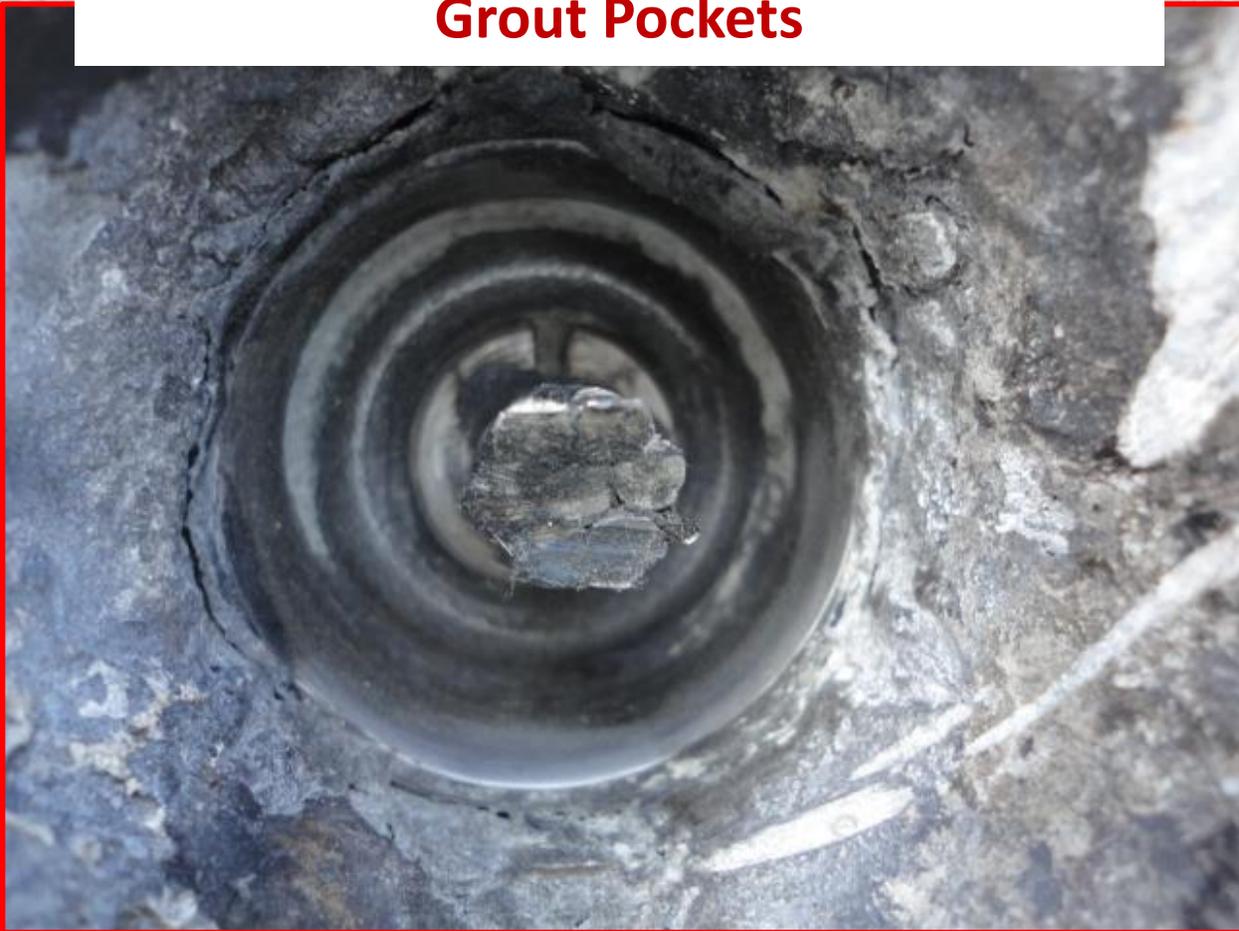
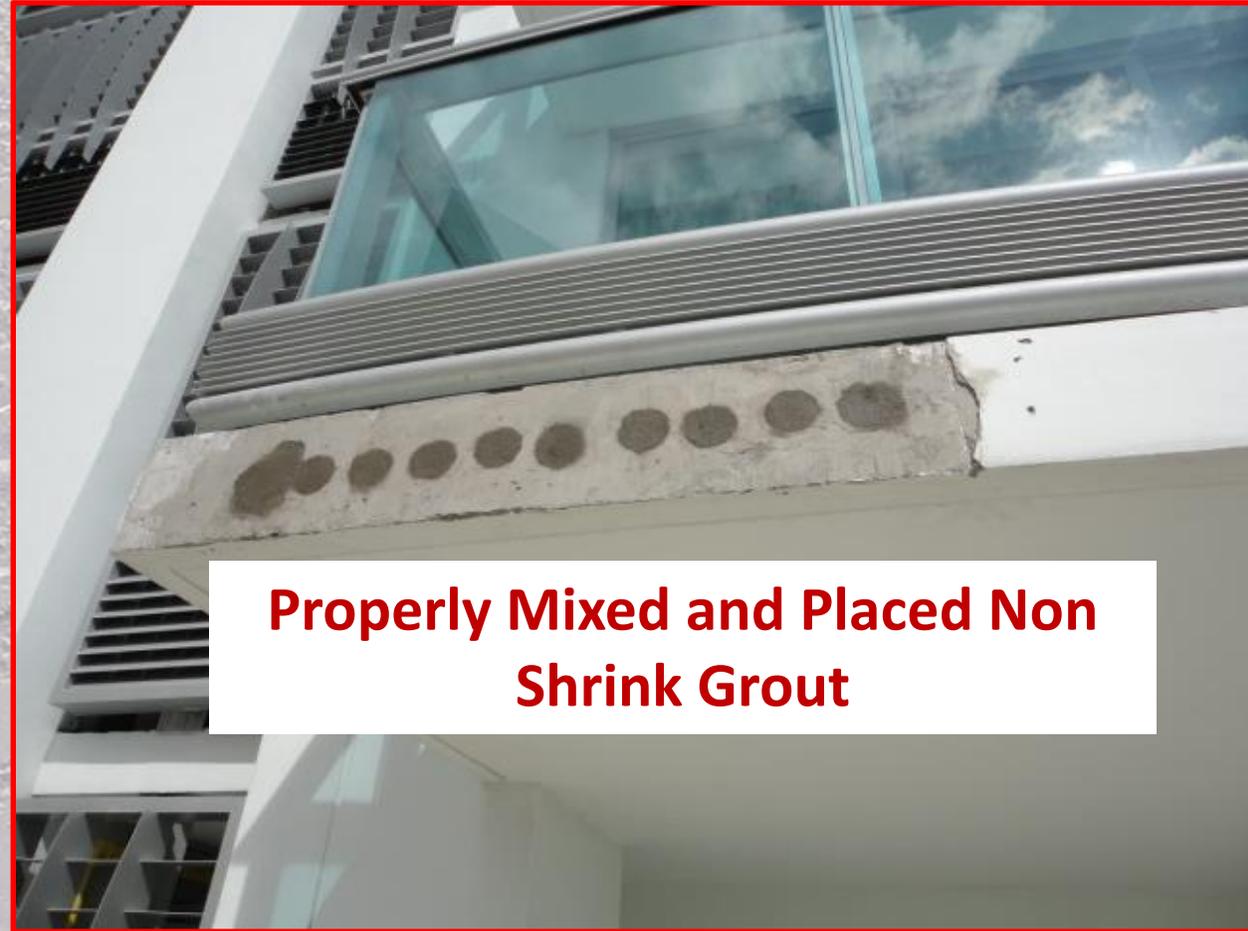
Stressing Pocket Grouting

**Cut Tendon Ends and Properly Clean
Grout Pockets**

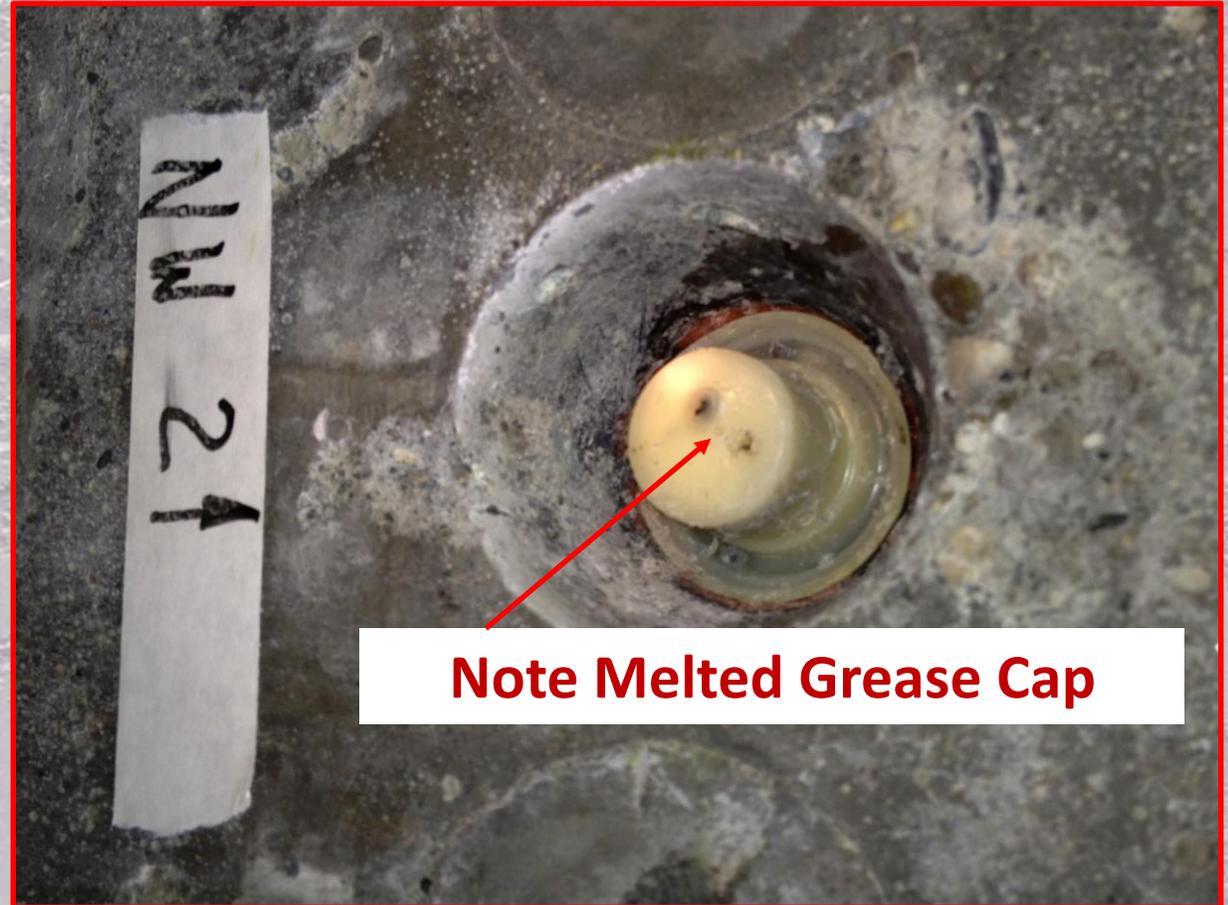
**Properly Mixed and Placed Non
Shrink Grout**

Grease Caps

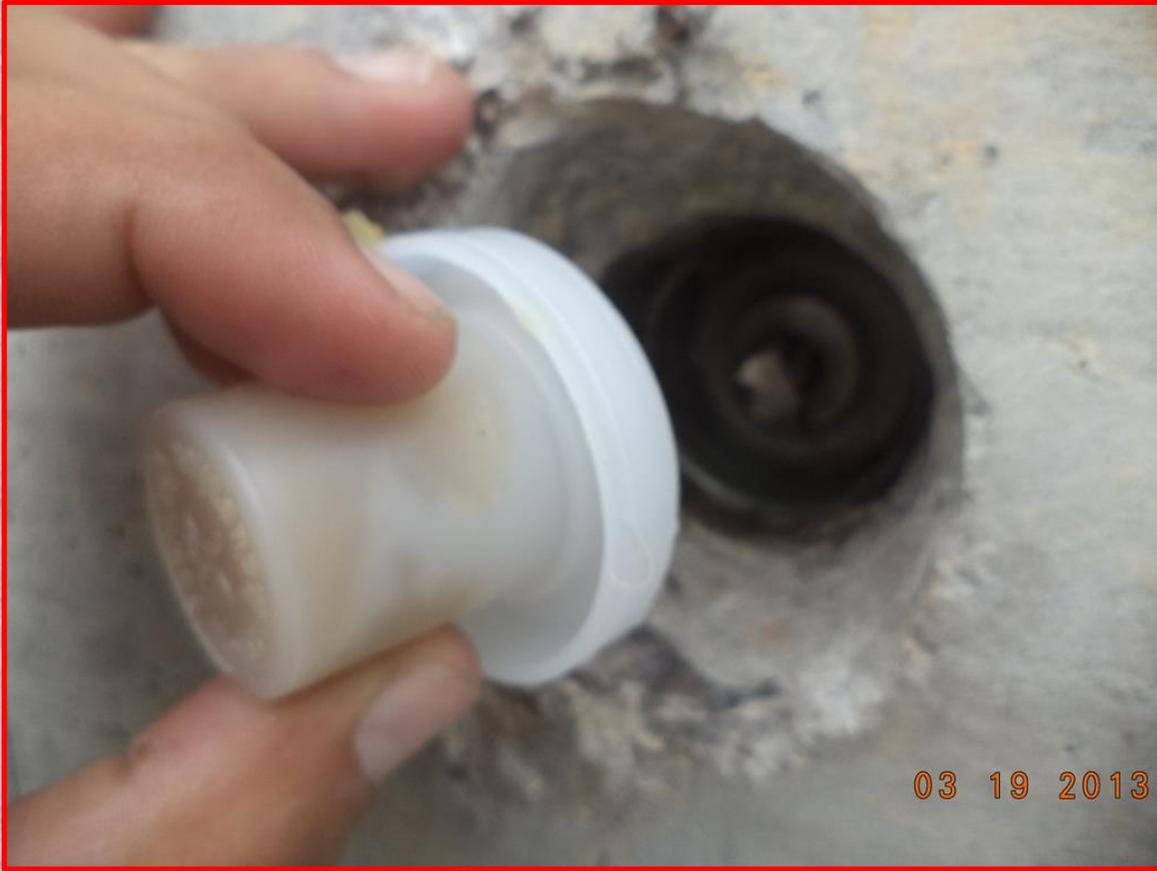
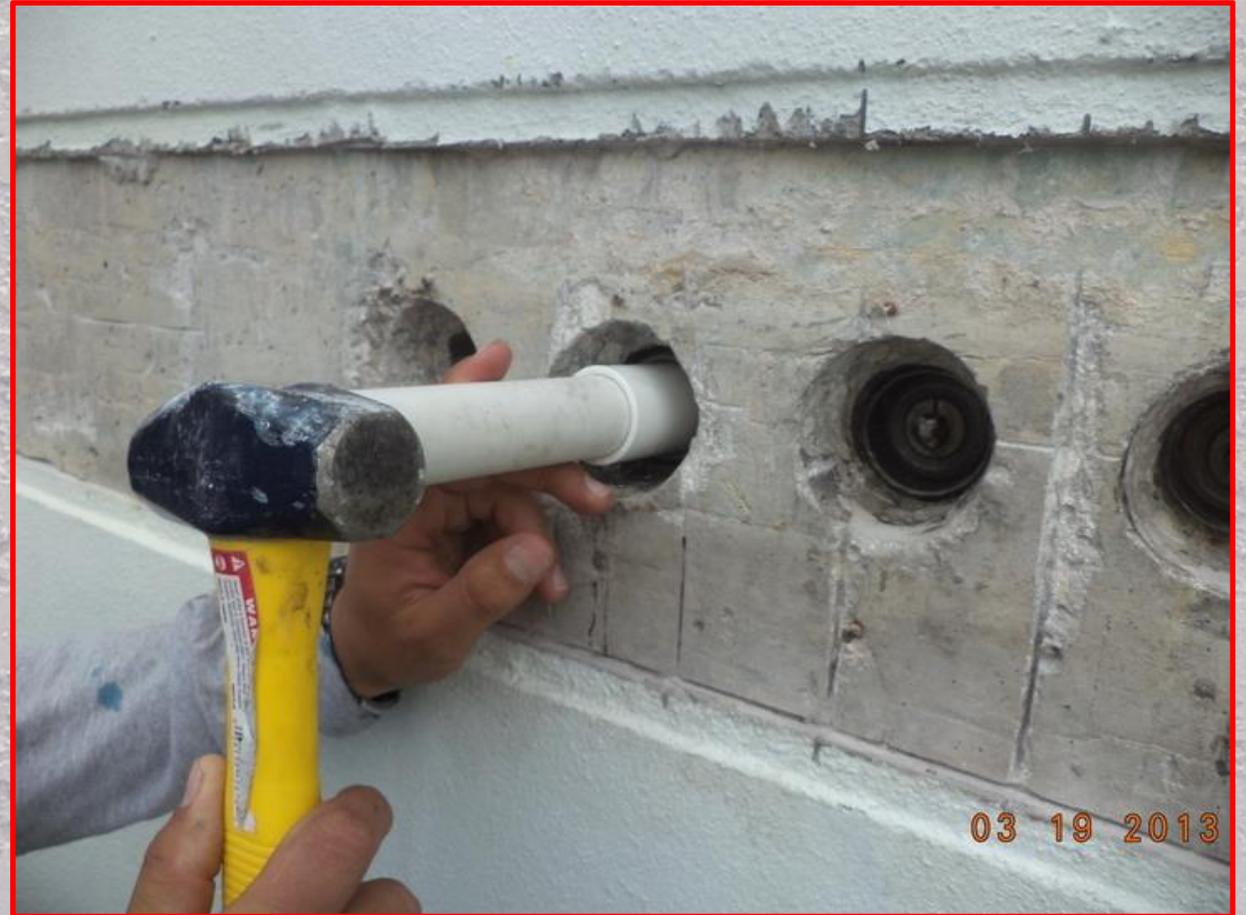
Note Melted Grease Cap

Grease Cap Placement

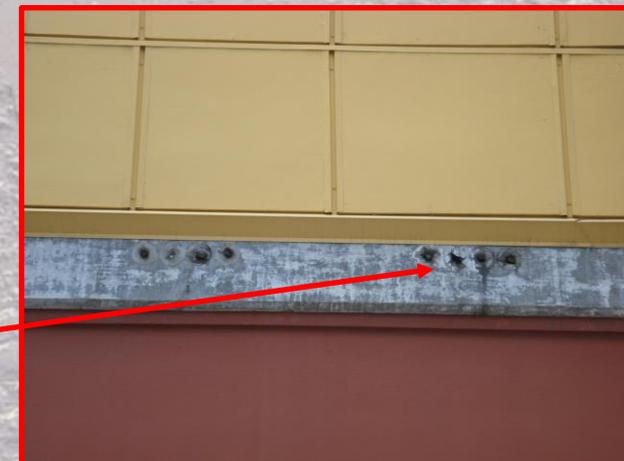
No Repair Necessary—
Tendons Never Stressed

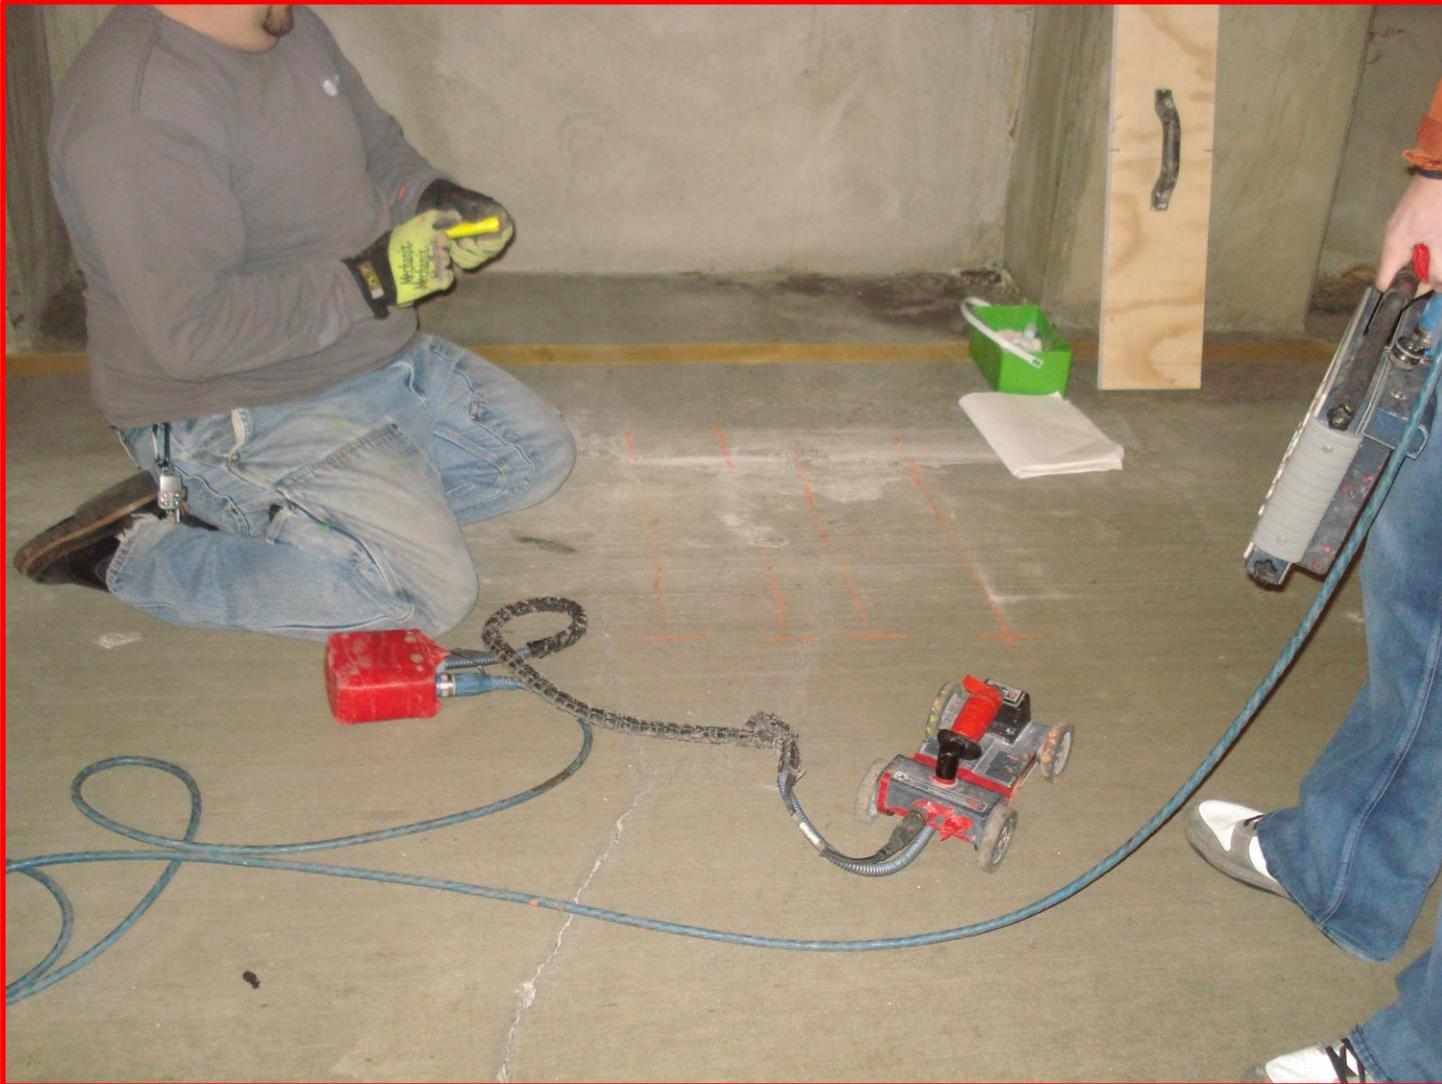
Know What You Are Getting Into

- Review PT Shop Drawings
- Locate Tendons
- Locate Anchors
- #of Tendons/Group
- Location in Slab
