**Repair of Concrete Session in Memory
of Tony Murray**

**Post Tensioning Repairs and
Modifications**

Contech Services, Inc.

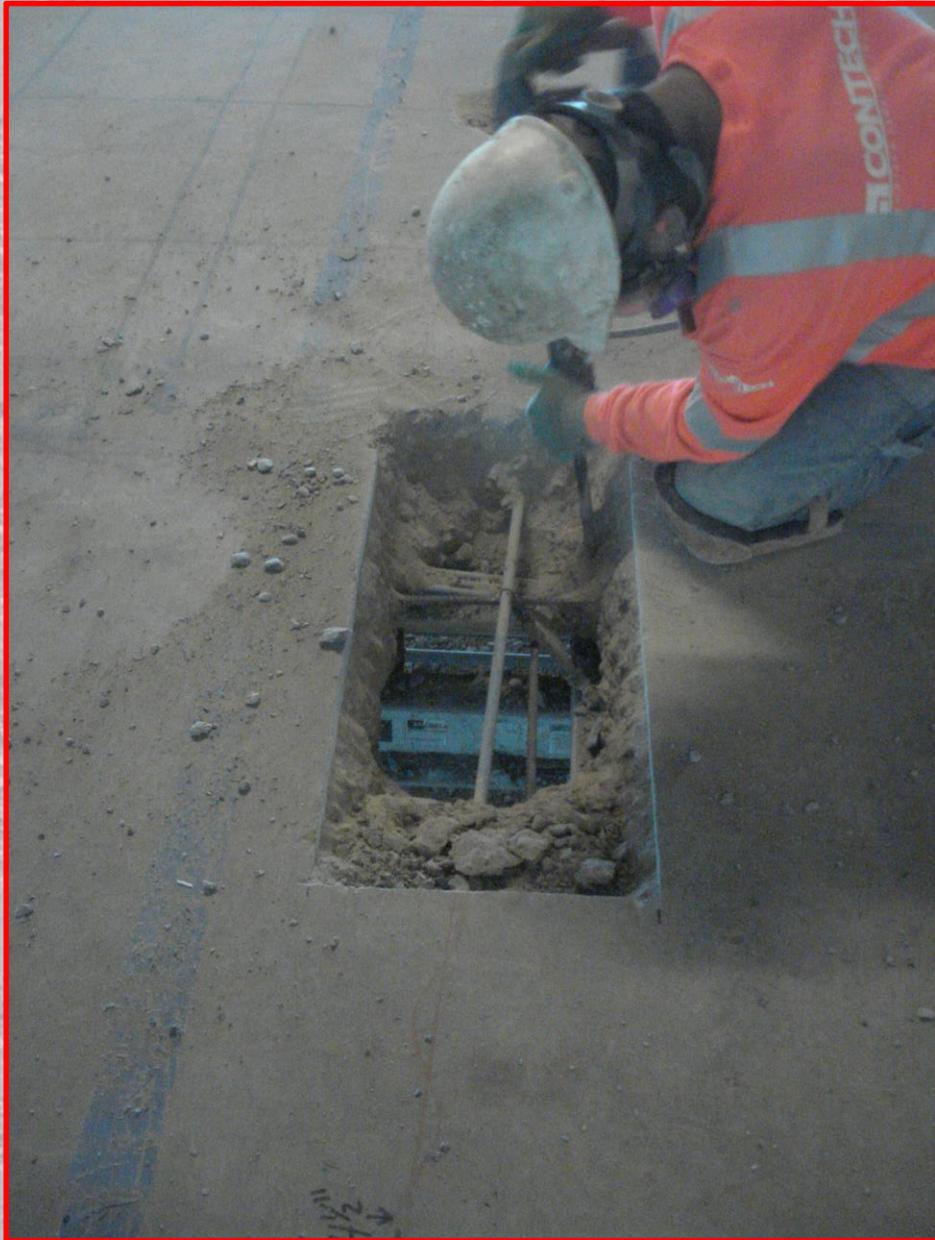
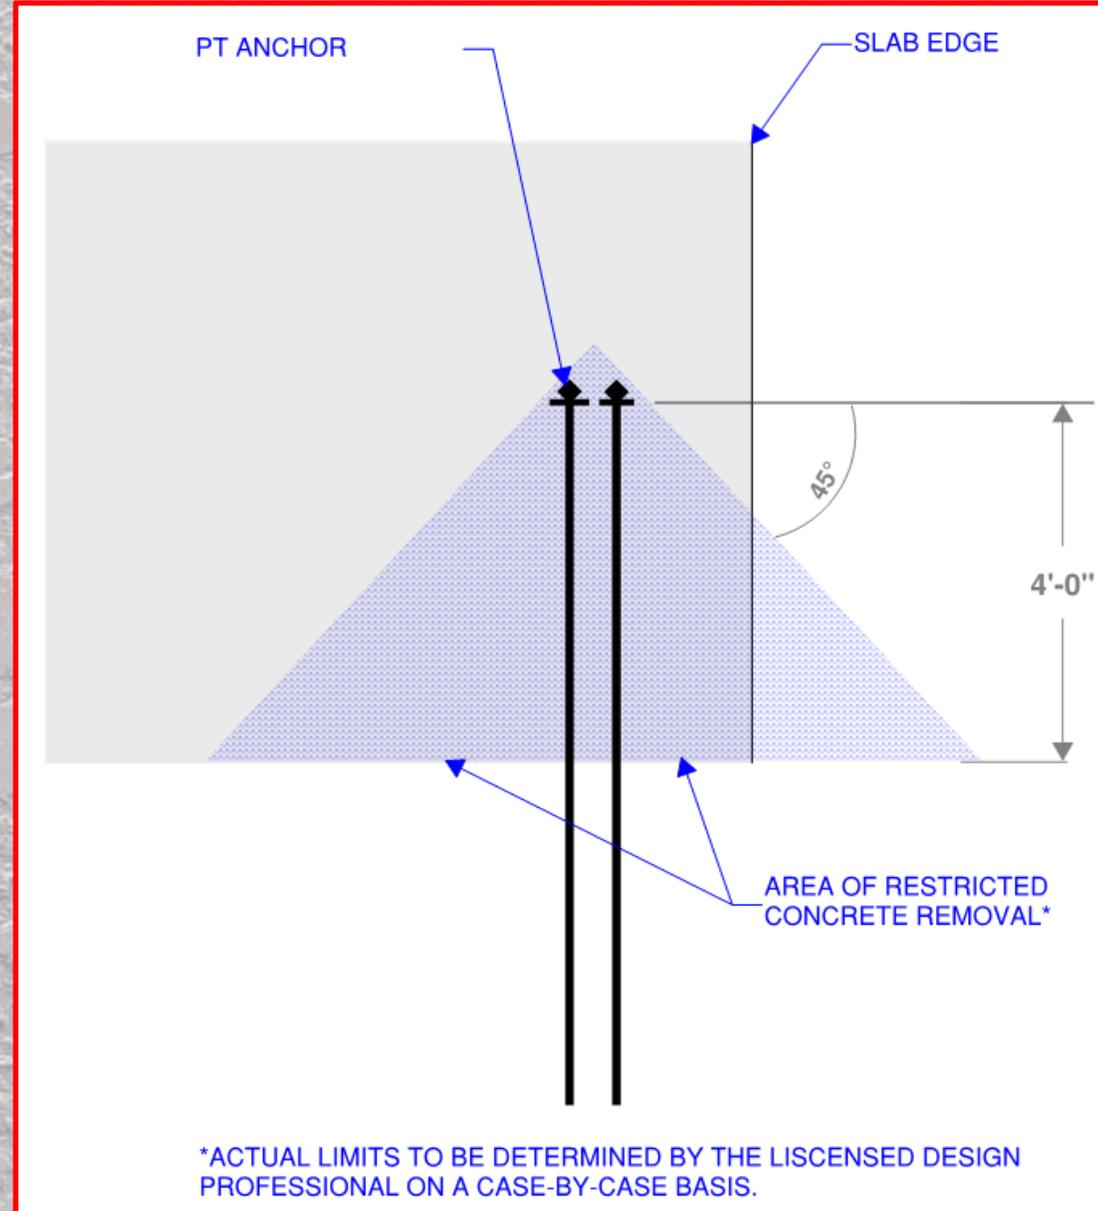
Concrete Removal—Cautiously

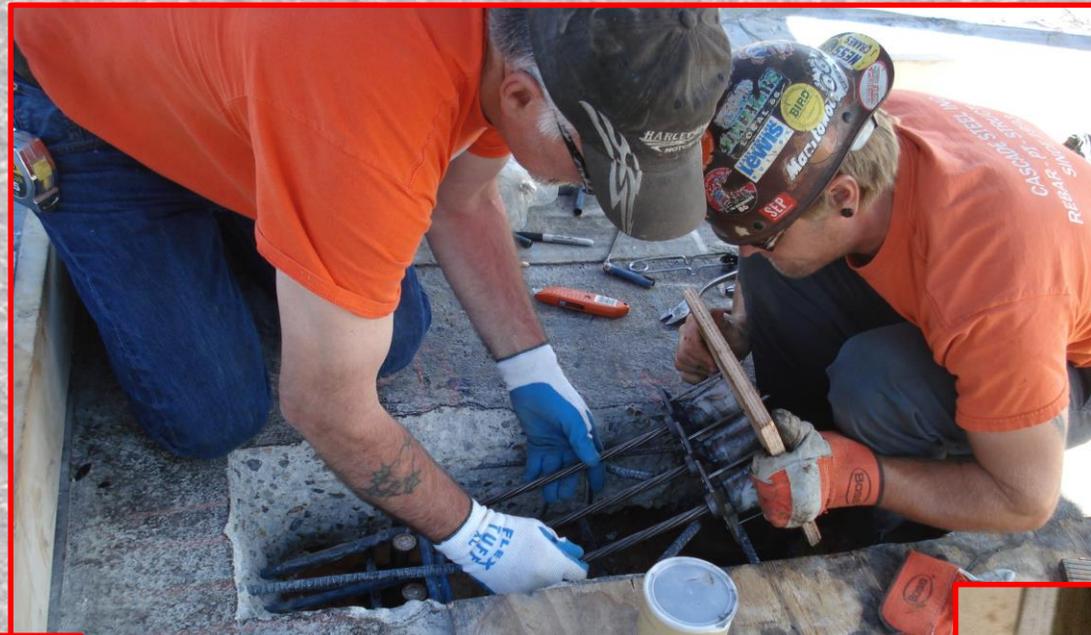
Repair of Unintentionally Cut Tendons

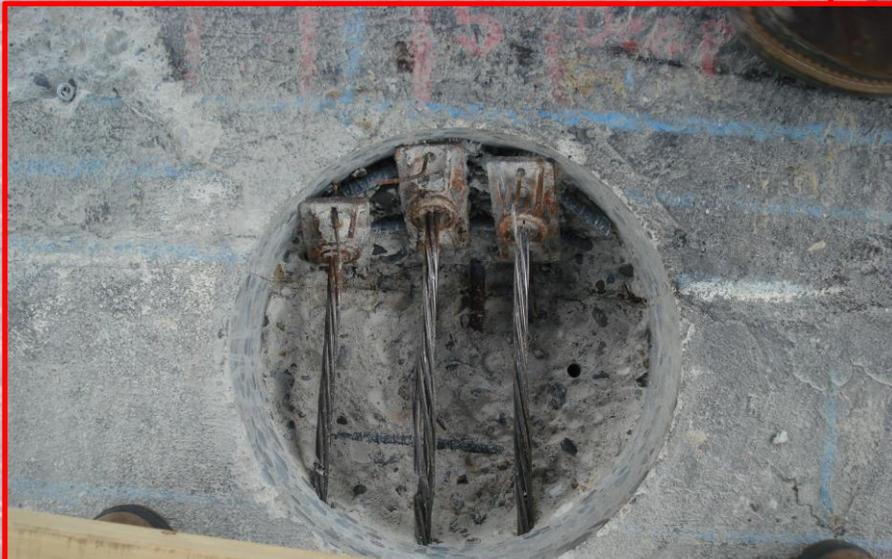
Installing New Anchors

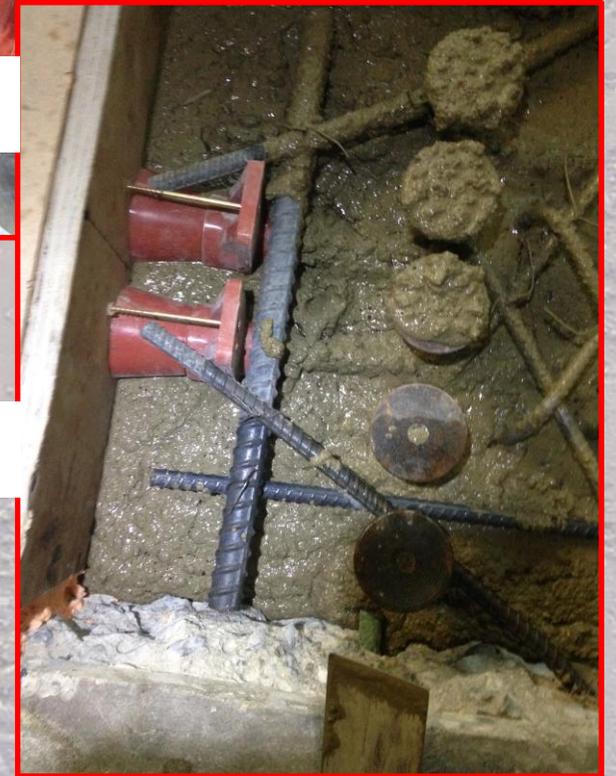
Severed Anchors by Core Drilling

Casting New Anchors

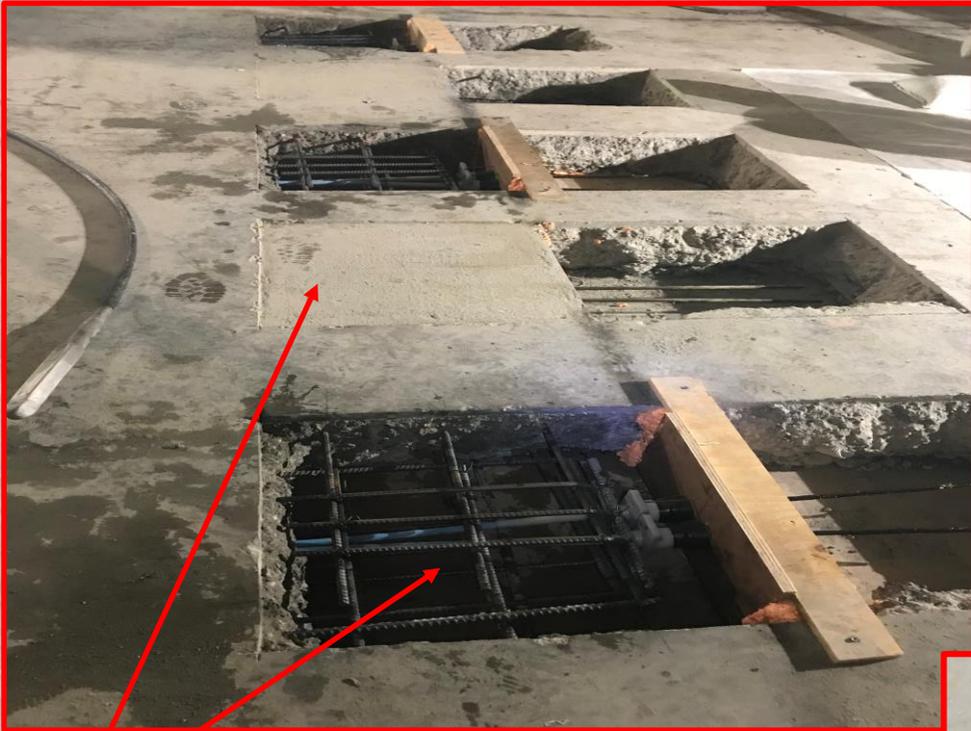
Destressing & Restressing

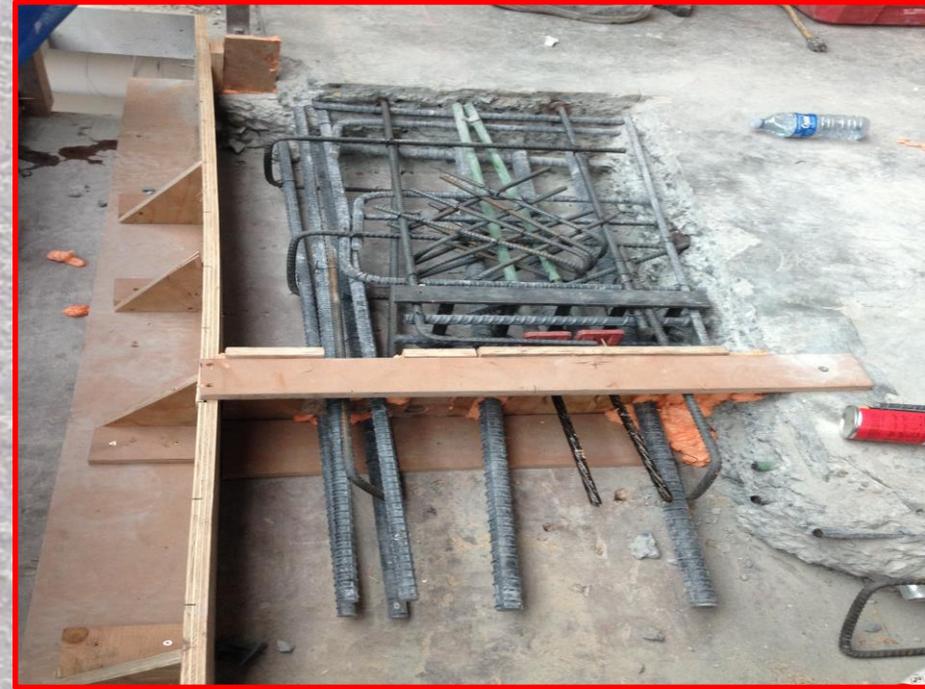
Staggered Destressing & Restressing

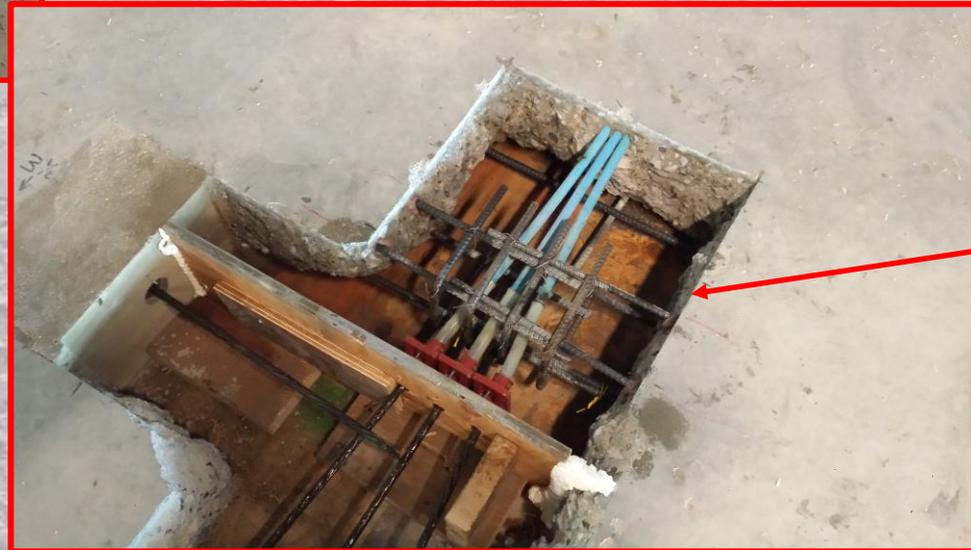
Destressing & Restressing in Both Directions

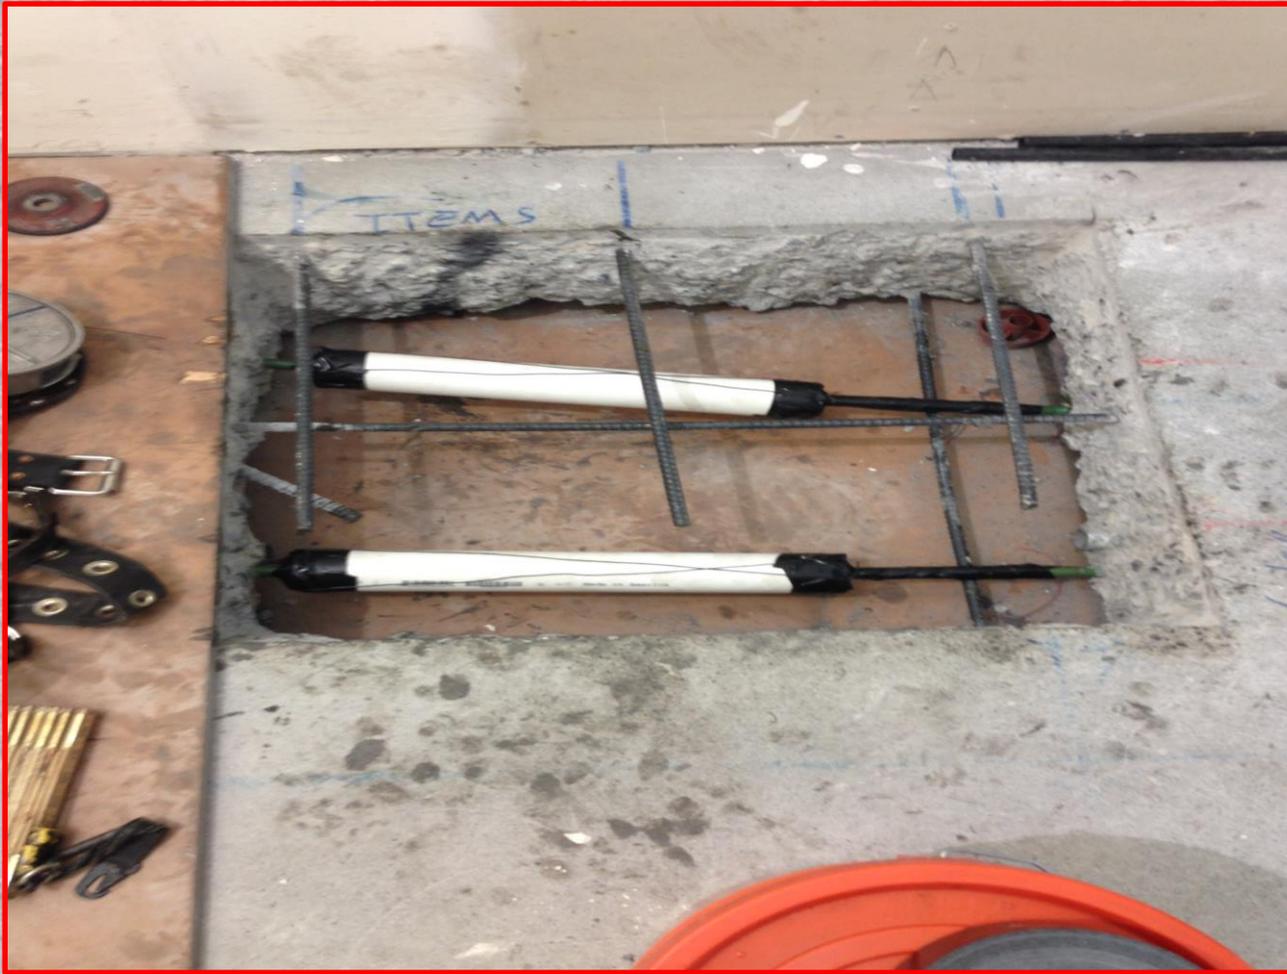
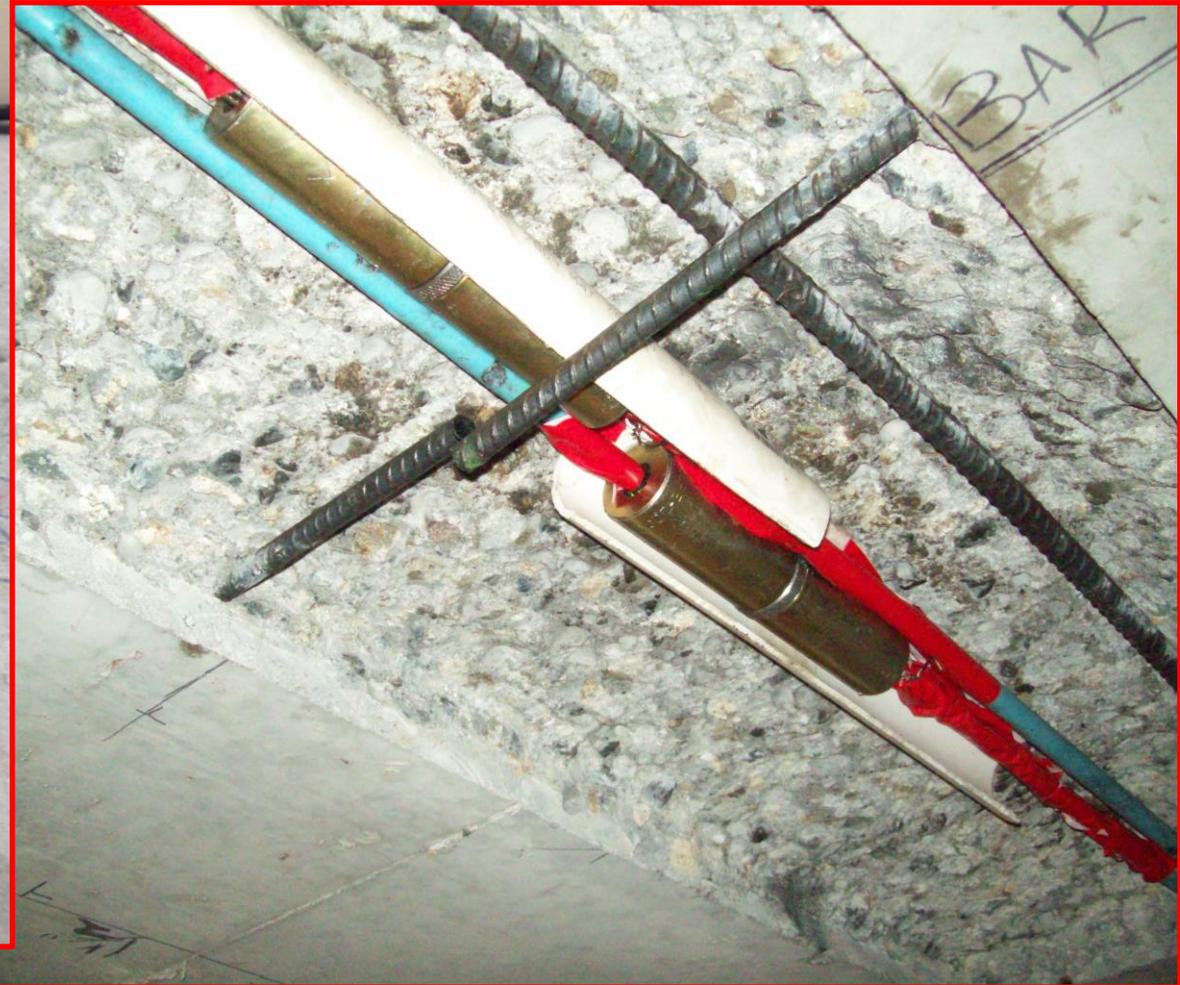
Examples of Tendon Couplers

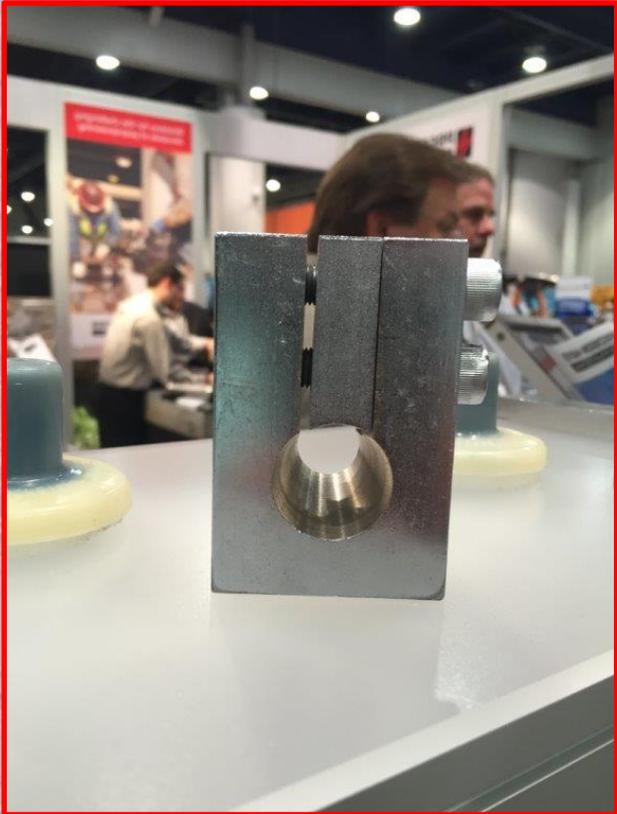
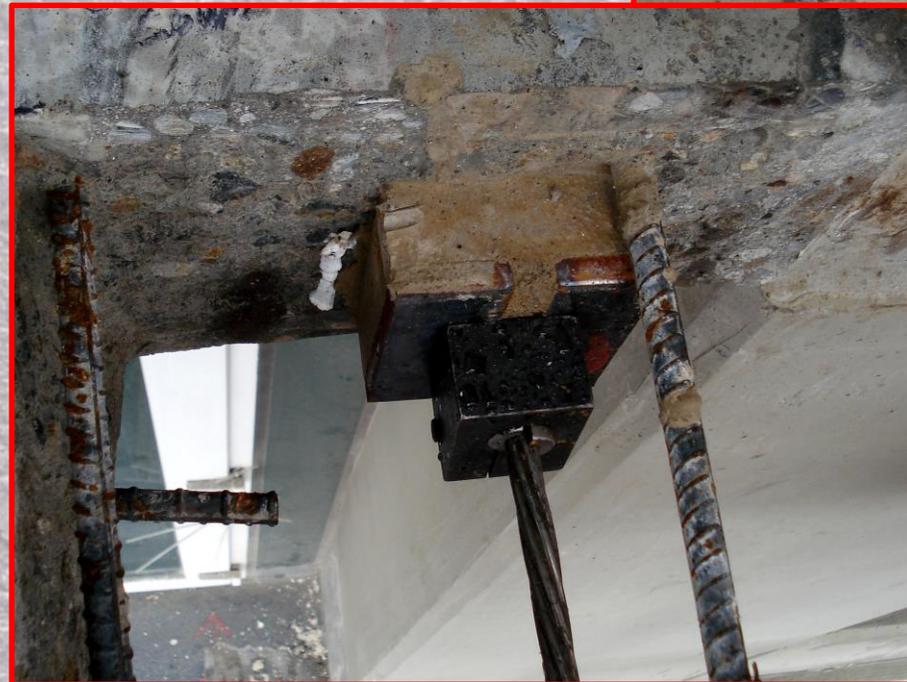
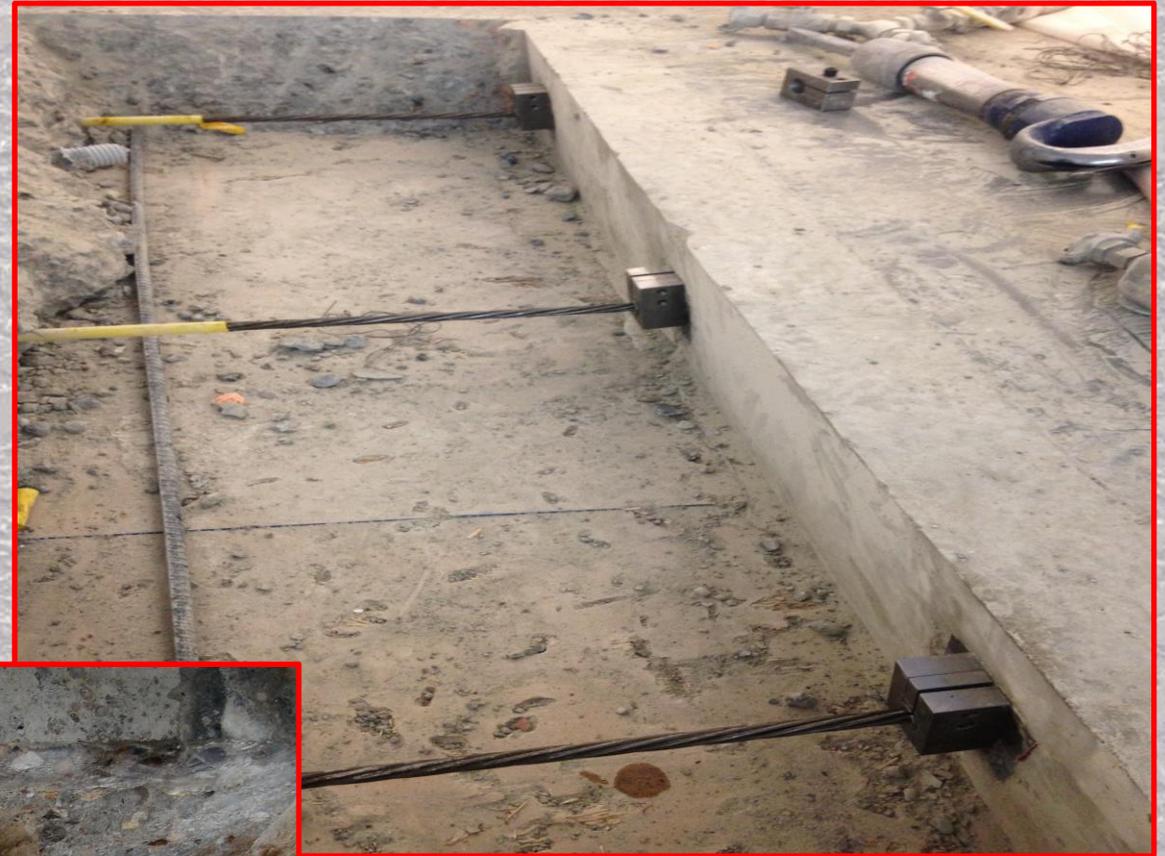
Temporary Anchors/Trouble Shooting Anchors

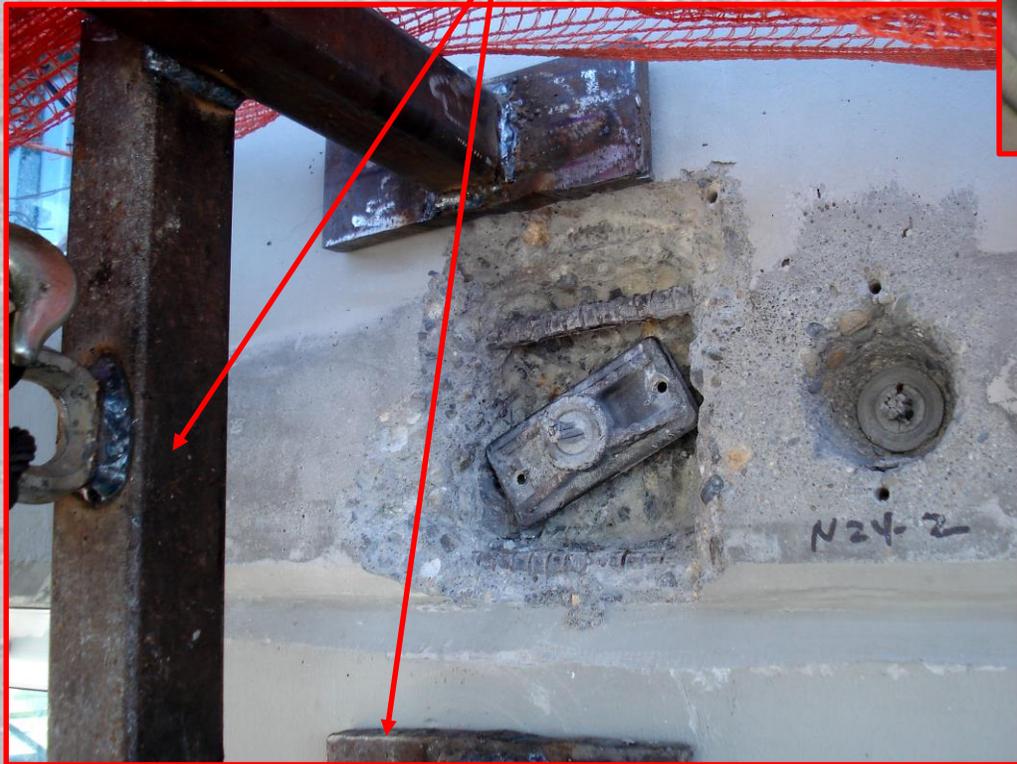
Tendon Extraction

Extraction Frame

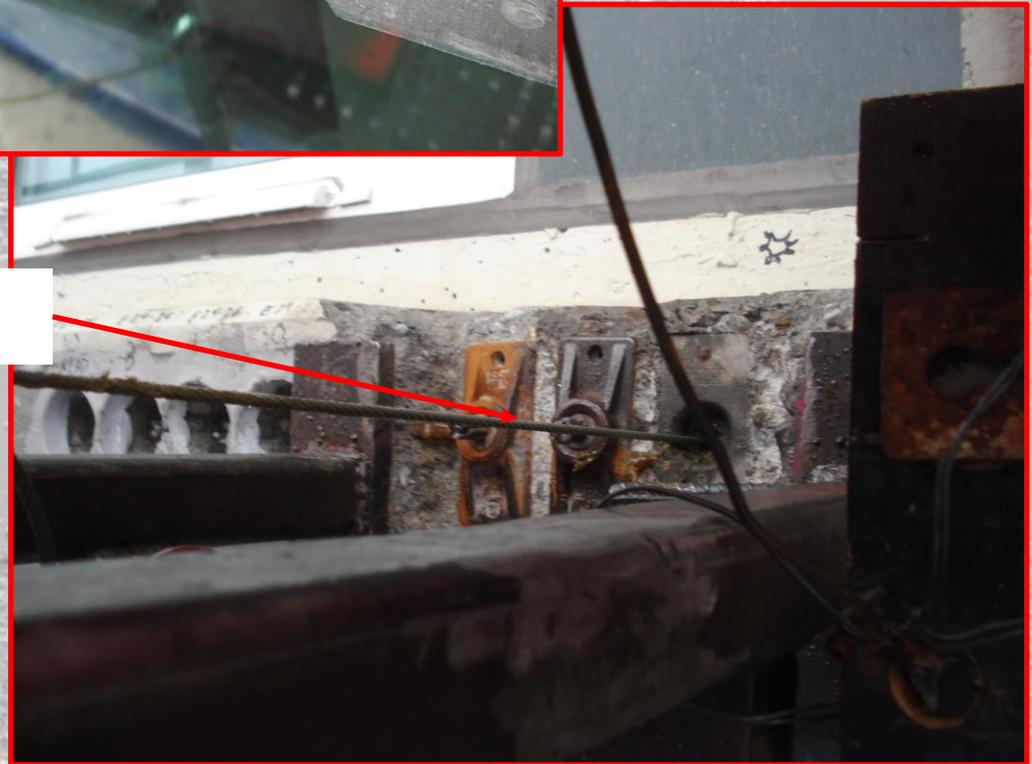
Pulling Tendon

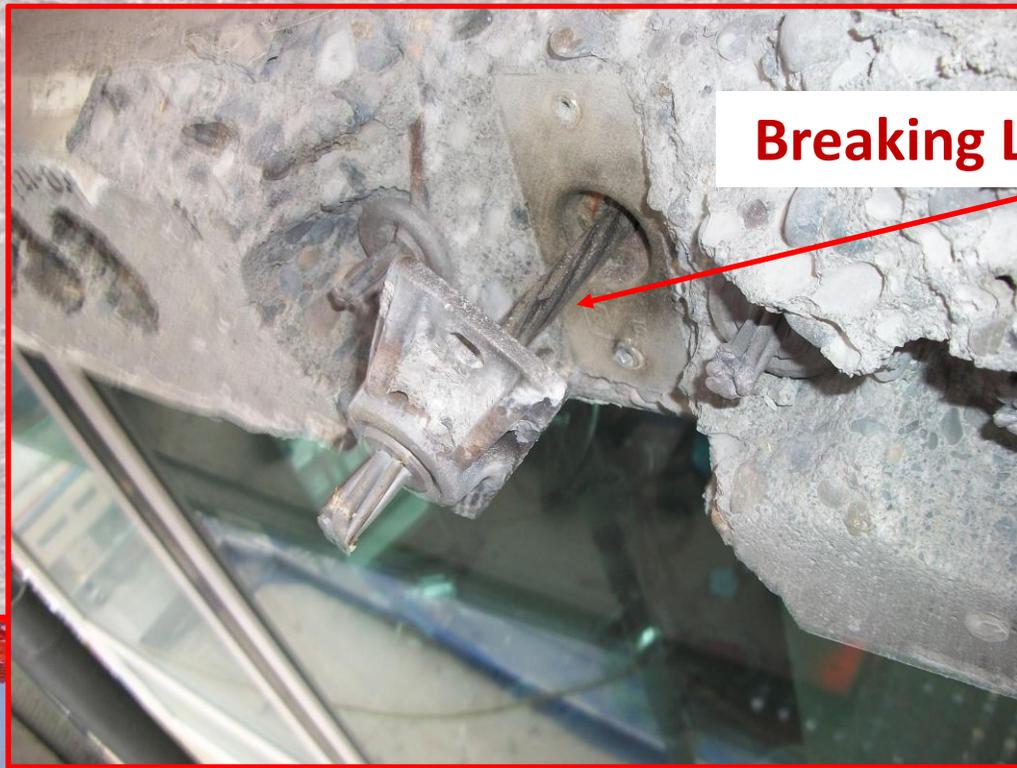
Breaking Loose Anchorage

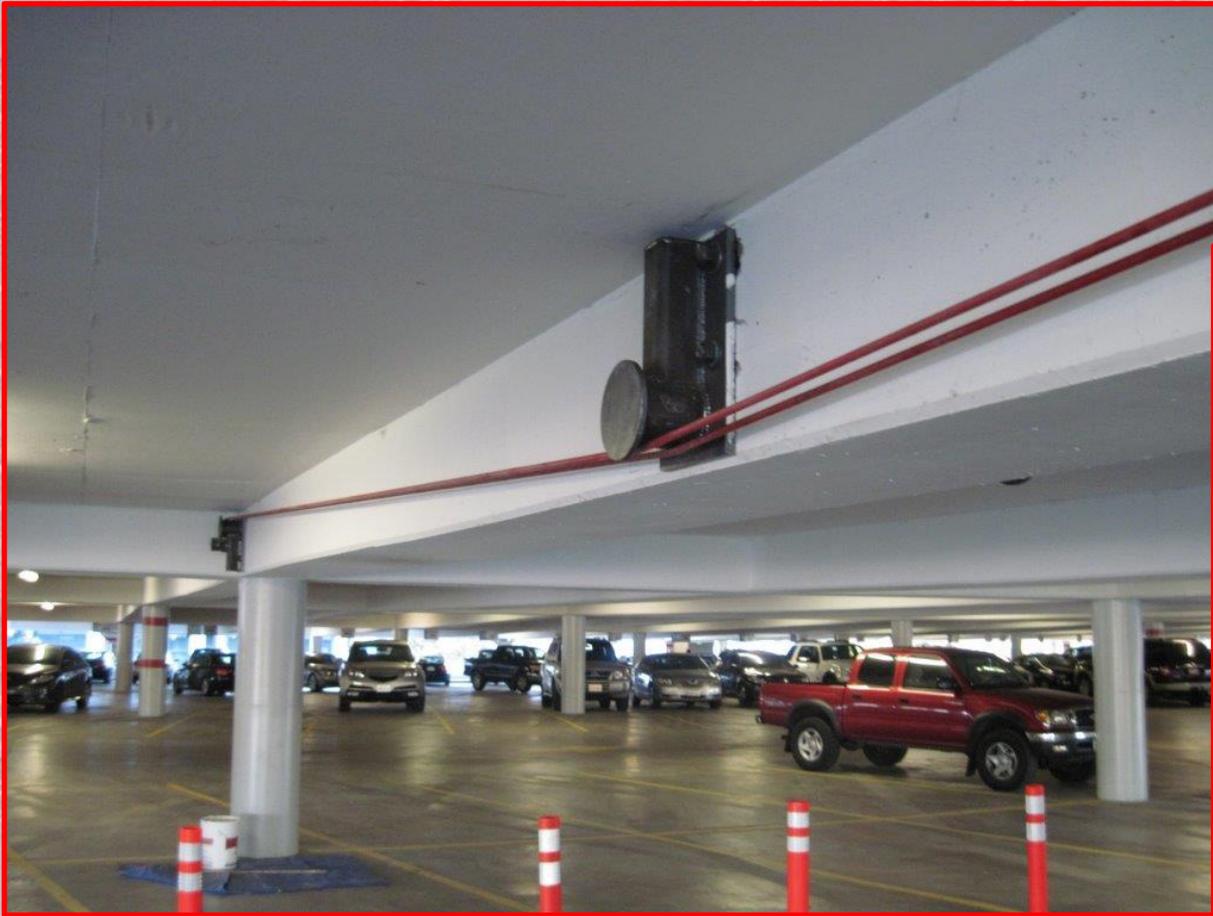
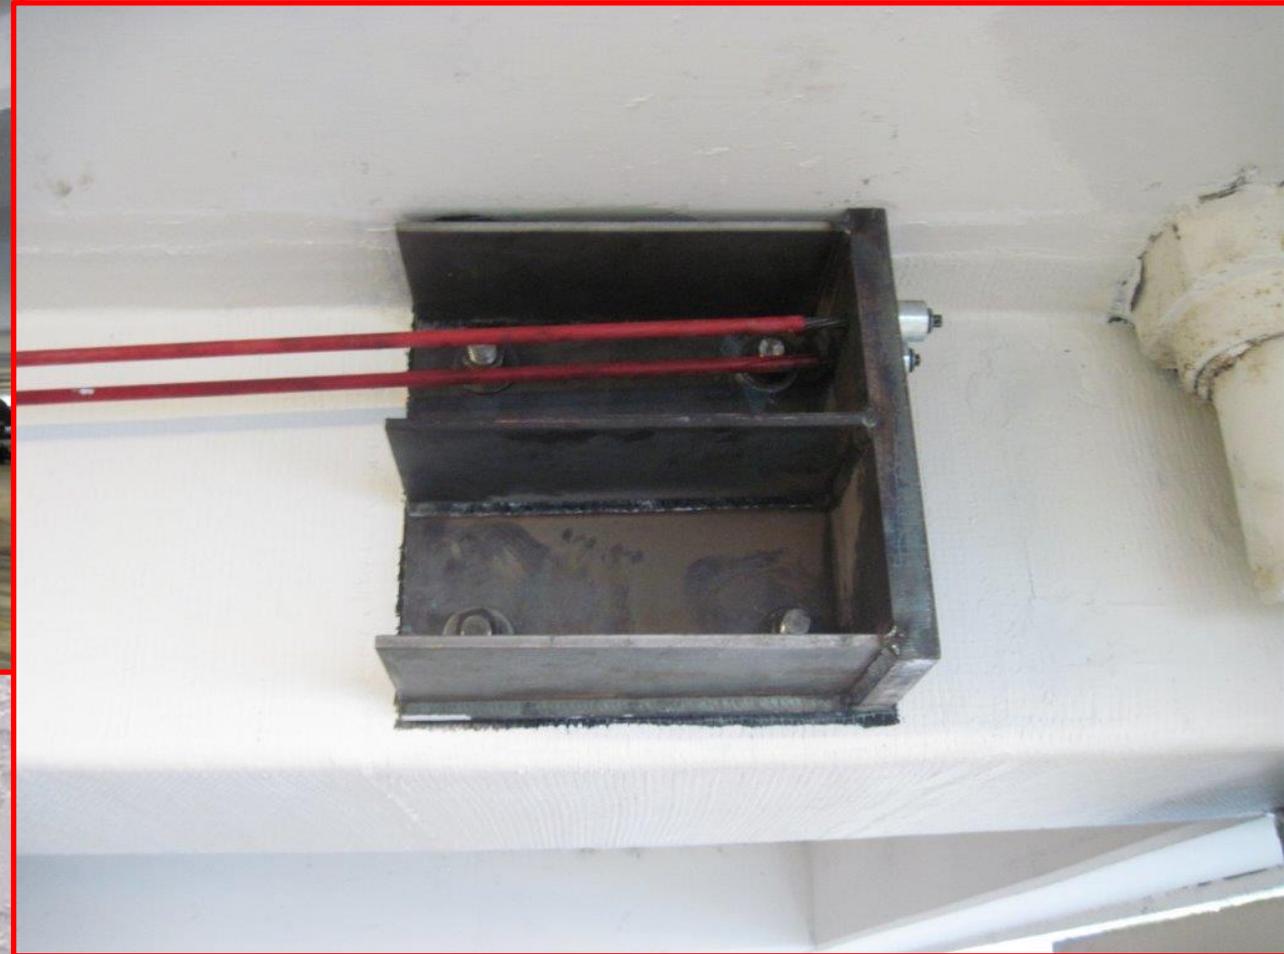
Externally Installed Post Tensioning
