# Bridge Deck Evaluation with Non-Destructive Testing

Yail J. Kim, Jun Wang

Presented by: Thi Ha (University of Colorado Denver)

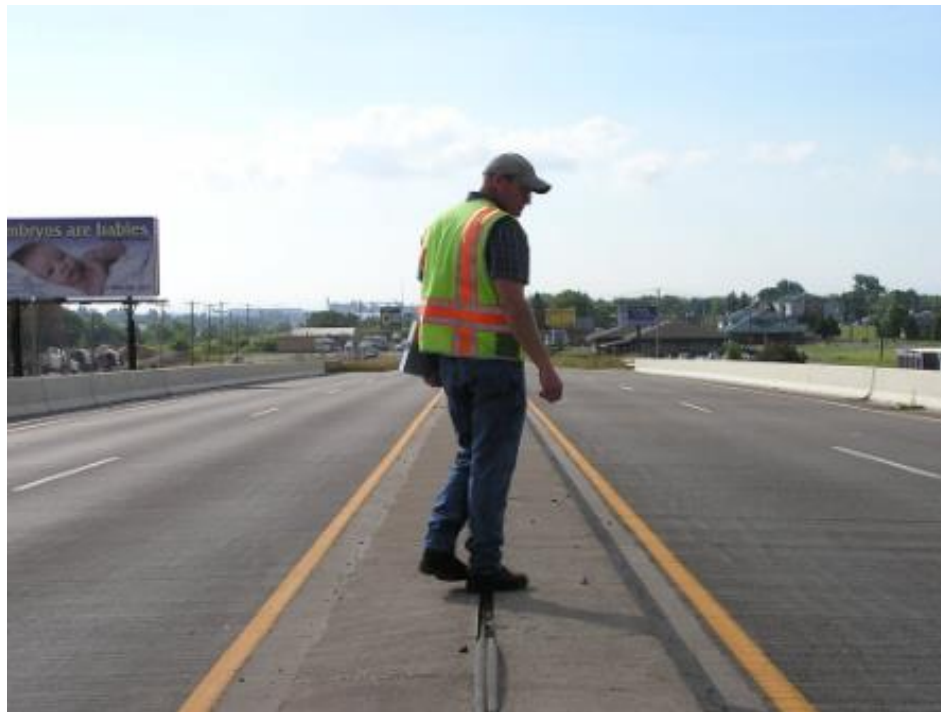
## 2. Ground-penetrating radar (ASTM D6087).

Electromagnetic waves were transmitted into the decks and reflections were recorded to quantify the severity of concrete degradation.

The signal attenuation and dielectric discontinuities of the reflected waves were interpreted to identify deteriorated regions.

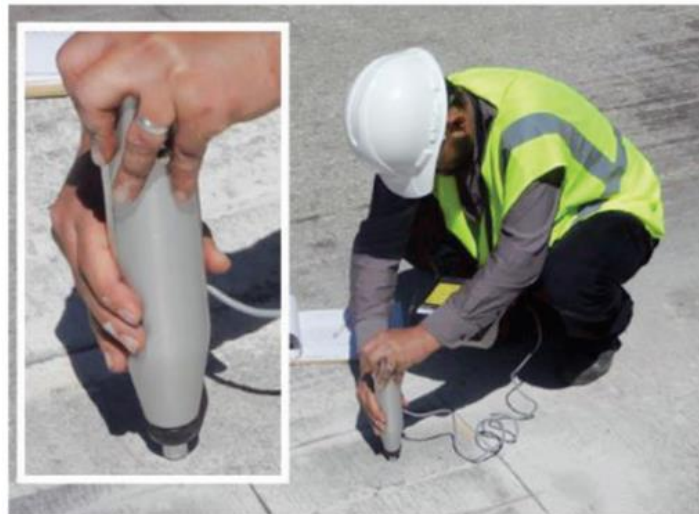
Each traffic lane of the bridges was divided into three to four lines, and the strength of the deck concrete was recorded at intervals of 7 ft (2 m).

Because rebound readings are concerned with the hardness of an elastic material, degradation of the concrete cover (deck surface to top bars) was of interest.

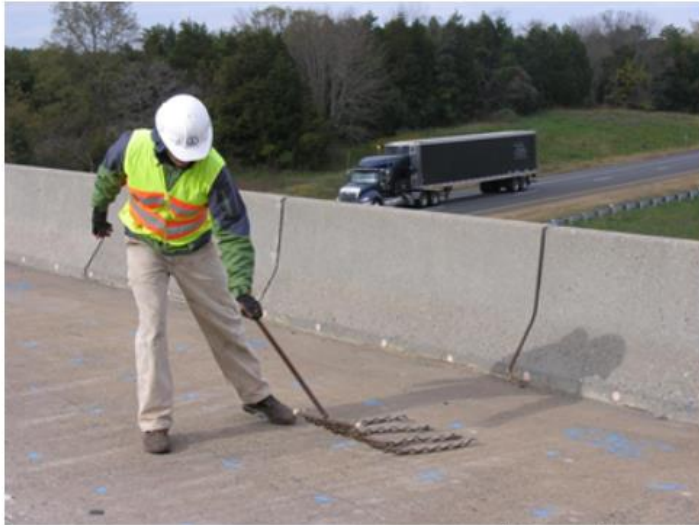
An experienced field engineer dragged steel chains on the deck surface, compared tonal differences (clear vs. dull), and marked possible delaminated regions.

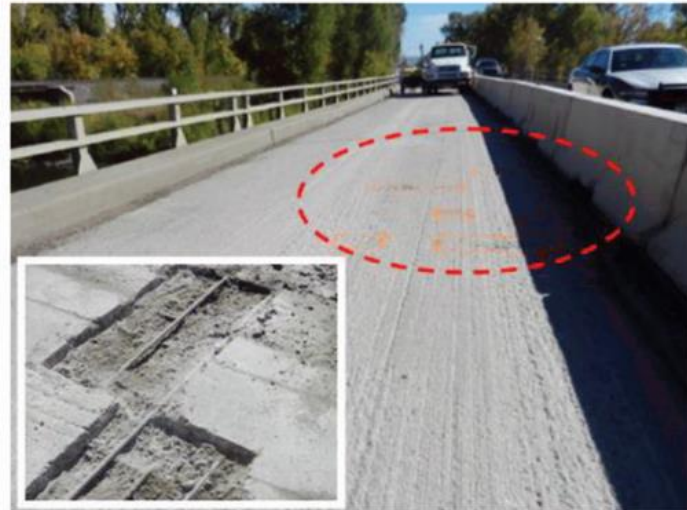
## 1. Visual inspection.

The evaluative information of the bridge decks excerpted from the NBI for the last decade (2010 to 2019). The deck condition rating was maintained to be 7 (Good condition: some minor problems); consequently, no major maintenance and rehabilitation were necessary.

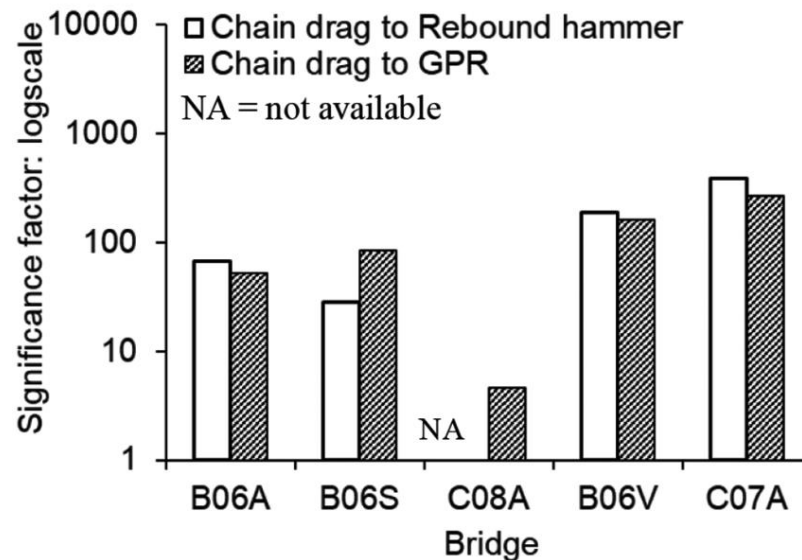
To demonstrate the extent of mutual agreement between the test methods, the significance factor ( $I$ ) proposed by Barnes and Trottier was modified ( $I \geq 5$  means a noticeable discrepancy).

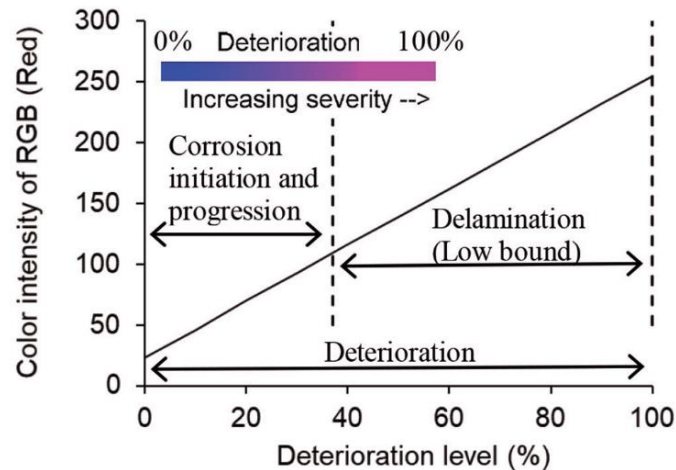
The deterioration of the GPR contours was decoded in RGB model space, comprising a combination of red, green, and blue, so that the condition of the bridge decks was numerically linked with the scale bar.

After completing a calibration process, using the formulated analytical model.

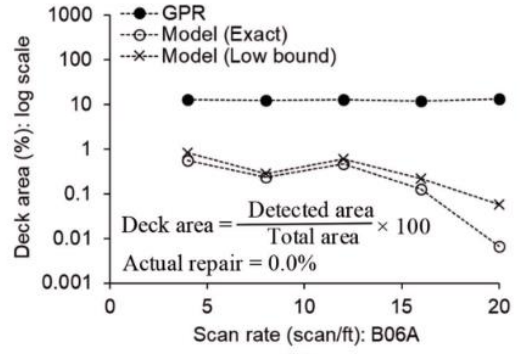
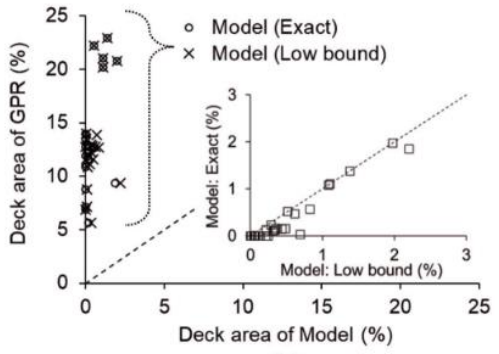
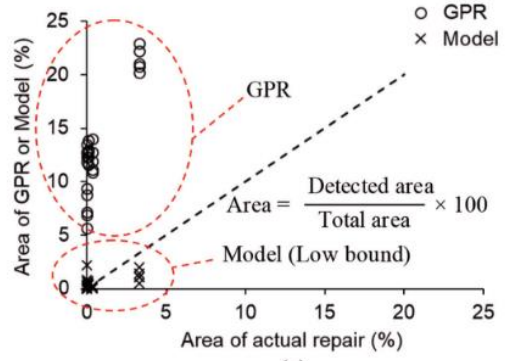
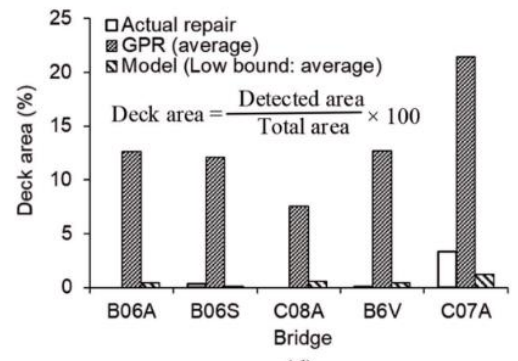
Evaluation of delaminated area: (a) deck area with scan rate for B06A; (b) comparison between GPR and model; (c) comparison among actual repair, GPR, and model; and (d) average comparison.

The low bound level of the model extracted delaminated areas using the deterioration intensity of the GPR scale above 40%, and reasonable agreement was made with the repaired areas.
