Long-Term Monitoring and Instrumentation for Steel and Concrete Bridges

Structural Monitoring Projects in Oklahoma

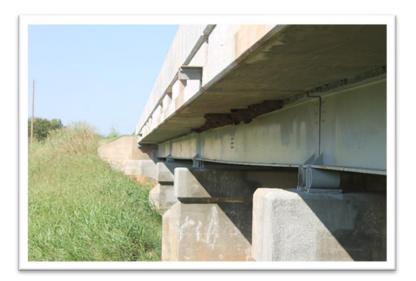
- Full size bridge built at the bert Cooper Engineering Laboratory (BCEL)
- Replica of Eagle Chief Creek Bridge "A" on SH14 in Woods Co., Oklahoma.

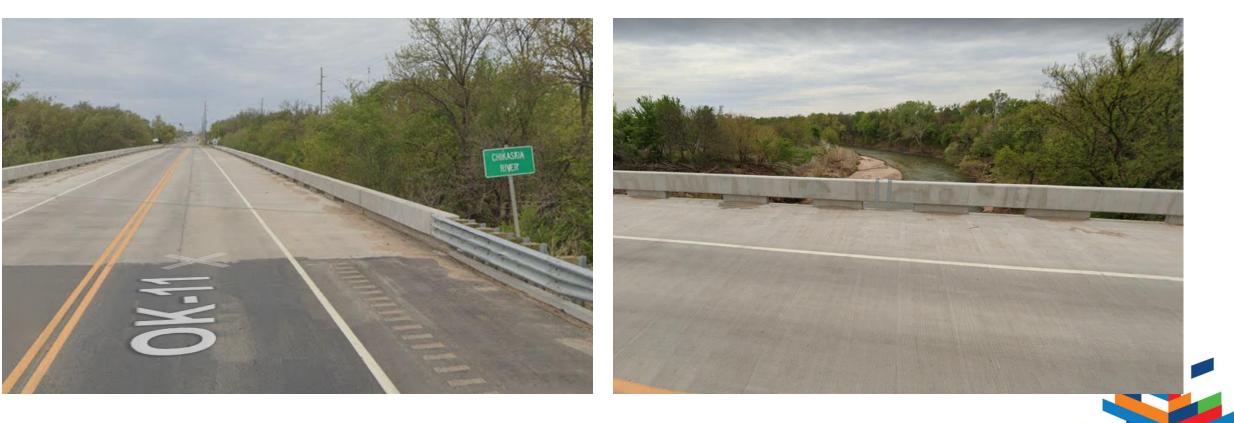
SH 11 over the Chikaskia River

SH 11 Rehabilitation = New Deck Slabs Use Existing Steel Girders, 100 ft (30 m) spans

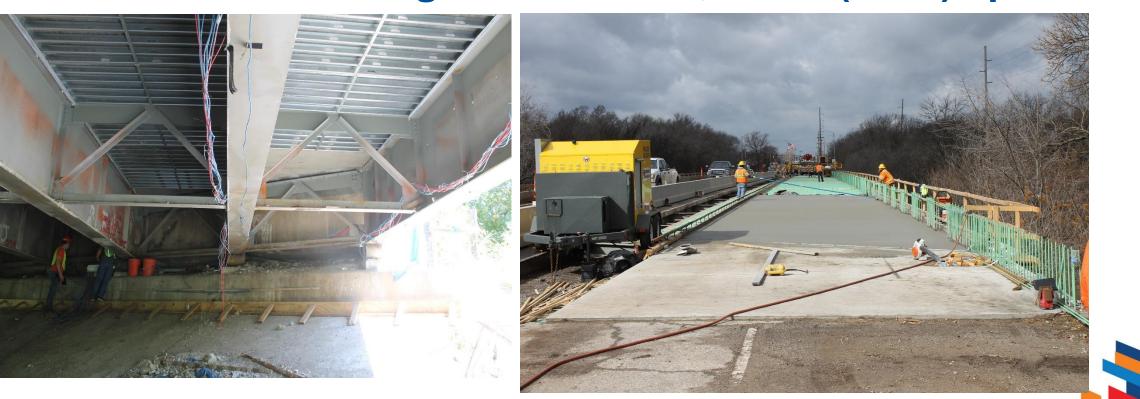
Total Span 120 m - Four 100 ft (30 m) spans – 6 girder lines w/ 30° Skew and Cross Bracing

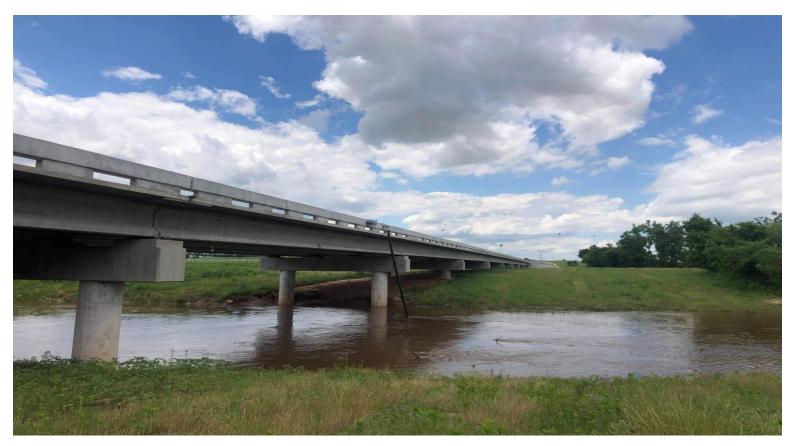
SH 4 over the North Canadian River, Canadian Co., OK

- Fifteen 100 ft. spans
- Clear Roadway Width = 40'-0
- Each Span
 supported by four
 AASHTO Type IV PC
 Girders
- Girders are simply supported on neoprene bearing pads with "poor-boy continuous" deck slabs over the joints.
