## Fracture Energy of GFRP-Concrete Bonded Interface after Sustained Loading in Natural Environments

**Evaluate effects of multi-year sustained loading and environmental exposure on Mode II interfacial fracture energy of GFRP/concrete bond**

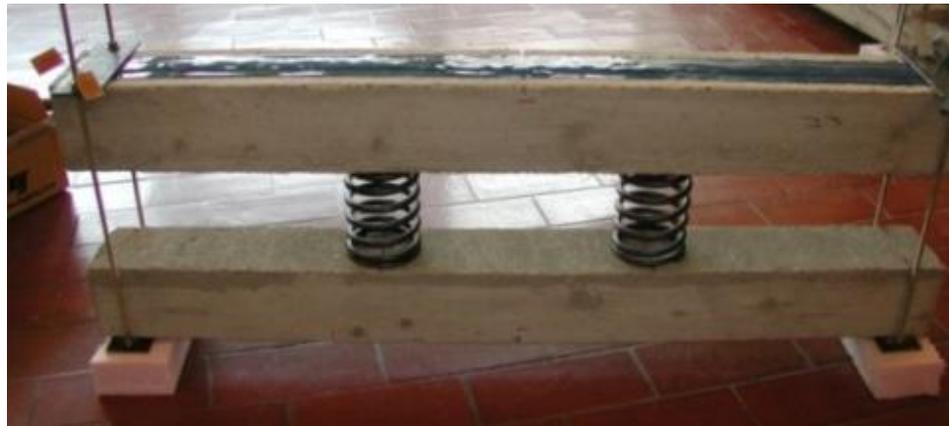
- Unconditioned beams: 0 time
- Conditioned beams: 6 and 13 years with sustained loading in indoor and outdoor environments

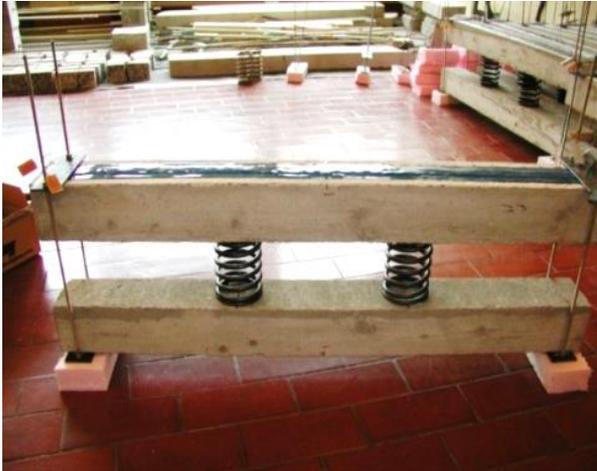
Indoor condition  
(21-23°C)

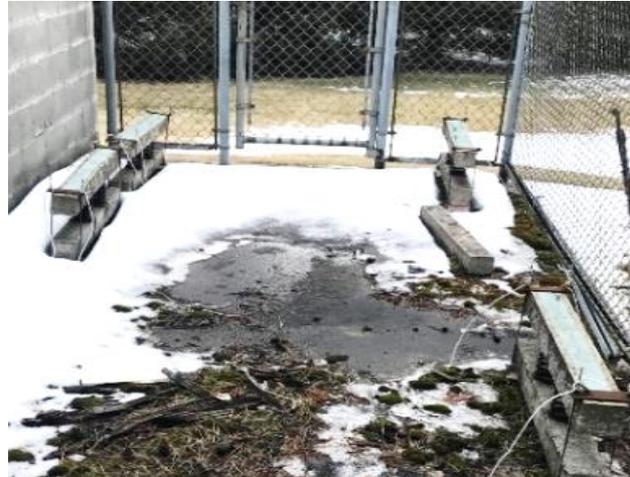
Outdoor condition  
(during winter)

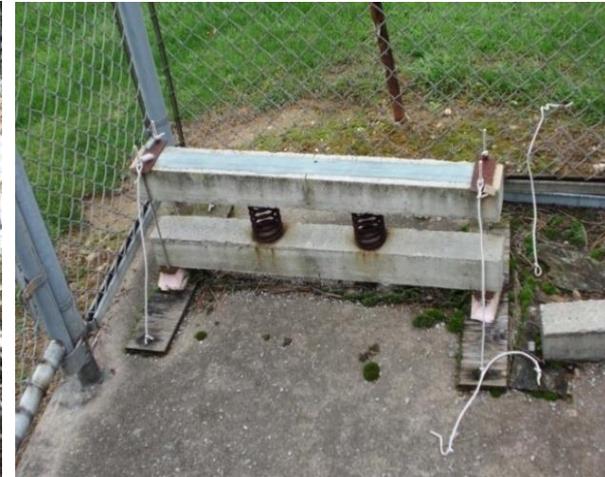
Outdoor condition  
(during summer)

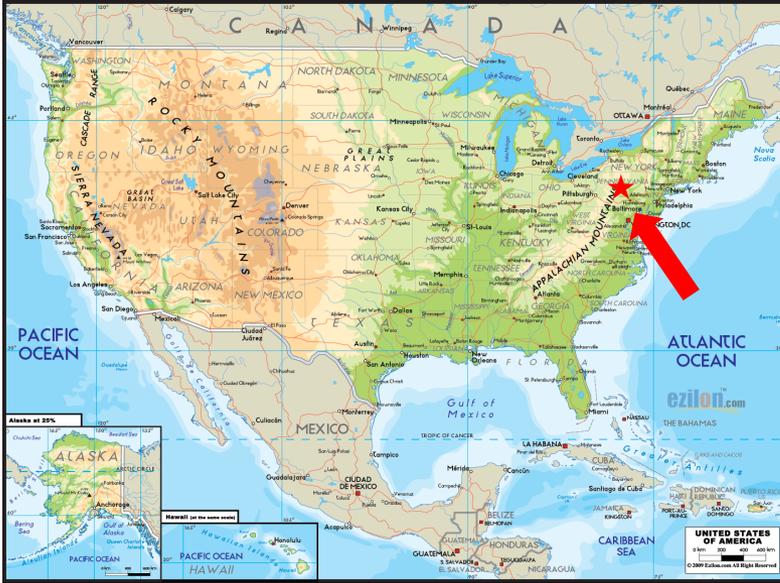
# Outdoor Weather in Central Pennsylvania

- “Warm-summer humid continental” climate -- Group Dfb according to the Köppen-Gieger climate classification system
- ~65 freeze/thaw cycles per year (~840 over 13 years)

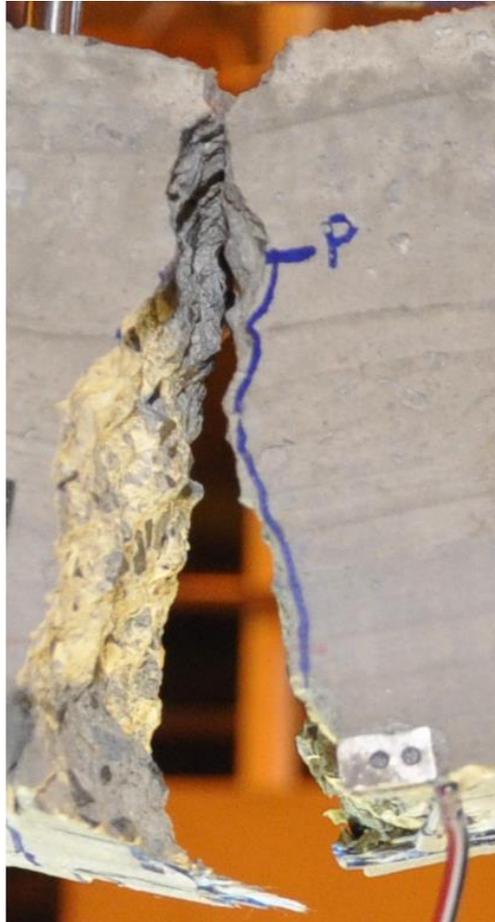
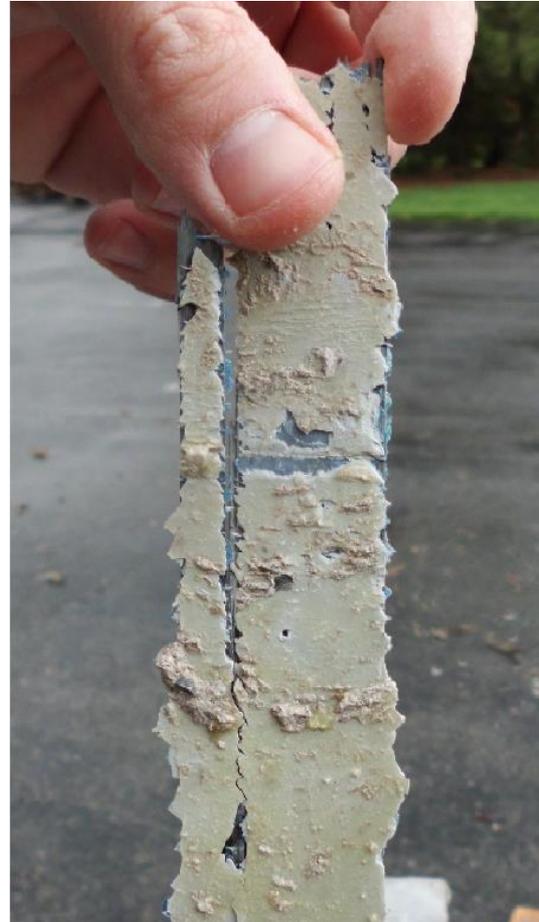
# Typical Failure Mode

Debonding, followed by GFRP rupture @ notch or secondary crack

Mix of adhesive failure and concrete-cohesive failure
