The Condition Assessment Term Project

Applying Materials Knowledge in the Real-World

The Term Project – Example Final Report

BRIDGE CONDITION ASSESSMENT IN LARAMIE AND DETAILED REPORT

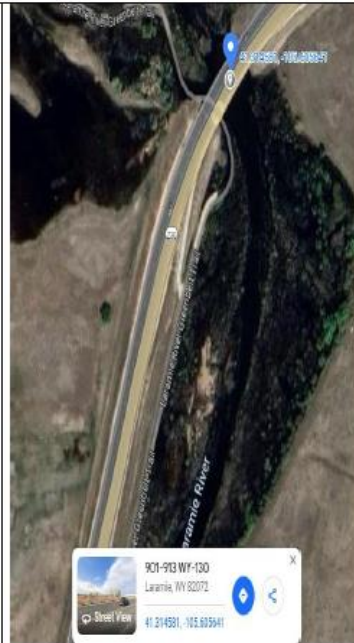
Figure 2: Coordinates from Google Maps

General	Inspector's Name	
	Date of Inspection	11/09/2024
	Purpose of Inspection	Educational
	Weather Conditions During Inspection	<ul style="list-style-type: none"> • Snowy, with heavy snowfall an hour before the visit • Temperature 2° C (felt like -5° C) (<i>Figure 1</i>) • Windy, and clear skies
Description of Structure	Name	Officially unnamed.
	Location	A bridge connecting East and West Laramie on Snowy Range Road, located above Laramie River, accessed underside via Laramie River Greenbelt Trail, Laramie, Wyoming, USA. Coordinates: 41.314581, -105.605641 (Google Maps) (<i>Figure 2</i>)
	Type	Highway Bridge
