# Type IL Cement and Concrete Scaling

by David R. Lankard

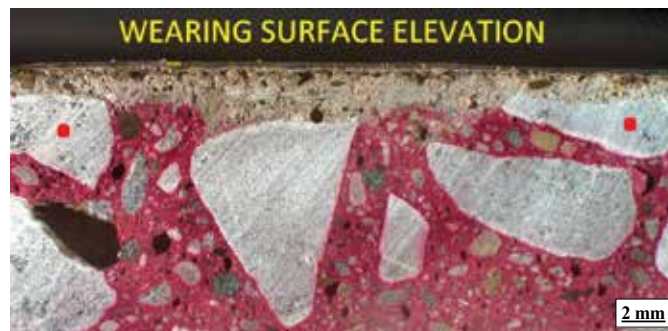
**Fig. 1:** A saw-cut surface of a scaled air-entrained Type IL cement and slag cement concrete core section containing a durable limestone coarse aggregate after the application of phenolphthalein. The compromised wearing surface layer (mortar) is carbonated (no pink color)

Figure 1 shows a saw-cut surface of a scaled concrete core in which the cementitious constituent is a binary blend of Type IL cement and slag cement. Prior to the saw-cutting step, the wearing surface of the core was coated with an epoxy

adhesive to preserve pre-sawing features. Shortly following the saw cut, the surface was sprayed with a pH-indicating solution (phenolphthalein). On a concrete surface that is not carbonated ( $\text{pH} \geq 13$ ), the treated surface turns a bright pink color. Where the concrete is carbonated ( $\text{pH} < 10$ ), there is no color change. Features of interest in Fig. 1 are:

- The compromised wearing surface layer is the 2 to 4 mm (0.08 to 0.16 in.) thick carbonated layer (no pink color). There is an abrupt transition between the carbonated layer and the underlying scale-resistant concrete. Typically, only the thin carbonated layer is lost in the scaling event. Tests made during the petrographic examination revealed that the cement paste in the compromised wearing surface is softer and weaker, has a higher level of permeability and porosity, and has fewer residual portland cement particles relative to the underlying concrete. This condition is attributed to an elevated  $w/c$  in the affected layer relative to the underlying concrete. The estimated  $w/cm$  in the affected layer can range from 0.5 to 0.8 in a single core sample;

- The affected layer has not yet been lost (scaled). However, a thin layer of the weakened cement paste was pulled off by the epoxy layer; and
- The near-surface limestone coarse aggregate particles (red dots) are in contact with the carbonated layer. Due to the high level of permeability of the affected layer, water on the slab surface gains easy access to these particles, and they can quickly become fully saturated.

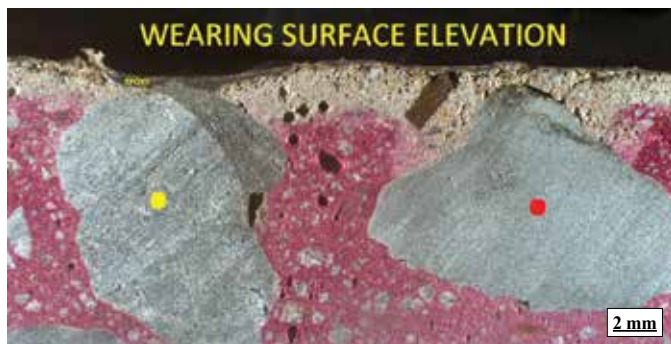
Fig. 3: A compromised wearing surface layer in a saw-cut surface of a scaled concrete core section following the application of the phenolphthalein. The cementitious constituents in the concrete are Type IL cement and fly ash, and coarse aggregate is a durable limestone rock

involved in the mortar liftoff scaling feature. At this location, the affected surface layer has been lost completely (scaled). Note that remnants of the mortar are still attached to the particle, confirming an adequate cement paste/aggregate bond; and

- In the middle and at the right portion of the view, the compromised wearing surface layer is still intact and shows another example of an incipient mortar liftoff over the durable limestone coarse aggregate particle (marked with red dot). Note the increased depth of the carbonated layer on both sides of the aggregate particle.

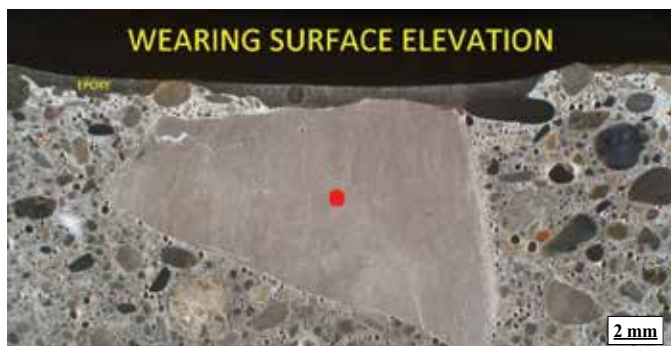
Fig. 4: A compromised wearing surface layer in a lapped surface of a scaled concrete core section. The cementitious constituents are Type IL cement and slag cement, and coarse aggregate is a limestone rock

Figure 4 shows scaling within the compromised wearing surface layer, next to a mortar liftoff form of scaling. In this example, the cementitious constituents are Type IL cement and slag cement, and the noticeable features include:

- On the left two-thirds of the view, around half to the full thickness of the light-colored compromised wearing surface layer has been lost (scaled). This includes the mortar liftoff over the durable limestone coarse aggregate particle (marked with red dot); and
- On the right one-third of the view, the compromised wearing surface, at a thickness of 2 to 3 mm (0.08 to 0.12 in.), is still intact (has not yet scaled). Entrained air voids are present throughout and below the affected surface layer.

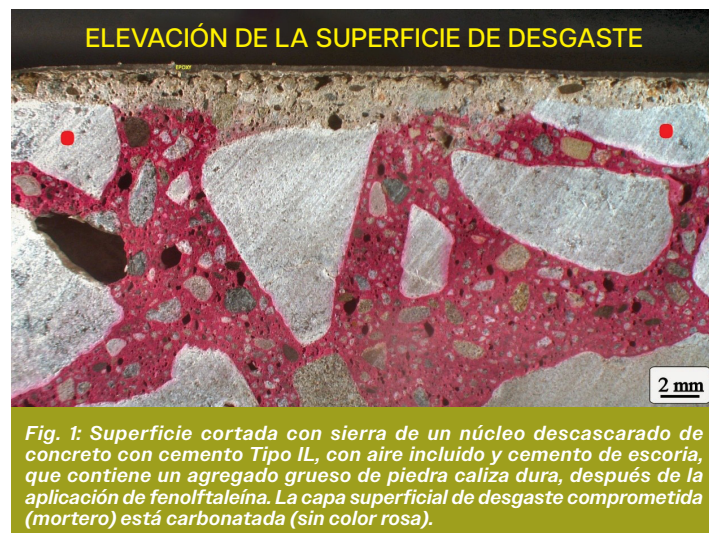
La Figura 1 muestra la superficie de un núcleo de concreto descascarado, cortado con sierra, en el que el compuesto cementante es una mezcla binaria de cemento Tipo IL y cemento de escoria. Antes del paso de corte con sierra, la superficie de desgaste del núcleo se recubrió con un adhesivo epóxico para preservar las características previas al corte. Poco después del corte con sierra, se roció la superficie con una solución indicadora de pH (fenolftaleína). En una superficie de concreto que no está carbonatada ( $\text{pH} \geq 13$ ), la superficie tratada adquiere un color rosa brillante. Cuando el concreto está carbonatado ( $\text{pH} < 10$ ), no se produce ningún cambio de color. Las características de interés en la Fig. 1 son:

- La capa superficial desgastada es la capa carbonatada de 2 a 4 mm (0.08 a 0.16 pulgadas) de espesor (sin color rosa). Hay una transición abrupta entre la capa carbonatada y el concreto resistente al descascaramiento subyacente. Por lo general, solo se pierde la delgada capa carbonatada en el proceso de descascaramiento. Las pruebas realizadas durante el examen petrográfico revelaron

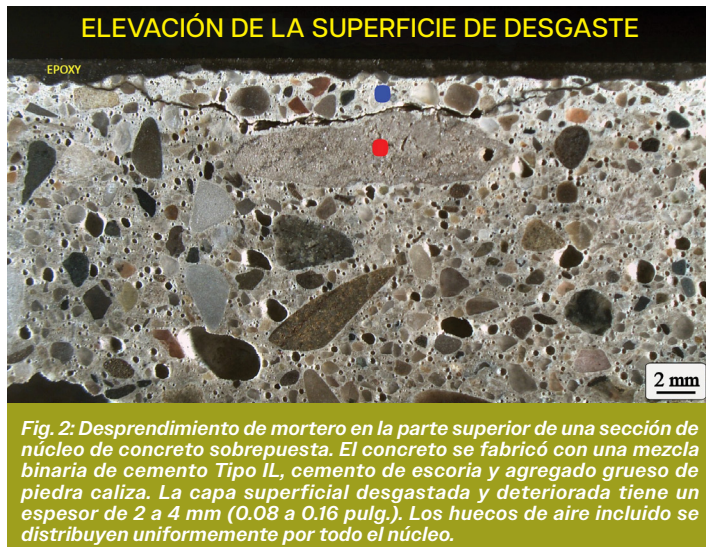
La Figura 2 muestra una superficie sobrepuesta de una sección del núcleo de concreto con levantamiento de mortero, en una región de la superficie de desgaste, donde aún no se ha producido el descascaramiento (pero es incipiente). El concreto contiene aire incluido, y los huecos de aire están presentes en la capa superficial de desgaste comprometida, lo que indica que la inclusión de aire no ha hecho que la capa afectada, debilitada y porosa, sea inmune al descascaramiento.

Otras características que se muestran en la Fig. 2 incluyen:

Debido a una mayor relación  $a/cm$ , la capa superficial desgastada de 2 a 4 mm de espesor, es de color más claro que el concreto subyacente (una característica para el diagnóstico);

- Una mayor relación  $a/cm$  en la capa afectada causó un alto grado de permeabilidad y porosidad capilar en la pasta de cemento. El agua de la superficie de la losa se ha desplazado rápidamente hacia y a través de la capa porosa, hasta llegar a las partículas del agregado grueso de piedra caliza cercanas a la superficie (marcadas con un punto rojo). En el escenario de descascaramiento del mortero, las partículas del agregado grueso son sólidas y resistentes al congelamiento y deshielo.

- Cuando se congelan en condiciones de saturación de agua, las partículas de piedra caliza duras se expanden elásticamente y levantan la capa de mortero debilitada que las recubre (marcada con un punto azul). Esta característica microestructural es común en los concretos descascarados que tienen una capa superficial desgastada. Las partículas de agregado duro participan en el descascaramiento, pero no son la causa del mismo. El ejemplo que se muestra aquí es un descascaramiento incipiente del mortero. Los ciclos continuos de congelamiento y deshielo acabarán provocando el descascaramiento de la capa de mortero dañada, y

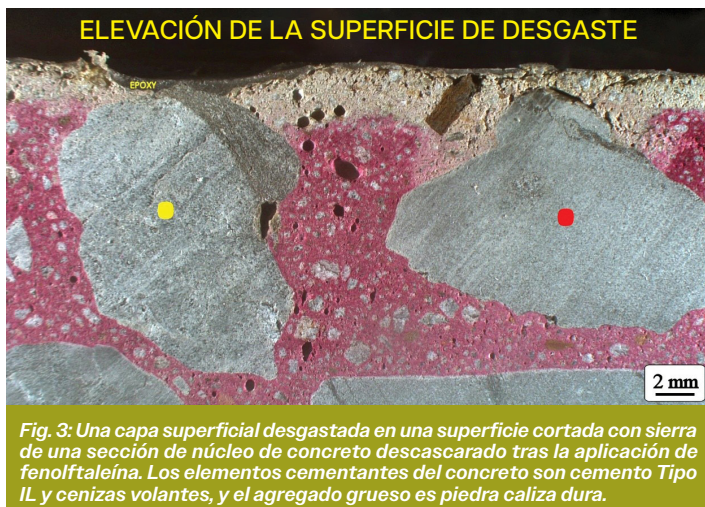
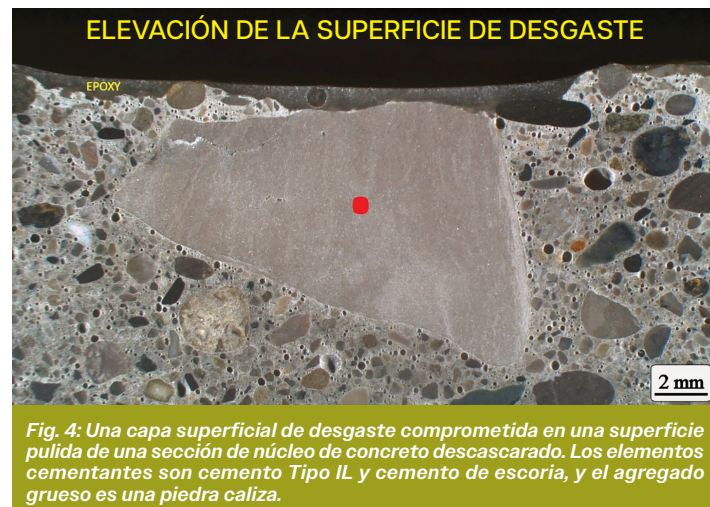
En las Fig. 3 y 4 se muestran otros ejemplos para el diagnóstico de estas características microestructurales en concretos con descascaramientos. En la Fig. 3, los ingredientes cementantes son cemento Tipo IL y ceniza volante, y las características de interés incluyen:

- La capa superficial desgastada carbonatada (sin color rosa) tiene un espesor de entre 2 y 6 mm (0.08 y 0.24 pulg.);
- En el lado izquierdo de la sección central hay un agregado grueso de piedra caliza dura (marcada con un punto amarillo) que forma parte de la característica de descascaramiento del mortero. En esta ubicación, la capa superficial afectada se ha perdido por completo (descascarada). Obsérvese que aún quedan restos de mortero adheridos a la partícula, lo que confirma una unión adecuada entre la pasta de cemento y el agregado; y
- En la parte central y derecha de la imagen, la capa superficial desgastada sigue intacta y muestra otro ejemplo del descascaramiento incipiente en el mortero sobre el agregado grueso de piedra caliza dura (marcada con un punto rojo). Obsérvese el aumento de la profundidad de la capa carbonatada a ambos lados de la partícula de agregado.
