# Evaluation of Degree of Rusting on Prestressed Concrete Strand

*Presents a procedure for classifying the degree of rust on a piece of prestressing strand and discusses the reasons for acceptance or rejection of each classification. Visual standards are developed by which inspectors can identify the degree of corrosion at which pitting occurs.*

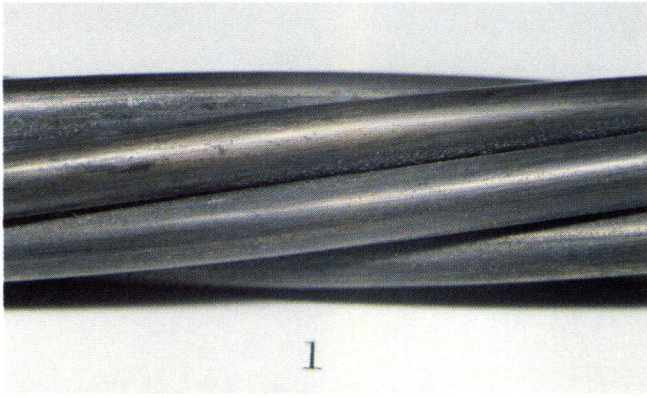
Photo 1. Strand surface before cleaning.

Bright strand refers to the surface quality of uncoated strand with no signs of rusting. This type of surface finish is obtained by the conventional dry drawing process, followed by stranding and the stress relieving operation.<sup>1</sup> Photo 1 shows a typical strand surface before cleaning.

Photo 1 represents a new strand with no rust and has a bright surface. Photos 2 through 6 illustrate various amounts of corrosion on strand samples that were exposed to a corrosive environment for different lengths of time and include some pits that are to be considered cause for rejection.

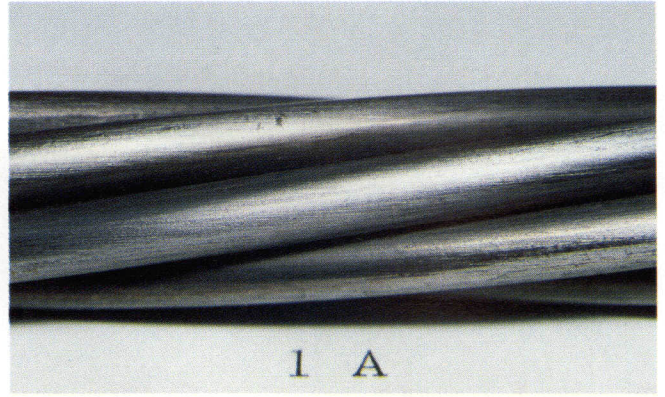
Photo 1A. Strand surface after cleaning.

After the samples were cleaned, additional photographs were taken and these are marked as Photos 1A through 6A. All pictures with the suffix "A" were taken after cleaning and are placed next to those taken prior to cleaning for ease in making the comparison.

It is the opinion of the writer that Picture Sets 1 through 3 are acceptable. Picture Set 4 is borderline and is subject to discussion, agreement or compromise. Some engineers may find this level of rusting objectionable for critical applications. Picture Sets 5 and 6 are pitted and unacceptable.

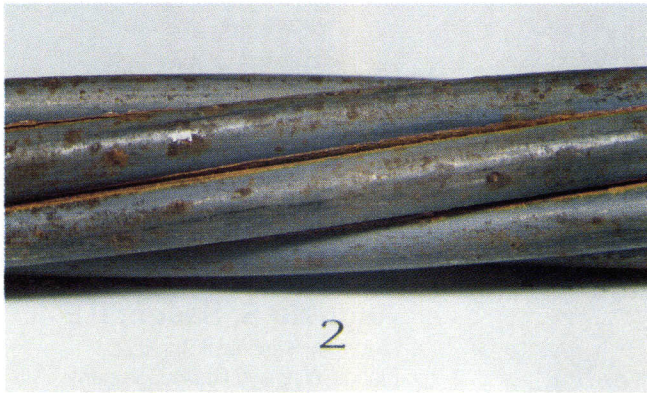
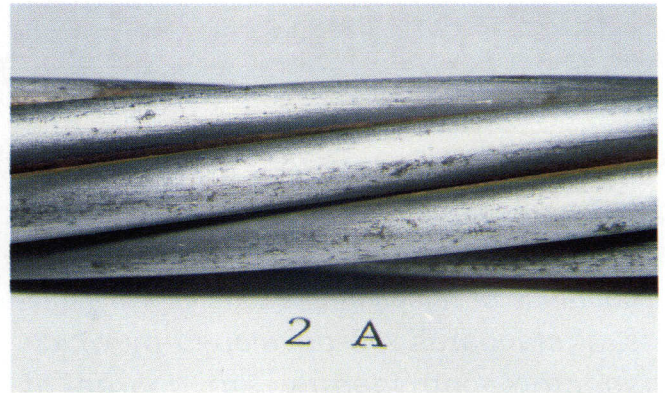
Photo 2. Strand surface before cleaning.

Photo 2A. Strand surface after cleaning.

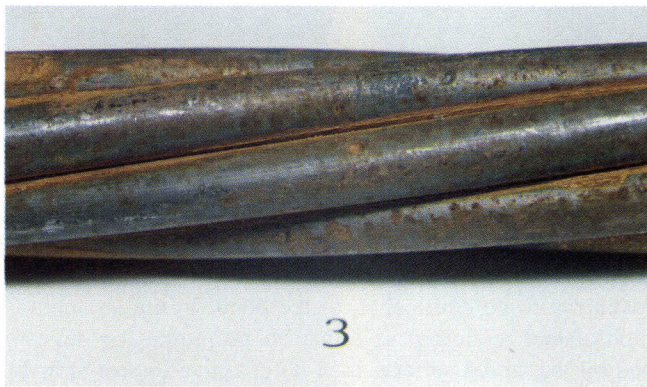
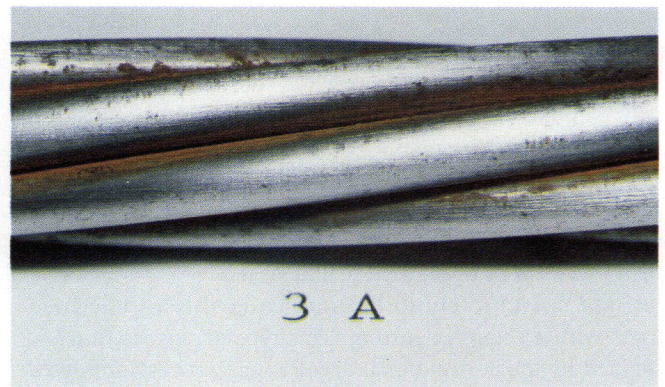
Photo 3. Strand surface before cleaning.

Photo 3A. Strand surface after cleaning.

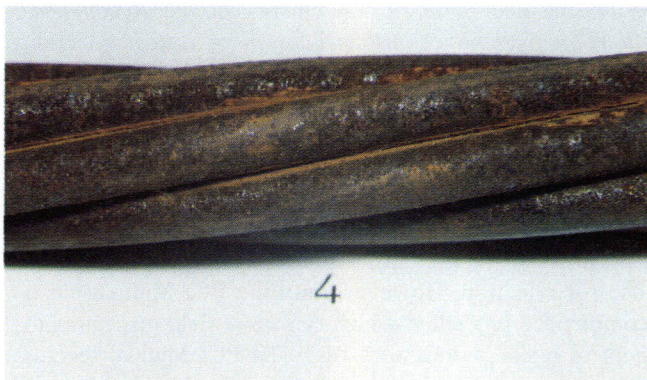
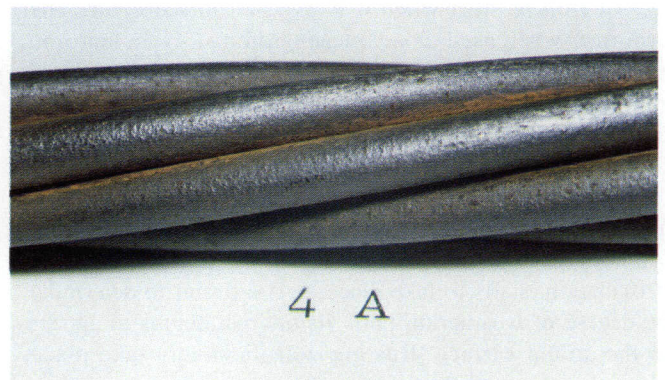
Photo 4. Strand surface before cleaning.

Photo 4A. Strand surface after cleaning.

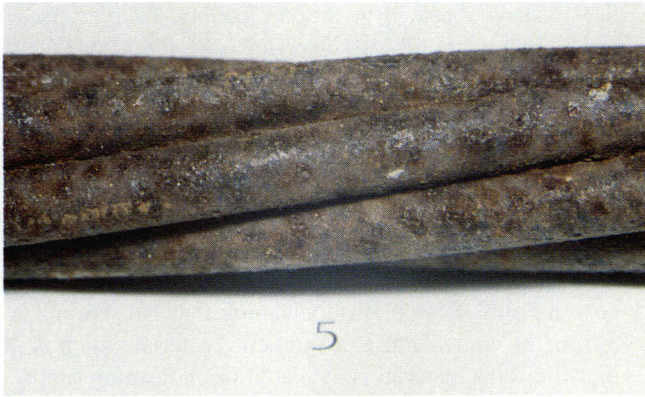
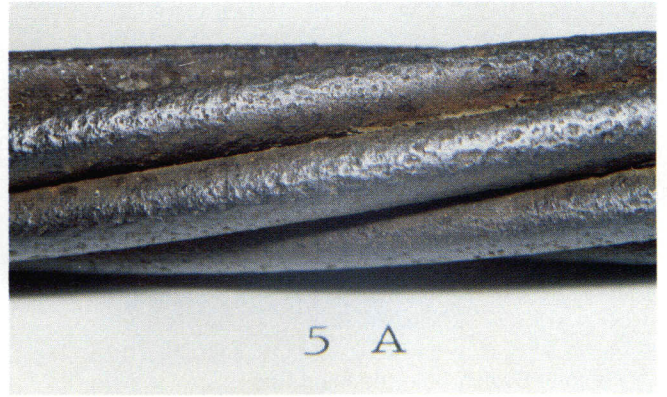
Photo 5. Strand surface before cleaning.

Photo 5A. Strand surface after cleaning.

The differences in values between Samples 1 through 4 are within the normal variation in the testing procedure and equipment. Samples 5 and 6 showed a significant drop in breaking strength compared to Sample 1 because of excessive pitting, as shown in Photos 5 and 6 and also in Photomicrographs 5 and 6. However, the breaking strengths are high enough to meet the minimum requirement of ASTM A 416 because the loading was axial and the decrease in cross-sectional area was very small.

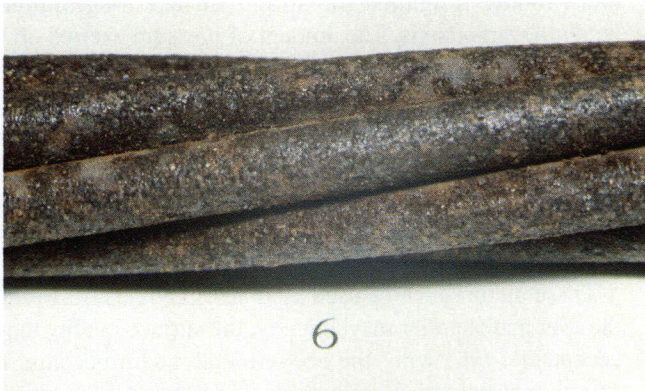
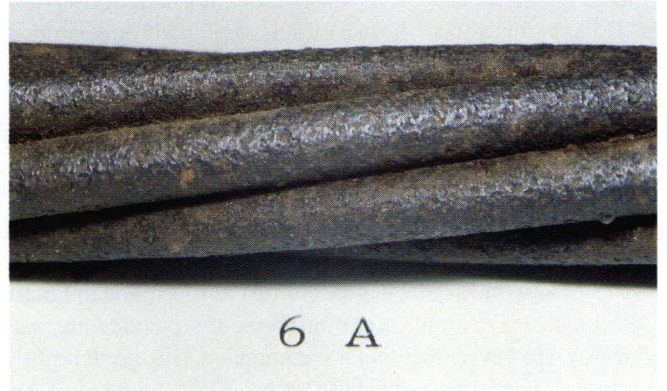
Photo 6. Strand surface before cleaning.

Photo 6A. Strand surface after cleaning.

Samples were removed at different exposure times, such that the second set of samples has a comparable amount of rusting as shown in Photos 2 through 6. It took 19 months of exposure time to get the surface condition similar to that shown in Photo 6.

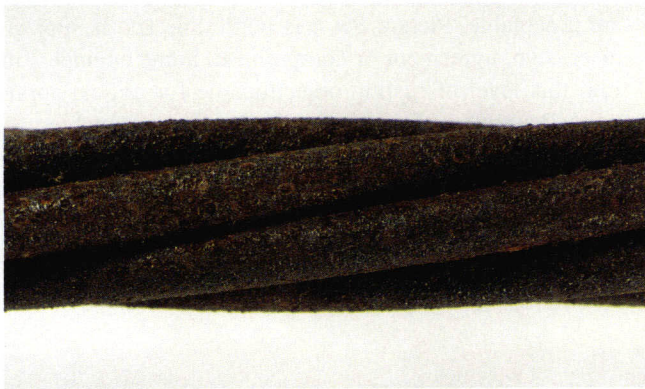
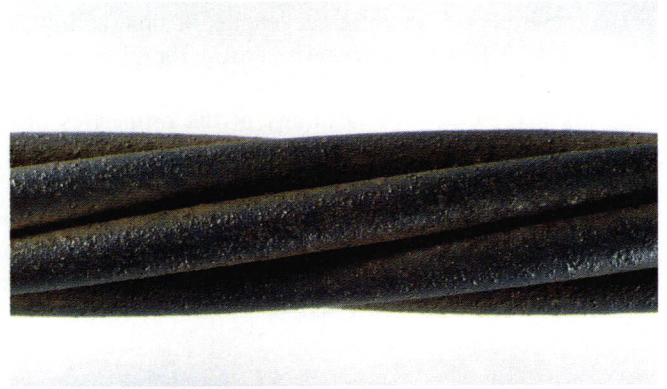
Photo 7. Strand surface before cleaning.

Photo 7A. Strand surface after cleaning.

The corrosion and pitting in the center wire were examined. A rusty strand sample shown in Photo 7 has corroded the outer wires with the same degree of pitting as in Picture Set 5. After cleaning with a Scotch Brite pad, the pitted surface is revealed as shown in Photo 7A.

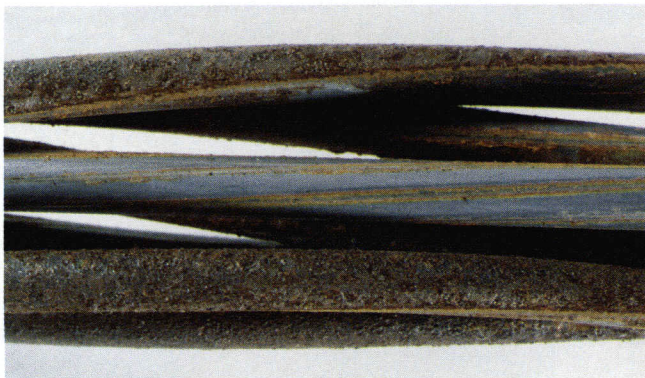
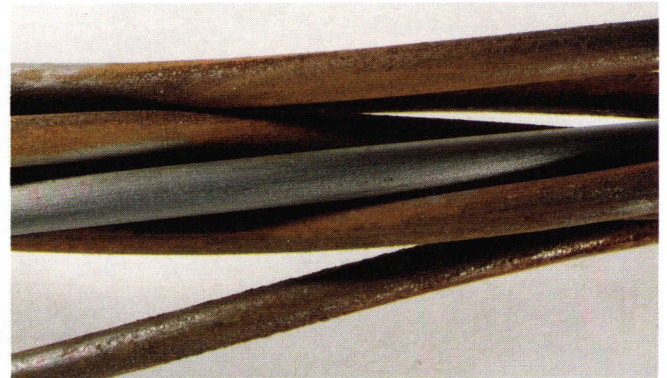
Photo 8. Strand surface before cleaning.

Photo 8A. Strand surface after cleaning.

When the strand was opened by unstranding the outer wires, the center wire showed that it was not pitted. A closeup picture of the center wire after unstranding is shown in Photo 8. The center wire did not show any pitting, as shown in Photo 8A, after cleaning with the Scotch Brite pad.

These two pictures indicate that pitting due to corrosion takes place at the outer wires, which are exposed to a humid atmosphere, while the center wire is protected. A similar condition exists on portions of strand located inside the reel, which are protected by the outer layers. The outer layers get full exposure to the atmosphere and have a heavier degree of rusting compared to the inner layers.

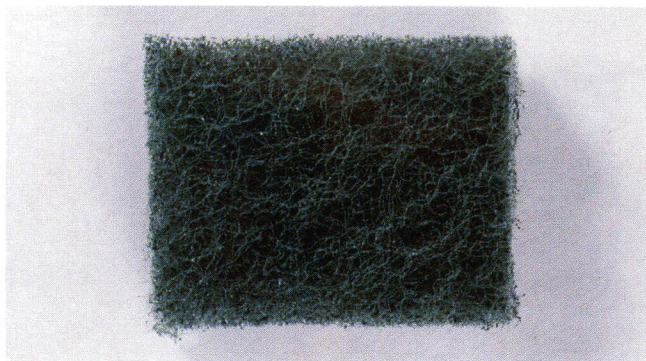
Photo 9. Scotch Brite Cleaning Pad.

In order to evaluate the extent of pitting, the superficial rust has to be removed. In the samples described herein, care was taken to not abrade the strand surface below the iron oxide or rust layer. This was accomplished by cleaning the surface with Scotch Brite™ cleaning pads in order to expose the pits. Scotch Brite Cleaning Pad No. 96, made by 3M, or its equivalent, is a synthetic material which is non-metallic. This material is available from cleaning supply retailers or supermarkets for general purpose cleaning. A sample of this material is shown in Photo 9.

Cleaning is accomplished by holding a new pad by hand and rubbing it against the strand surface longitudinally along the strand axis. The amount of pressure exerted on the pad against the strand is equivalent to that when cleaning pots and pans.

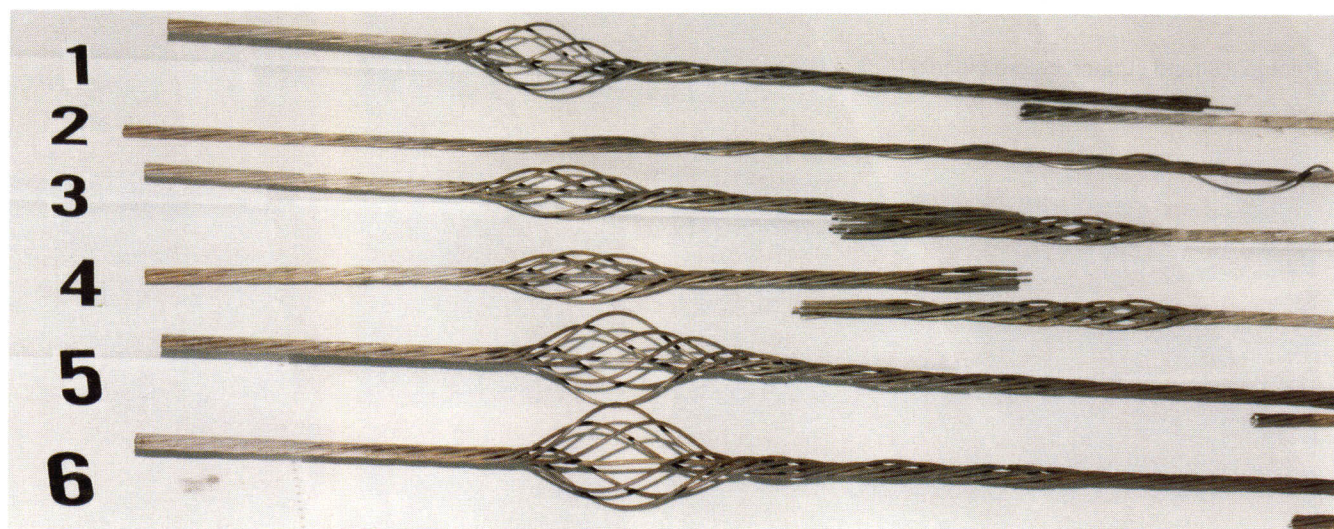
Photo 10. Samples after testing for mechanical properties.

Except for Sample 2, which broke with one wire fracture, all samples showed maximum breaking strength with seven wire fractures which occurred away from the grips of the tensile testing machine. This explains why Sample 2 has a slightly lower elongation value. The samples after testing are shown in Photo 10.

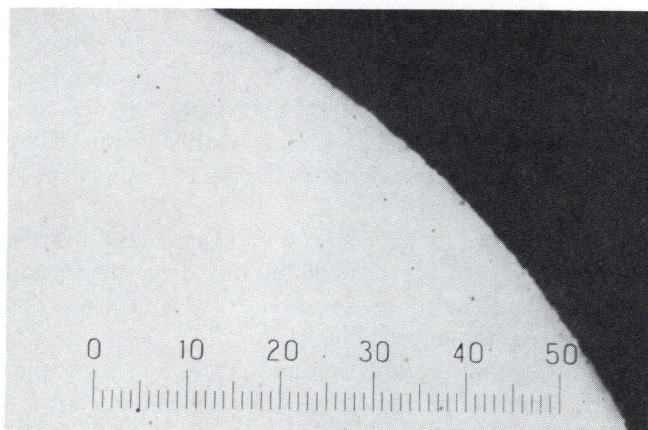
Photomicrograph 1. Sample from Photo 1.

The micro-examination was done by cutting a transverse section of the outer wire. The cut specimen was then mounted and polished using standard metallographic techniques for specimen preparation. The polished section was examined under a metallographic optical microscope at a magnification of 75X, but scaled down for publication.

Photomicrographs 1 through 6 show a section of the wire circumference from samples corresponding to Photos 1 through 6. Measurable depths of pits are observed in Photomicrographs 4, 5 and 6, and the corresponding measurements are shown in Table 3. One small division of the scale imprinted on the photomicrographs is equivalent to 0.00077 in. (0.02 mm).

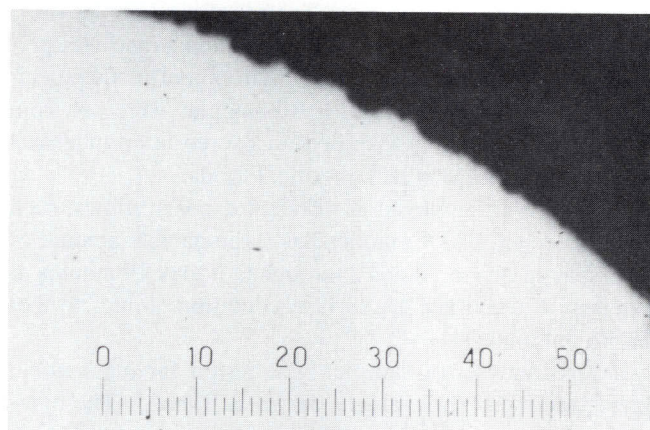
Photomicrograph 4. Sample from Photo 4.

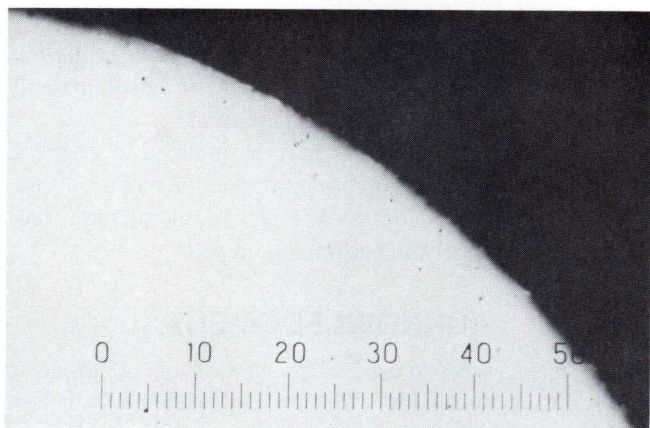
Photomicrograph 2. Sample from Photo 2.

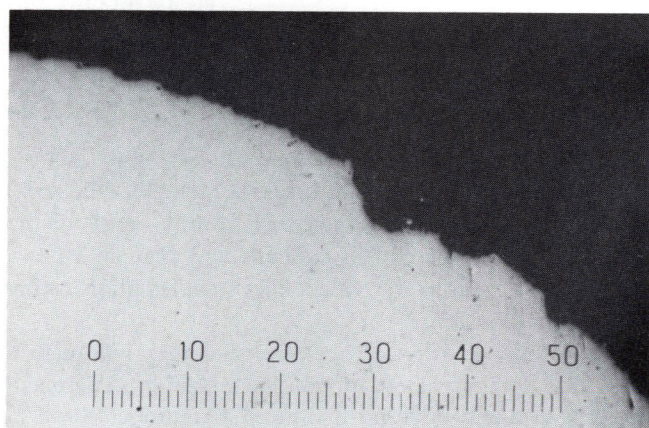
Photomicrograph 5. Sample from Photo 5.

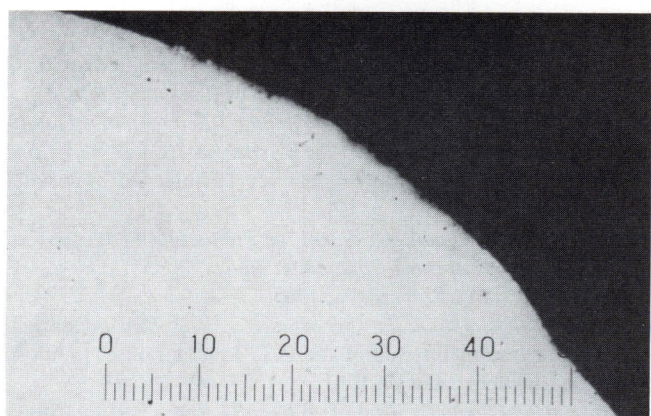
Photomicrograph 3. Sample from Photo 3.

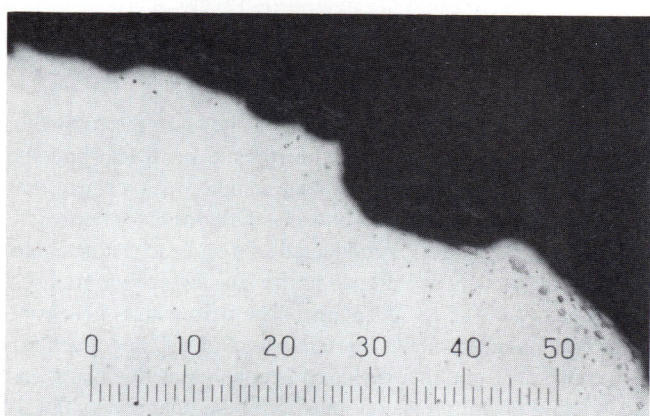
Photomicrograph 6. Sample from Photo 6.

Based on these examinations, it can be deduced that the sample with the deepest pits will fail first when subjected to cyclic loading. The pits are stress raisers which will serve as initiation sites for fatigue failure.
