Title No. 120-S58

Behavior of Unbonded Post-Tensioned Concrete Slabs Exposed to Fire

Keywords: cover thickness; fire-resistance performance; tendon configuration; unbonded post-tensioned (PT) slab.

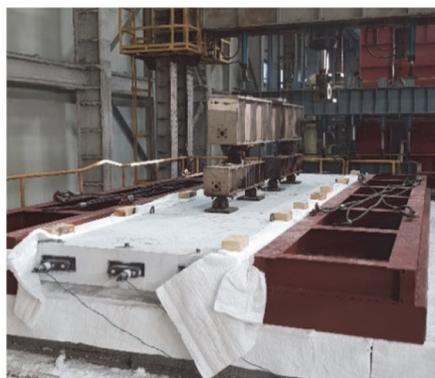
(a) Furnace, actuator, and insulated covers

(b) Front view (unit: mm). (Note: 1 mm = 0.0394 in.)

Fig. 4—Fire test settings.

Figure 4 shows the fire test settings. The dimensions of the furnace were 6000 x 2400 x 1500 mm (236.4 x 94.6 x 59.1 in.). An internal column was located inside the furnace to protect it should the slab test specimen rupture. The slab specimens were simply supported on two transverse cylindrical rods, having a span length of 6200 mm (244.3 in.). Insulated covers were installed on both sides of the specimens to prevent temperature loss due to heat transfer between the furnace and the air and to preserve the furnace’s internal pressure. Sustained vertical loading was applied to each slab using a hydraulic jack, spreader beam, and four loading plates. A total force of 120 kN (27.0 kip), including the self-weight of the actuator, was applied to the slab. Said load corresponds to 40 and 37.5% of the moment capacity of the slabs having a thickness of 250 and 280 mm (9.9 and 11.0 in.), respectively. The furnace temperature followed the ISO 834-1:1999⁴³ time-temperature curve.

A wire linear variable displacement transducer (LVDT) was installed at the center of the slab to monitor the deflection of the slab during the fire tests. Self-made load cells were installed at anchorage points, as shown in Fig. 4(a).

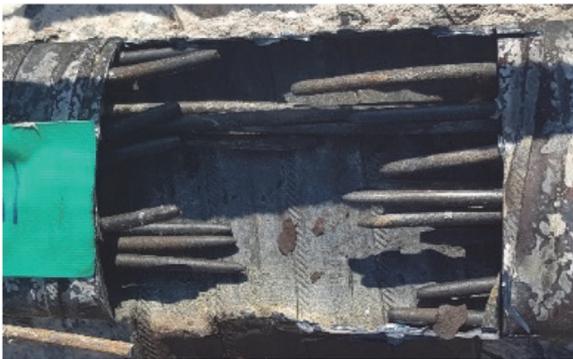
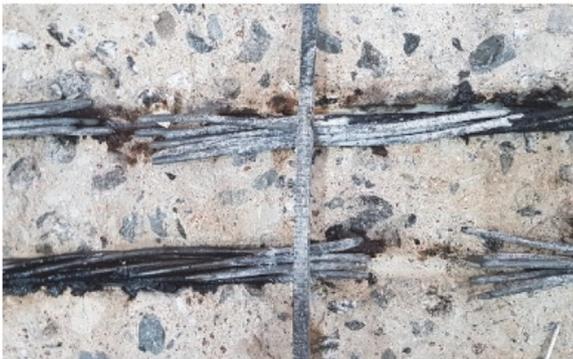
(a) PF-U45

(b) PF-S45

Fig. 12—Photographs of fractured tendons after fire tests.

The third stage was the period linked to rapid change in the tensile force and slab rupture. The deflection of the slabs rapidly increased as a result of the tendons being directly exposed to fire due to concrete delamination (blowout) and the accompanying fracture of the tendon near the support (Fig. 12) or failure to sustain imposed loading due to mechanical degradation.
