# **In-Service Behavior of a Cast-in-Place Segmental Concrete Box Girder Bridge**

**Presented to the American Concrete Institute Foundation**

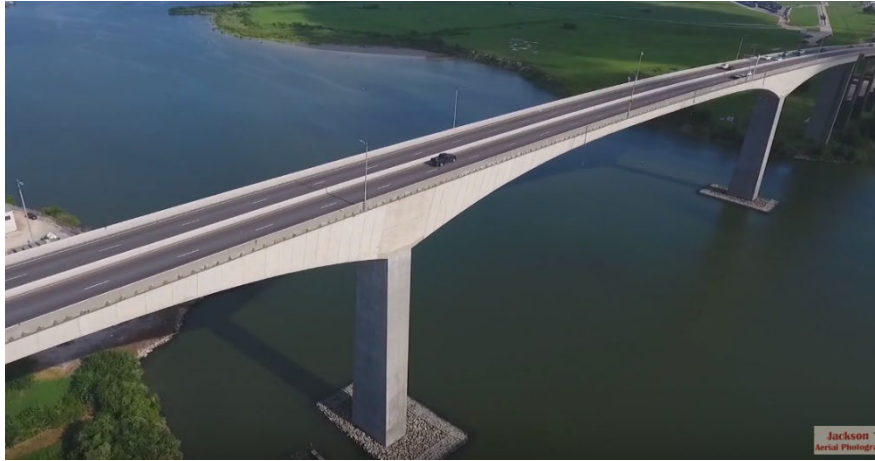
**Figure 1: Sam Houston Ship Channel Bridge (SHSCB)**

The goal of this study is to further the state of knowledge with regard to the behavior of segmental concrete box girder bridges. The existing Sam Houston Ship Channel Bridge (SHSCB) (Figure 1) is in the process of being replaced by the Harris County Toll Road Authority (HCTRA) in Houston, Texas, after nearly 40 years of service due to traffic volume and ship clearance demands. SHSCB is a critical structure in the history of segmental bridges. When constructed, it was the longest of its kind in the United States [1]. A unique opportunity is presented now that the structure is being decommissioned. The project team is taking full advantage of this situation through a detailed field study that can identify the in-service behavior, primarily under thermal variations<sup>1</sup>.

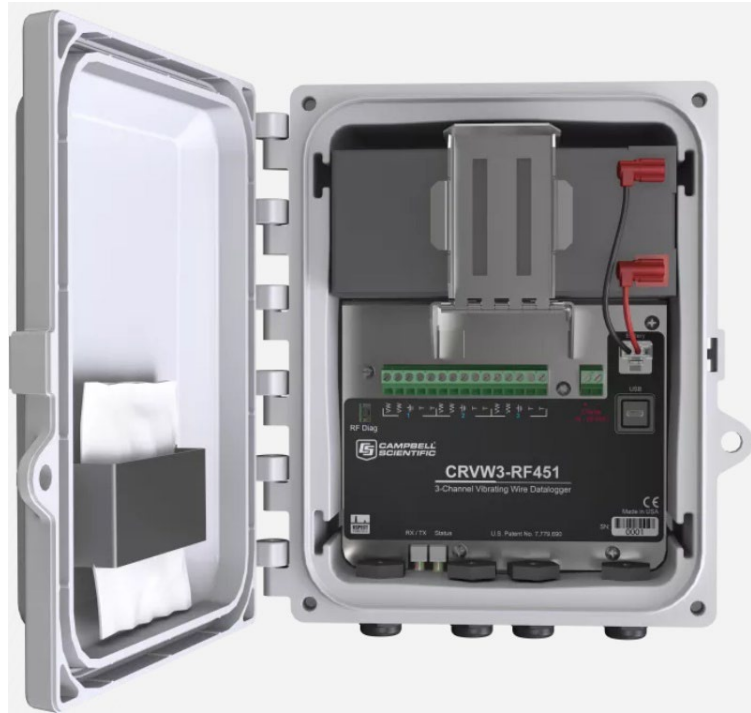
**Figure 10: Campbell Scientific CRVW3 Datalogger**

Campbell Scientific was the logical choice for the DAQ system due to its proven capabilities in these areas. The CRVW3 datalogger was selected (Figure 10). This system has the capability to sample three paired VW sensors with thermistors at slow speeds. It is powered by a 12-volt battery that can run for over six months, depending on the sampling rate. The entire DAQ system comes housed in a rugged weatherproof enclosure. There is an option for an RFI radio, but that was not selected for this study due to the additional power drain and cost. Each datalogger runs autonomously. The download of the data was conducted through a direct connection.

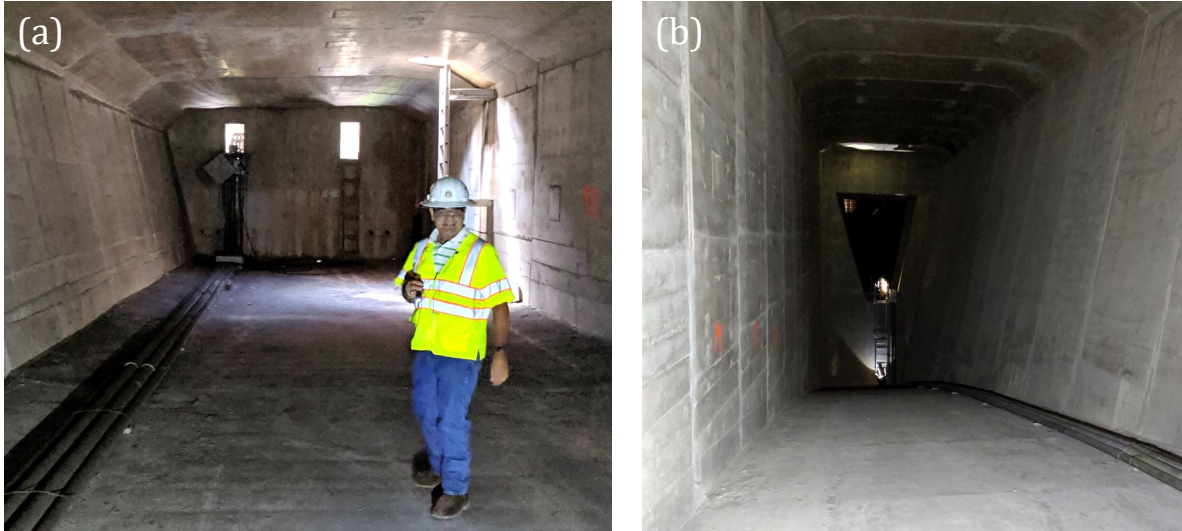
**Figure 11: Inside SHSCB Showing the (a) End Diaphragm and (b) Pier Diaphragm**

installations included handheld lighting and headlamps. In addition, the scale of the two diaphragms at each pier was better appreciated. All work in the center span required transporting equipment over two sets of ladders. Figure 11 shows photos from inside the box girder looking at the end diaphragm (a) and the pier diaphragm (b).

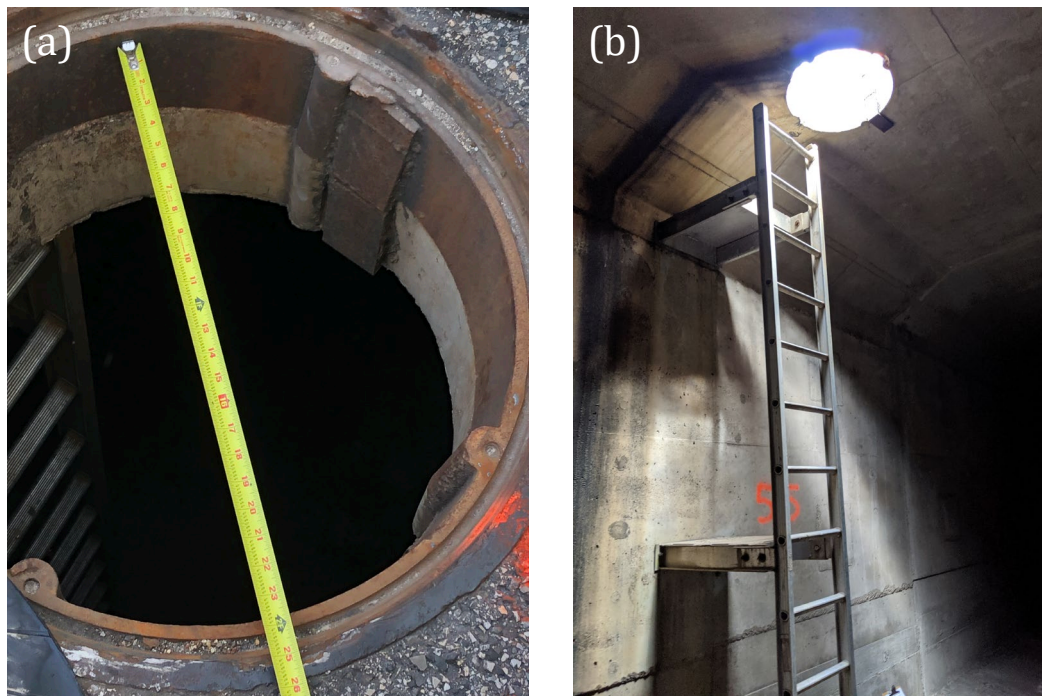
**Figure 12: SHSCB (a) Manhole and (b) Ladder Access Inside the Segmental Box Girder**

Other helpful information included the dimensions of access holes. The manhole into the box girder and the hole between the two cells were relatively small. Only narrow ladders and equipment could be used (see Figure 12).

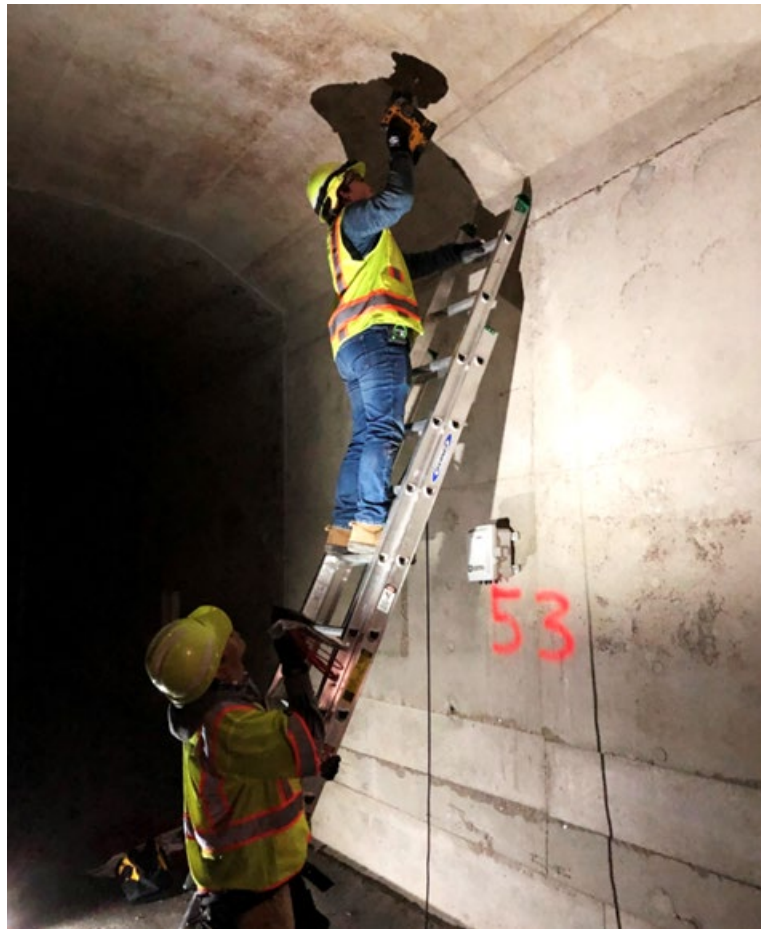
**Figure 13: Installation of Strain Gauge in Section 1**

1. Identify the location with the cross-section
2. Mark the holes to be drilled
3. Drill pilot holes
4. Drill  $\frac{1}{2}$ " diameter holes 1.0" deep (see Figure 13)
5. Clean out the holes of dust and debris
6. Verify the sensor with a dry fit
7. Inject adhesive into the holes and install the gauge (see Figure 14)
8. After sufficient cure time, attach the plucking coil assembly
