Cracking Behavior of Ceramsite Aerated Concrete Block Infill Wall in the Coastal Areas

Abstract

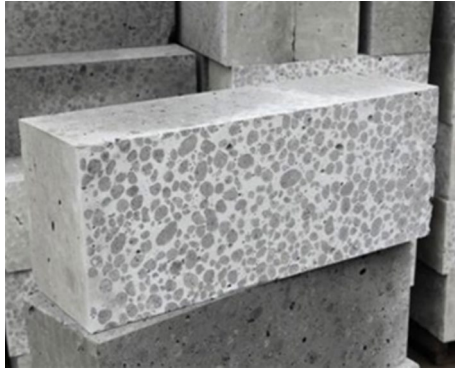
**Fig. 6** Photo of CACB

The infill walls were constructed using special masonry mortar and CACB with dimensions of 200 mm \times 240 mm \times 600 mm which were made in a local factory in Taizhou, Zhejiang province (Fig. 6). The mix proportions of CACB are shown in Table 3 and the mechanical properties are shown in Table 4. To ensure stability, five rows of tie bars were added based on the number of layers of blocks, with the first, third, and fifth layers having a tie bar length of 900 mm and the second and fourth layers having a length of 700 mm.

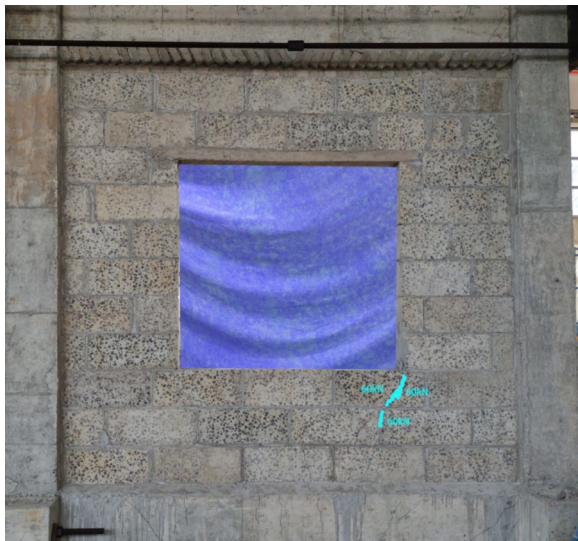
Fig. 11 First cracks at 60 kN. The lake blue lines were cracks of horizontal load 60 kN, the blue lines for 70–80 kN, the green lines for 100–140 kN, the yellow lines for 160–180 kN and the pink lines for 200–280 kN

of approximately 75° along the direction of the force. The maximum width of these cracks was measured at 0.22 mm. The maximum inter-story drift ratio was $\theta = 0.465 \times 10^{-3}$ (the expression of fractions is: $\theta = 1/2149$). The distribution of these cracks is shown in Fig. 11.

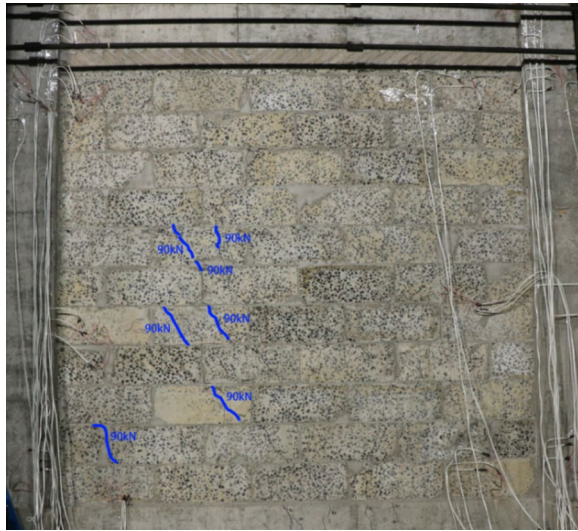
Fig. 13 First cracks at 90 kN. The blue lines were cracks of horizontal load at 90 kN, and light green lines at 100–140 kN, and yellow lines at 150–180 kN, and pink lines at 200–250 kN, and red lines at 280 kN

When subjected to a horizontal tensile force of 90 kN, the CACB infilled wall developed its first round of small cracks in the middle of the wall, with a width 0.2–0.3 mm. The maximum inter-story drift ratio was $\theta = 0.426 \times 10^{-3}$ (the expression of fractions is: $\theta = 1/2347$). The cracks were inclined down about 60° along the direction of loading, which was towards the right. The distribution of cracks is illustrated in Fig. 13.

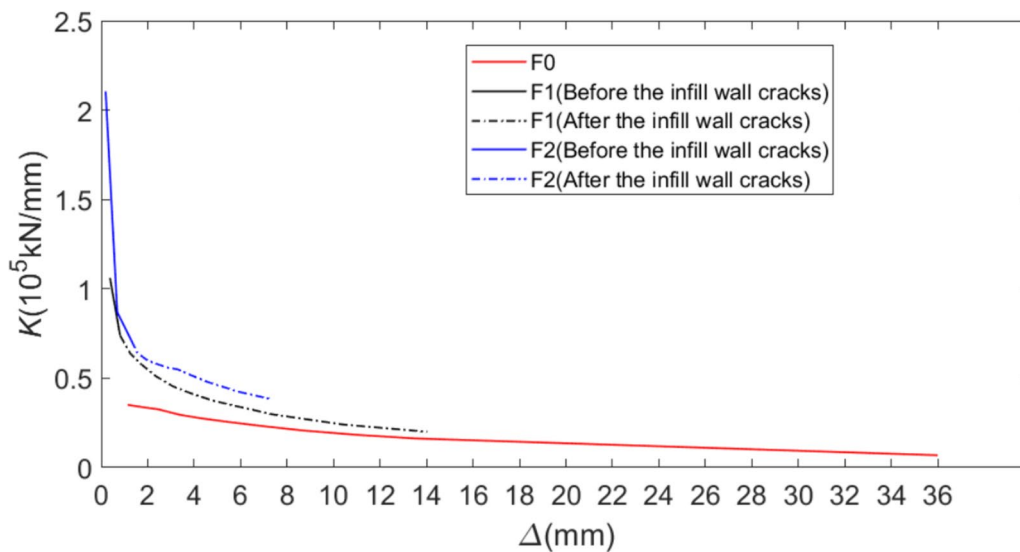
Fig. 18 Stiffness degradation with lateral drift

When cracks appear, the inter-story drift of F1 was 1.454 mm, and the measured stiffness decreased to 38.89% of its initial stiffness. In contrast, the inter-story drift of F2 was 1.332 mm, and the stiffness decreased to 32.09% of its initial stiffness. Compared with the initial stiffness, the stiffness of the windowed infill wall frame decreased by 61.11% when cracks appeared, while that of the windowless infill wall frame decreased by 67.91%. This indicates that cracks can cause a decrease in the stiffness of infill frame, and the stiffness of the windowless infill wall frame decreases more than that of the windowed infill wall frame. Figure 18 shows a graph of stiffness degradation with inter-story drift and cracking.
