Experimental Research of Fatigue Performance of OSDs with Severe Fatigue Cracking After Reinforcement Using UHPC Layer

Abstract

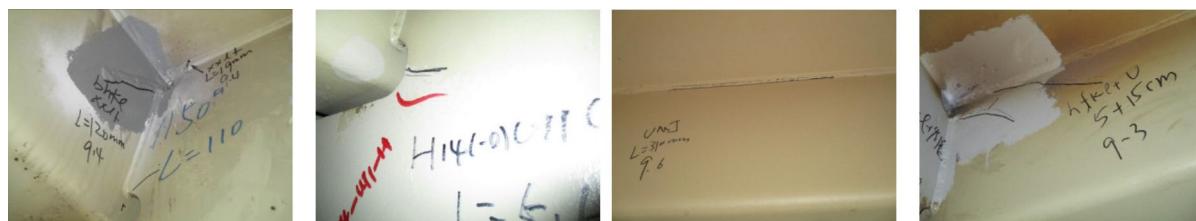
Fig. 1 Cracking condition after initial maintenance of the Junshan Yangtze River Bridge

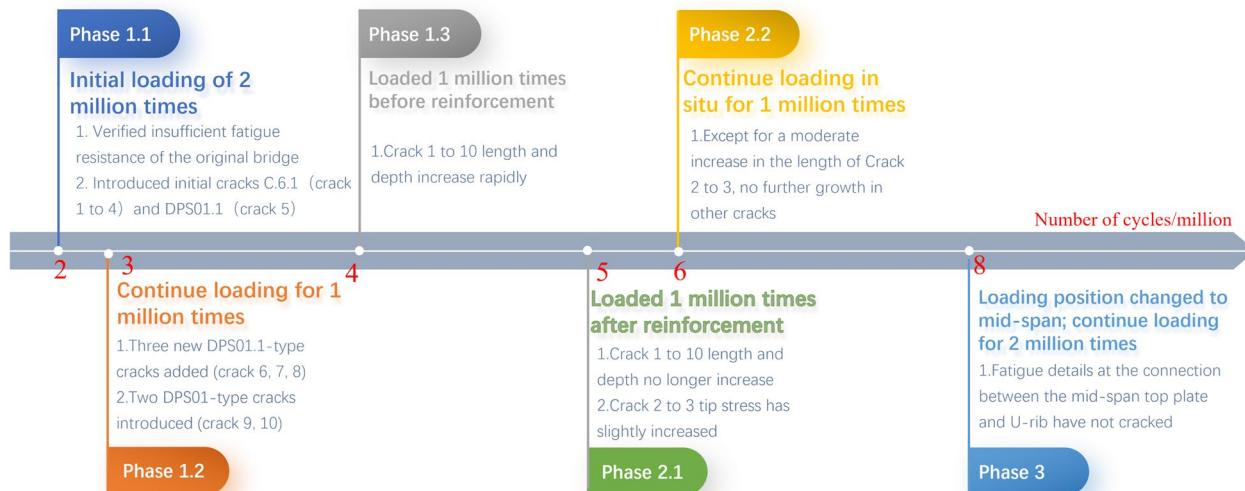
Fig. 11 Loading process axis diagram of the laboratory-test specimen

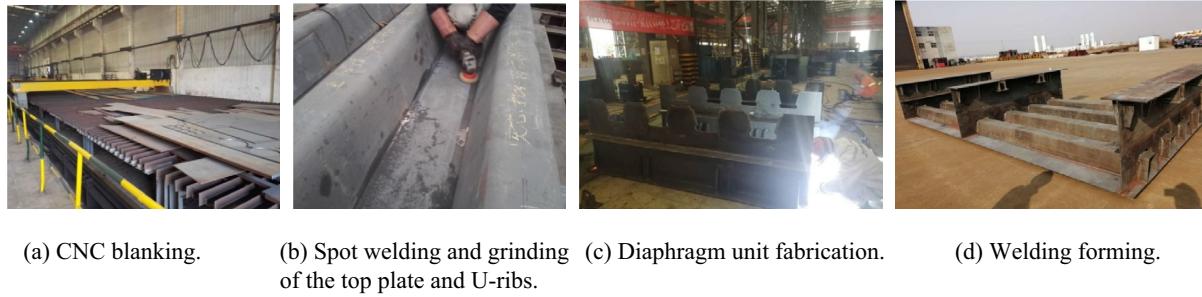
**Fig. 14** Main manufacturing process of the laboratory-test specimen pieces

Fabrication of the steel deck specimen was carried out by a professional bridge fabrication company in strict accordance with standard bridge manufacturing procedures. Figures 14 and 15 illustrate the key fabrication steps; Fig. 16 records UHPC casting and curing. All welding procedures, consumables, and inspection criteria match those specified for the actual bridge, ensuring that fatigue-sensitive weld details in the test model behave identically to those in service. No artificial notches were introduced; cracks were allowed to initiate naturally during Phase 1 loading.

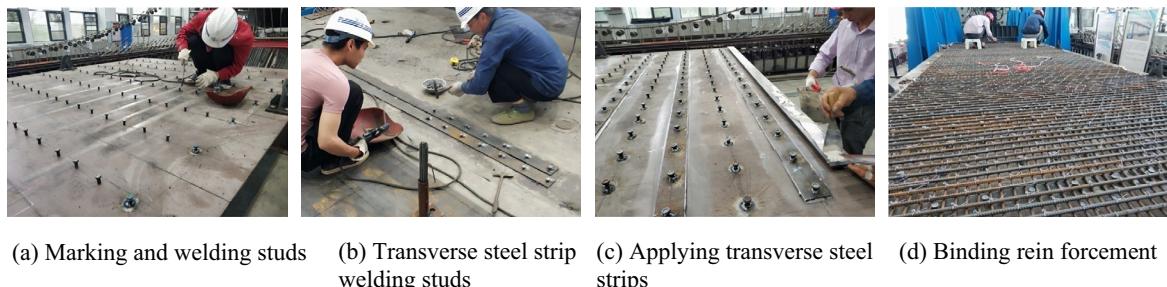
Fig. 15 Construction stage before UHPC casting
