# Assessment and Repair of a Precast Parking Deck with Construction Defects

Kyle Stanish, Ph.D., S.E., P.E.

Klein & Hoffman

# Background

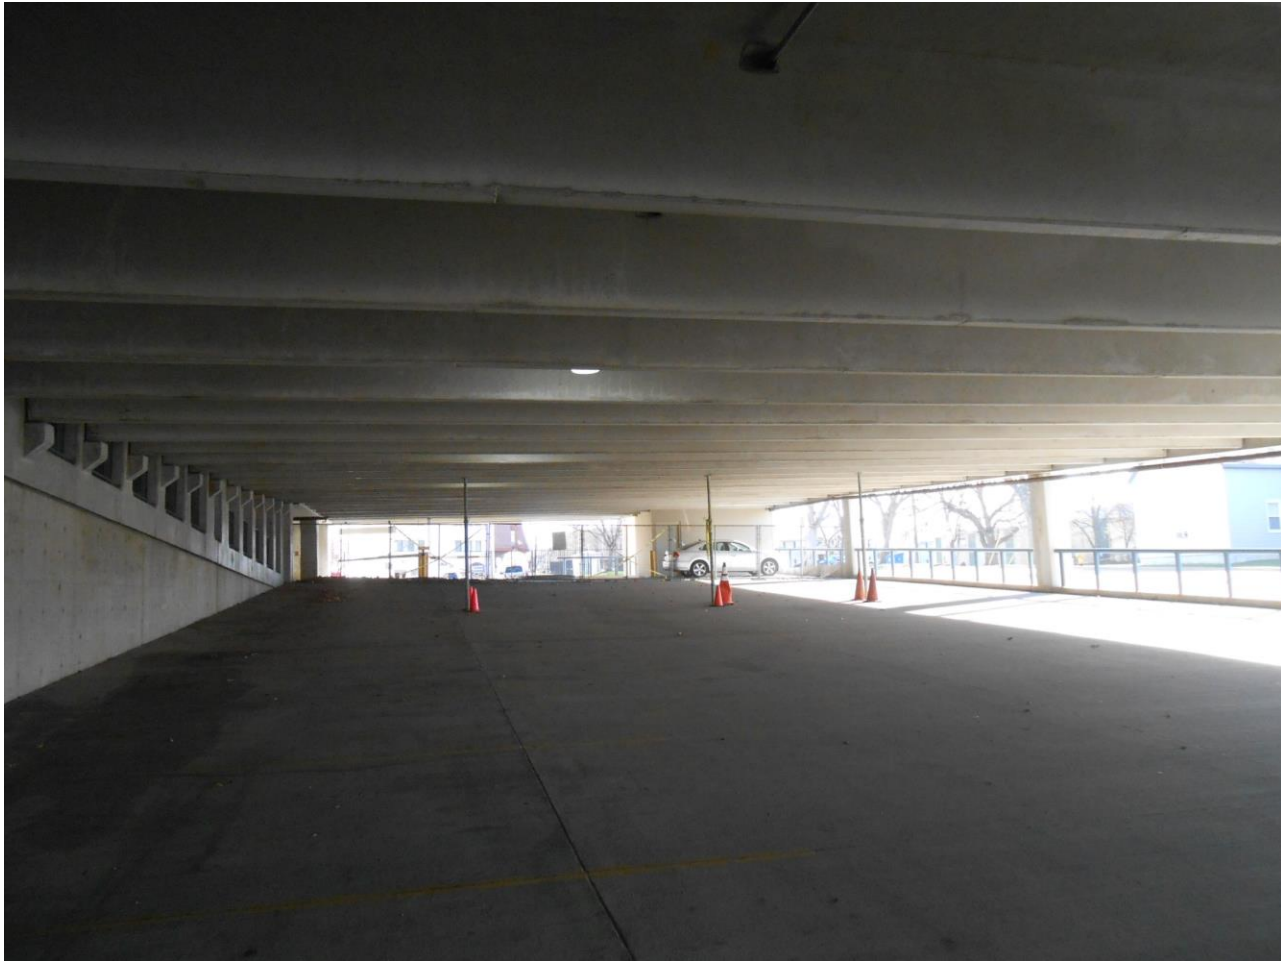
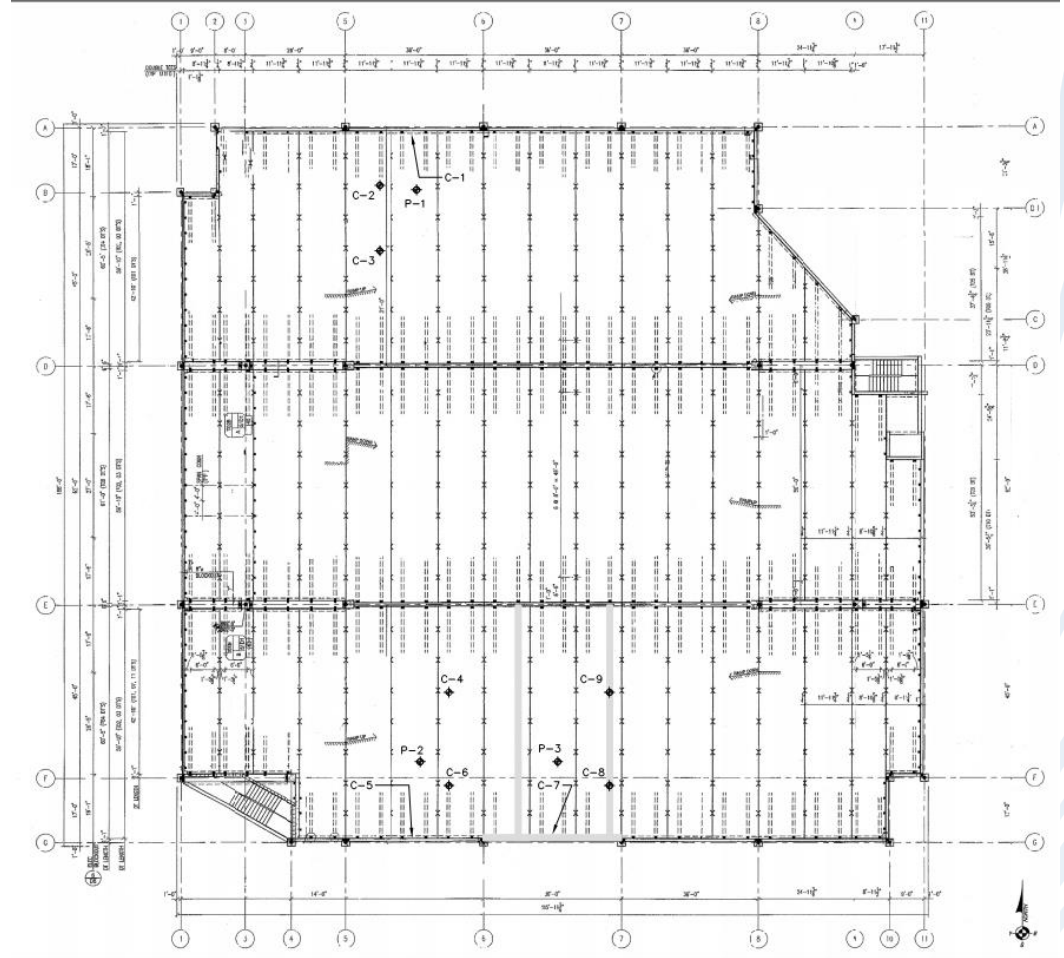
# Cracking of Double Tee Stem

- Piece drawings for each member
- Compared the shop drawings to the calculations
- Overall Dimensions - Agreed
- Concrete Strength – Agreed
- Number of Tendons – Agreed
- Size of Tendons:
  - Calculations: 0.6 in diameter tendons
  - Shop Drawings: 0.5 in diameter tendons

1. Confirmed load requirements
2. Calculated member applied load effects
3. Calculated capacities
  1. 0.6 in Strands - OK
  2. 0.5 in Strands – Did not meet strength requirements

- Exterior Post-tensioning of the Double Tee with the large crack
- FRP Strengthening of remaining double tees

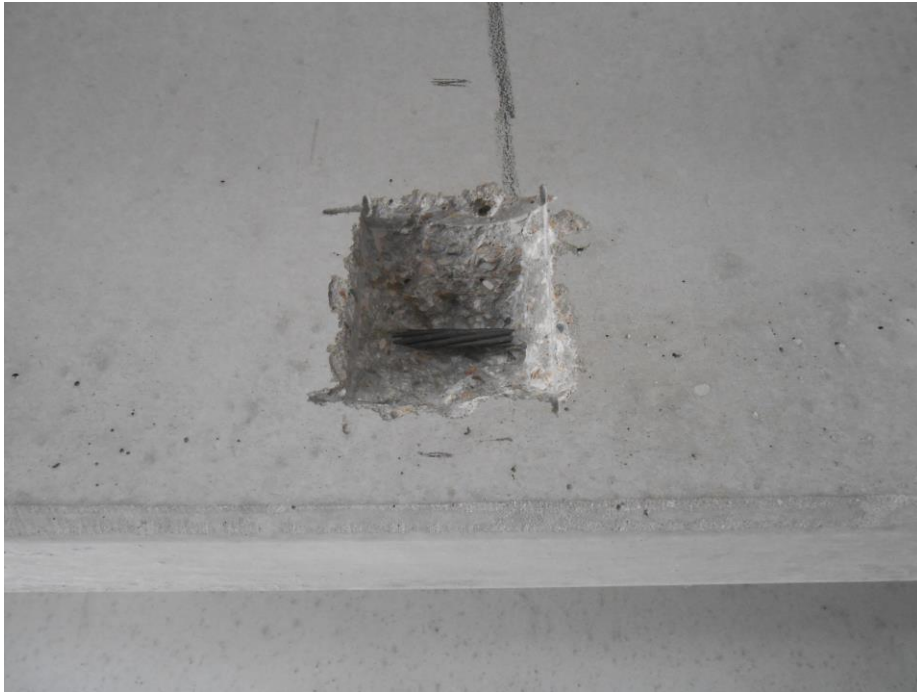
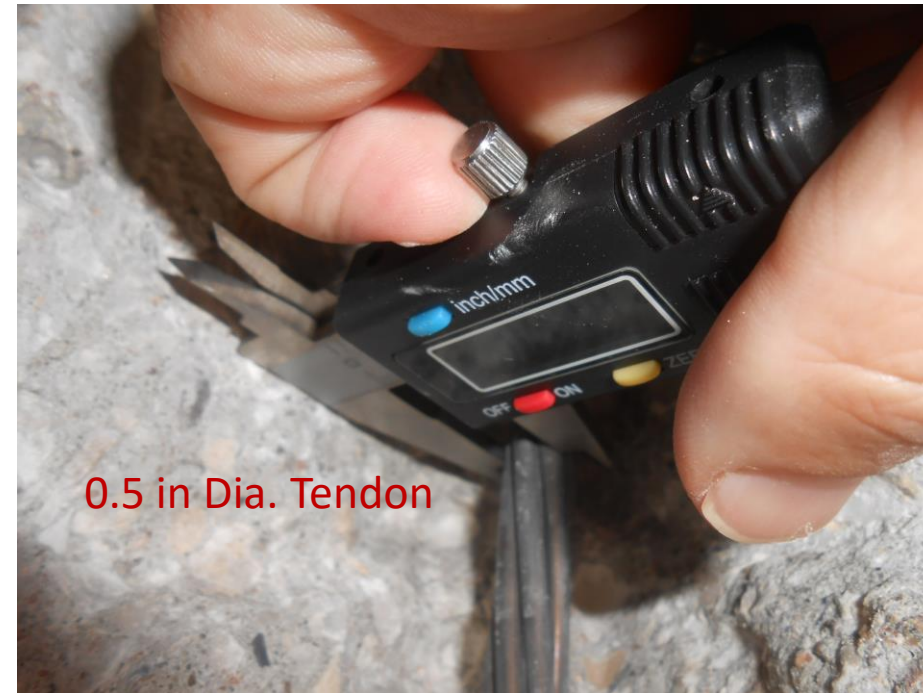
# Field Investigation

- Characterized the primary crack
  - Location, width at different points, height, looked at both sides
- Other tee stems
  - General location of cracks and width
  - Less detailed look
- Other locations in the parking facility
- **CONCLUSIONS** – the majority of the double tee stems on the lower level were cracked, but not under the roof level
